Remediation Summary and Closure Request

Turkey Track Line

Eddy County, New Mexico

NMOCD Incident # nAPP2212238312

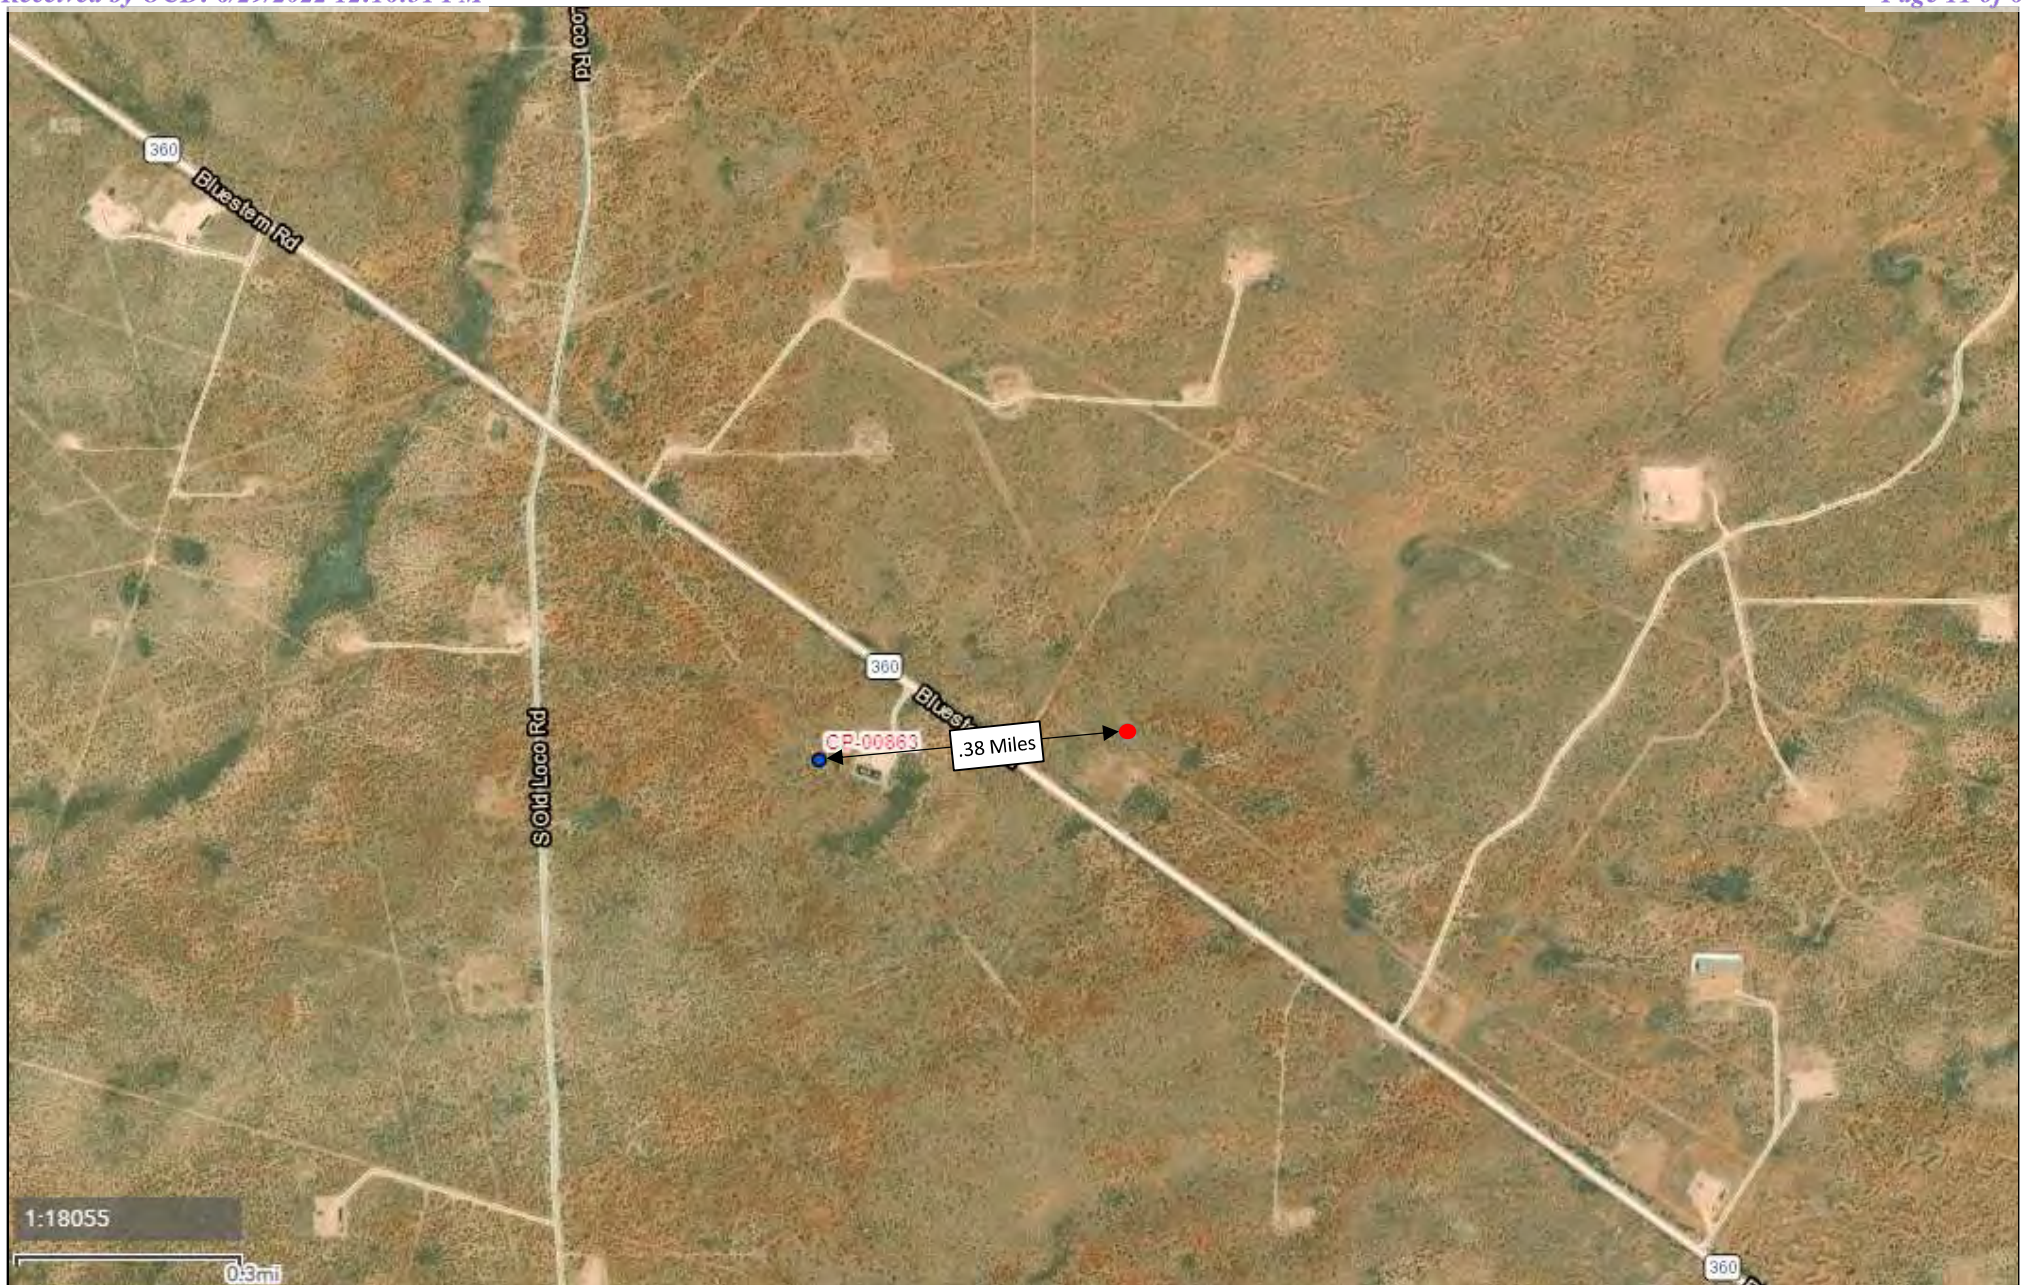
**Figure 2**

A search of the New Mexico Office of the State Engineer (NMOSE) and United States Geological Survey (USGS) groundwater databases was completed in an effort to determine the horizontal distance to known water sources within a half mile radius of the Release Site. Approximate depth to groundwater was determined using maintained and published water well data. Karst mapping indicates the site is not located in a Karst designated area. Depth to groundwater information is provided as Attachment II and the results are depicted on Figures 2 & 3.

OSE POD Locations Map
Frontier Field Services, LLC
Turkey Track Line
GPS: 32.721712, -104.050322
Eddy County

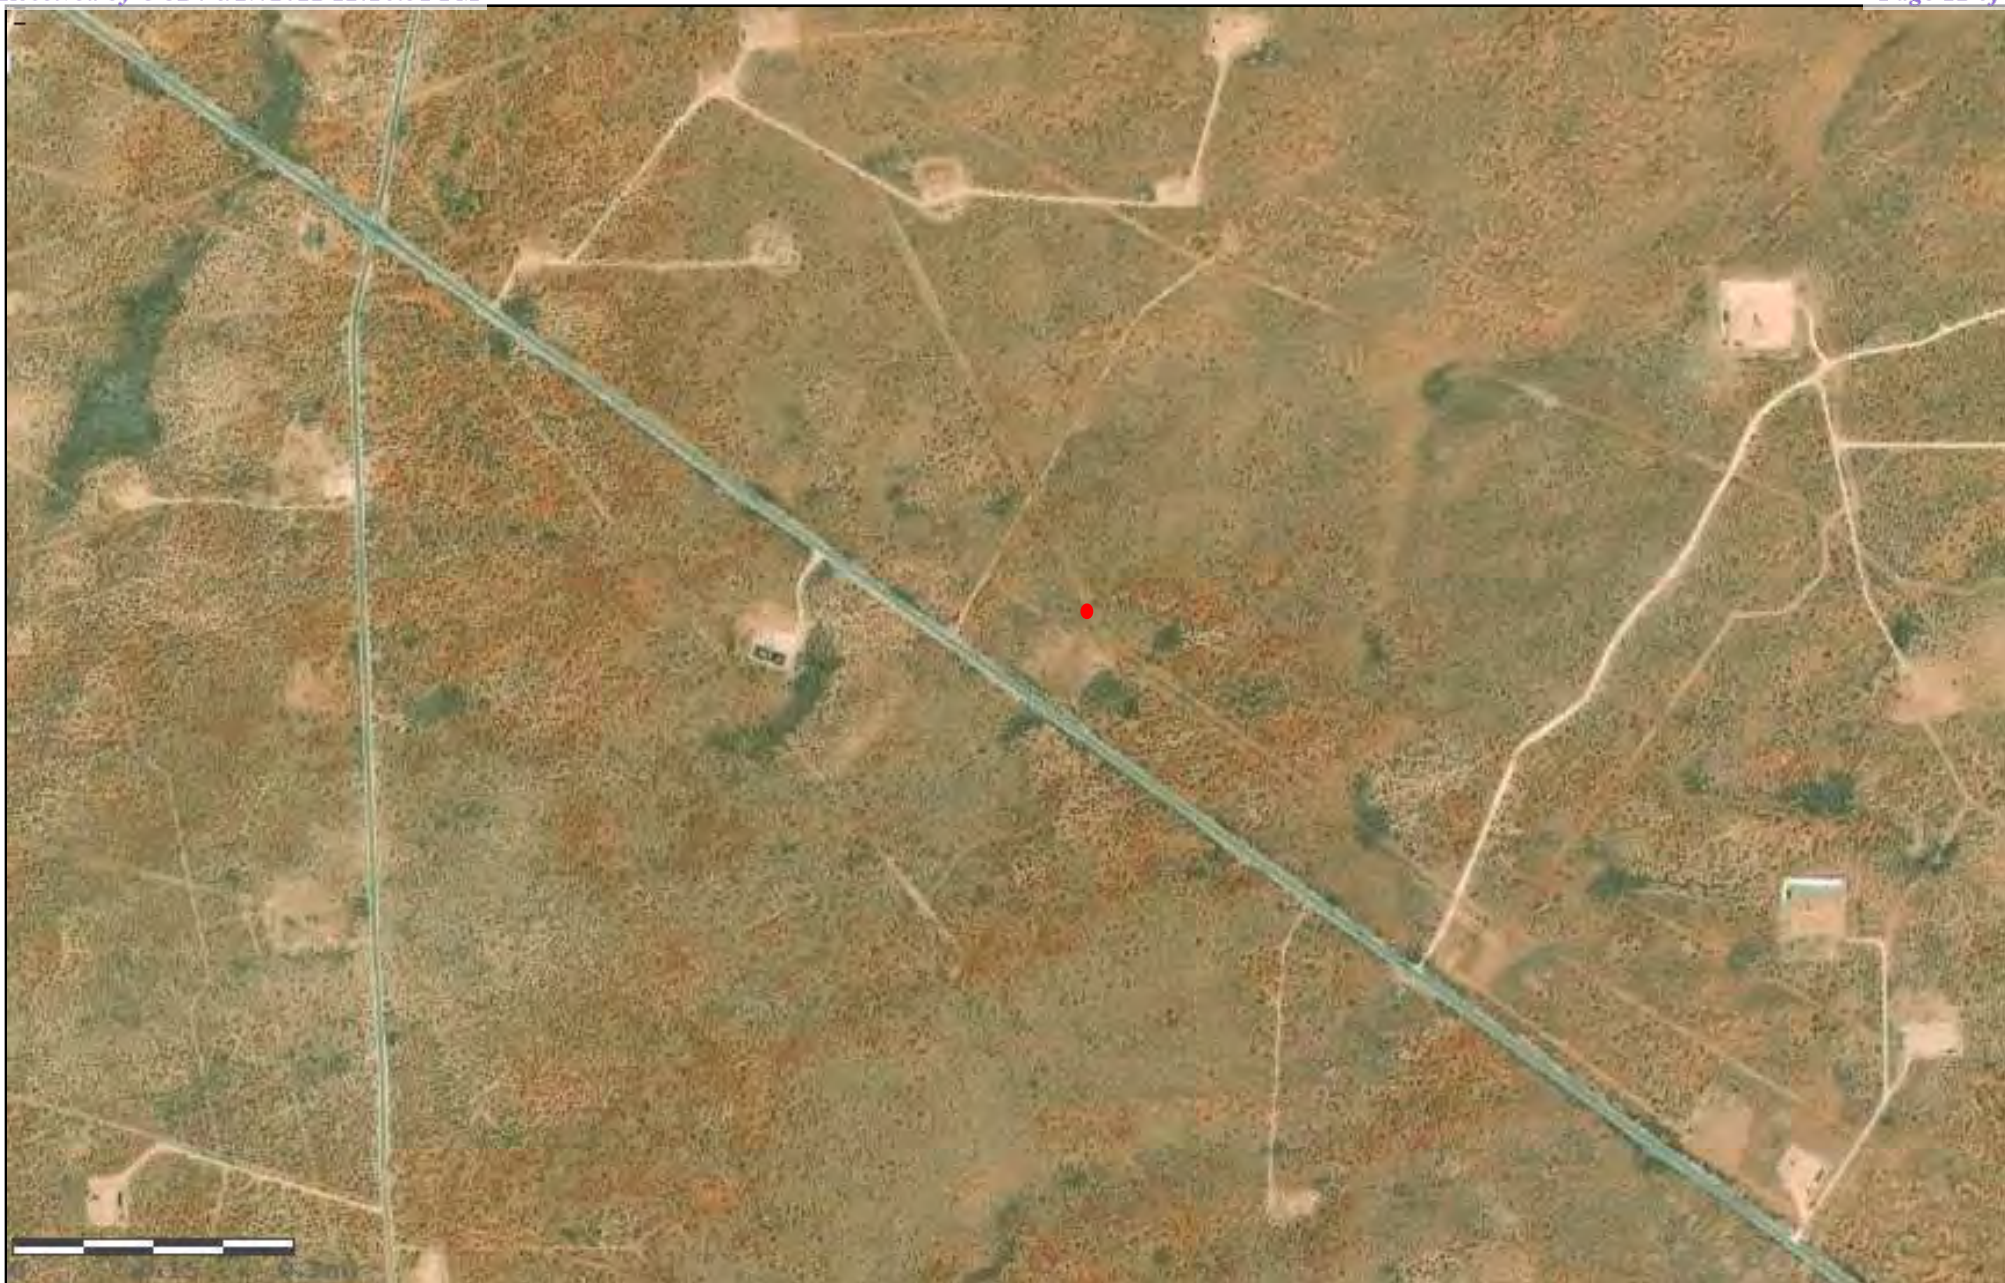
**Figure 3**

USGS Well Locations Map
Frontier Field Services, LLC
Turkey Track Line
GPS: 32.721712, -104.050322
Eddy County

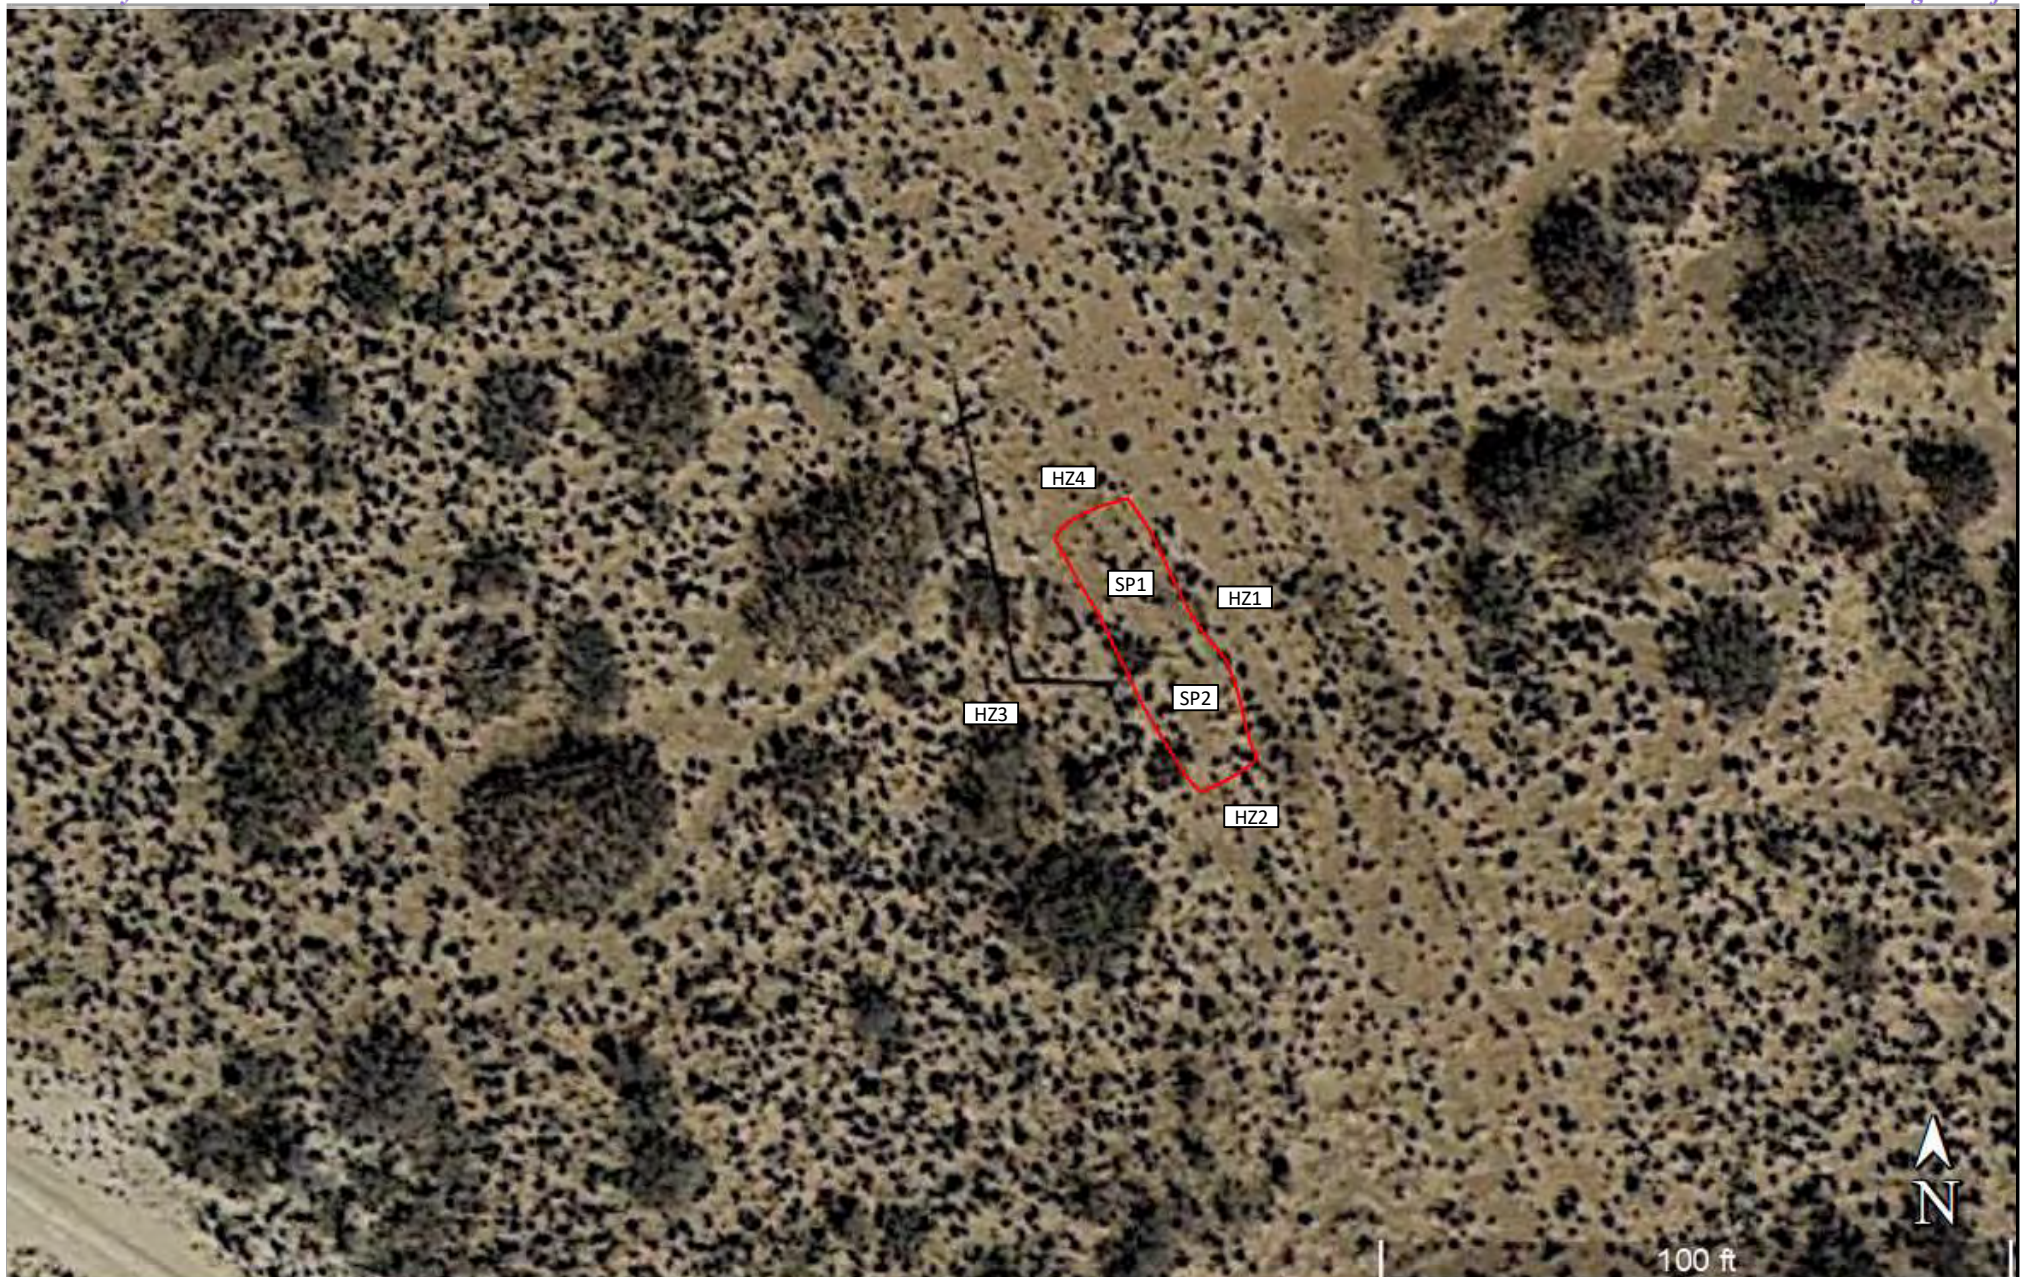
**Figure 4**

On May 26-27, 2022, Hungry Horse conducted an initial site assessment and a series of sampling events. During the sampling events, hand augered soil bores were advanced in the floor of the excavated area in an effort to determine the vertical extent of contamination. These sample locations are identified by SP designation. In addition, hand augered soil bores were advanced along the outside edges of the excavated area in an effort to determine the horizontal extent of contamination. These sample locations are identified by HZ designation. During the advancement of the soil bores, soil samples were collected and field screened for the presence of chloride concentrations utilizing a Hach Quantab® chloride test kit.

Based on field observations and field test data, ten representative soil samples were selected for laboratory analysis. Delineation soil samples SP1 and SP2, HZ1 through HZ4, were submitted to the laboratory for analysis of BTEX, TPH, and chloride. Laboratory analytical results indicated contaminant concentrations were below the NMOCD Closure Criteria in each of the submitted samples.

Delineation Sample Map
Frontier Field Services, LLC
Turkey Track Line
GPS: 32.721712, -104.050322
Eddy County

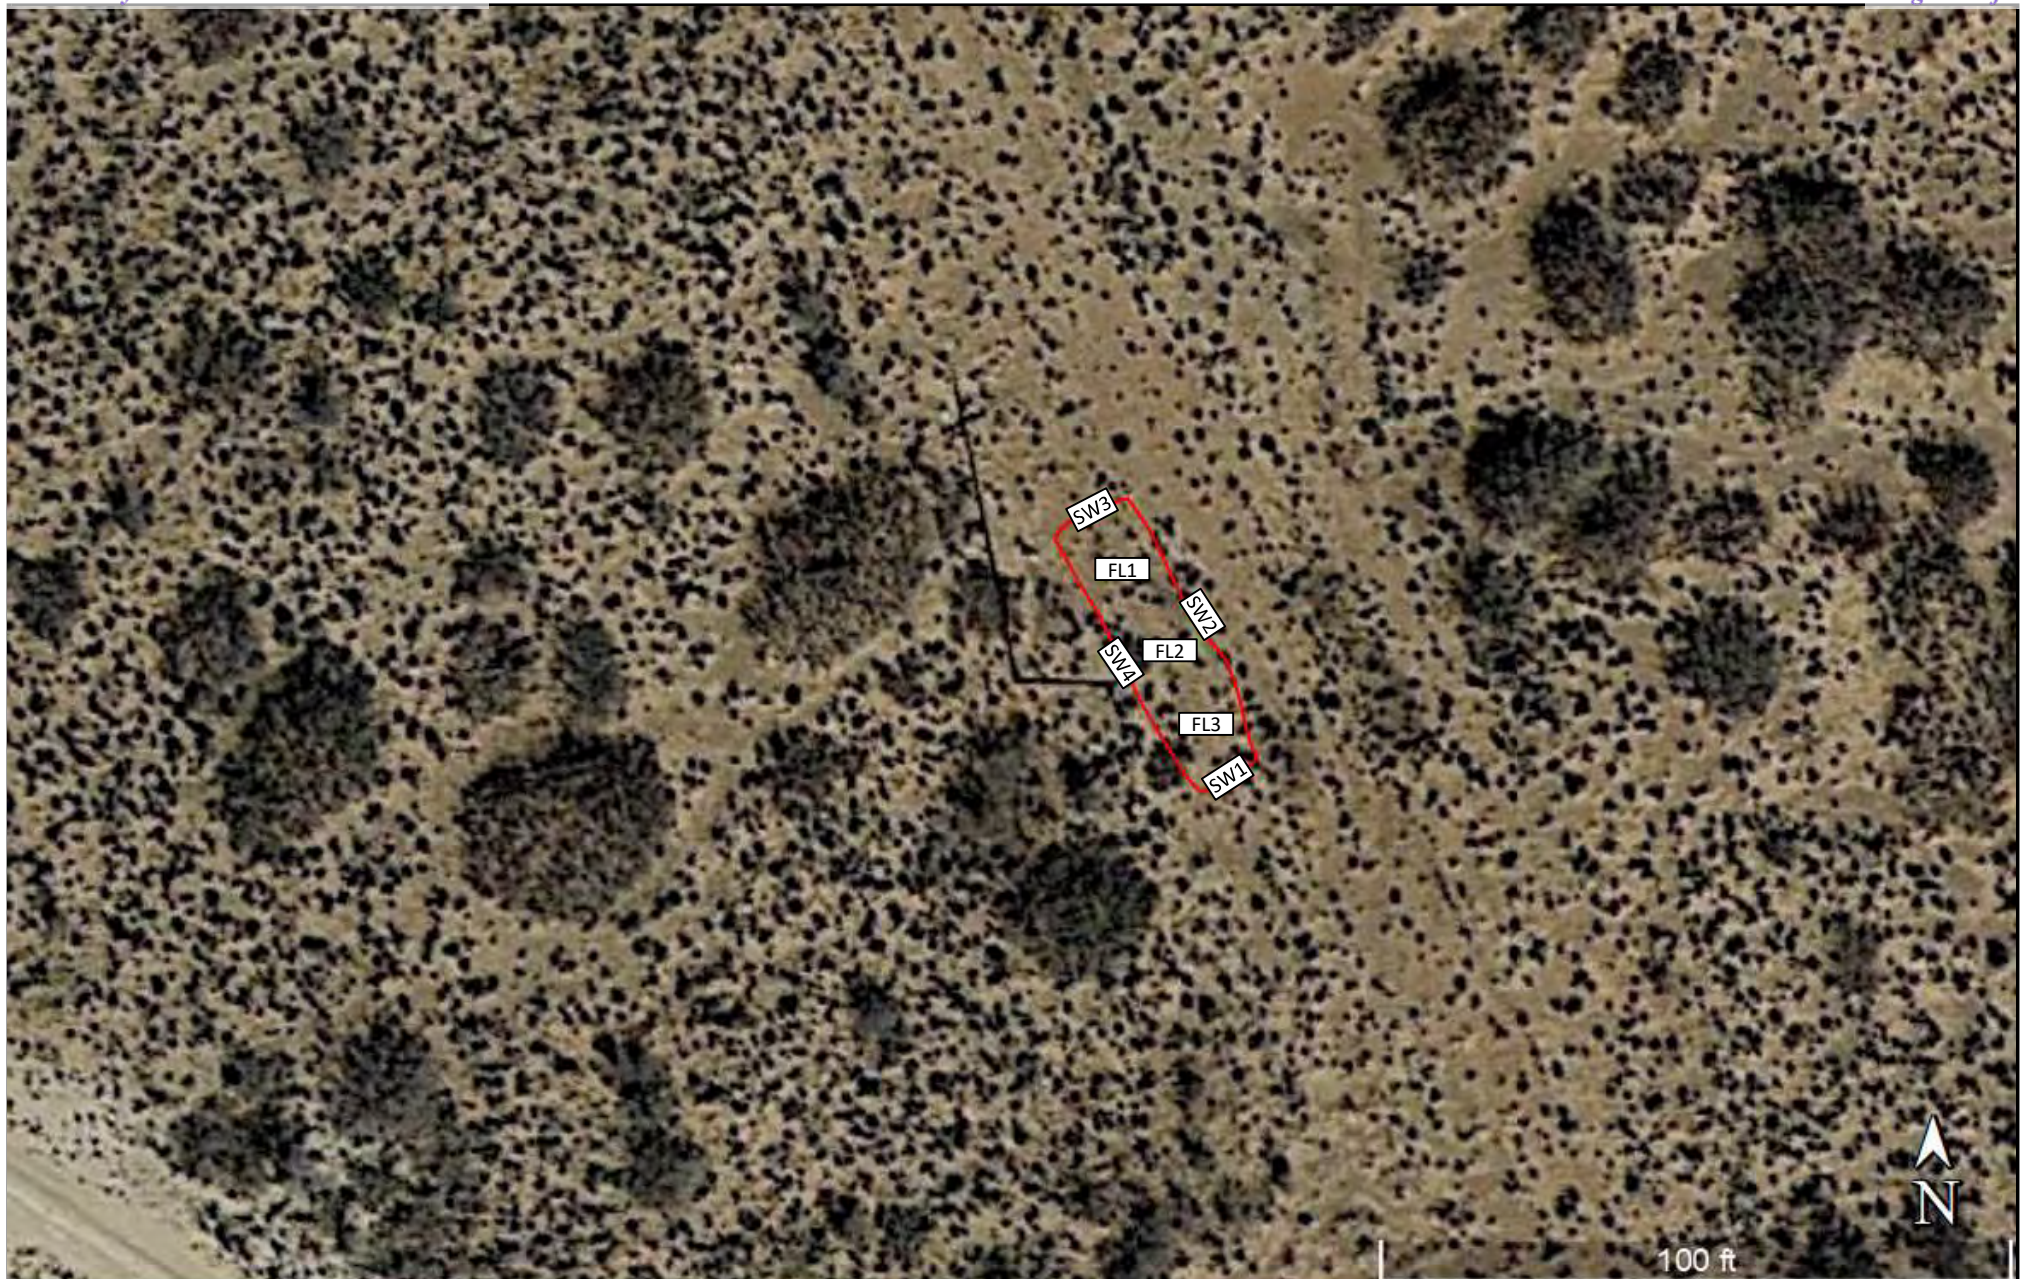
**Figure 5**

From June 14-15, 2022, soil excavated and stockpiled during pipeline repair activities was hauled to an NMOCD approved disposal facility. On June 14, 2022, seven composite confirmation soil samples were collected from the excavation floor and sidewalls, every 200 square feet and every 50 linear feet, respectively. Soil samples FL1 through FL3 and SW1 through SW4, were submitted to the laboratory for analysis of BTEX, TPH, and chloride. Laboratory analytical results indicated contaminant concentrations were below the NMOCD Closure Criteria in each of the submitted samples.

The excavated area measured approximately fifty feet in length, twelve feet in width, and six feet in depth. During remediation activities approximately 144 cubic yards of impacted soil were excavated and hauled to an NMOCD approved disposal facility. Manifests can be provided upon request.

Excavation Sample Map
Frontier Field Services, LLC
Turkey Track Line
GPS: 32.721712, -104.050322
Eddy County

Based upon laboratory analytical results from confirmation soil samples, the excavated area was backfilled with locally sourced, clean, non-impacted material. The area was contoured to achieve erosion control and preserve surface water flow. The affected area will be reseeded with an approved seed mixture during the first favorable growing season following these completed remediation activities.
