**Re:** Closure Letter

Illustrated Man Fee Com #001H

API #: 30-015-41025 RP#: 2RP-4462

**Eddy County, NM**

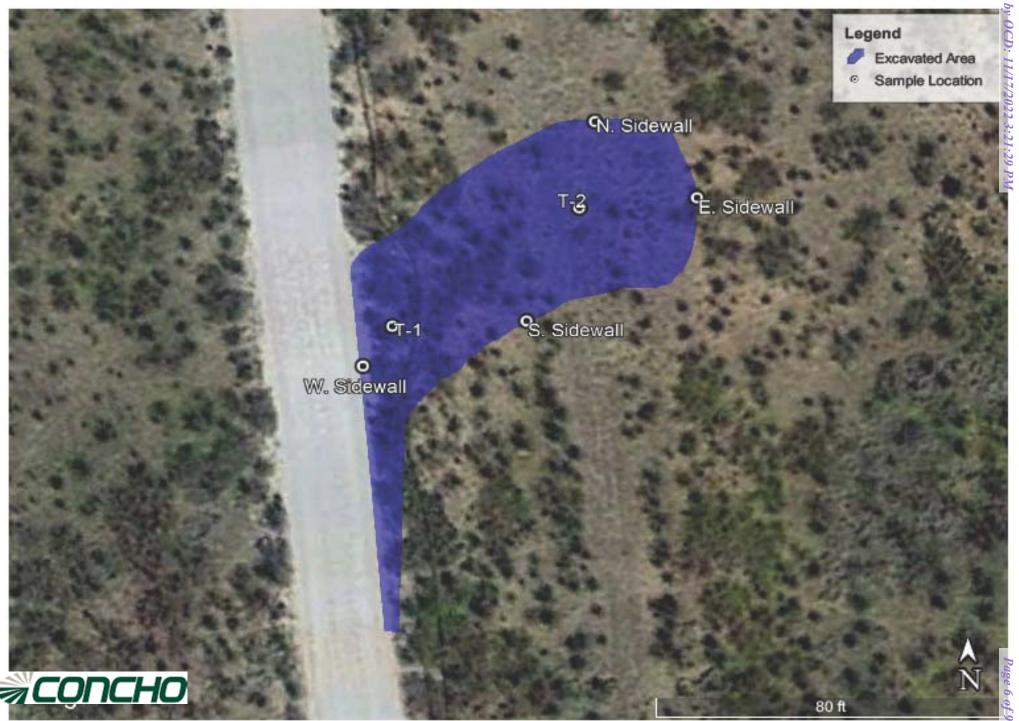
Appendix I: Site Diagram

On November 31, 2017, a site assessment and soil sampling were conducted in order to define the impacted area. A site diagram is included in Appendix I. The analytical results from the soil sampling activities are summarized in the table below.

- The impacted area in the vicinity of sample location T-1 was excavated to a depth of four (4) feet BGS.
- The impacted area in the vicinity of sample location T-2 was excavated to a depth of three (3) feet BGS.

- Confirmation soil samples were taken from the bottom of the excavation at sample location
  T-2 and from the sidewalls of the excavation in all four cardinal directions on June 19, 2018.
  Laboratory results from the northern portion of the excavation returned above NMOCD
  RRAL's. The excavation was extended to the north and resampled on June 26, 2018.
  Analytical results from this soil sampling event confirmed that all impacted soil above
  NMOCD RRAL's was successfully removed.

- All of the excavated material was hauled to an NMOCD approved solid waste disposal facility.
- A 20-mil liner was installed at the bottom of the excavation in the vicinity of sample location T-1 in order to encapsulate the remaining chloride impacts.

- The excavation was backfilled with clean "like" material, contoured to match the surrounding terrain and seeded with BLM #1 seed mixture.
