Closure Report

Derna Booster Station
Lea, New Mexico
Incident # **nAPP221865667**
L-20-26S-32E

Subject: **Closure Report**
Derna Booster Station
Lea County, New Mexico
Incident # **nAPP221865667**

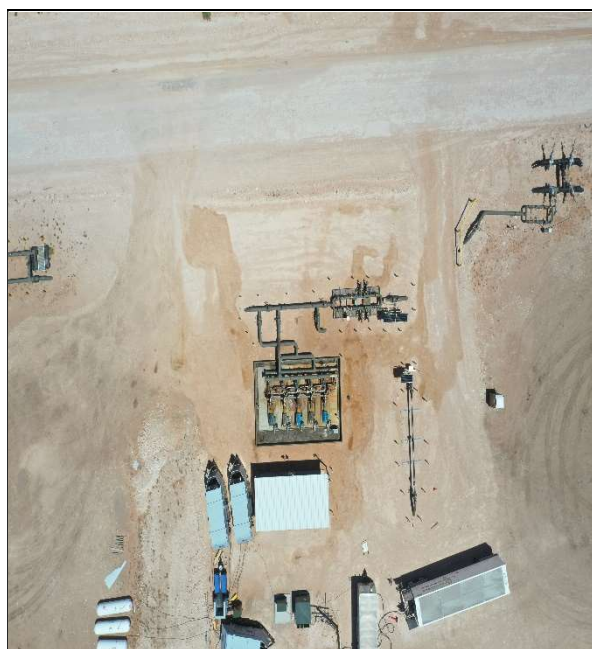
**Photograph No.2 Description:**

Aerial of stained area around containment.

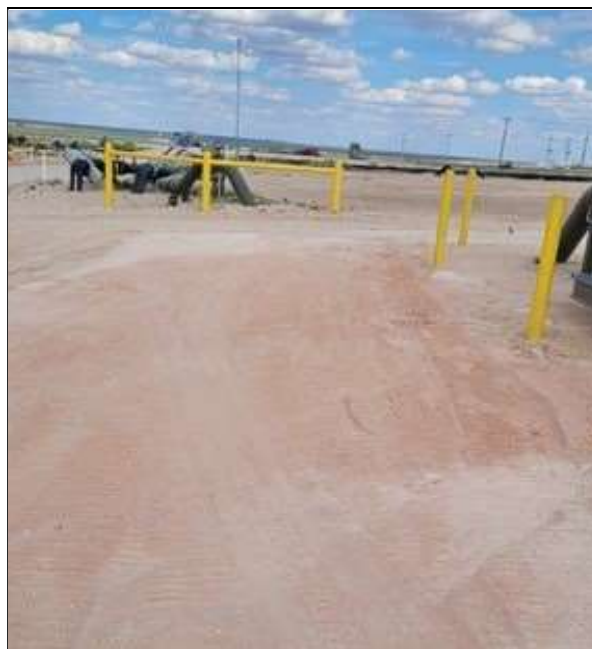
**Photograph No.6 Description:**

Area of backfill of east side of containment.
