Re: Closure Letter
SRO State Com #006H
API #: 30-015-37467
RP#: 2RP-4589
Unit Letter D, Section 5, Township 26 S, Range 28 E
Eddy County, New Mexico

COG Operating, LLC (COG) is pleased to submit for your consideration the following closure report for the SRO State Com #006H. This release occurred on January 20, 2018. Following the release an assessment of impacted soils was conducted. A remediation work plan was submitted to and subsequently approved by the New Mexico Oil Conservation Division (NMOCD) and the New Mexico State Land Office (NMSLO). A copy of the approved work plan is attached in Appendix V.

CLOSURE REQUEST

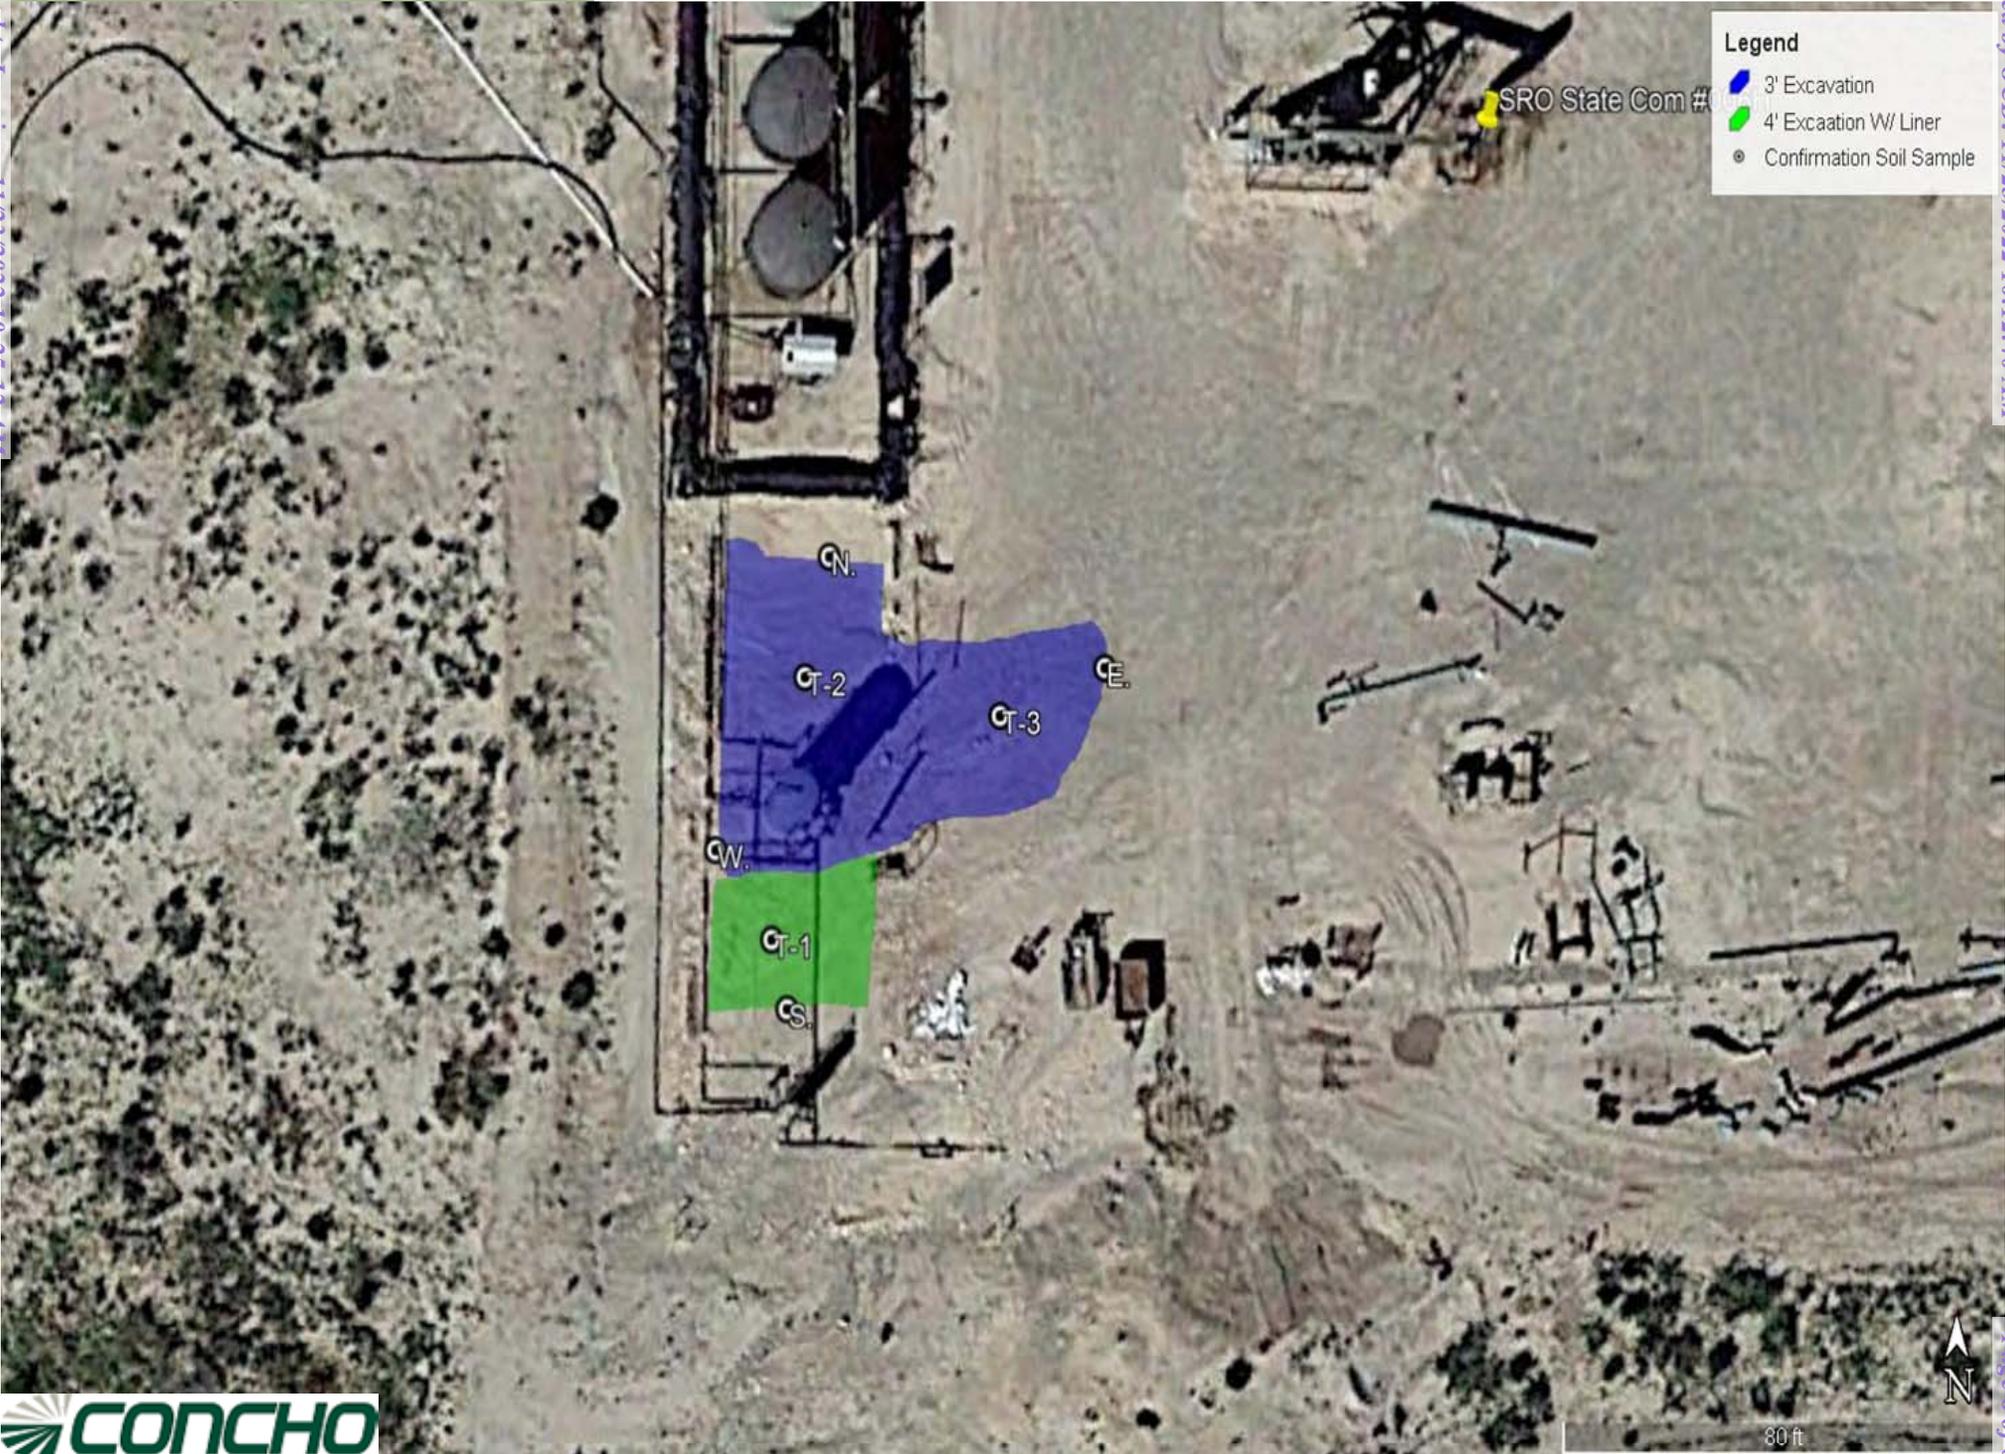
SRO State Com #006H

- 3' Excavation
- 4' Excavation W/ Liner
- Confirmation Soil Sample

GN
GT-2
GT-3
CE
CW
GT-1
CS

Remediation activities were conducted in accordance with the approved work plan and NMOCD/NMSLO stipulations. The analytical results from the stipulated confirmation soil sampling activities are summarized in the table below. A site diagram of the excavated area is presented in Appendix I.

- The impacted area in the vicinity of sample locations T-2 and T-3 was excavated to a depth of three (3) feet BGS.
- The impacted area in the vicinity of sample location T-1 was excavated to a depth of four (4) feet BGS. A test trench was installed at this location to complete the vertical chloride delineation of this sample location.
- All of the excavated material was hauled to an NMOCD approved solid waste disposal facility.
- Confirmation Bottom and sidewall samples were collected per NMOCD and NMSLO stipulations.
- Upon receipt of analytical results from stipulated confirmation and delineation soil sampling activities a 20-mil poly liner was installed in the bottom of the excavation in the vicinity of sample location T-1 in order to encapsulate the remaining chloride impacts. The excavation was backfilled with clean "like" material and contoured to match the surrounding location.

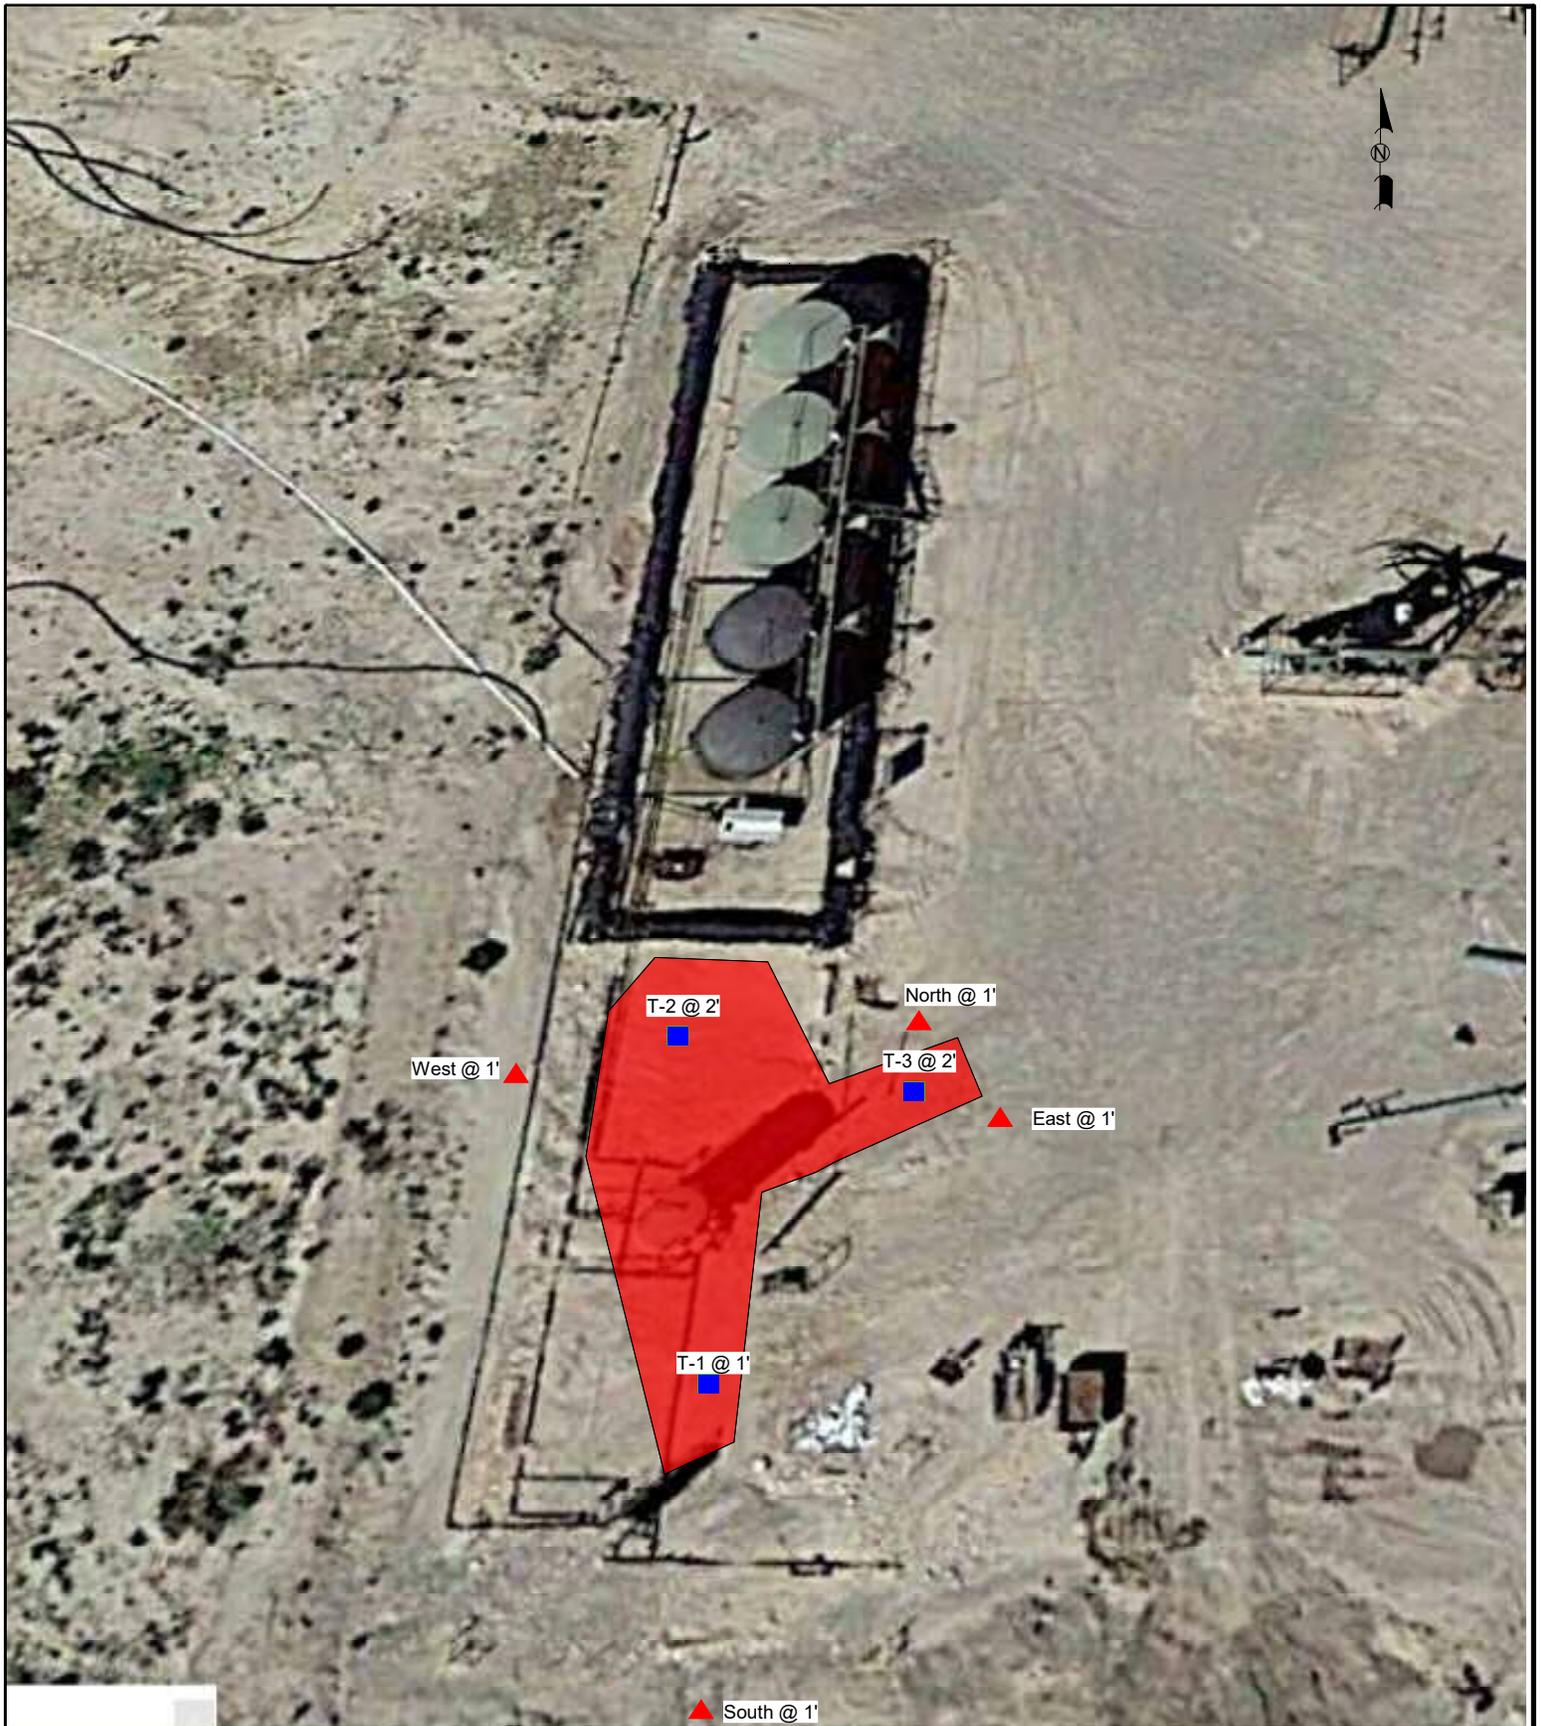
LEGEND:
■ Excavate Area to >600 mg/Kg for chlorides
■ Horizontal Delineation Soil Sample Location
▲ Vertical Soil Sample Location

On February 27, 2018, 2M, on behalf of Concho, utilized a hand auger and/or a backhoe to collect three (3) delineation soil samples (T-1 @ 1', T-2 @ 2', and T-3 @ 2') from the impacted area. In addition to the soil samples described above, four (4) soil samples (North @ 1', East @ 1', South @ 1', and West @ 1') were collected utilizing a hand auger and/or backhoe approximately five (5) feet from the outer perimeter of the stained surface soil. The soil samples were submitted to Xenco Laboratories in Midland, Texas for determination of concentrations of BTEX using Method SW 846-8021B, TPH using Method SW 846-8015M, and chloride using Method E-300.1. The analytical results are provided as an attachment (Table 1 Concentrations of Benzene, BTEX, TPH, and Chloride in Soil).

Based on the analytical results of the soil samples collected on February 27, 2018, Concho proposes the following field activities designed to remediate the SRO State COM # 006H Release:
