Site Assessment Summary & Closure Request

ConocoPhillips Company Tyrell Fee 001H

Lea County, New Mexico
Unit Letter "A", Section 14, Township 24 South, Range 33 East
Latitude 32.22426 North, Longitude 103.53631 West
NMOCD Reference No. nAPP222341136

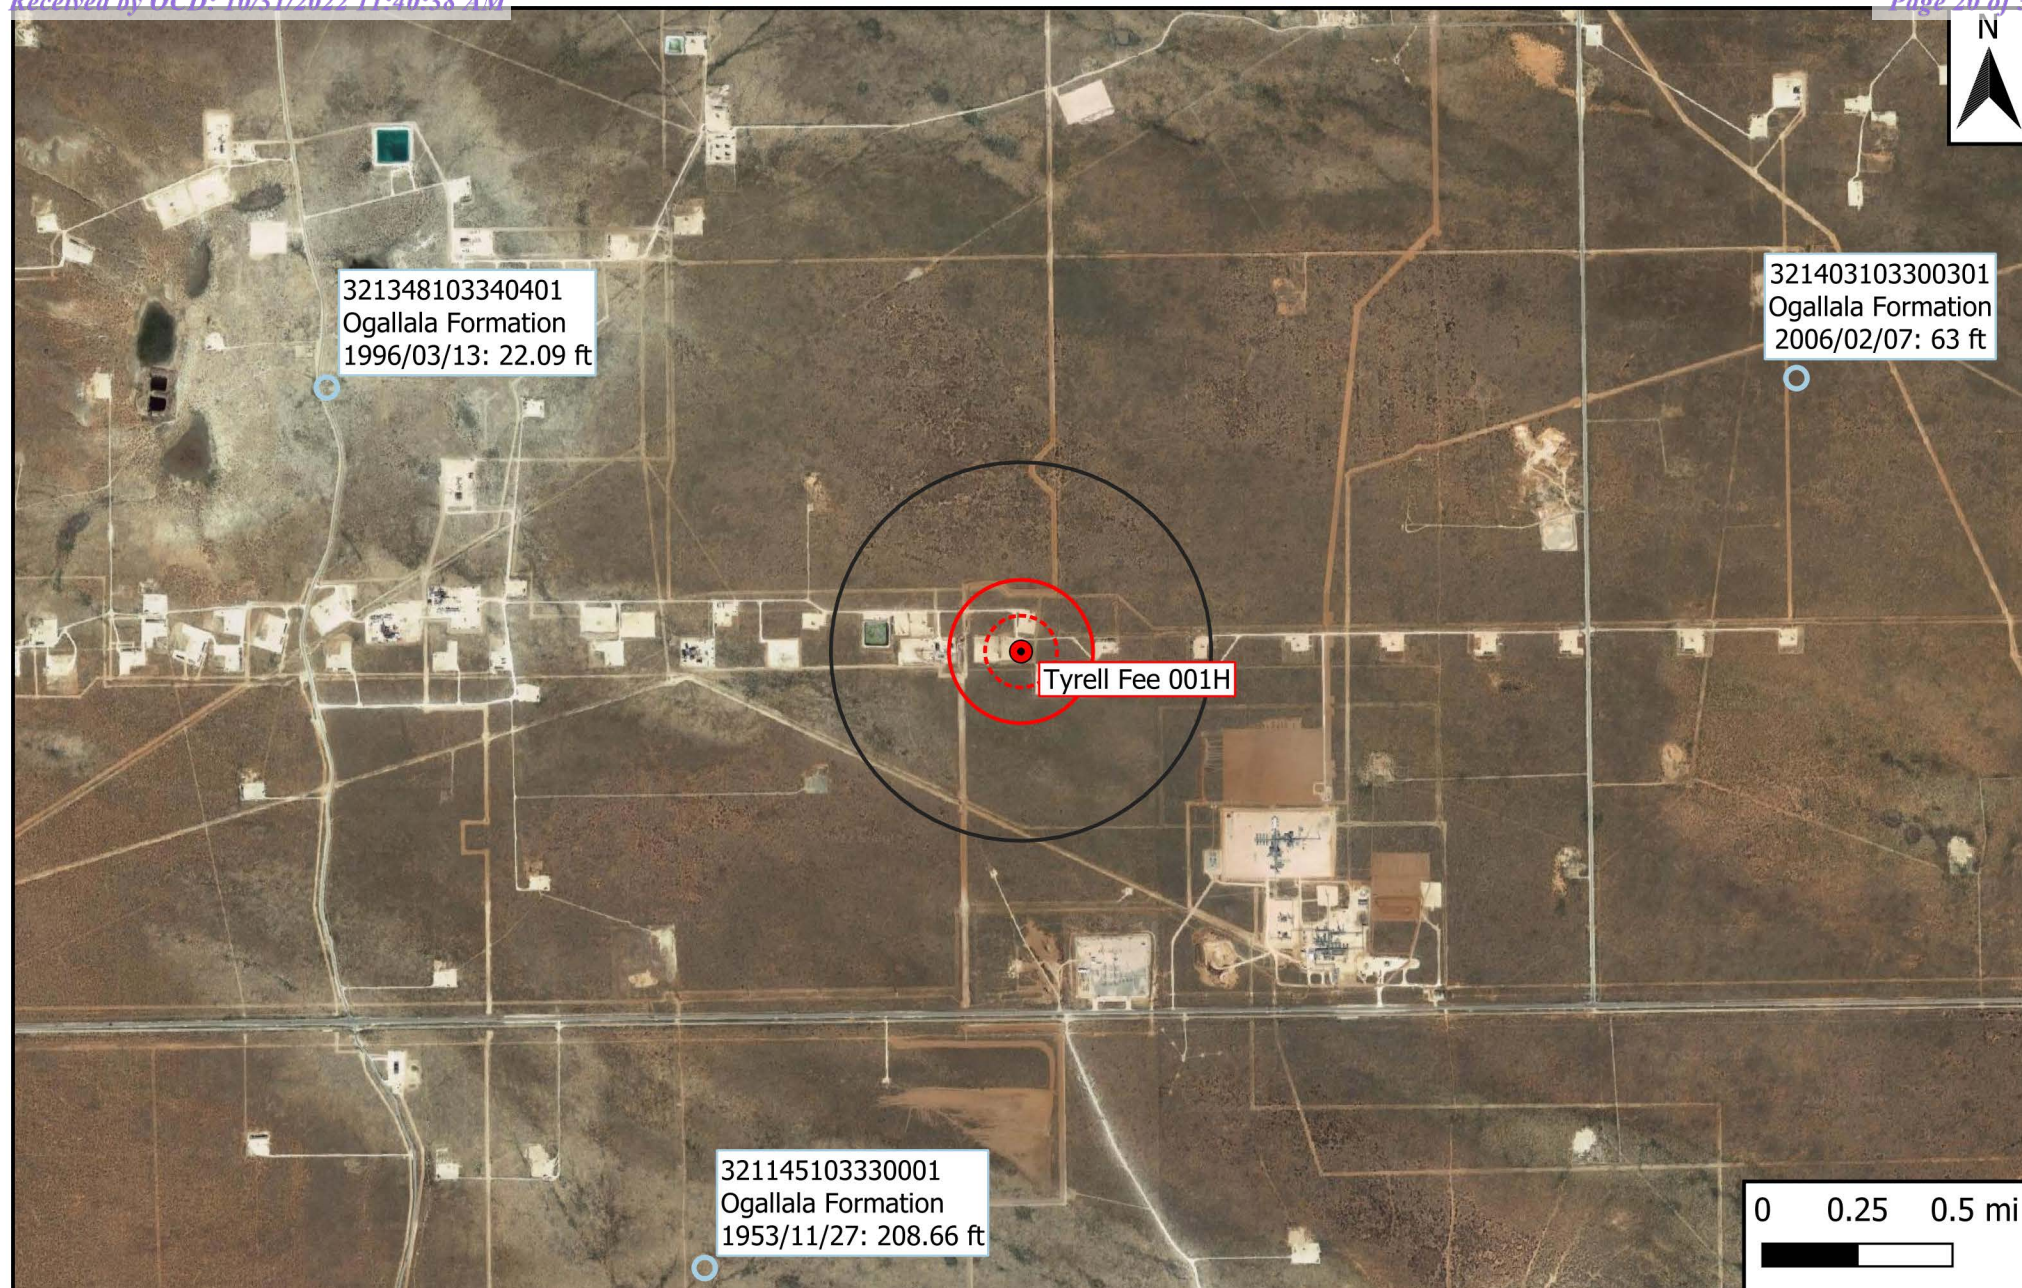
Figure 4

USGS Well Proximity Map
ConocoPhillips Company
Tyrell Fee 001H
GPS: 32.22426, -103.53631
Lea County

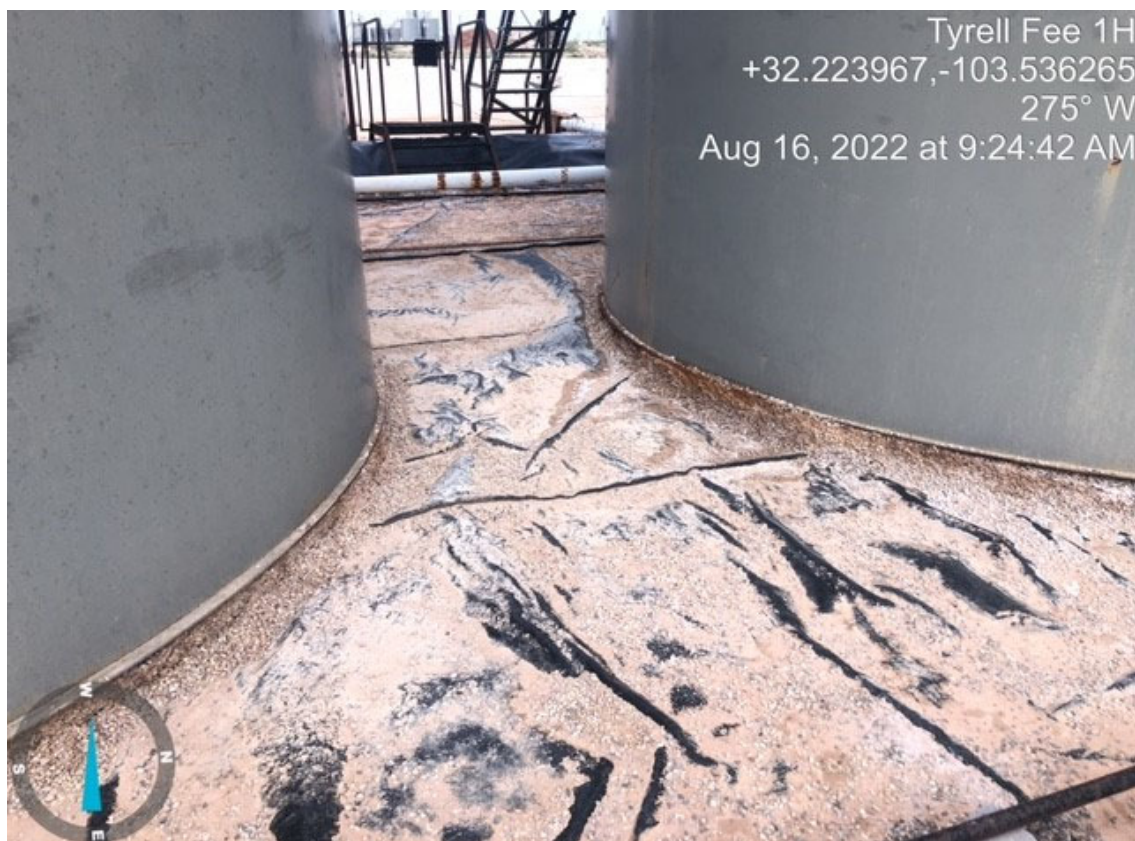
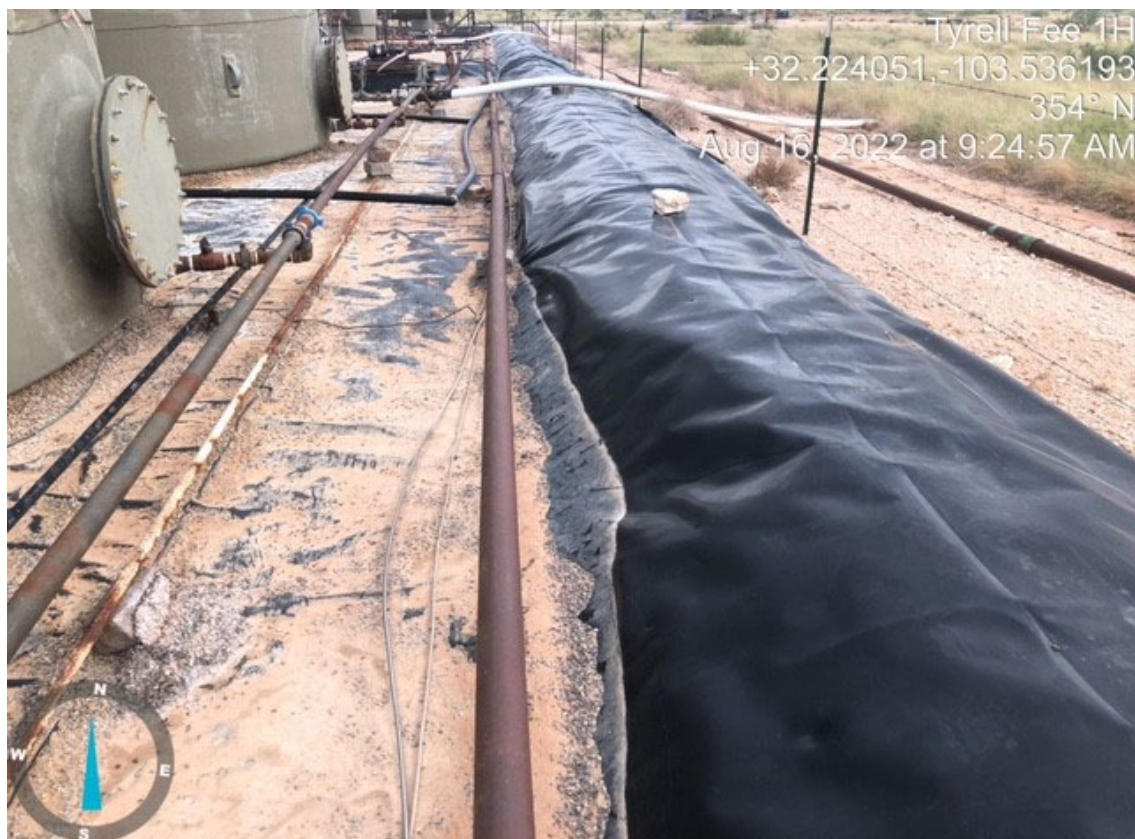
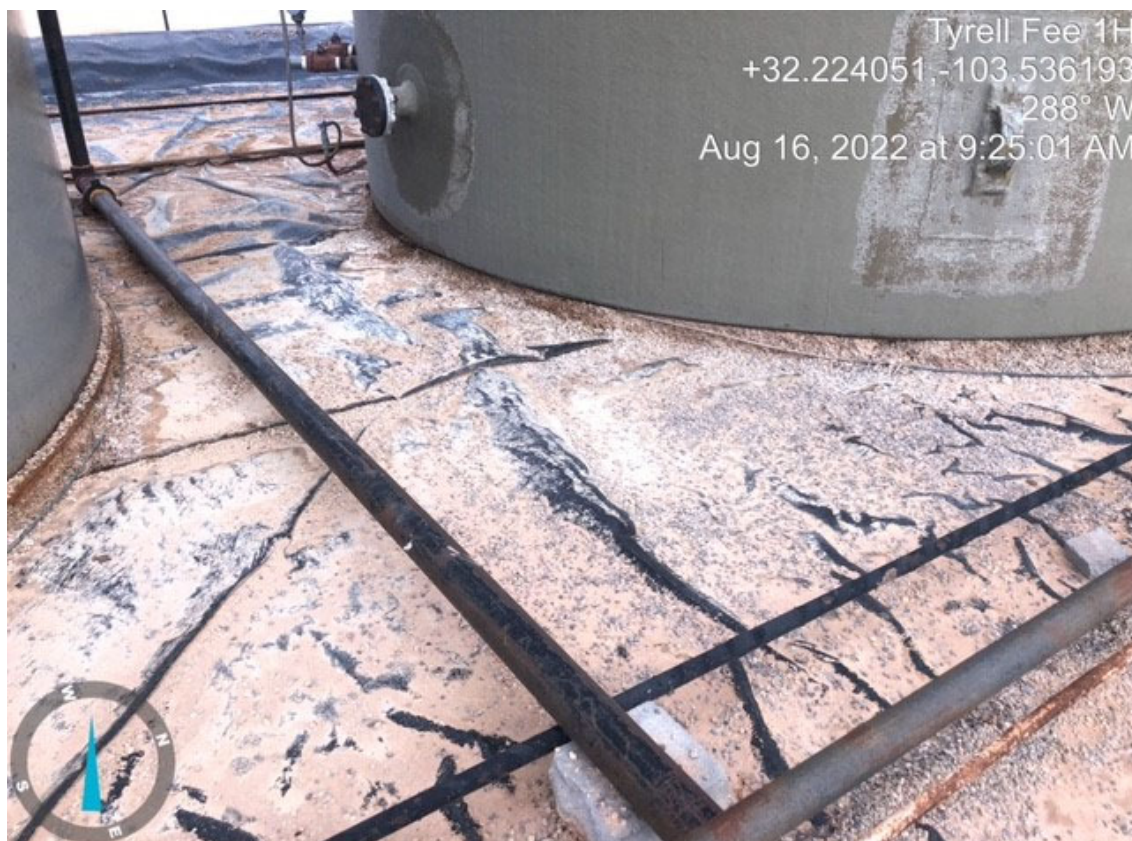
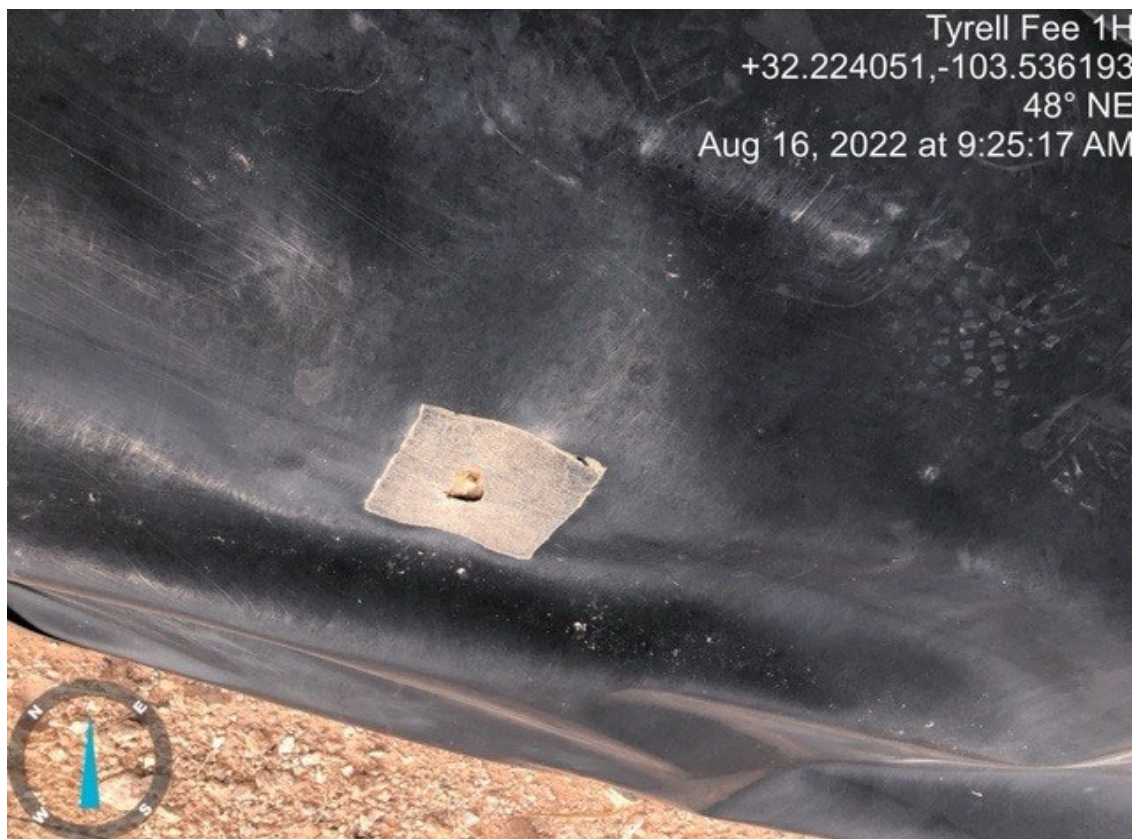
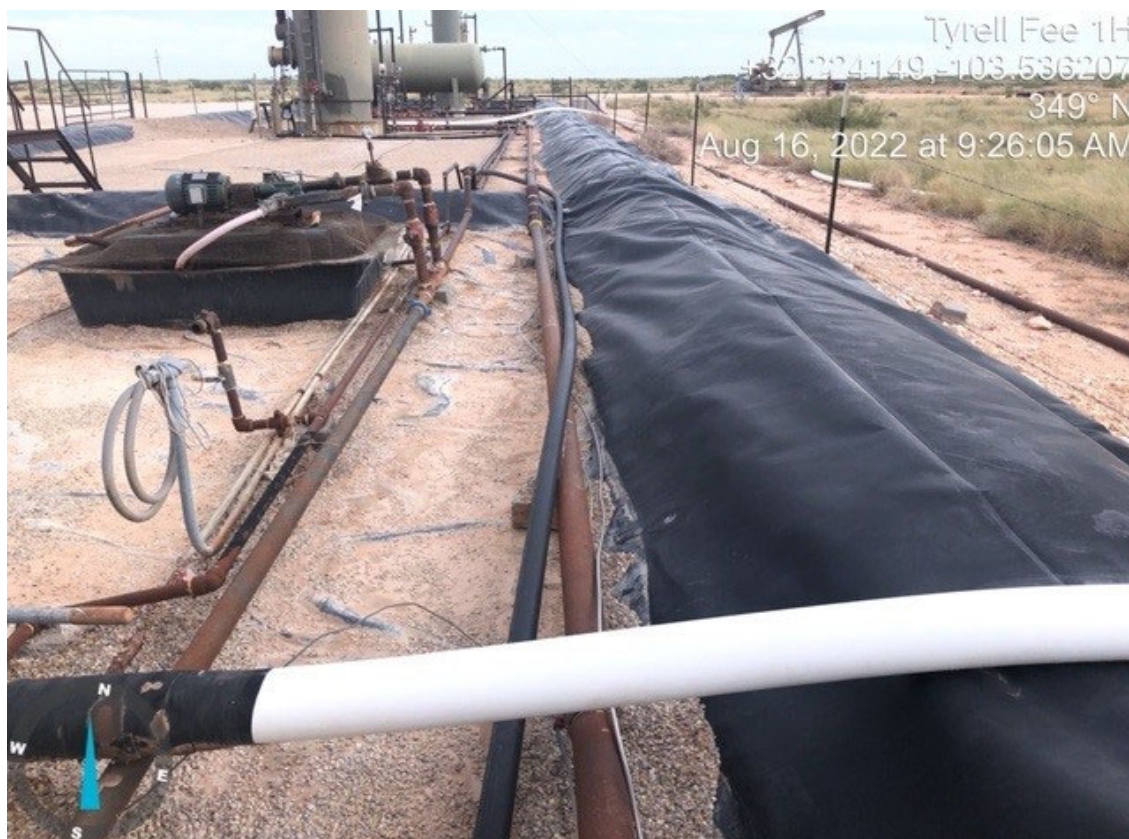
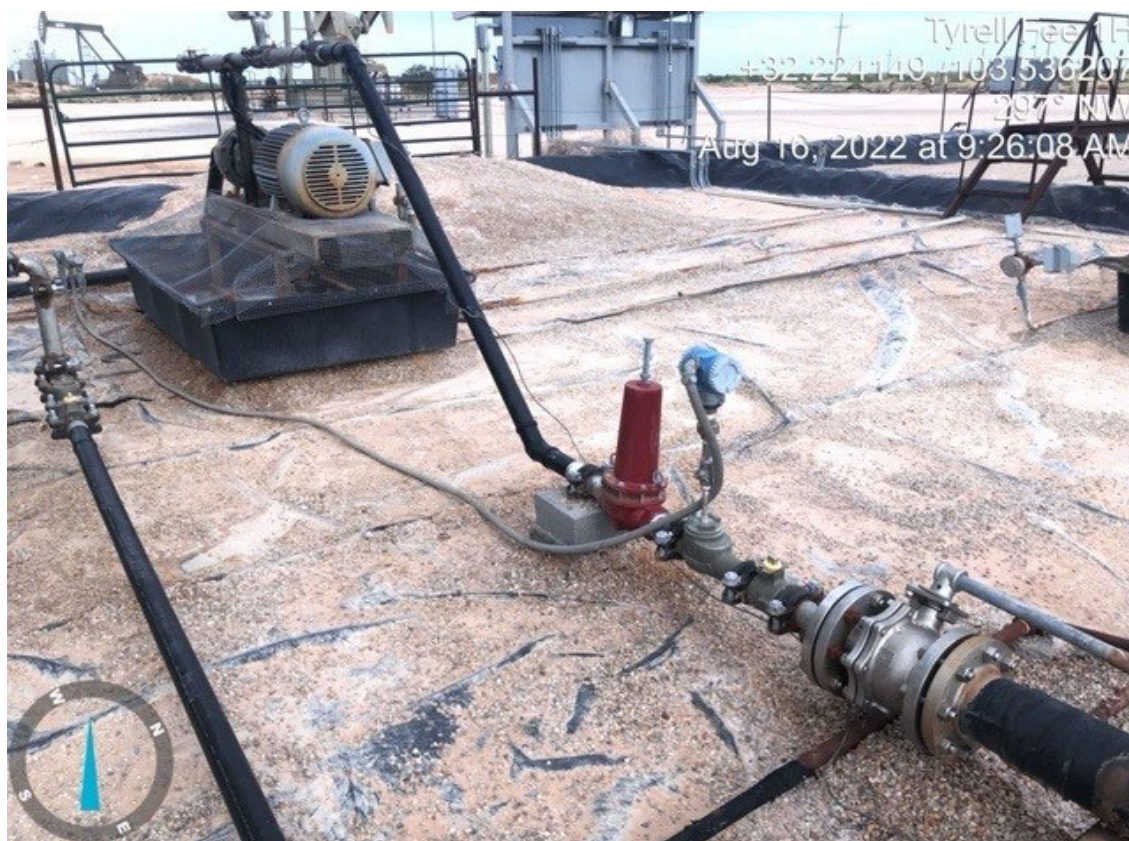
Photographic Log

On August 16, 2022, Etech conducted an initial assessment at the release site. During the initial site assessment, a visual inspection of the containment area liner was performed to check its integrity and confirm that it was able to contain the release. During the site assessment, no pre-existing holes or breaches were discovered at or near the base of the containment area, however, a few holes were discovered on or near the top of the containment area berm wall above the free board level. Based on field observations made during the liner inspection it was determined that the liner within the tank battery was effective at containing the subject release.

Upon completing the liner inspection, non-impacted gravel was installed in the base of the tank battery containment. Additionally, holes discovered on or near the top of the containment area berm wall were patched and repaired.
