November 23, 2022

**Re: Release Characterization and Work Plan Addendum  
ConocoPhillips  
Heritage Concho  
Compadres Fee Tank Battery Release  
Unit Letter H, Section 4, Township 22 South, Range 27 East  
Eddy County, New Mexico  
Incident ID NAB1803951001  
2RP-4608**

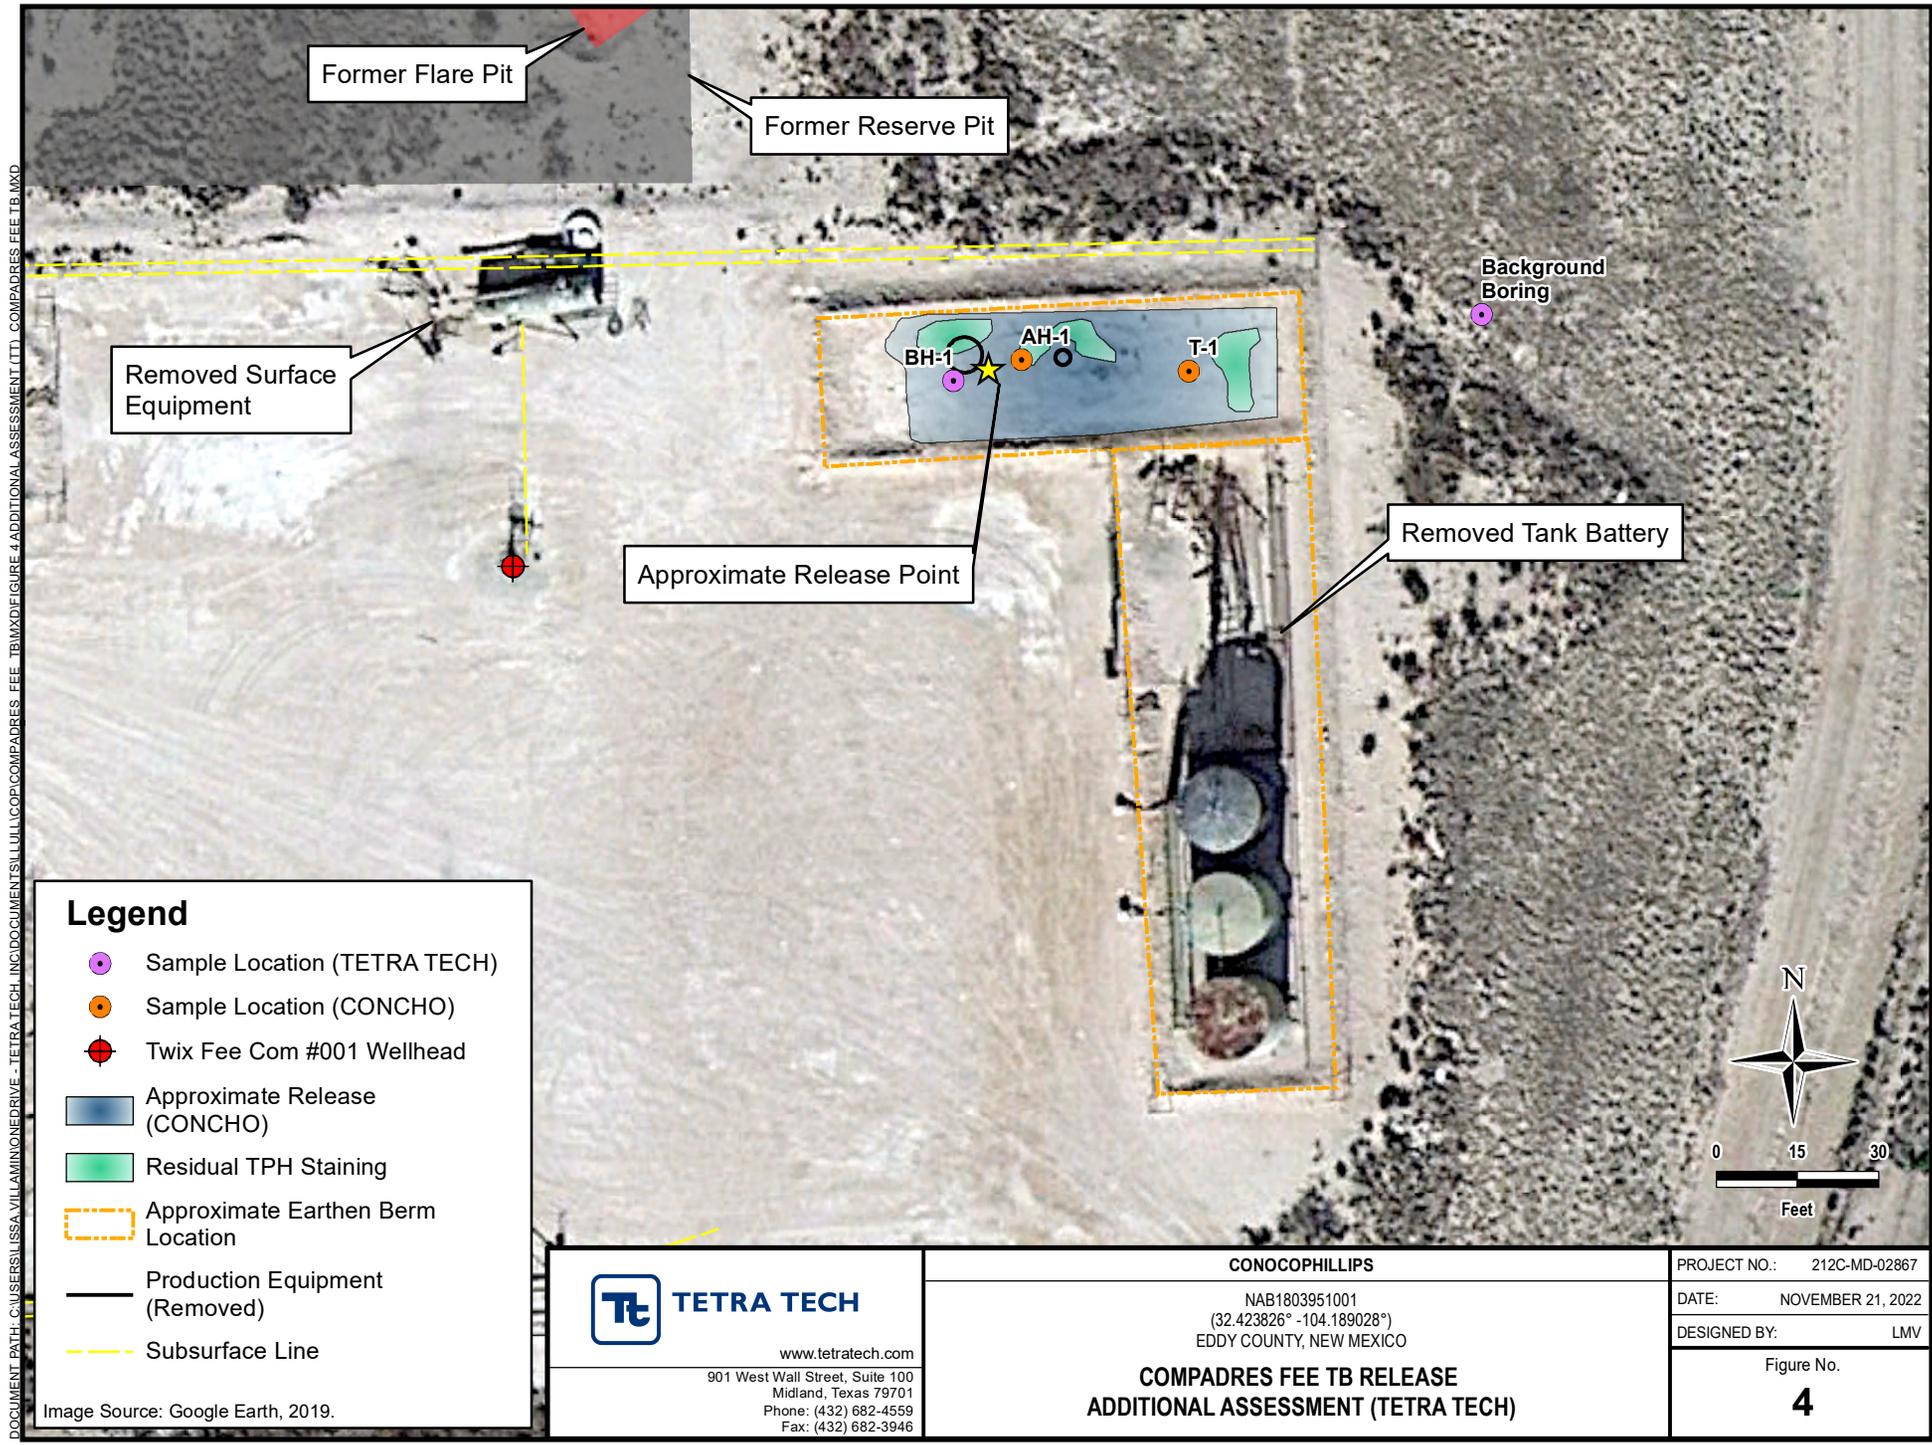
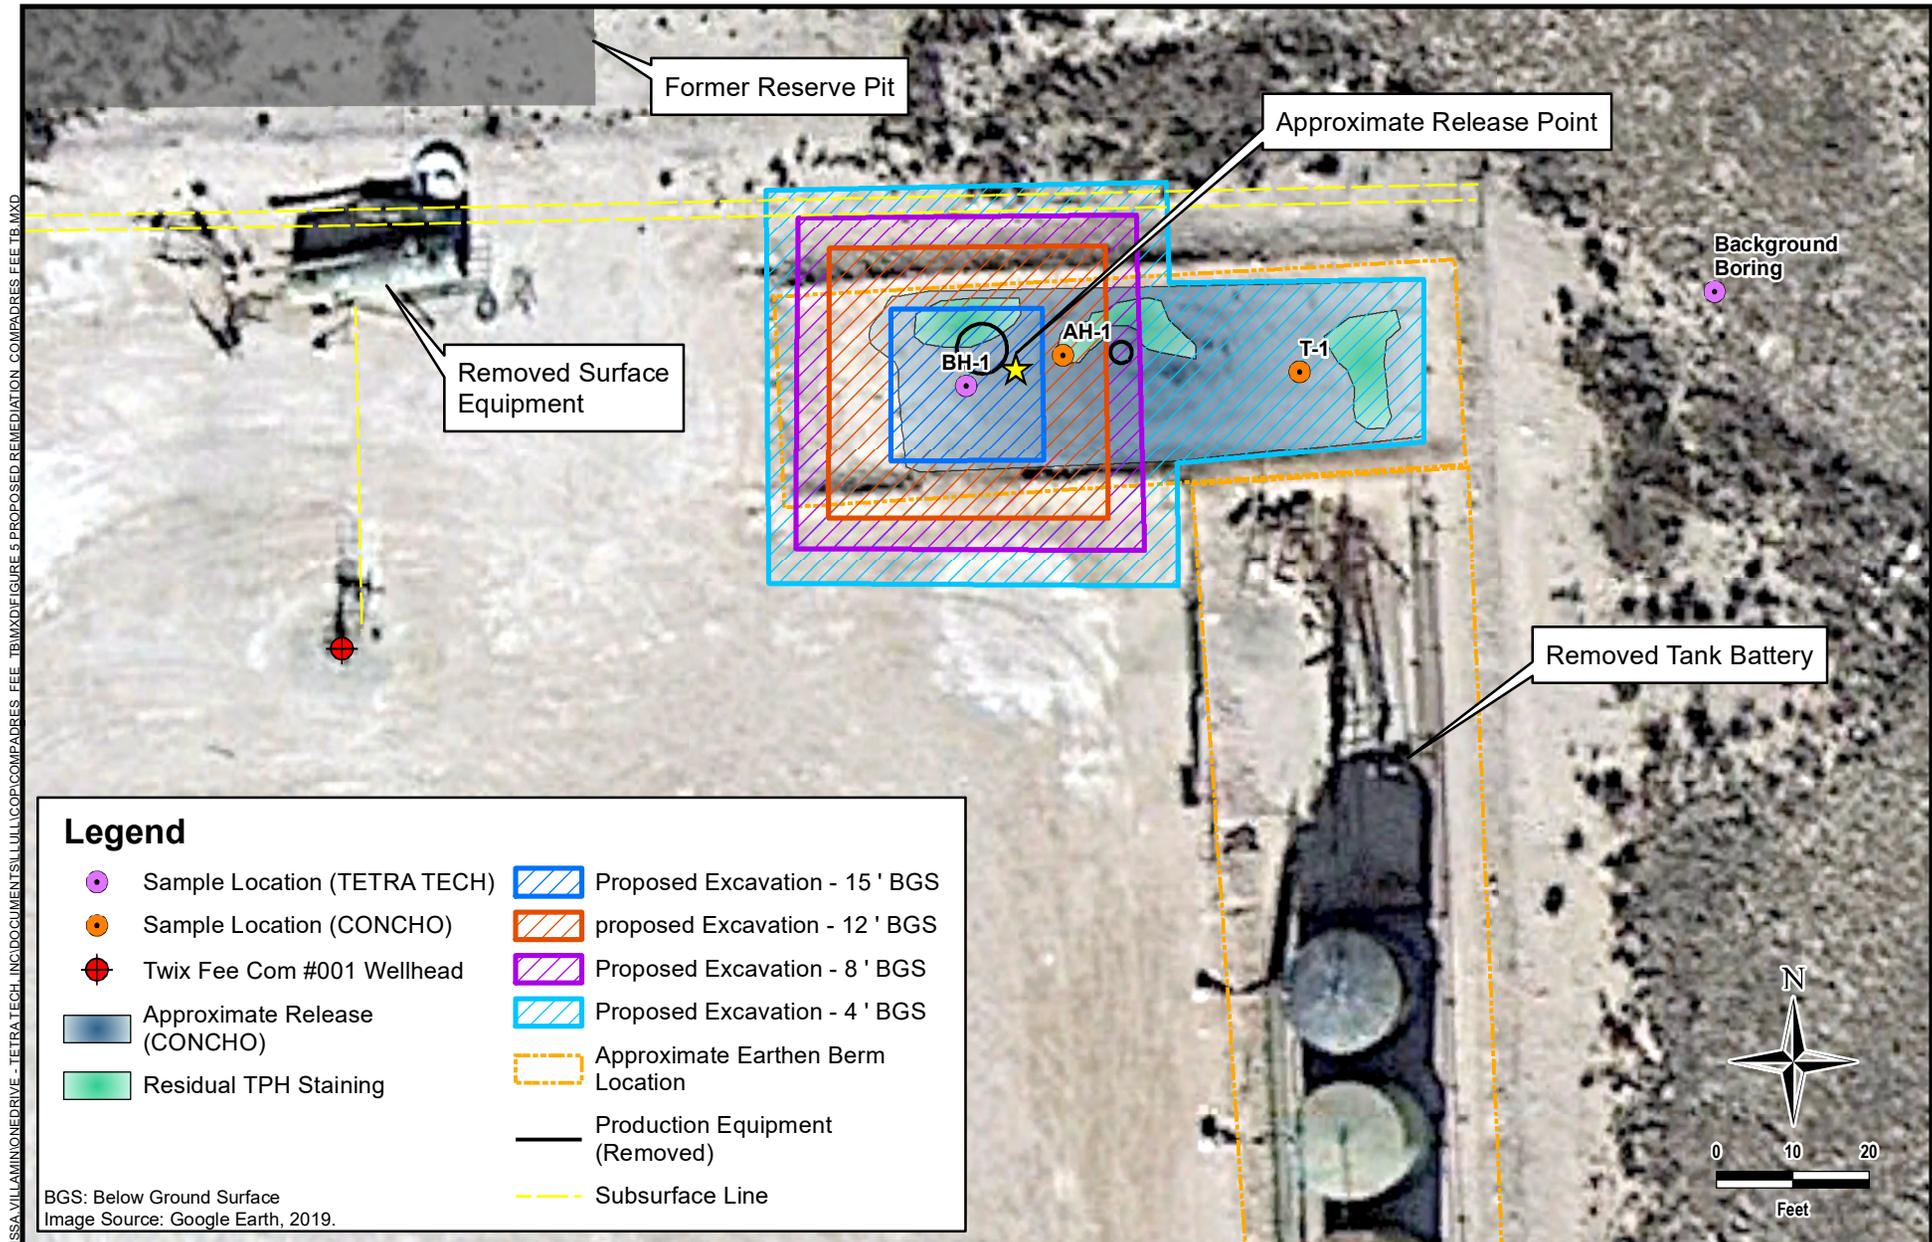
On February 22, 2018, COG personnel collected assessment samples from two (2) locations located within the release extent, T-1 and AH-1. The assessment was conducted with piping and infrastructure present within the tank battery. Six (6) samples were collected from T-1 to a depth of 6 feet and two (2) samples from AH-1 to a depth of 0.5 feet. A total of eight (8) soil samples were sent to Xenco Laboratories in Midland, Texas to be analyzed for chloride via EPA Method 300, TPH via EPA Method 8015M, and BTEX via EPA Method 8021B. Sample locations are shown in Figure 3.

In September 2018, Tetra Tech personnel conducted a site visit and additional soil sampling on behalf of COG. During the site visit, it was noted that the previously noted production equipment and infrastructure had been removed from the bermed area (see Appendix D). A total of two (2) soil borings were installed with an air rotary drill rig, one within the release footprint (BH-1) and a second (Background) in the pasture outside of the facility area to analyze for background levels of chloride. The borings were sampled and each terminated at 20 feet bgs. These soil samples were sent to Xenco Laboratories in Midland, Texas to be analyzed for chloride via EPA Method 300, TPH via EPA Method 8015M, and BTEX via EPA Method 8021B. Sample locations are shown in Figure 4. Boring logs, included as Appendix E, present soil descriptions, sample depths, and field screening data from September 2018 Site assessment. Photographic documentation of the assessment activities is included as Appendix D.

## **REMEDIATION WORK PLAN ADDENDUM**

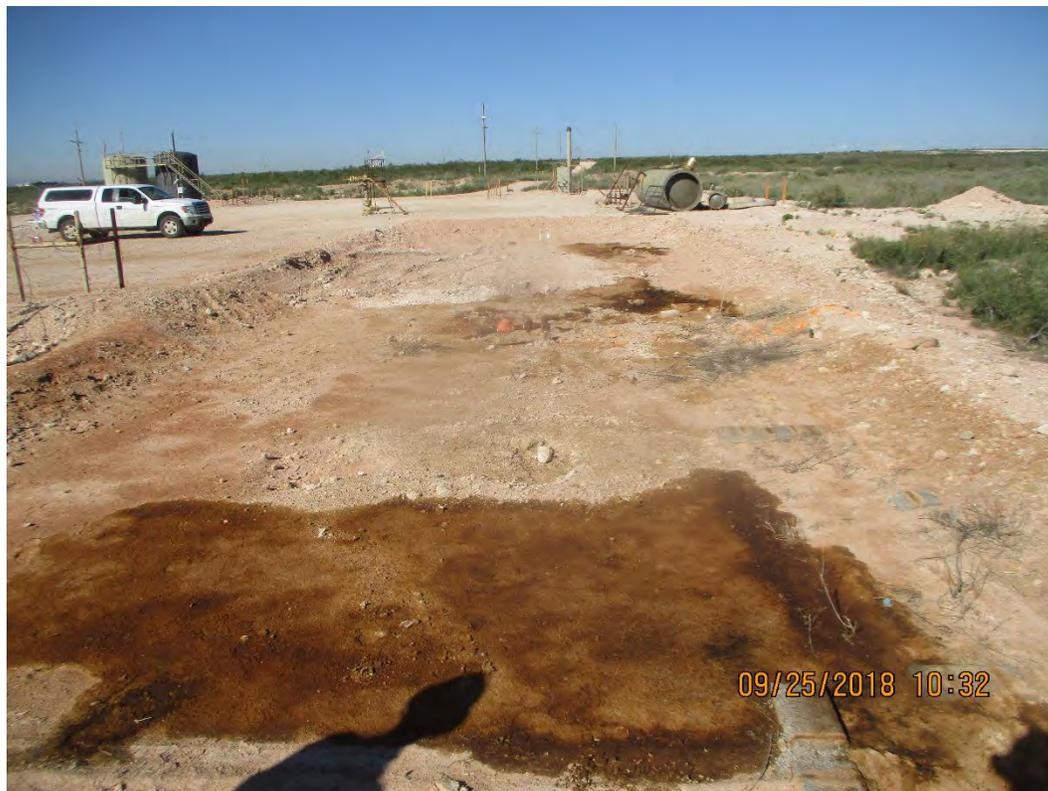
TETRA TECH, INC. PROJECT NO. 212C-MD-02867	DESCRIPTION	View west, berm area of former tank. Residual surface staining visible. Tank laying on side in background of photo.	2
	SITE NAME	ConocoPhillips Compadres Fee Tank Battery	9/25/2018

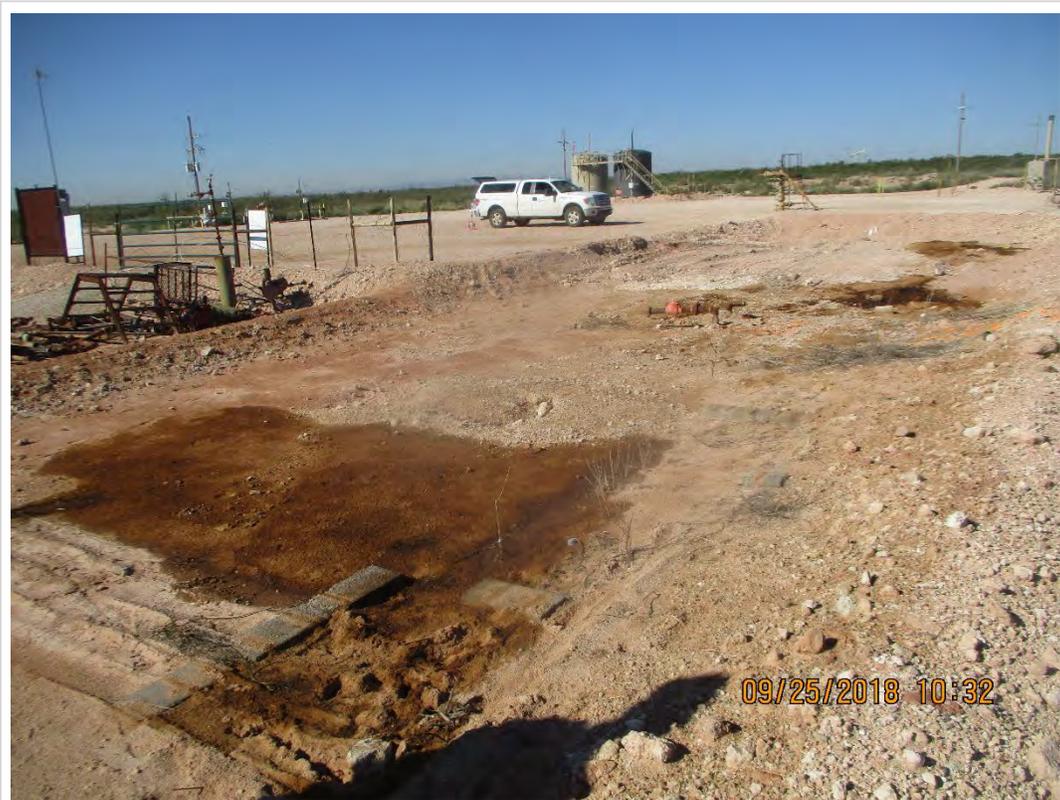
TETRA TECH, INC. PROJECT NO. 212C-MD-02867	DESCRIPTION	View southwest, visible residual surface staining inside berm where former tank located.	3
	SITE NAME	ConocoPhillips Compadres Fee Tank Battery	9/25/2018

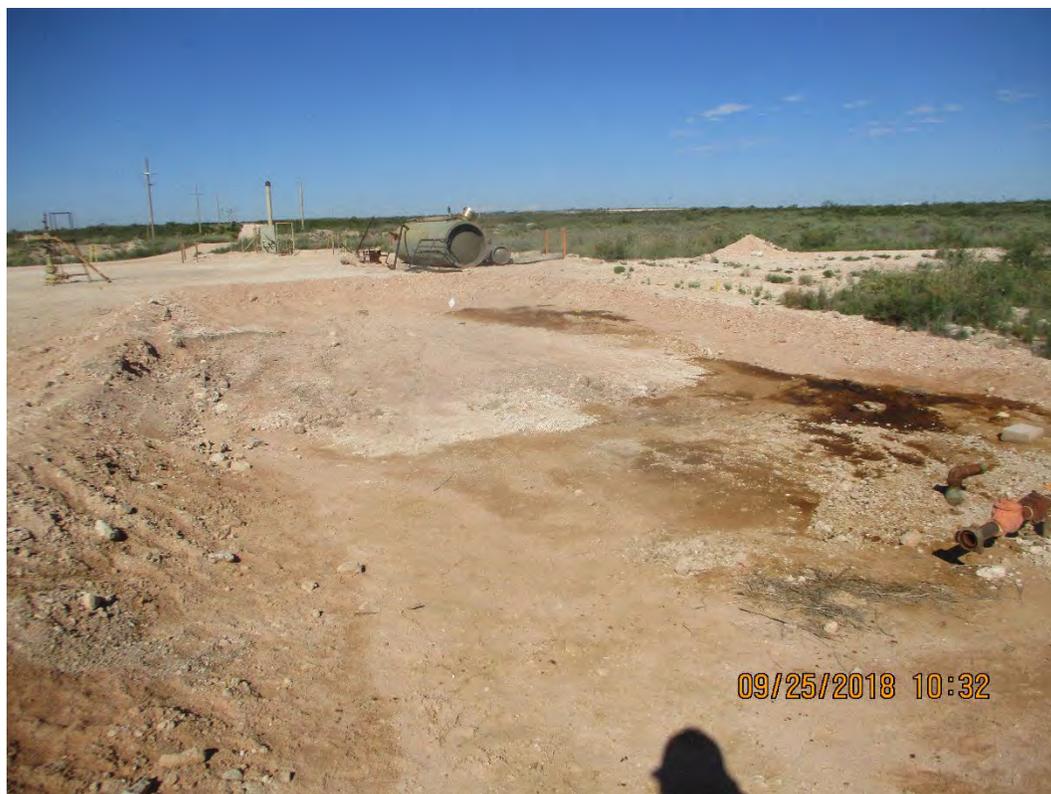
TETRA TECH, INC. PROJECT NO. 212C-MD-02867	DESCRIPTION	View west-northwest, visible residual surface staining within berm-area around former tank location.	4
	SITE NAME	ConocoPhillips Compadres Fee Tank Battery	9/25/2018

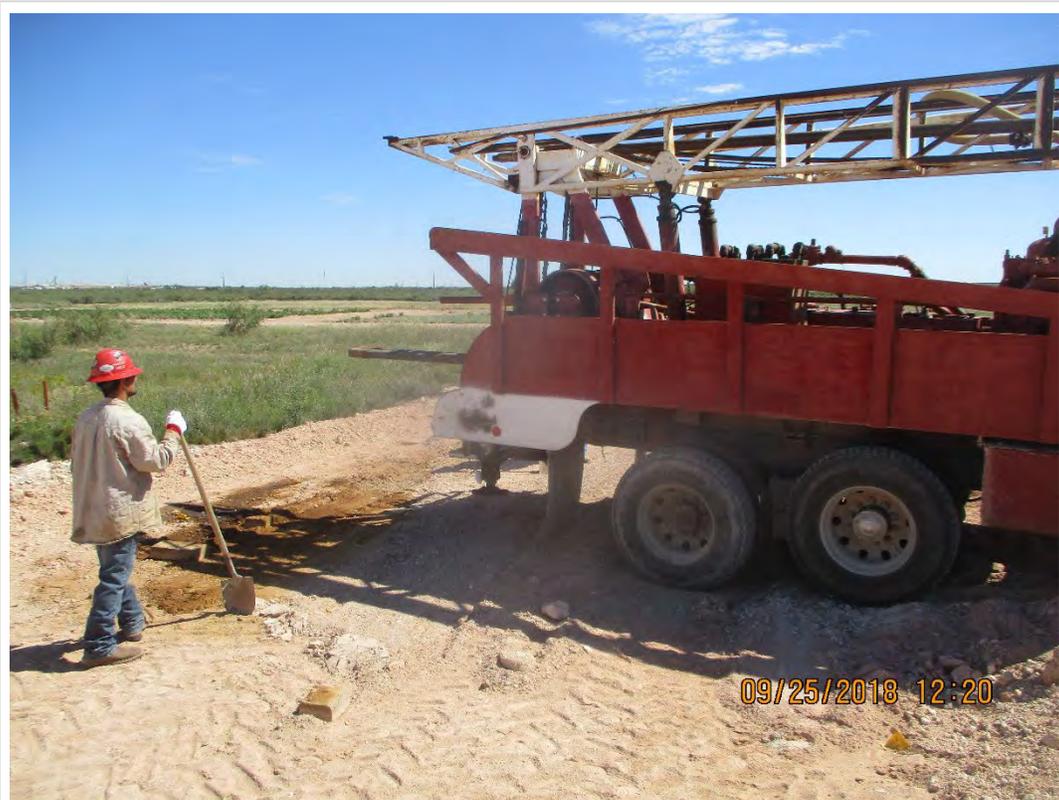
TETRA TECH, INC. PROJECT NO. 212C-MD-02867	DESCRIPTION	View northeast, drill rig entering through cut in berm to drill and sample at BH-1 location.	5
	SITE NAME	ConocoPhillips Compadres Fee Tank Battery	9/25/2018

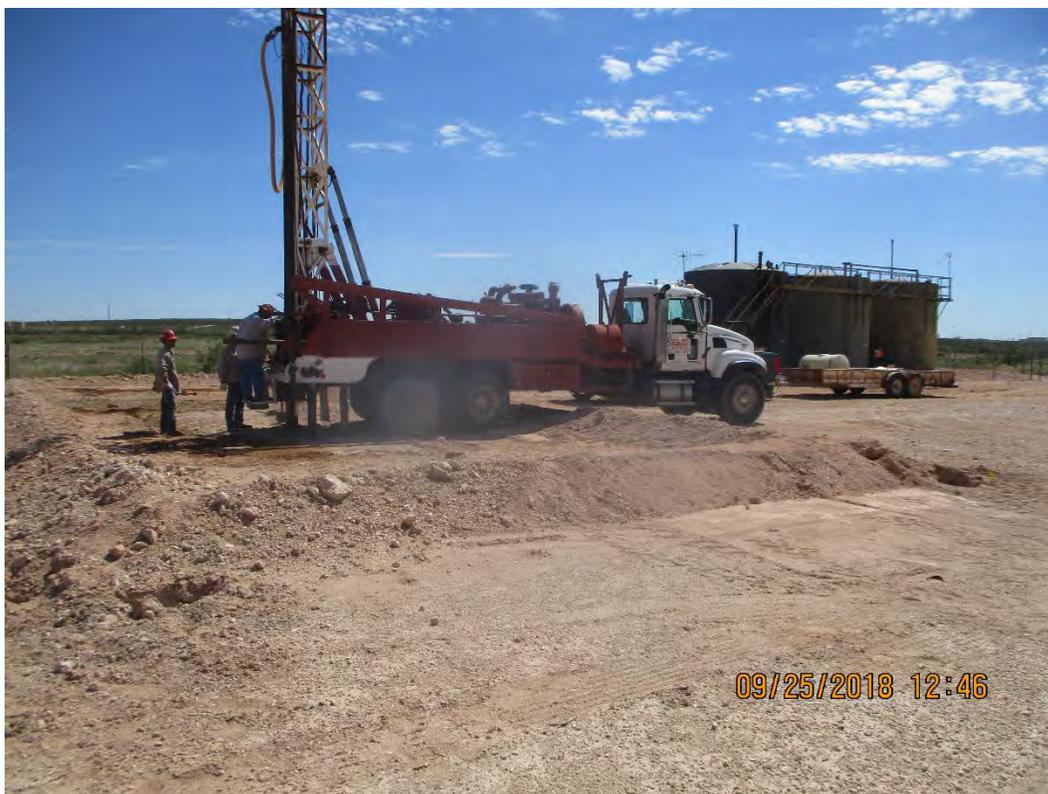
TETRA TECH, INC. PROJECT NO. 212C-MD-02867	DESCRIPTION	View east-southeast, drilling of BH-1 and sampling.	6
	SITE NAME	ConocoPhillips Compadres Fee Tank Battery Release	9/25/2018

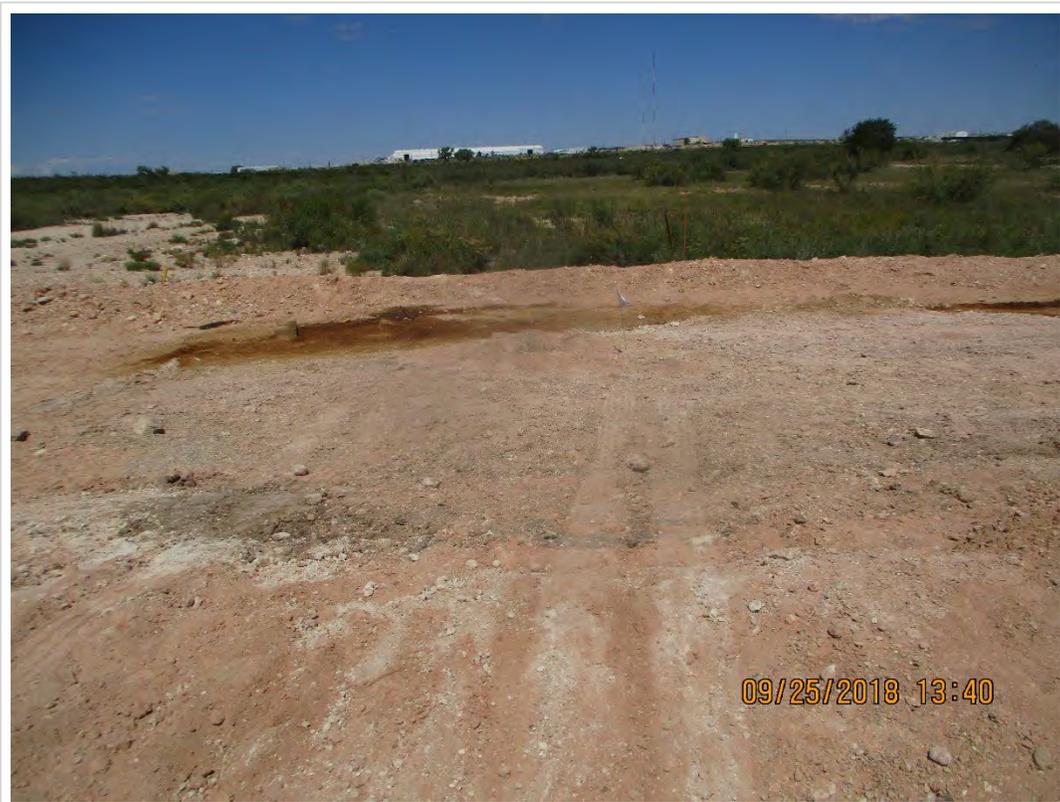
TETRA TECH, INC. PROJECT NO. 212C-MD-02867	DESCRIPTION	View north, cut in berm for drill rig entry in foreground. Residual TPH staining along north side of berm-area.	7
	SITE NAME	ConocoPhillips Compadres Fee Tank Battery	9/25/2018

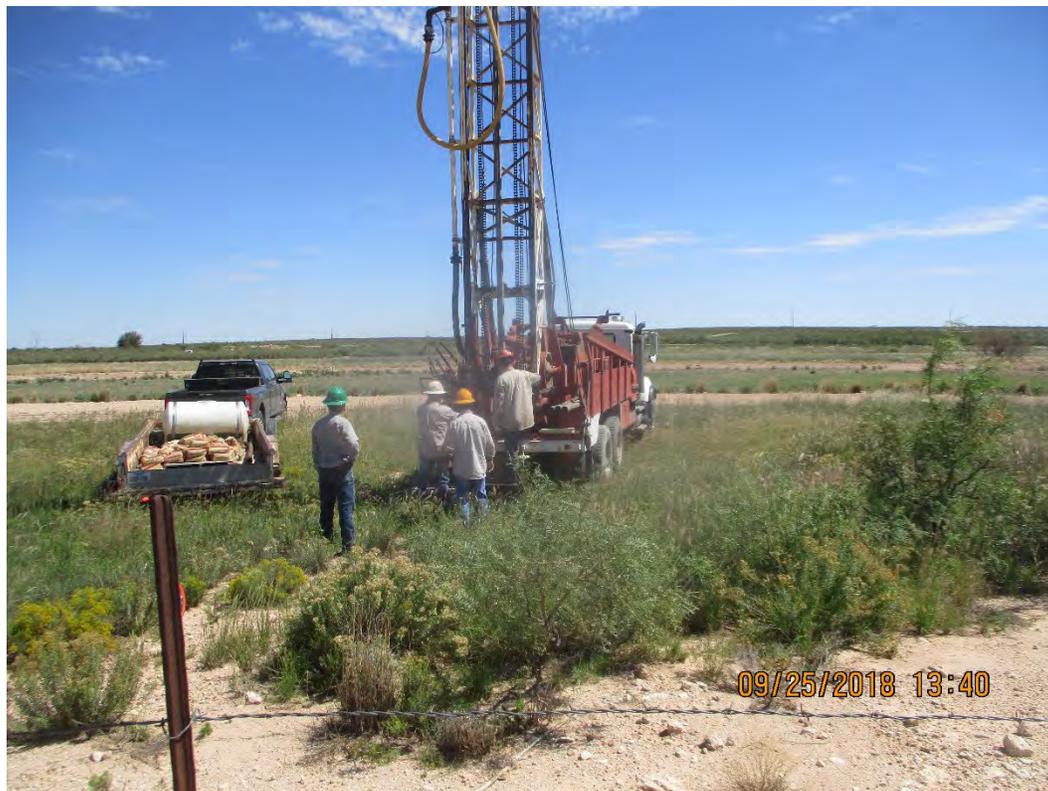
TETRA TECH, INC. PROJECT NO. 212C-MD-02867	DESCRIPTION	View east, background boring location. Support truck with backfill material in trailer.	8
	SITE NAME	ConocoPhillips Compadres Fee Tank Battery Release	9/25/2018

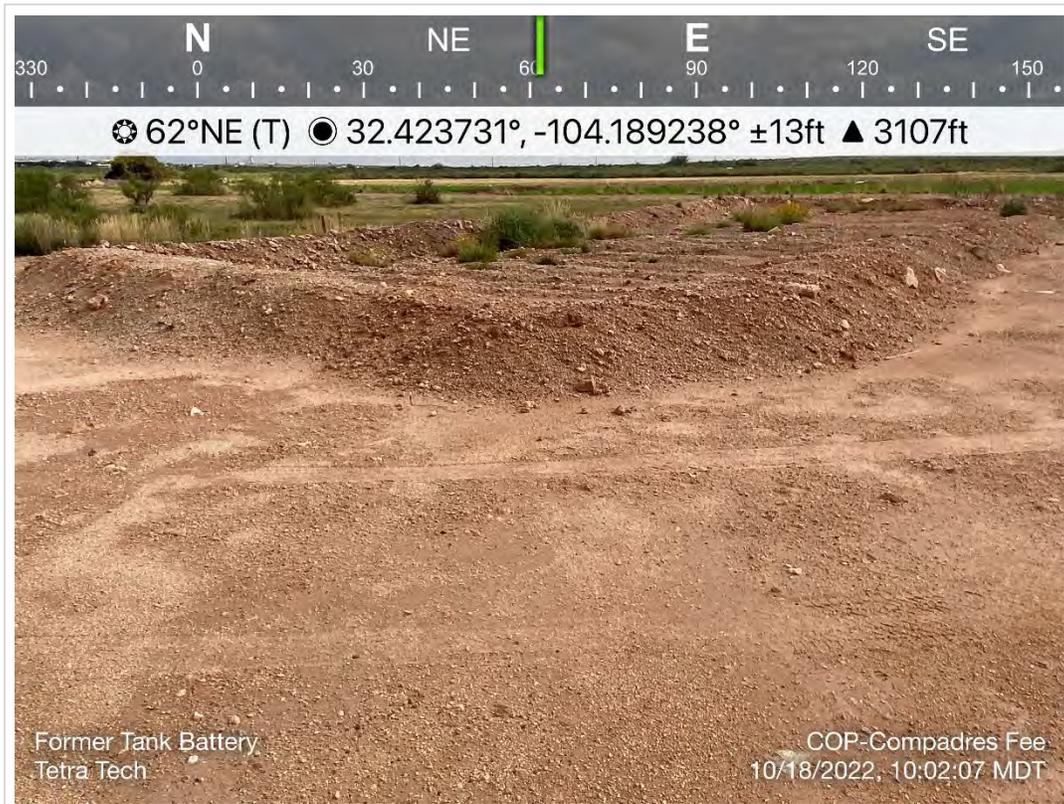
TETRA TECH, INC. PROJECT NO. 212C-MD-02867	DESCRIPTION	View northeast. Former production equipment removed. Berm area.	9
	SITE NAME	ConocoPhillips Compadres Fee Tank Battery Release	10/18/2022

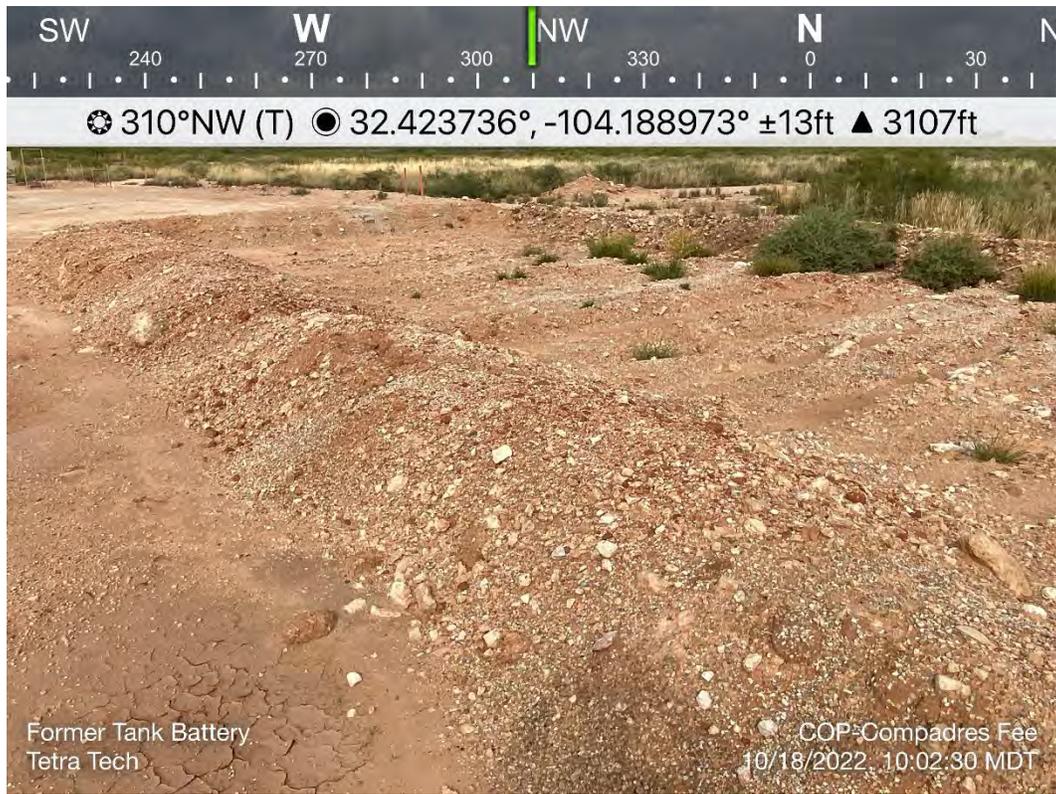
TETRA TECH, INC. PROJECT NO. 212C-MD-02867	DESCRIPTION	View northwest. Former release area, production equipment removed. No staining observed, vegetation present. Berm area.	10
	SITE NAME	ConocoPhillips Compadres Fee Tank Battery Release	10/18/2022

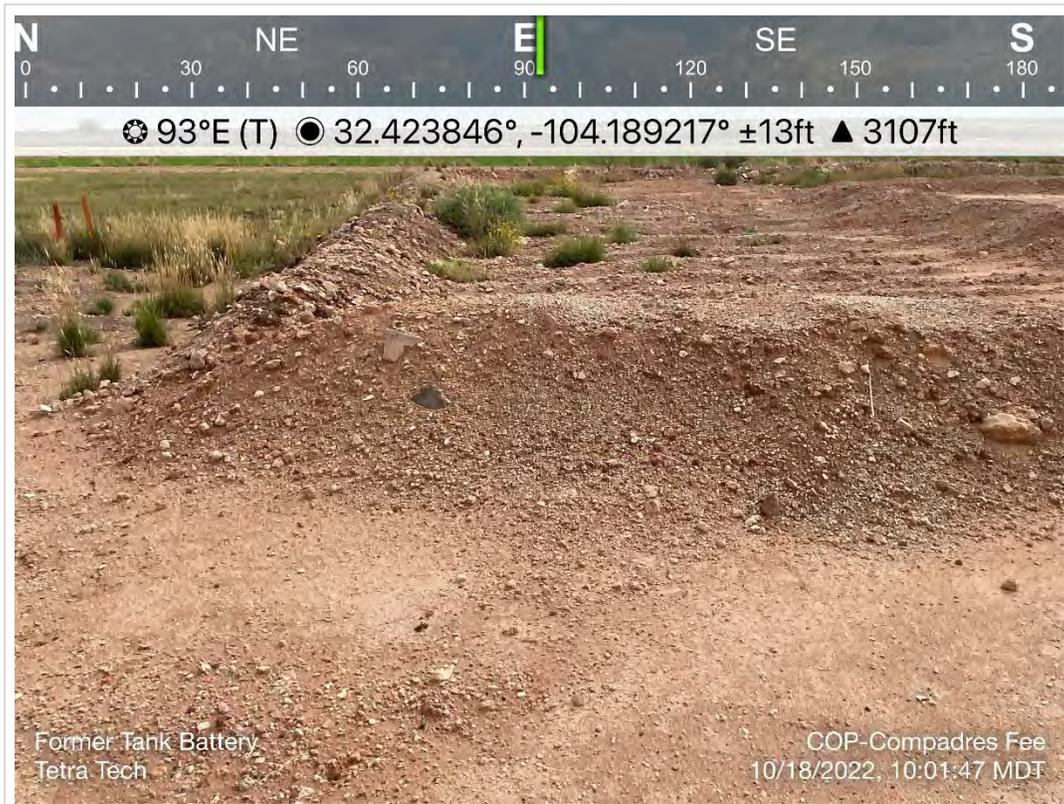
TETRA TECH, INC. PROJECT NO. 212C-MD-02867	DESCRIPTION	View east. Former release area, production equipment removed. No staining observed, vegetation present.	11
	SITE NAME	ConocoPhillips Compadres Fee Tank Battery Release	10/18/2022

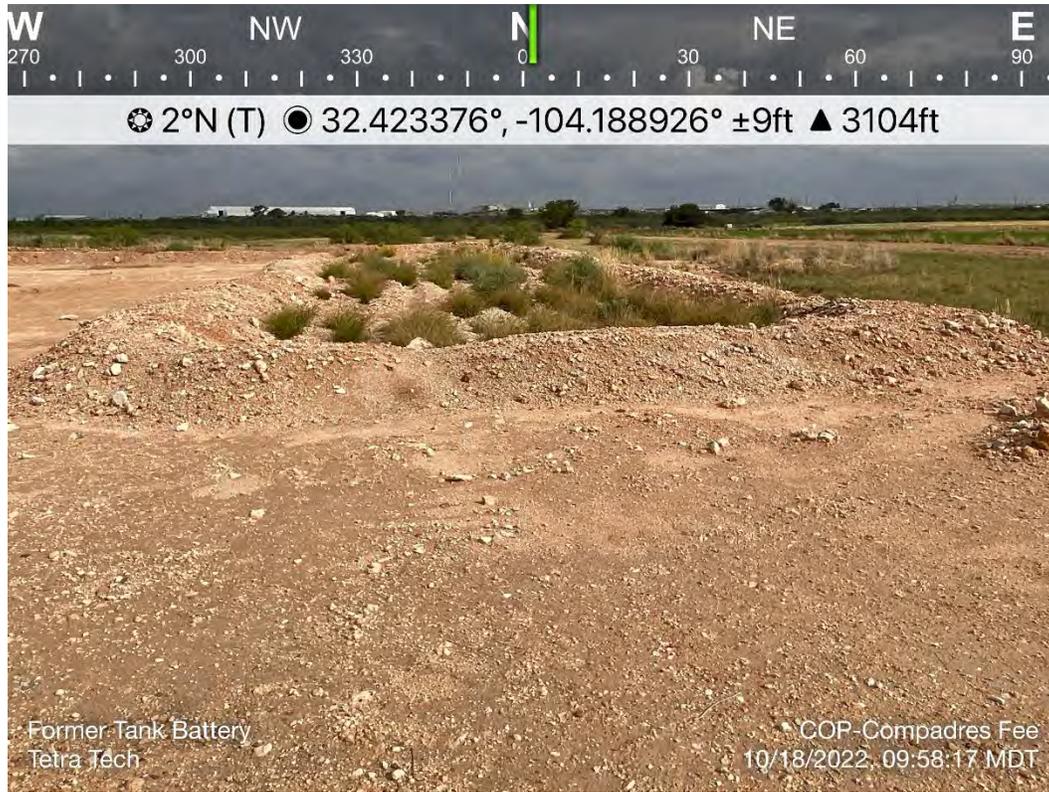
TETRA TECH, INC. PROJECT NO. 212C-MD-02867	DESCRIPTION	View north. Former tank battery southeast corner of lease pad. Vegetation observed.	12
	SITE NAME	ConocoPhillips Compadres Fee Tank Battery Release	10/18/2022

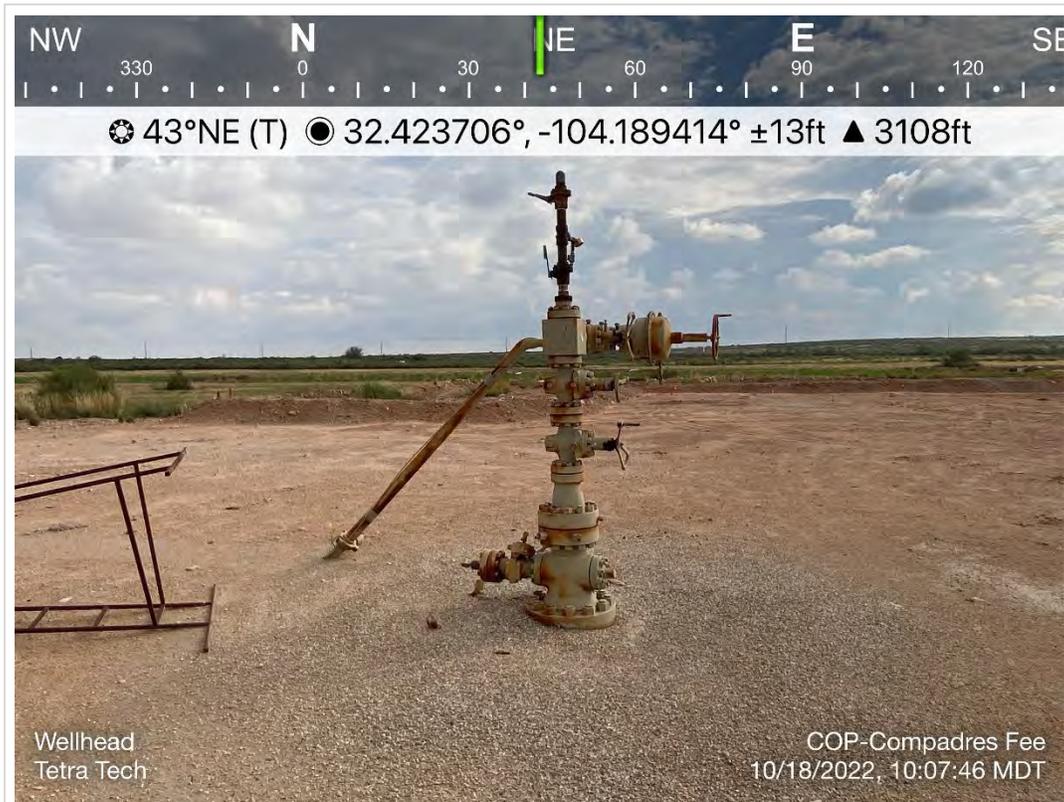
TETRA TECH, INC. PROJECT NO. 212C-MD-02867	DESCRIPTION	View northeast. Wellhead API 30-015-33246 – Twix Fee Com #001. View of former release area to the north.	13
	SITE NAME	ConocoPhillips Compadres Fee Tank Battery Release	10/18/2022

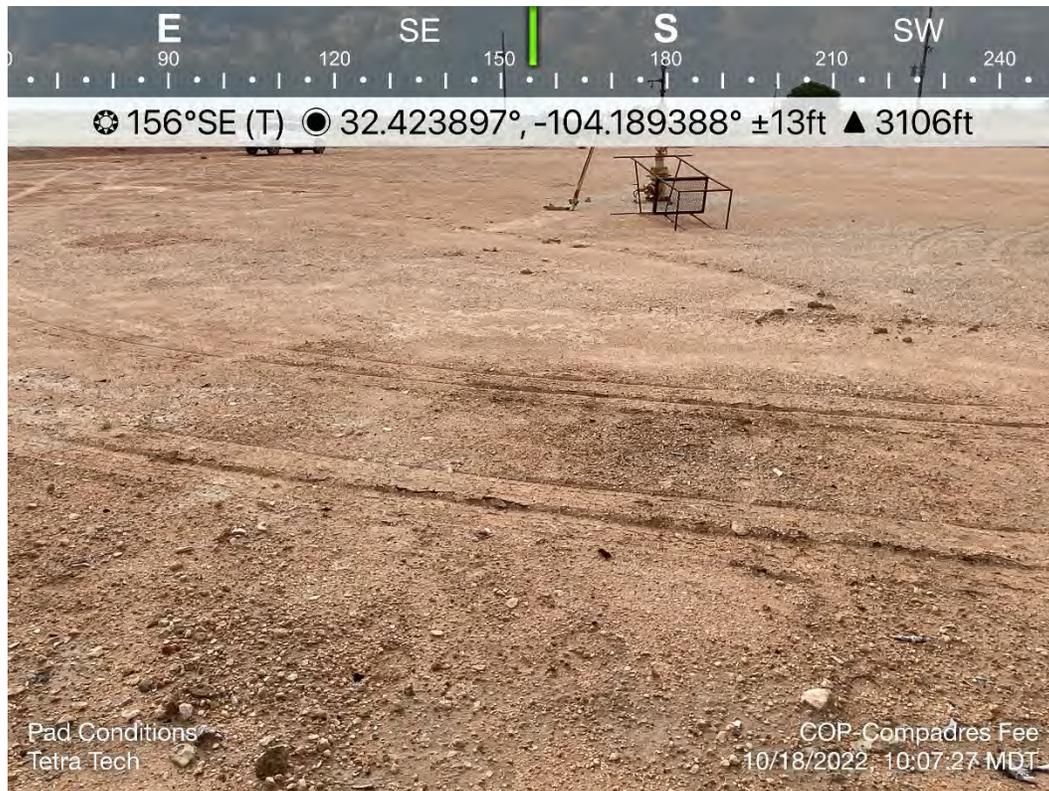
TETRA TECH, INC. PROJECT NO. 212C-MD-02867	DESCRIPTION	View southeast. Location of former equipment. View of wellhead.	14
	SITE NAME	ConocoPhillips Compadres Fee Tank Battery Release	10/18/2022

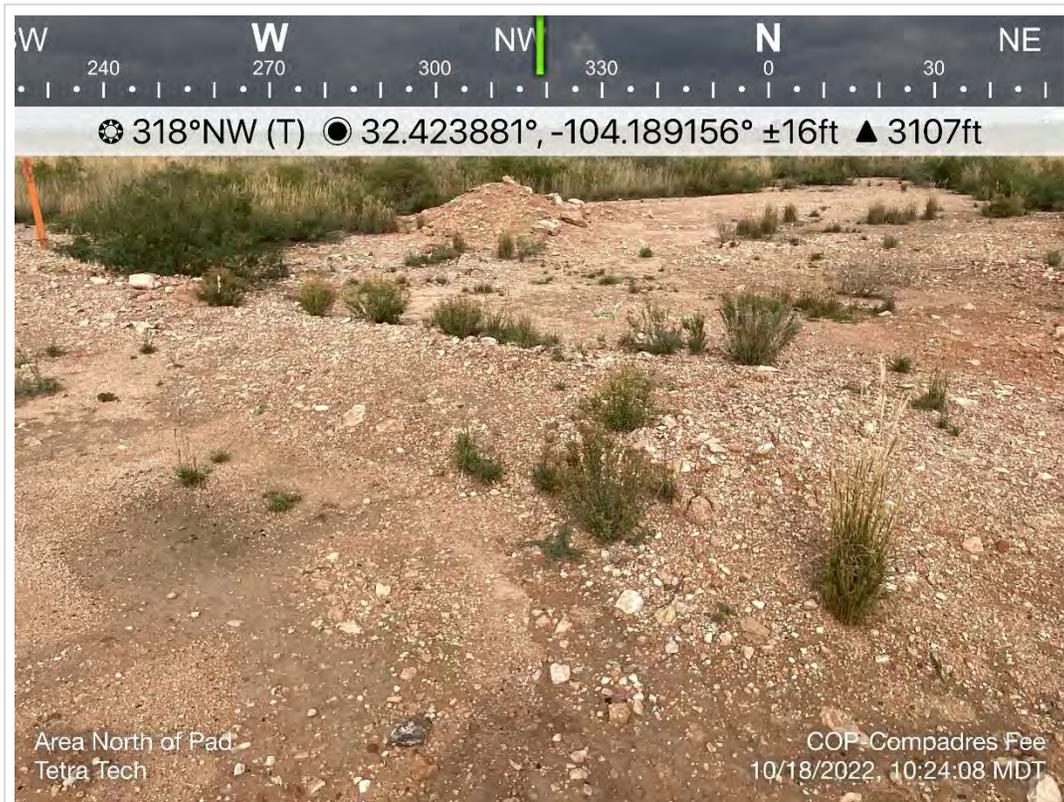
TETRA TECH, INC. PROJECT NO. 212C-MD-02867	DESCRIPTION	View northeast. View of former reserve pit, vegetation observed.	15
	SITE NAME	ConocoPhillips Compadres Fee Tank Battery Release	10/18/2022

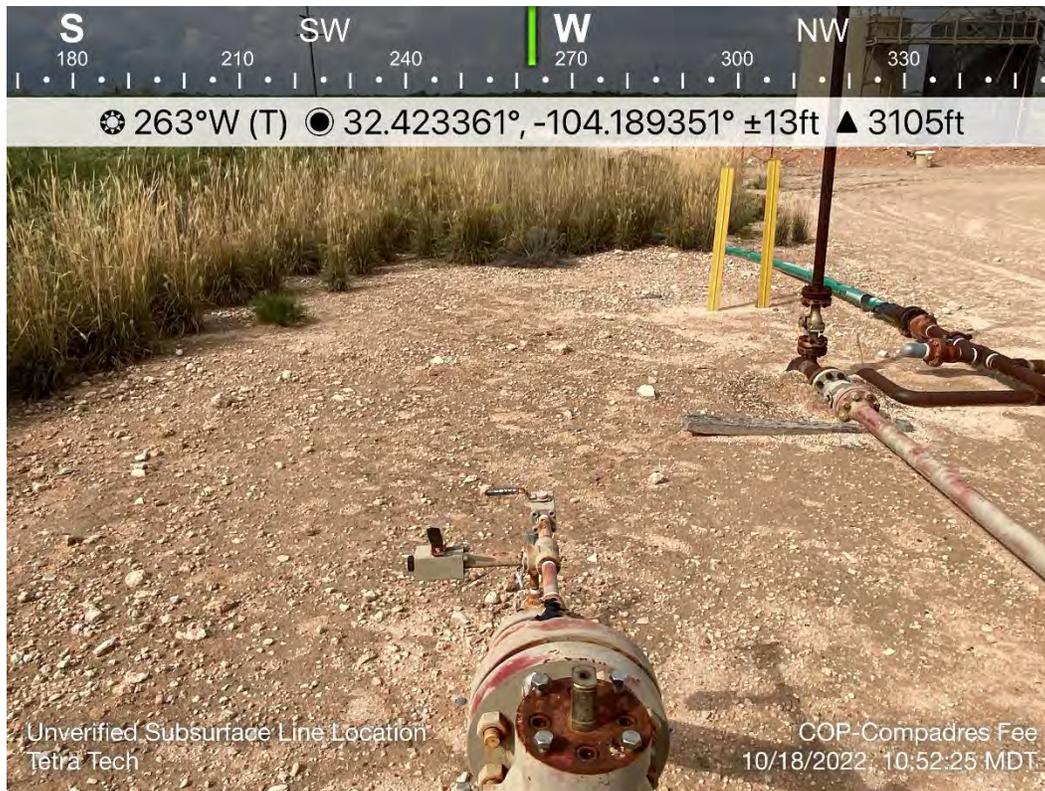
TETRA TECH, INC. PROJECT NO. 212C-MD-02867	DESCRIPTION	View west. Subsurface flowline located south of lease pad.	16
	SITE NAME	ConocoPhillips Compadres Fee Tank Battery Release	10/18/2022

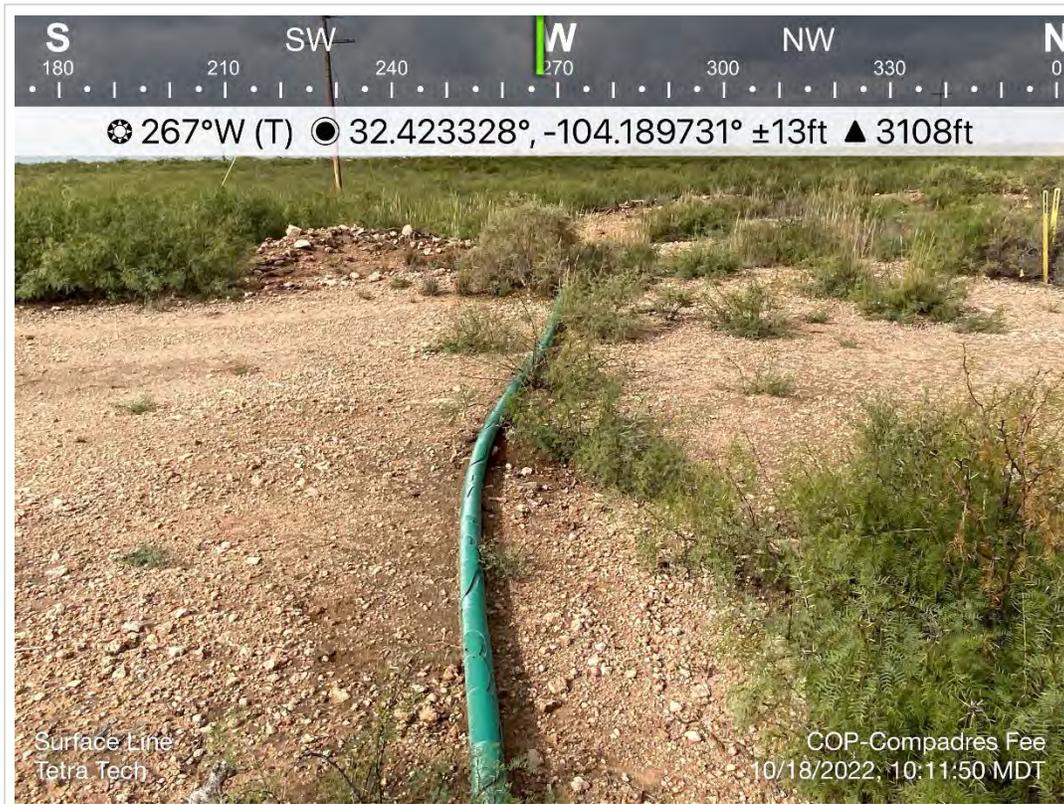
TETRA TECH, INC. PROJECT NO. 212C-MD-02867	DESCRIPTION	View east. View of subsurface flowline on the southwest corner of lease pad.	17
	SITE NAME	ConocoPhillips Compadres Fee Tank Battery Release	10/18/2022

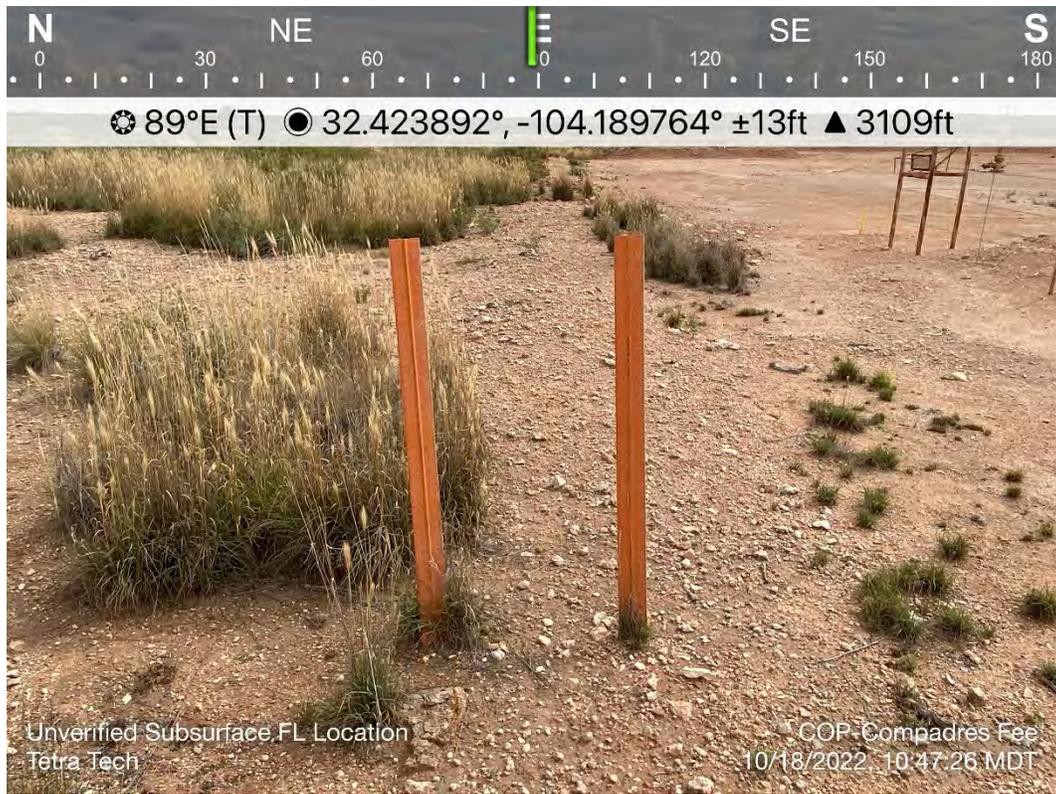
TETRA TECH, INC. PROJECT NO. 212C-MD-02867	DESCRIPTION	View east. Subsurface utilities on northwest corner of lease pad.	18
	SITE NAME	ConocoPhillips Compadres Fee Tank Battery Release	10/18/2022
