### Report Type: Closure Report 2RP-2826

| Site: | Maduro BOZ State Com #1H | | | | | |

**Re: Closure Report for the EOG Resources, Maduro BOZ State 1H, Unit P, Section 10, Township 25 South, Range 27 East, Eddy County, New Mexico.**

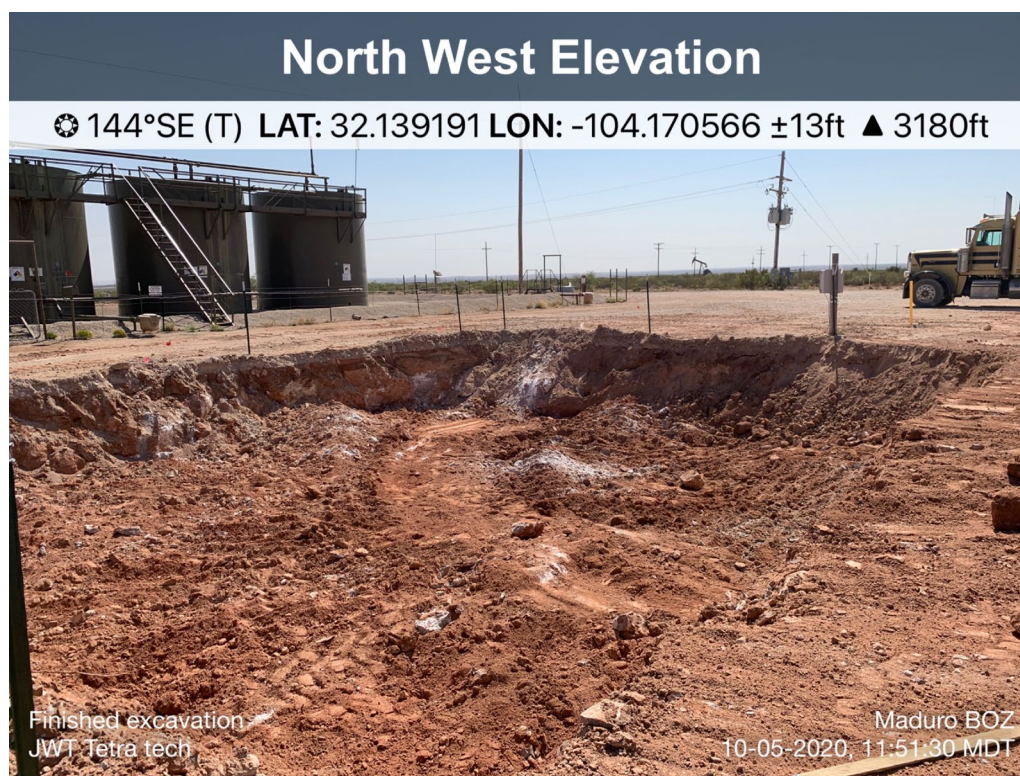
View of Remediation Activities – View Northwest

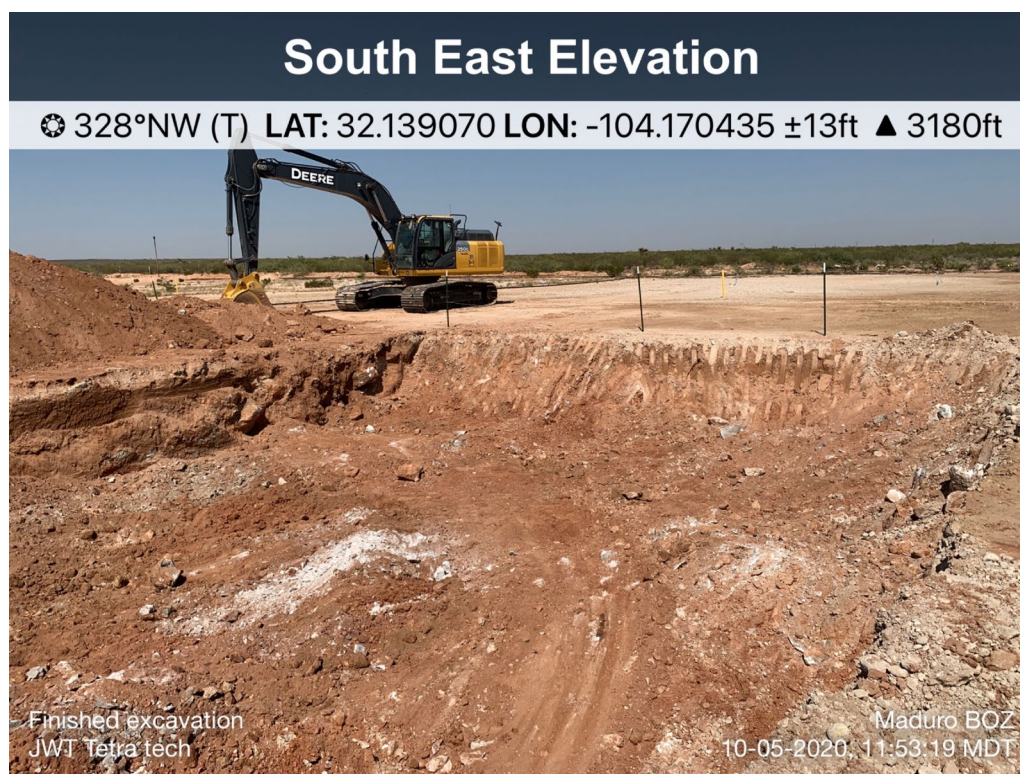
View of Remediation Activities – View Southeast

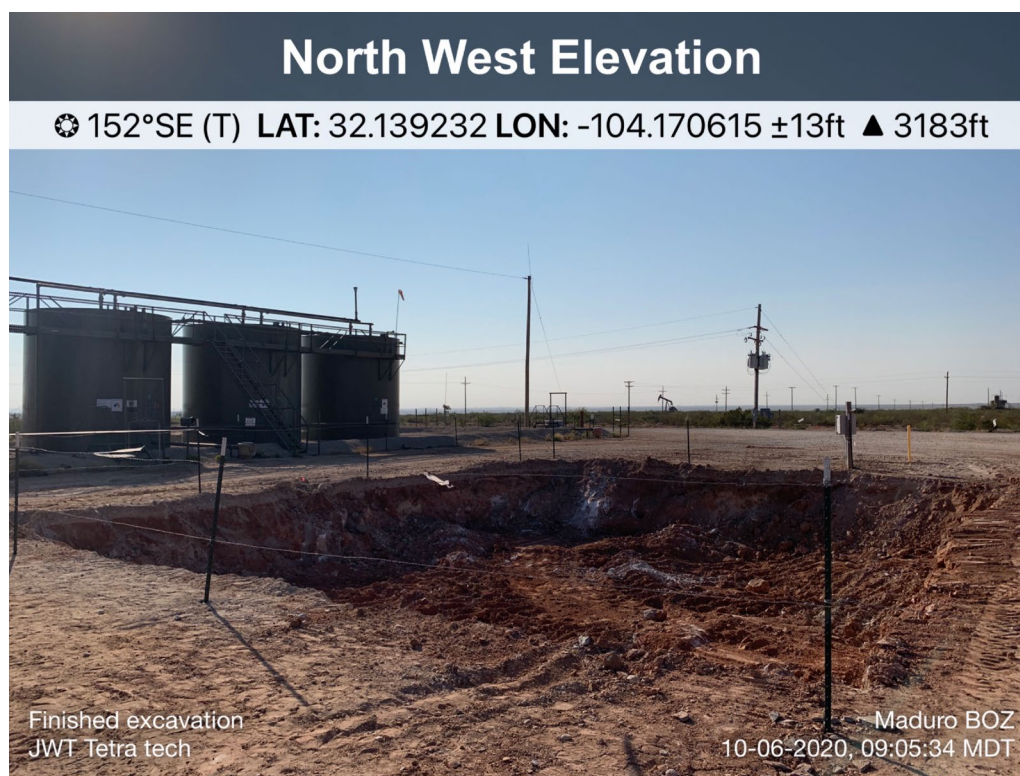
View of Remediation – View Northwest
