Hudson 30 Fed #4

CLOSURE REPORT

UL/D Sec 30, T18 south, R33 east, Lea County NM

API # 30-025-34301

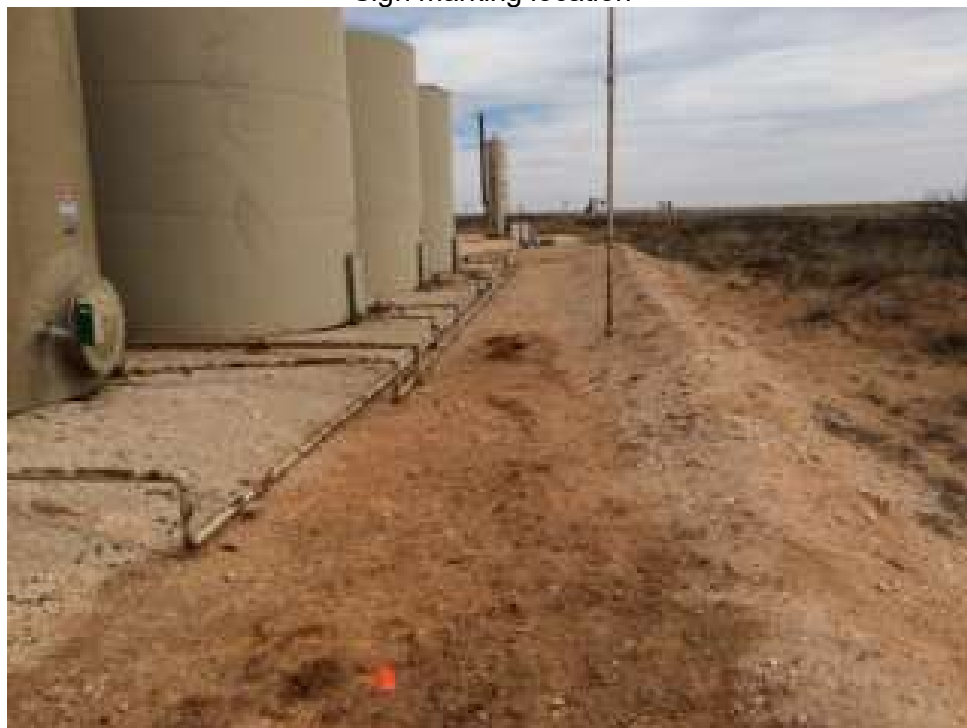
Spill area with sample point

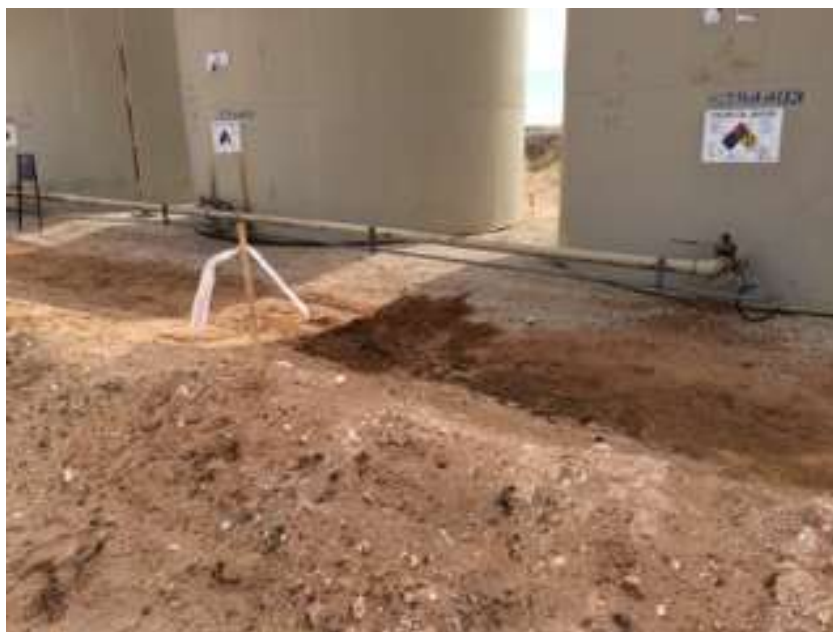
Spill area with sample point

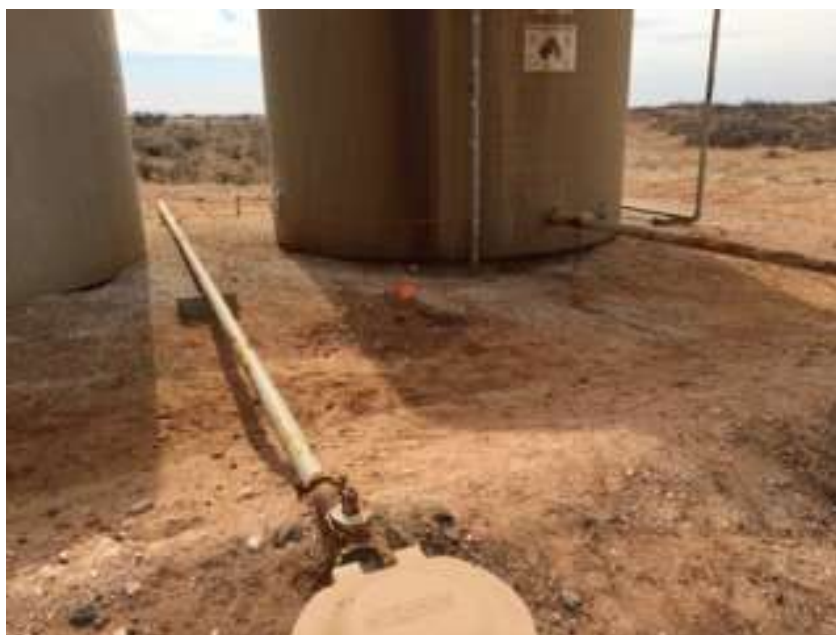
Spill area with sample point

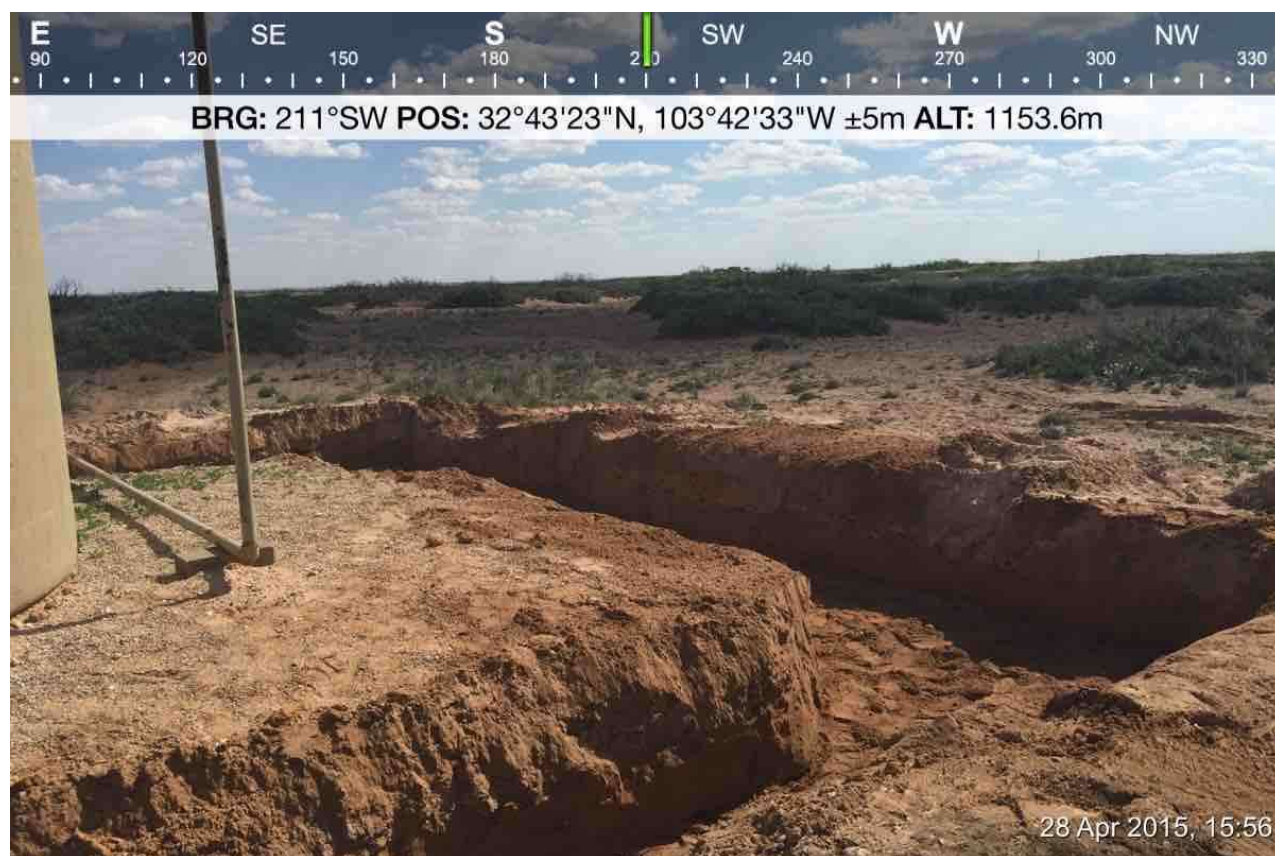
Excavated spill area

DFSI personnel returned to the location to remove 2' of contaminated soil inside the bermed facility. All contaminated material was hauled to an approved disposal facility. New caliche was brought in for backfill of the excavated area. The firewalls were also rebuilt and the location was restored to its previous state

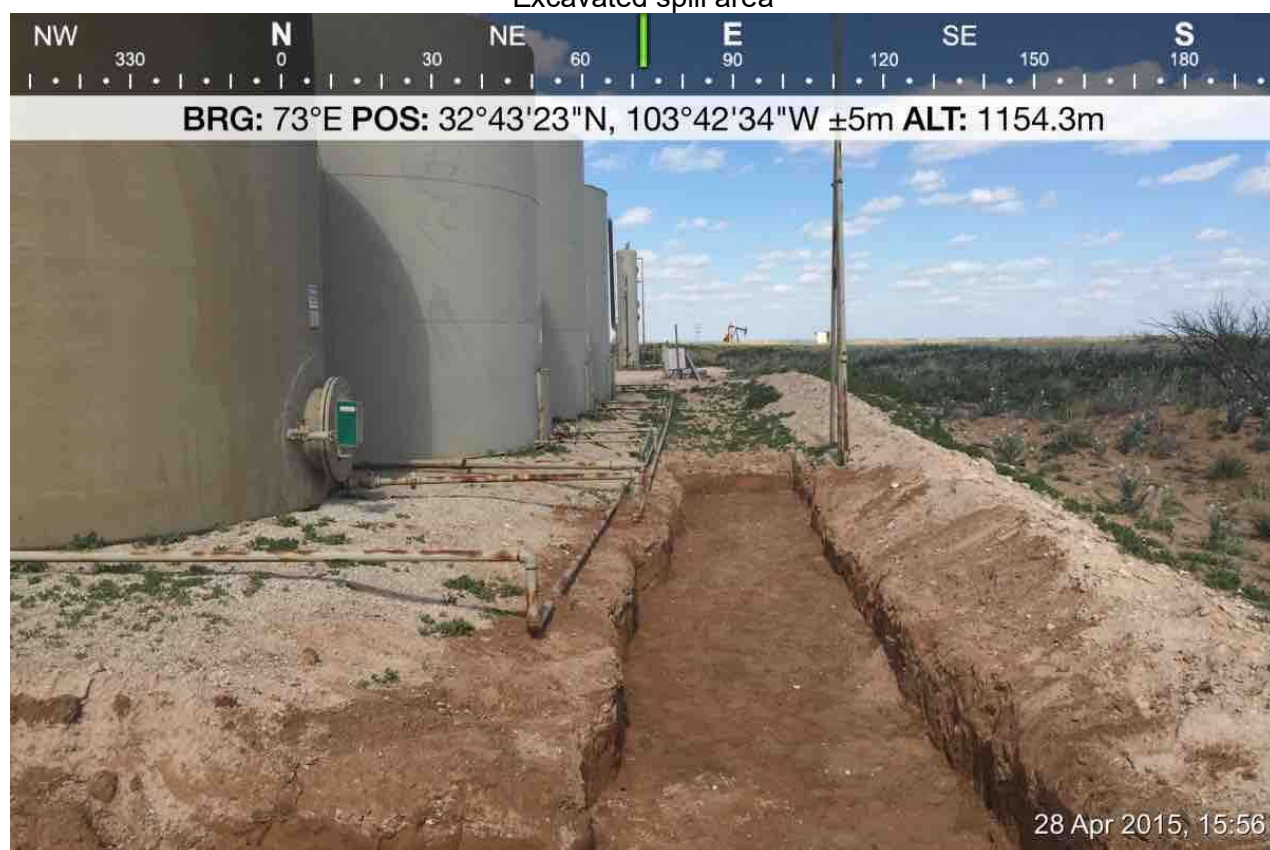
Excavated spill area
