Site Assessment/Characterization

Closure

**Re: Site Assessment and Closure Report
Burton Flats Deep Unit #52H
API No. 30-015-30780
GPS: Latitude 32.511694 Longitude -104.169029
UL "H", Sec. 3, T21S, R27E
Eddy County, NM
NMOCD Ref. No. NAB1515649061 (2RP-3031)**

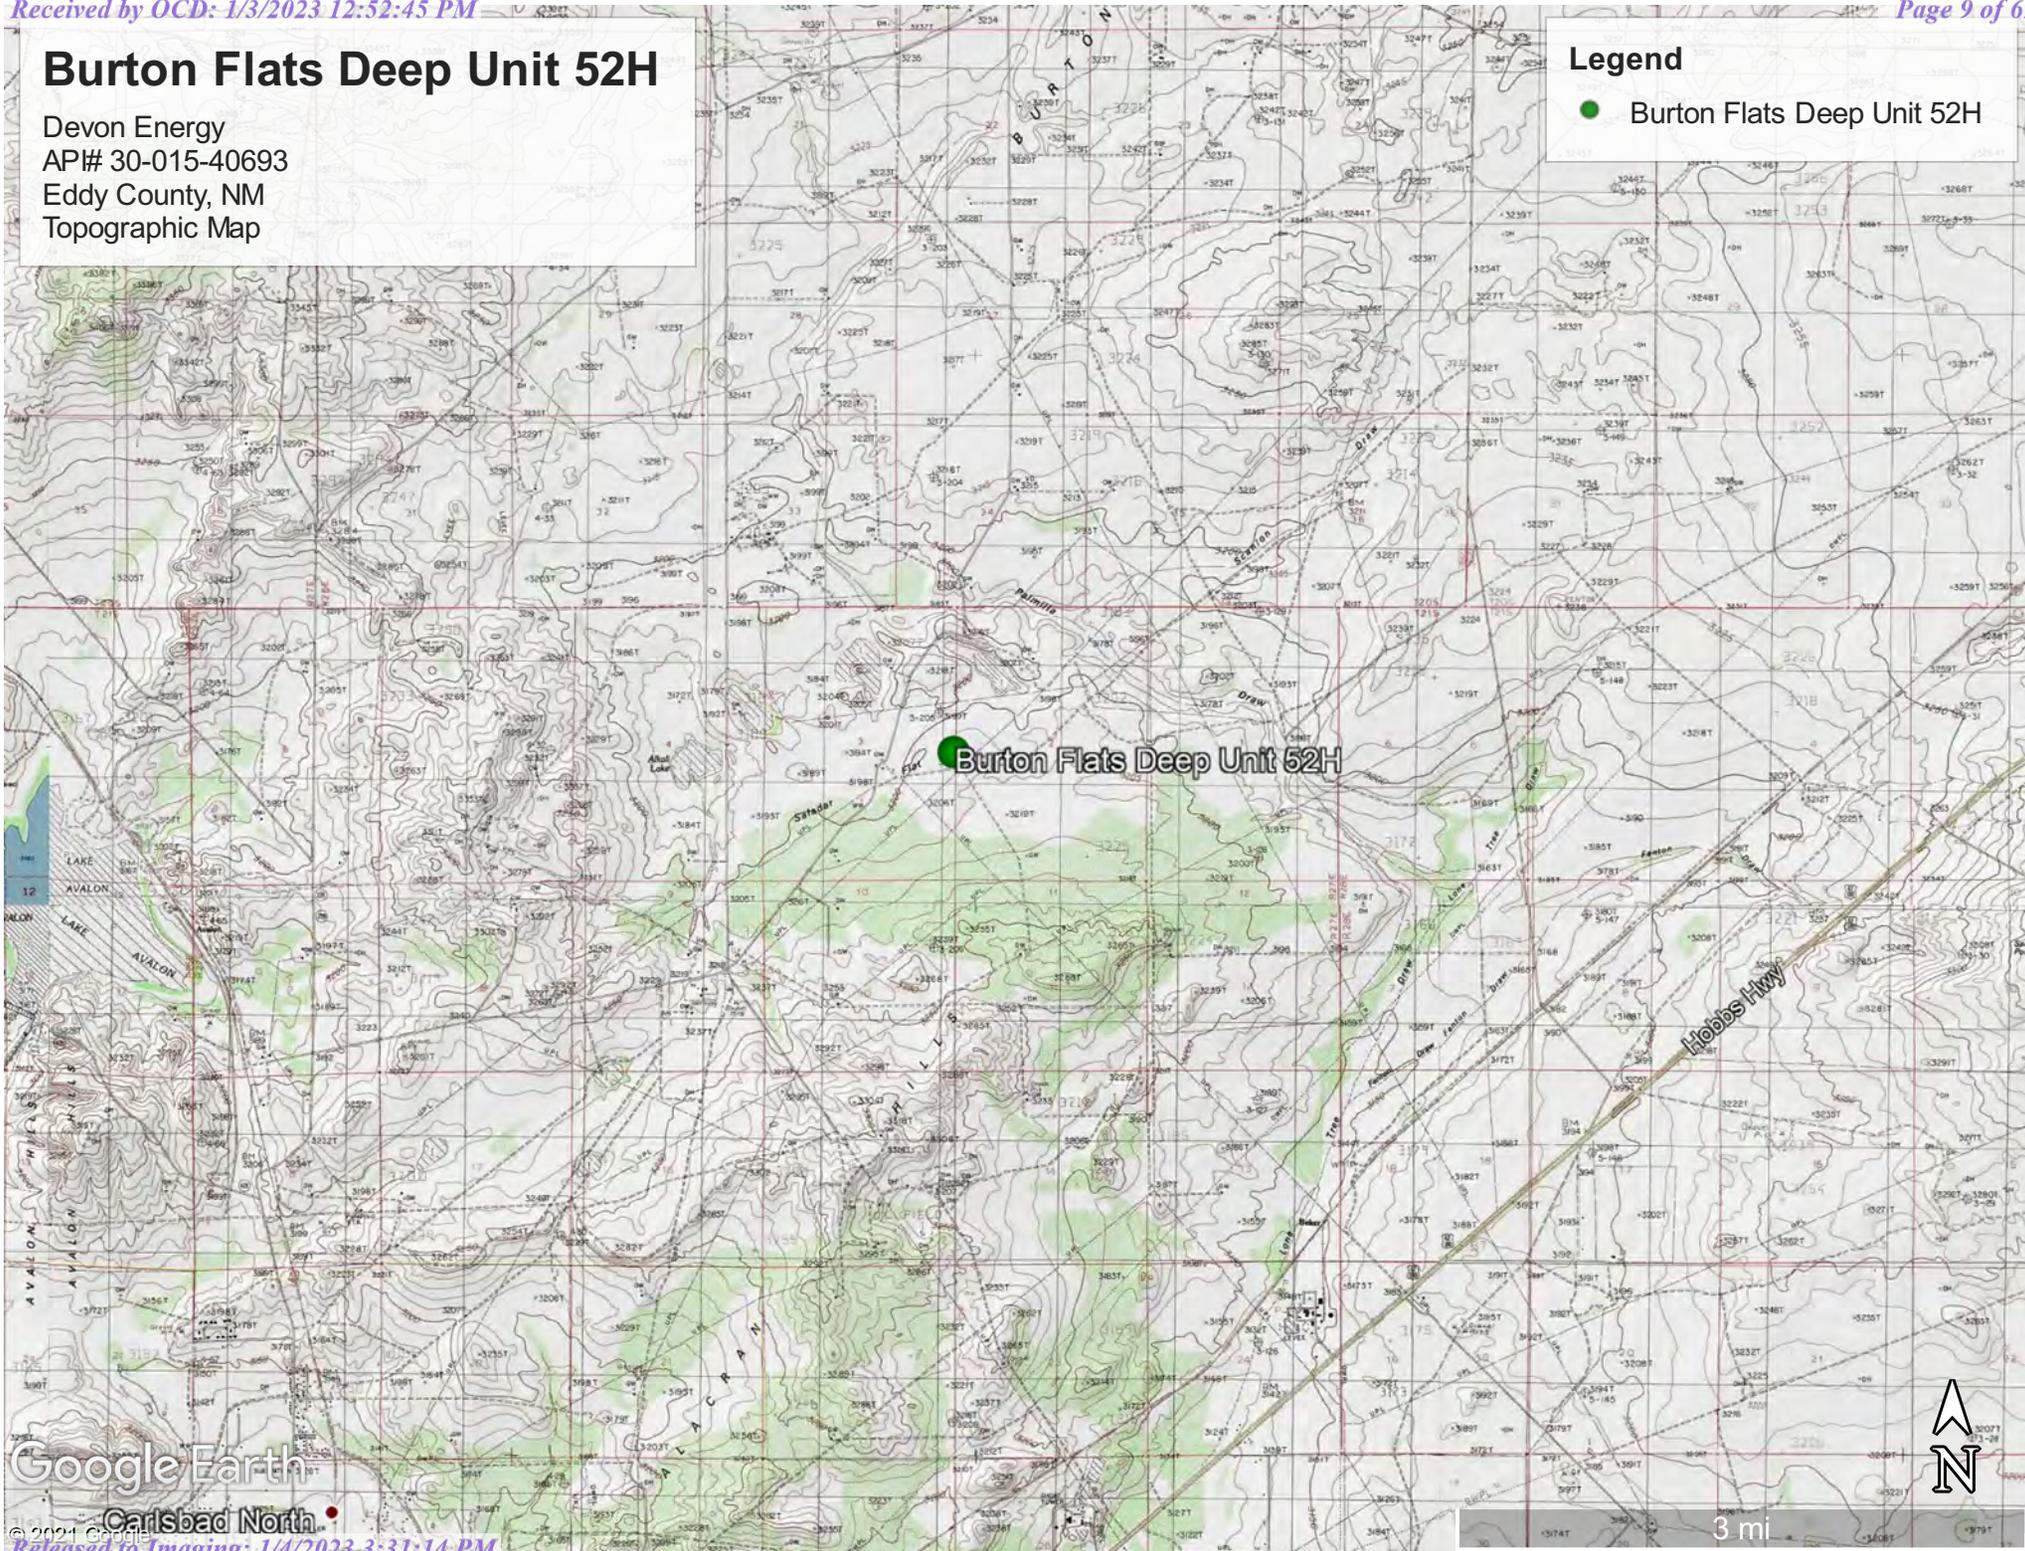
Devon Energy
API# 30-015-40693
Eddy County, NM
Topographic Map

Reference Figure 2 for a TOPO Map.

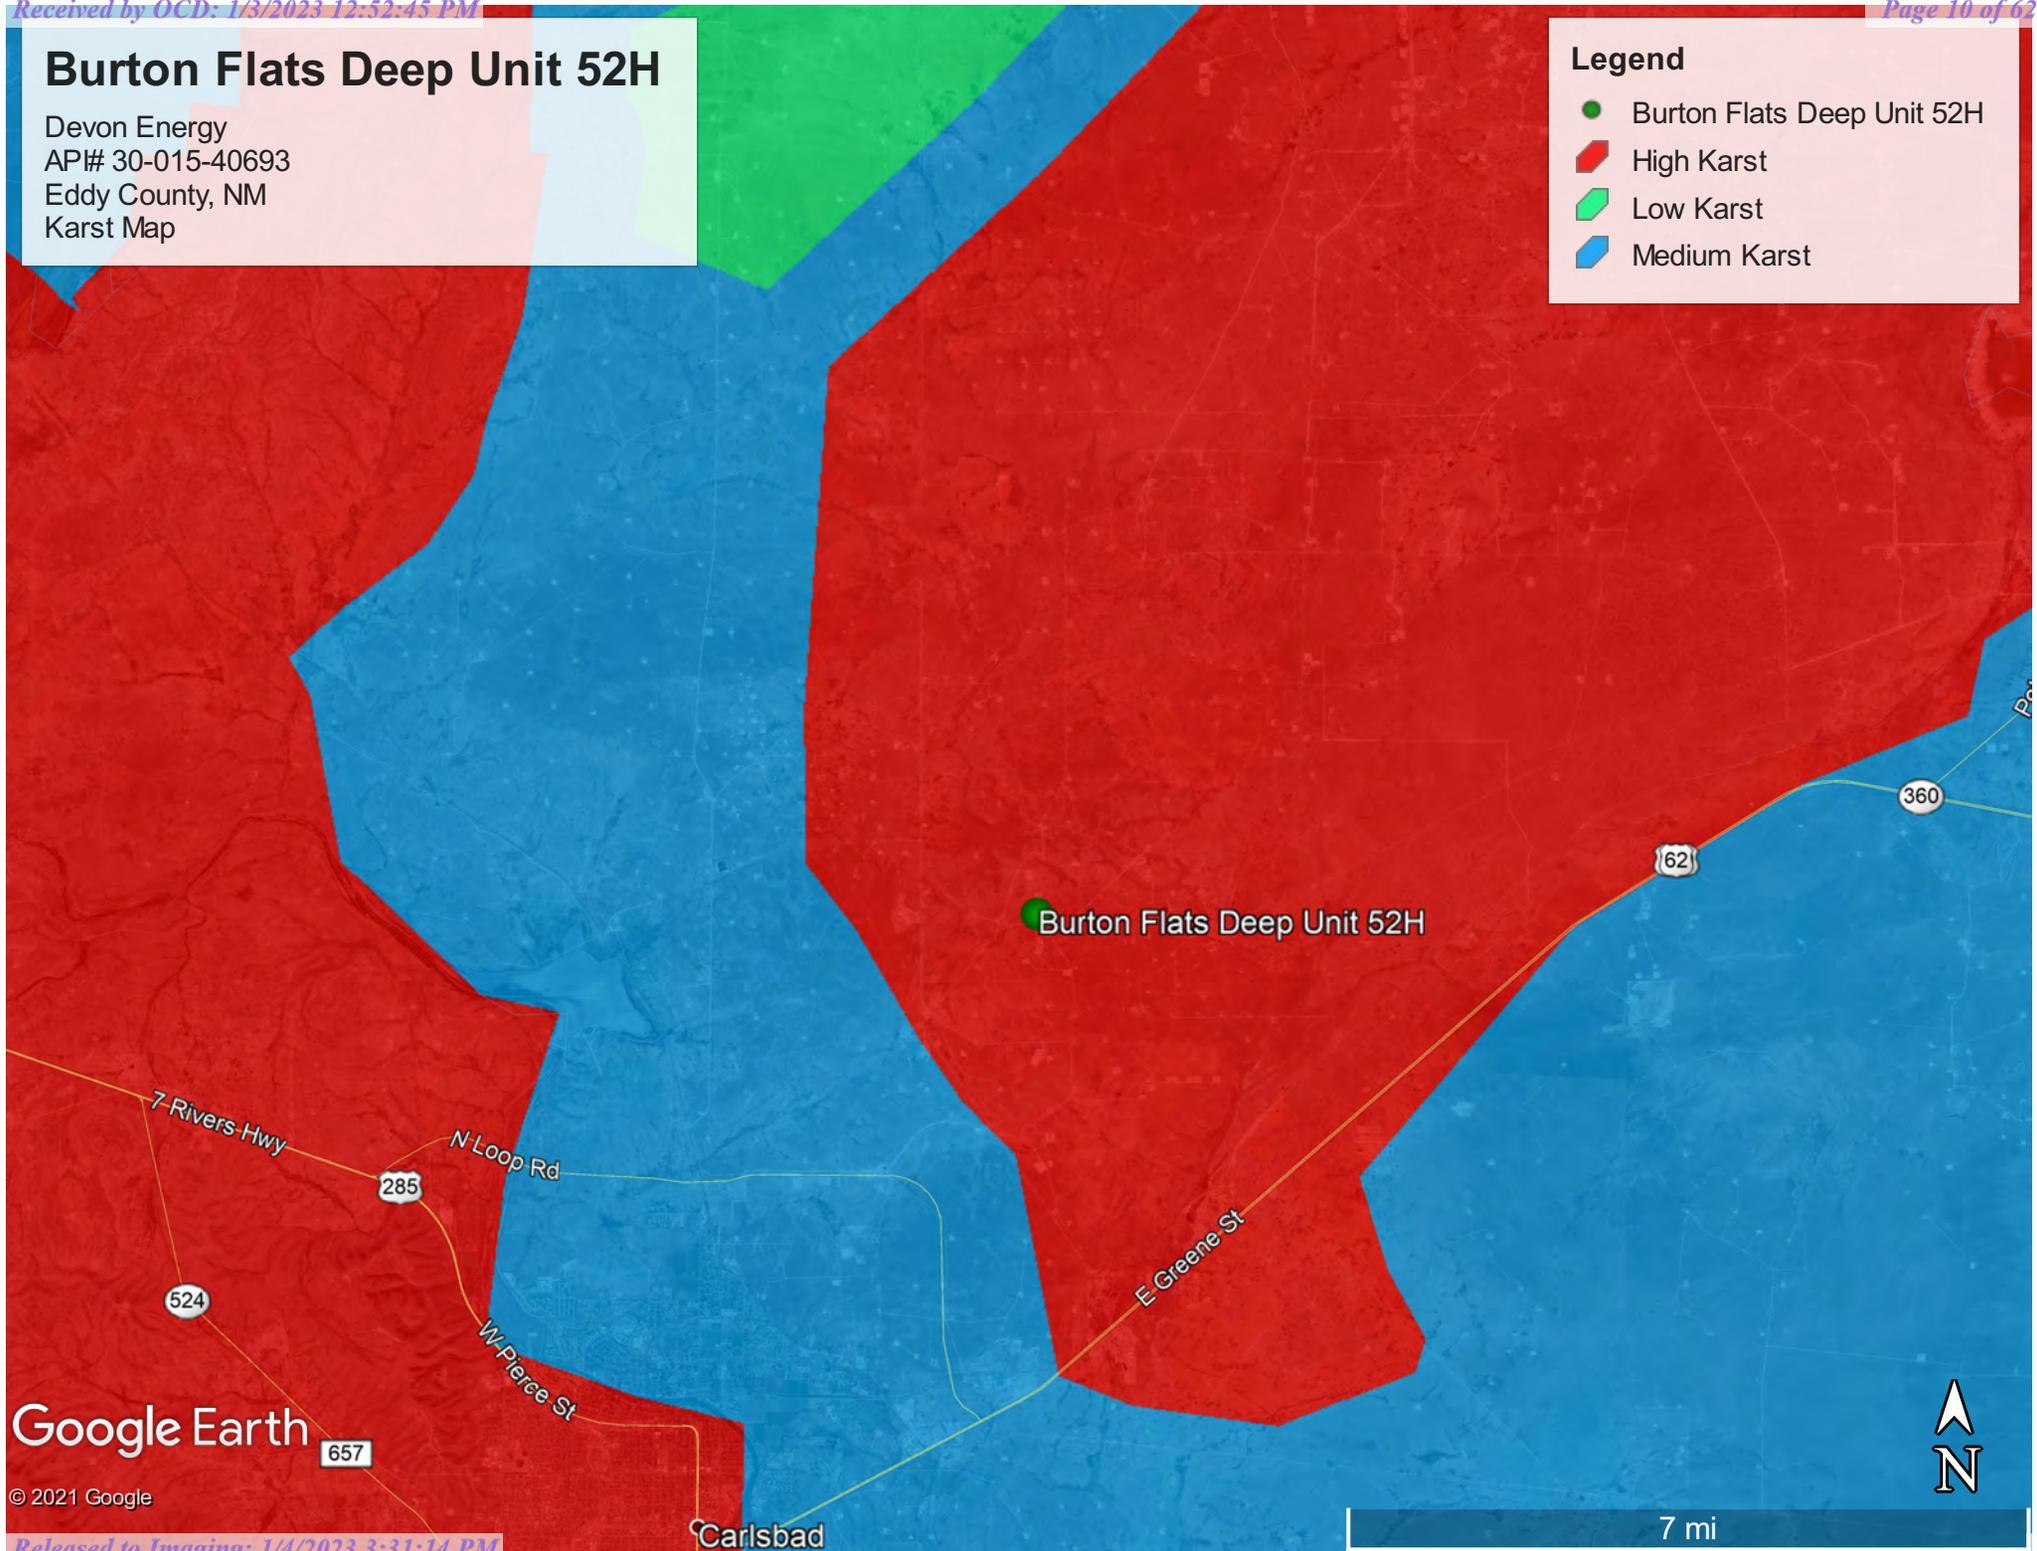
Devon Energy
API# 30-015-40693
Eddy County, NM
Karst Map

Per the New Mexico Bureau of Geology and Mineral Resources, the geology is in the Quaternary Formation- Eolian deposits (Holocene to middle Pleistocene). Interlayered eolian sands and piedmont-slope deposits along the eastern flank of the Pecos River valley, primarily between Roswell and Carlsbad. Typically capped by thin eolian deposits. The soil in this area is made up of Simona-Bippus complex, 0 to 5 percent slopes according to the United States Department of Agriculture Natural Resources Conservation Service soil survey (Appendix B). The drainage courses in this area are well-drained. There is a high potential for karst geology to be present in the area of the Burton Flats (Figure 3).

- Burton Flats Deep Unit 52H
- High Karst
- Low Karst
- Medium Karst

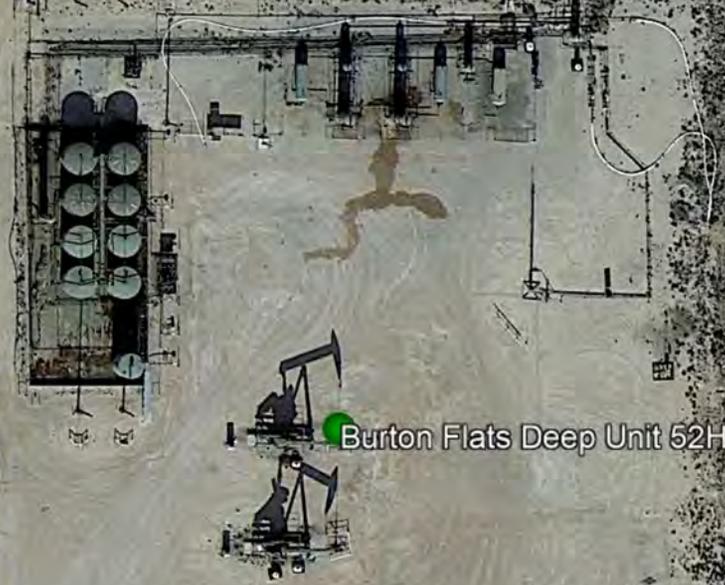
Devon Energy
API# 30-015-40693
Eddy County, NM
Site Map

On December 29th, 2020 Pima Environmental conducted a site assessment and obtained soil samples. The laboratory results of this sampling event can be found in the following data table.

NMOCD Table 1 Closure Criteria 19.15.29 NMAC (Depth to Groundwater is >100')								
Sample Date 12-29-20		NM Approved Laboratory Results						
Sample ID	Depth (BGS)	BTEX mg/kg	Benzene mg/kg	GRO mg/kg	DRO mg/kg	MRO mg/kg	Total TPH mg/kg	Cl mg/kg
S-1	0-6	ND	ND	ND	ND	ND	ND	ND
	1	ND	ND	ND	ND	ND	ND	ND
	2	ND	ND	ND	ND	ND	ND	ND
S-2	0-6	ND	ND	ND	ND	ND	ND	ND
	1	ND	ND	ND	ND	ND	ND	ND
	2	ND	ND	ND	ND	ND	ND	ND
S-3	0-6	ND	ND	ND	ND	ND	ND	ND
	1	ND	ND	ND	ND	ND	ND	ND
	2	ND	ND	ND	ND	ND	ND	ND
S-4	0-6	ND	ND	ND	ND	ND	ND	ND
	1	ND	ND	ND	ND	ND	ND	ND
	2	ND	ND	ND	ND	ND	ND	ND
S-5	0-6	ND	ND	ND	ND	ND	ND	ND
	1	ND	ND	ND	ND	ND	ND	ND
	2	ND	ND	ND	ND	ND	ND	78
S-6	0-6	ND	ND	ND	ND	ND	ND	ND
	1	ND	ND	ND	ND	ND	ND	130
	2	ND	ND	ND	ND	ND	ND	200

The sample results were below NMOCD Closure Criteria 19.15.29 NMAC. Based on these findings, no remediation activities were needed at this location.

S1
S2
S3
S4
S5
S6

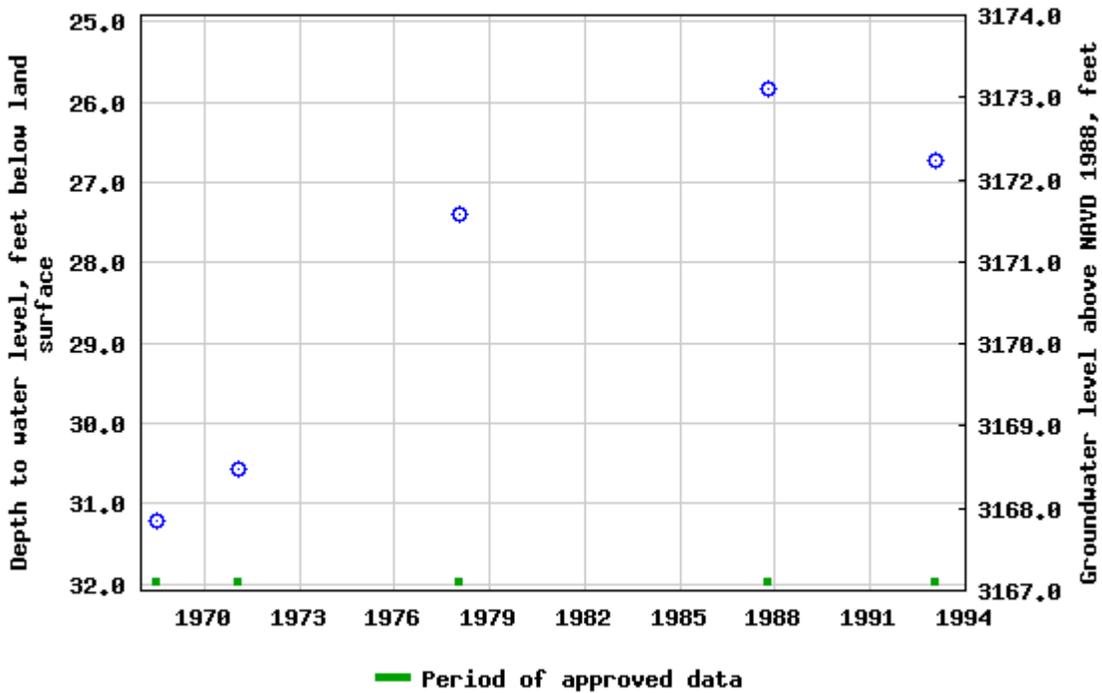
USGS 323029104103901 21S.27E.03.32244

Latitude 32°30'29", Longitude 104°10'39" NAD27

Land-surface elevation 3,199 feet above NAVD88

Breaks in the plot represent a gap of at least one year between field measurements.
[Download a presentation-quality graph](#)

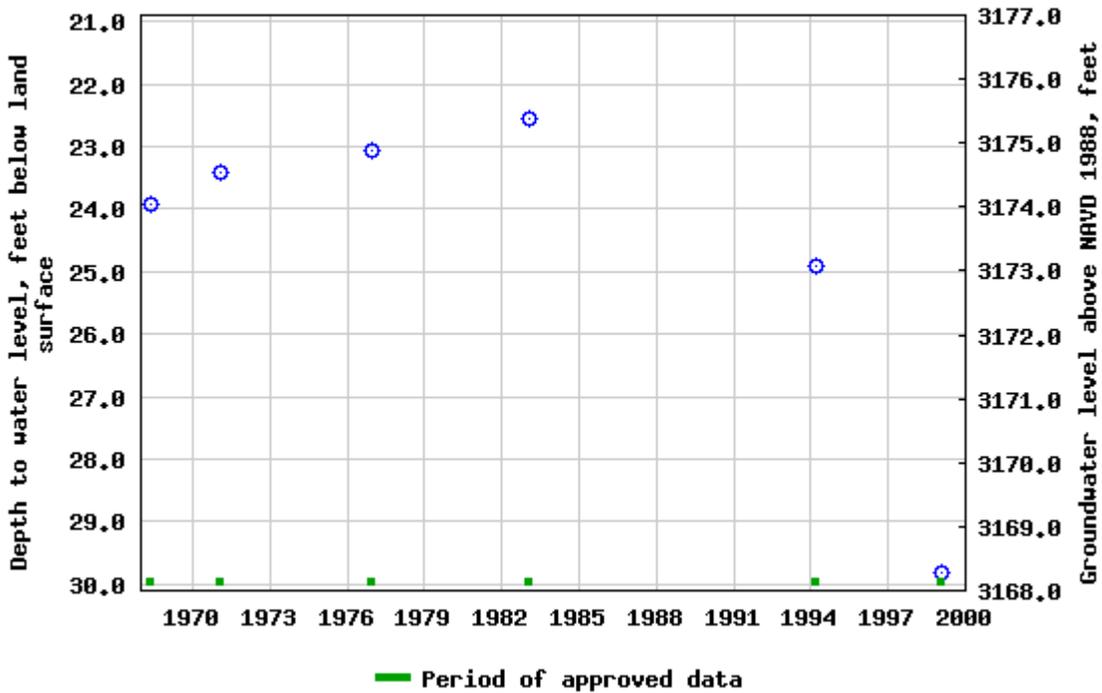
USGS 323146104105801 20S,28E,33,32322

The depth of the well is 43 feet below land surface.

Breaks in the plot represent a gap of at least one year between field measurements.

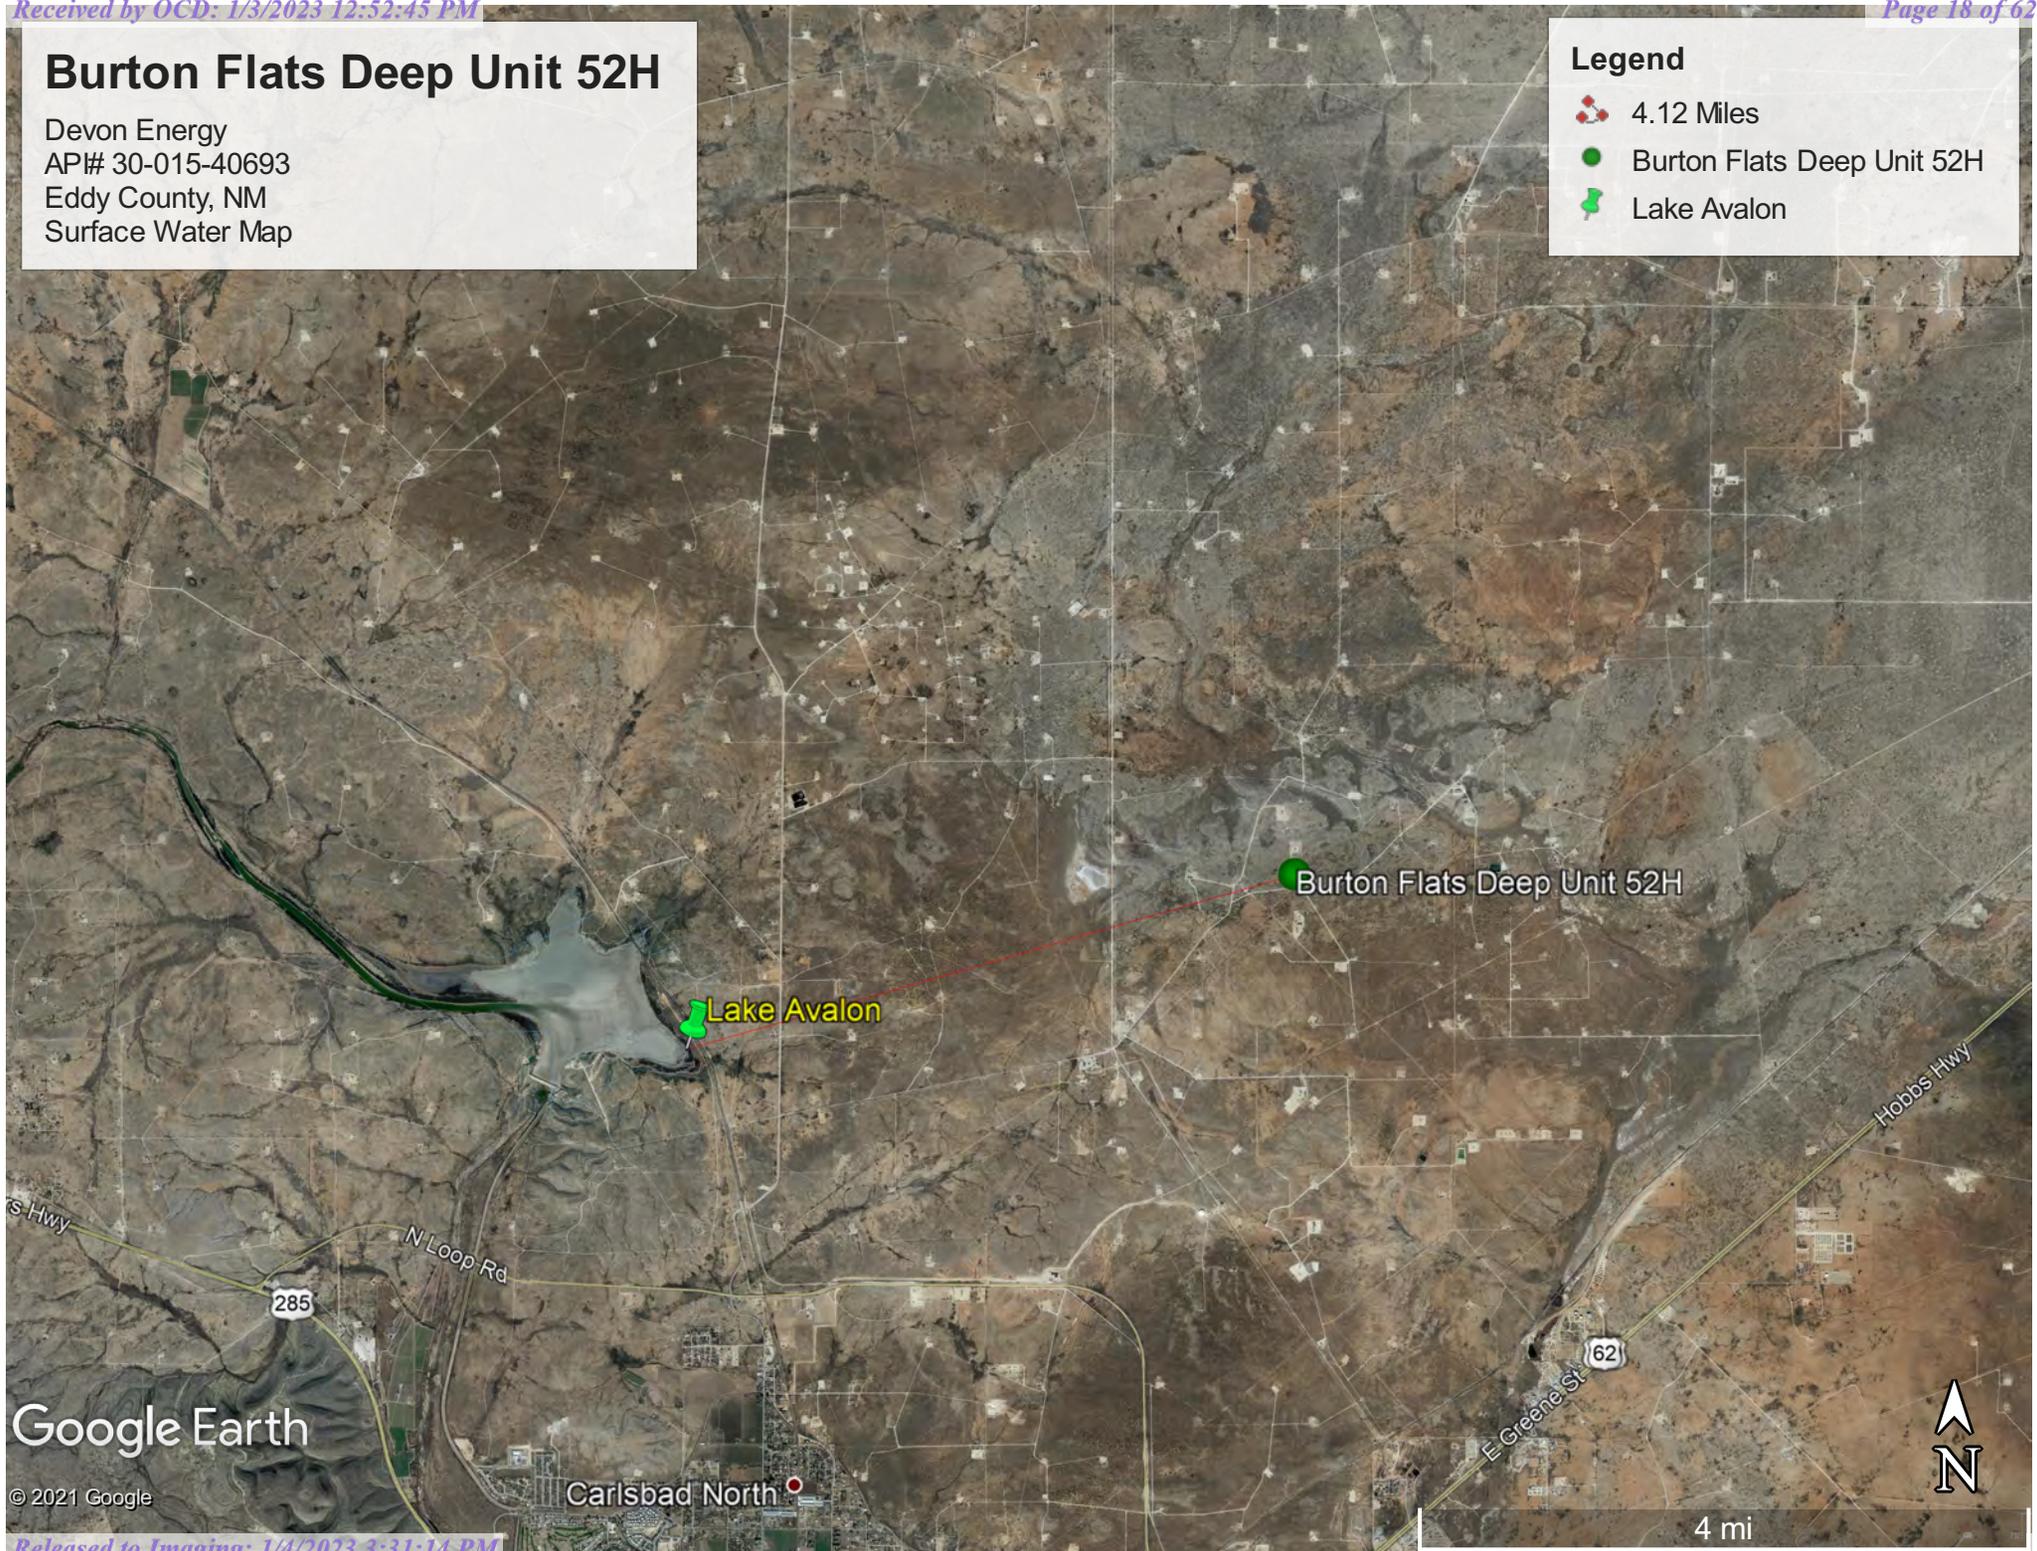
Devon Energy
API# 30-015-40693
Eddy County, NM
Surface Water Map

According to the New Mexico Office of the State Engineer, depth to the nearest groundwater in this area is 38 feet below grade surface (BGS). According to the United States Geological Survey (USGS), the nearest groundwater is greater than 27 feet BGS. The closest waterway is Lake Avalon located approximately 4.12 miles to the southwest of this location. See Appendix A for referenced Surface Water Map.

4.12 Miles
-
