RE: 1RP-4626 Lou Wortham 20

Closure Report

Re: Lou Wortham 20
Case # 1RP 4626

Lou Wortham 20

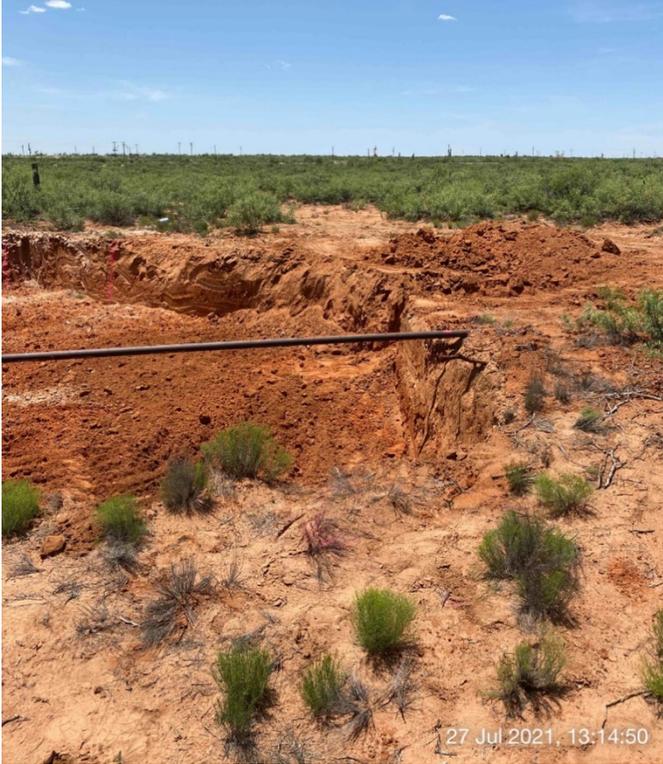
East Elevation

Lou Wortham 5' Final Excavation
