Site Name Hare 15	Site Type Well
Date Release Discovered 7/15/2020 @ 3:15pm	API# 3004508646

On July 15, 2020, vandalism of an aboveground storage tank (AST) caused a failure and release of approximately 115 barrels (bbls) of natural gas condensate. The release occurred on the well pad and remained inside the secondary containment. Upon discovery, Hilcorp removed the liquids remaining from inside of the AST; however, no other liquids were recovered during initial emergency response efforts. Hilcorp reported the release to the New Mexico Oil Conservation Division (NMOCD) by submitting a *Release Notification and Corrective Action Form C-141* (Form C-141) on July 27, 2020. The release was assigned Incident Number NRM2020945060.

Hare 15  
 Hilcorp Energy Company  
 36.749188, -107.877461  
 San Juan County, NM  
 PROJECT NUMBER: 07A1988006

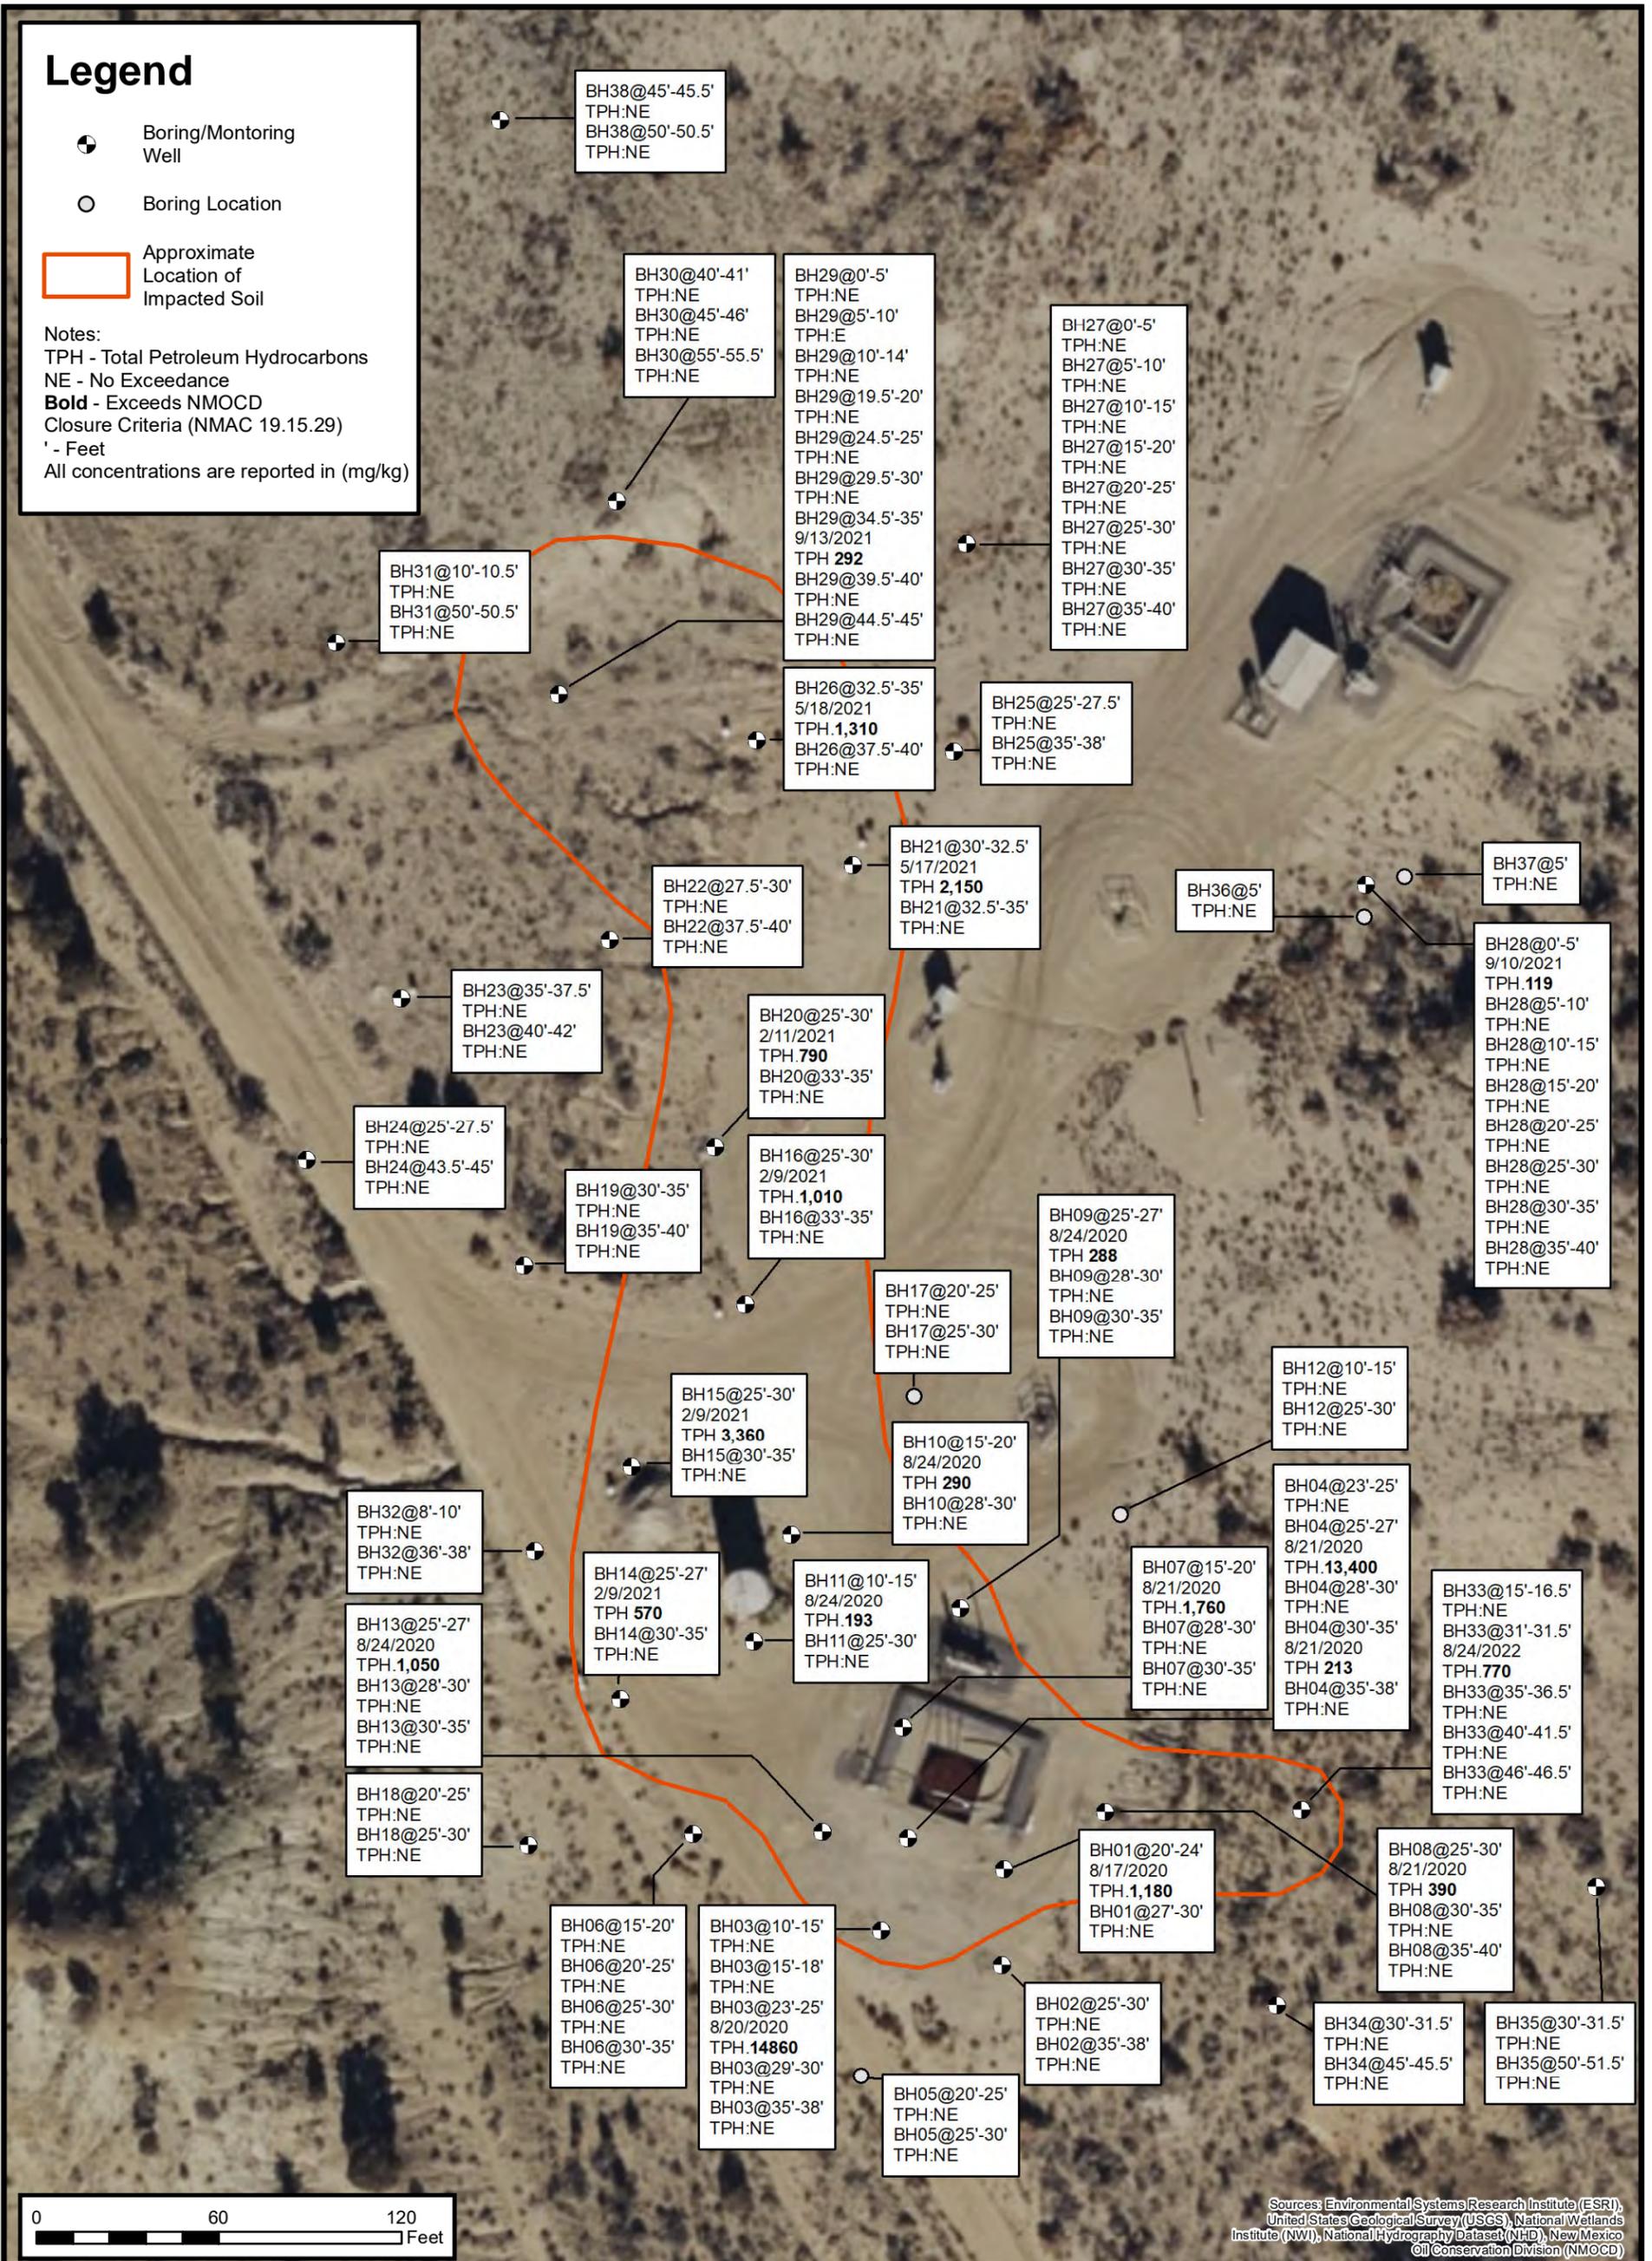
**Soil Analytical Results**

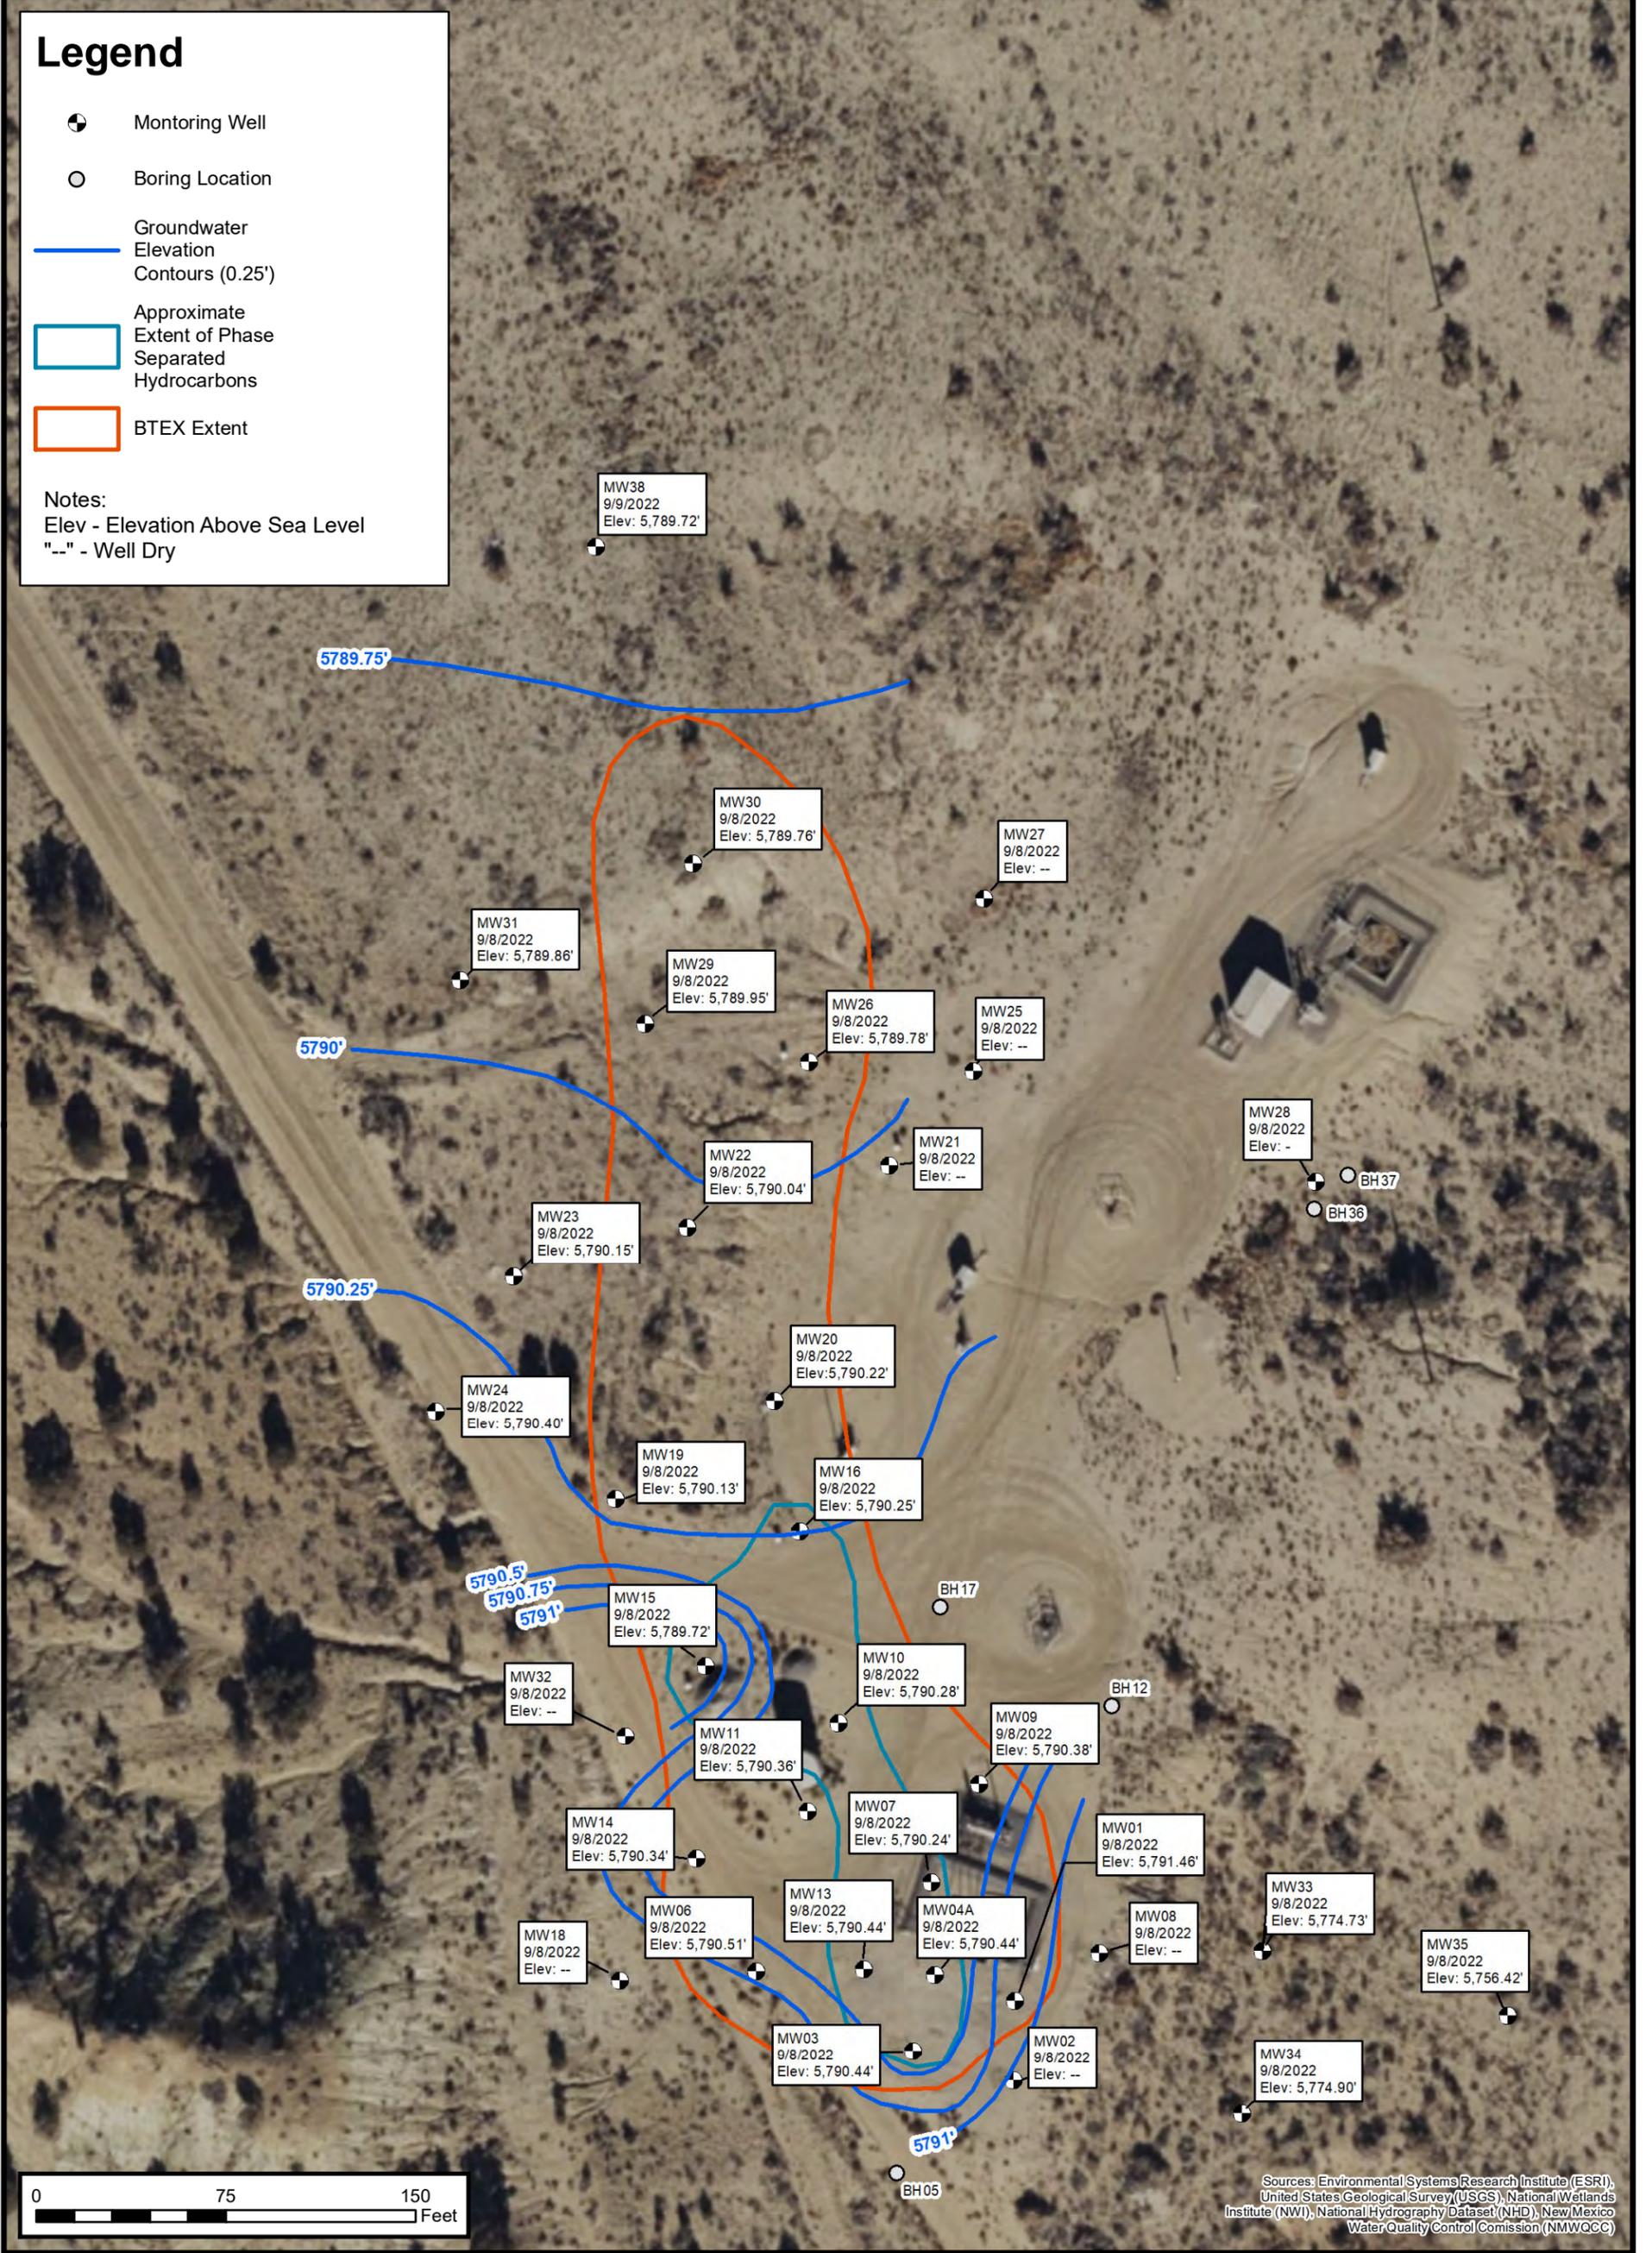
FIGURE 4

Document Path: C:\Users\Justin.Valdez\GIS\ENSOLUM GIS\1 - Durango\Hilcorp\07A1988006 - Hare 15 - MWD3\Figure 4 - Groundwater Elevation Contours - 11x17.mxd

a correction factor of 0.8 was applied to the elevation to account for the depression of the water column caused by the presence of overlying PSH. Table 2 presents a summary of groundwater elevations and thickness of PSH measured at the Site.

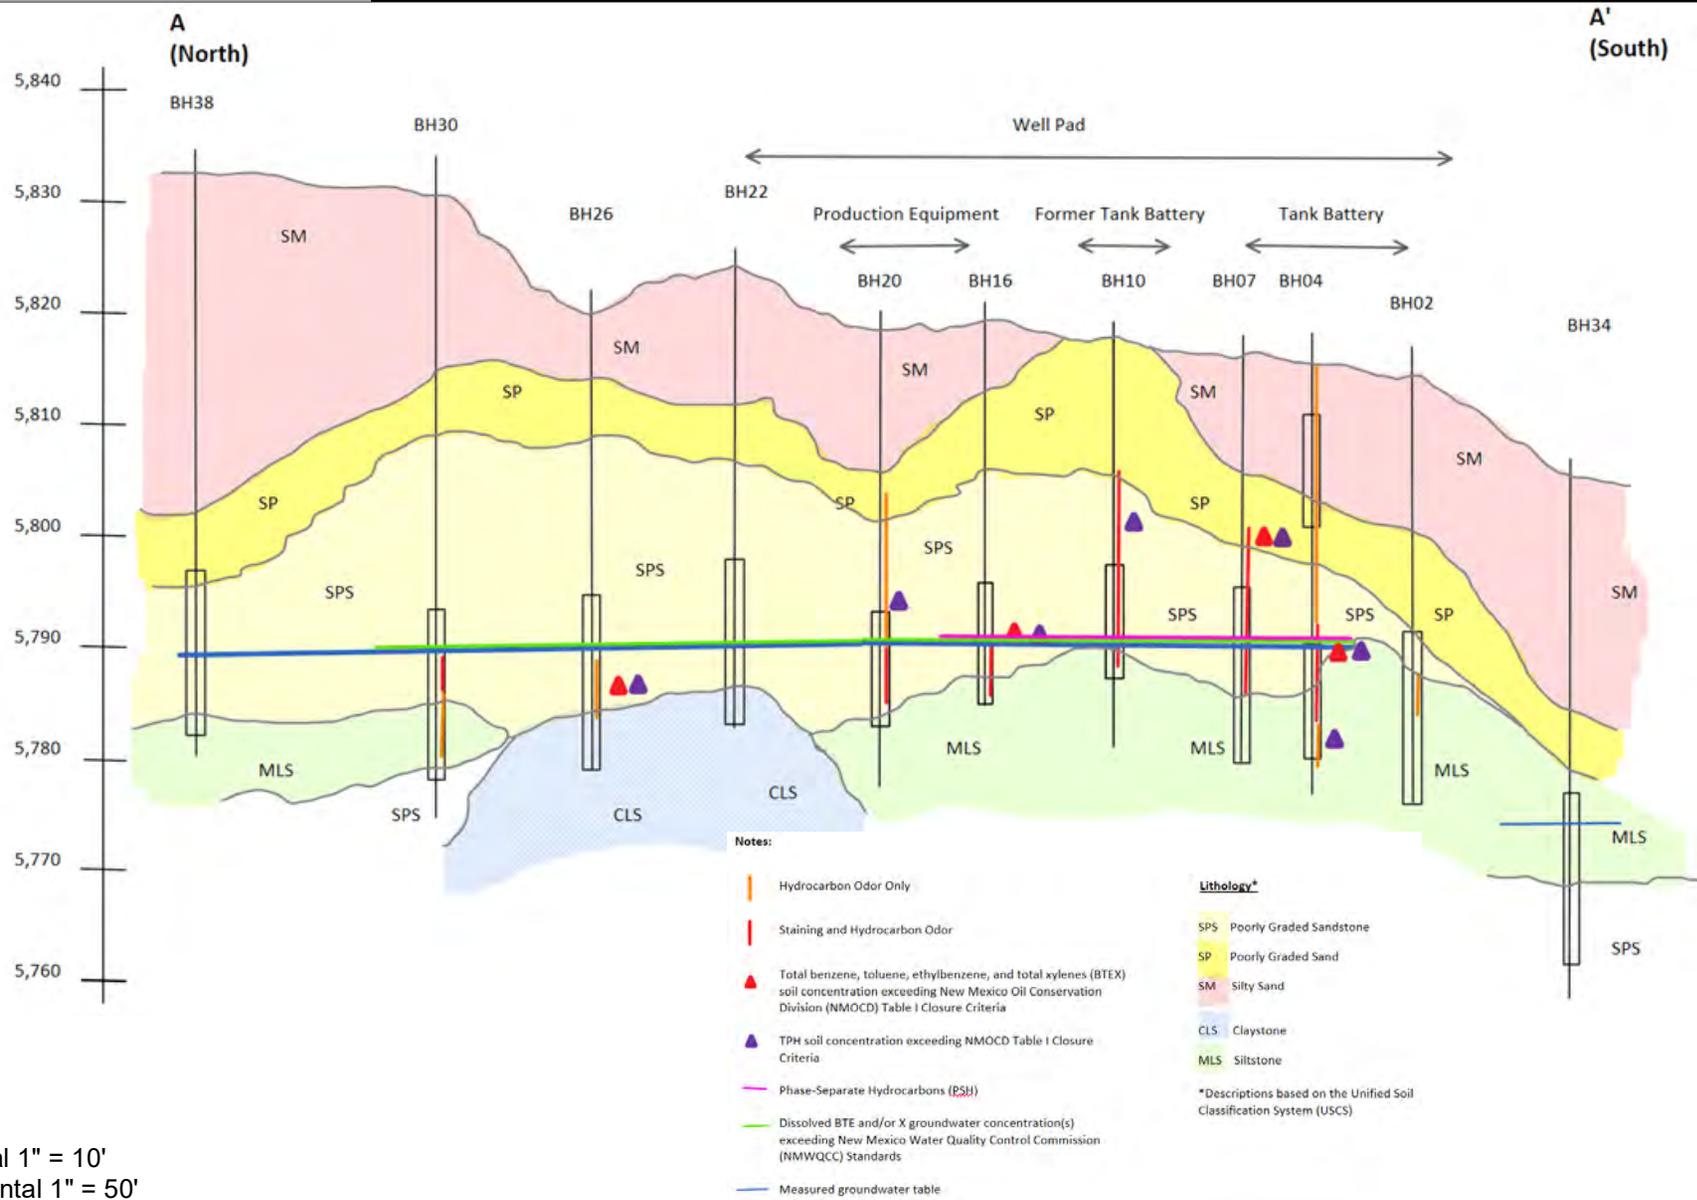
### Cross Section A-A'

A-A'  
Vertical 1" = 10'  
Horizontal 1" = 50'

In general, silty sands and sands were encountered at the Site between the ground surface and approximately 20 feet bgs. These unconsolidated sediments were generally underlain by sandstone to depths of up to 40 feet bgs. The sandstone was underlain by a dense siltstone at the terminal depths of most borings advanced during drilling. Field indications of petroleum hydrocarbons, including staining, odors, and/or elevated PID results, were noted in borings BH30 and BH33. Groundwater was encountered in borings BH30, BH31, BH33, BH34, B35, and BH38 at depths ranging from 33 to 47 feet bgs. All borings, except BH36 and BH37, were completed as permanent groundwater monitoring wells.

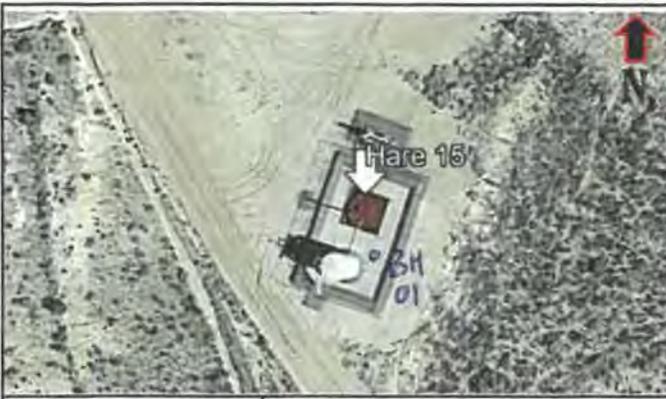
Penetration Resistance	Moisture Content	Vapor (ppm)	HC Staining?	Sample #	Depth (ft. bgs.)	Sample Run	Recovery	Soil/Rock Type	Lithology/Remarks	Well Completion
					0				Tan, lt. Brown med-coarse sand w/ fines.	
	Moist	0.0	No		1			SW-SM	Well graded sand w/ silt.	
					2			SM	No stain/odor (s/o)	
					3					
					4					
					5					
					6					
	Moist	0.1	No		7			SW-SM	Lt. Brown med sand w/ fines well graded. No s/o	
					8					
					9					
					10					
					11					
					12					
	Moist	0.2	No		13			SW-SM	Lt. Brown med-coarse sand w/ fines. well graded. No s/o	
					14					
					15

Penetration Resistance	Moisture Content	Vapor (ppm)	Staining	Sample #	Depth (ft. bgs.)	Sample Run	Recovery	Soil/Rock Type	Lithology/Remarks	Well Completion
	Moist	10.8	No		15			SW-SM	Lt. Brown/tan med-coarse sand w/ fines. Well graded. No stain/odor	
					16					
					17				Thin <del>ft</del> -6" layer of brown clayey sand no s/o.	
					18					
	SL Moist to Dry	2,540	No Mod. odor.		19			SP	Lt. grayish tan. medium poorly graded, semi-dense sand. No stain, mod. HC odor.	
					20					
				BH01 @ 20'-24'	21					
	Dry	3,118	No		22			SP	SAA, tan. med. <del>no</del> sand. No stain, mod to strong HC odor.	
					23

09:15	24					
	V-Moist	2,745	Yes, Heavy		25			SP	Black, strong stain/odor, med. sand.	
					26					
	Dry	53.7	<del>SP</del> No	BH01 @ 27'-30'	27			ML	Lt. Brownish gray silt w/ fn. sand, w/ oxidation. No stain/odor.	
					28					
					29			ML	Lt. gray + gray silt, trace fn. sand. Dense, compact. No stain/odor.	
	Dry	41.2	41.2	09:45	30					
					31			ML	SAA. No s/o. Limited to no recovery less than 3" split spoon sample 30-32'	
	Dry		No		32		X		refusal @ 32'	
					33					
					34					
					35					
					36					
					37

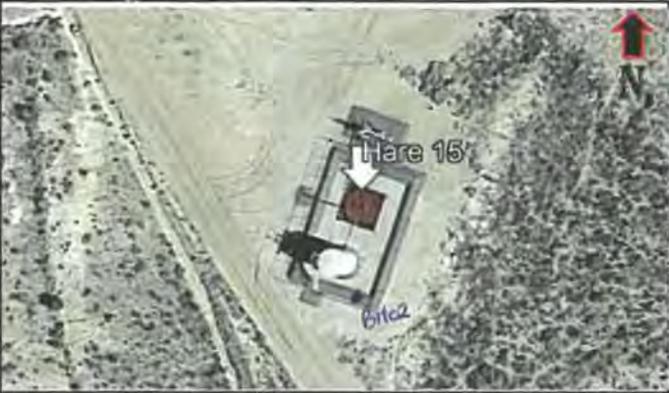
Penetration Resistance	Moisture Content	Vapor (ppm)	HC Staining?	Sample #	Depth (ft. bgs.)	Sample Run	Recovery	Soil/Rock Type	Lithology/Remarks	Well Completion
					0				brown, med. sand w/ fines. No stain/odor. well graded

Moist	0.6	No		1					
					2		SW-SM			
					3					
					4					
					5					
					6					
	Moist	0.8	No		7			SAA. No s/o.		
					8		SW-SM			
					9					
					10					
					11					
					12					
	SL Moist.	0.3	No		13			Brown, fn-med sand w/ some silt		
					14		SP-SM	No stain/odor		
					15

Penetration Resistance	Moisture Content	Vapor (ppm)	Staining	Sample #	Depth (ft. bgs.)	Sample Run	Recovery	Soil/Rock Type	Lithology/Remarks	Well Completion
					15					
					16					
	Dry	0.3	No		17			SW-SM	Tan, H. Brown well graded med. - coarse sand. Tr. fines.	
					18					
					19				No stain/odor.	
					20					
					21					
	Dry	0.1	No		22			<del>SW</del> SW	Well graded, med-coarse sand. some gravel, slightly dense, compact.	
					23				No stain/odor	
	Dry				24				Dense, oxidized gray & brown silt. No s/o.	
					25			ML		
					26					
					27					
	Dry	1.454	No	BH02 @ 25' - 30'	28			ML	Lt. grayish brown silt w/ fn. sand. Compact. No stain slight - med H/C odor.	
				R200	29					
					30					
	Dry	6.41	No		31			ML	Gray fn. semicemented sandy siltstone. No stain, slight musty odor.	
					32					
					33					
					34					
					35			ML	Gray & maroon shale w/ fn. sand. No s/o	
	Dry	5.15	No	BH 02 @ 35'	36			ML

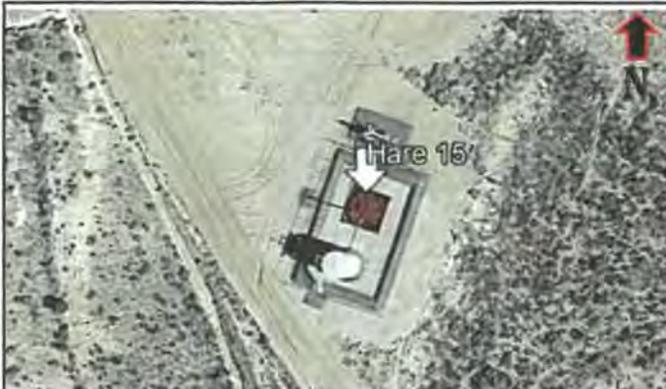
Penetration Resistance	Moisture Content	Vapor (ppm)	HC Staining?	Sample #	Depth (ft. bgs.)	Sample Run	Recovery	Soil/Rock Type	Lithology/Remarks	Well Completion
					0					
	<i>Moist</i>	<i>3.7</i>	<i>No</i>		1				<i>Brown med. sand w/ fines, silt. well graded. No stain/odor.</i>	
					2		<i>SW-SM</i>			
					3					
					4					
					5					
	<i>Moist</i>	<i>15.4</i>	<i>No</i>		6				<i>SAA. Med sand, w/ silt. No stain, v. silt. odor.</i>	
					7		<i>SW-SM</i>			
					8					
					9					
					10					
	<i>Dry</i>	<i>22.0</i>	<i>No</i>		11				<i>Brown &amp; tan well graded med. - coarse sand. No stain/odor. some oxidation</i>	
					12					
					13		<i>SW</i>			
					14					
					15

Penetration Resistance	Moisture Content	Vapor (ppm)	Staining	Sample #	Depth (ft. bgs.)	Sample Run	Recovery	Soil/Rock Type	Lithology/Remarks	Well Completion
					15					
					16					
	Dry	5.8	No	BH03 @ 15'-18'	17			SW	Lt gray / tan med-coarse well graded sand. No s/o	
					18					
	Dry	246.	No		19			SW	<del>Refusal @ 18'</del> w/ HSA new setup. Resume on 8-20-20 w/ set up. Lt. gray tan, coarse well gr. sand. No stain. v. slt. odor.	
					20					
	Dry	985	No		21				SAA. No stain. Mod. odor.	
					22					
	Dry	985	Yes Strong	BH03 @ 23'-25' 1515	23				Lt. gray to Black coarse sand. Heavy stain/odor.	
					24			SW		
	SL moist wet.	1,238	Yes Strong		25					
LIR COND.					26			SW	SAA, Heavy s/o. saturated w/ condensate.	
					27					
	Dry	702	No		28			SM ML	Dark brown v. fn. silty sand and sandy silt. Mod odor. No stain	
					29					
	Dry	2,246	No	BH03 @ 29'-30' 1545	30			ML	Gray. v. dense v. fn sandy silt. No stain, strong gassy odor.

31					
					32					
	Dry	1,204	No		33			ML	Gray v. fn. sandy silt + siltstone. Some cement. fissile. No stain.	
					34					
					35				mod. gas odor. gray + maroon shale w/ sand. No stain. v. slt. odor	
					36			ML	Gray v. fn. sandy siltstr. No stain. v slt. odor.	
	Dry	173	No	BH03 @ 35'-38' 1620	37

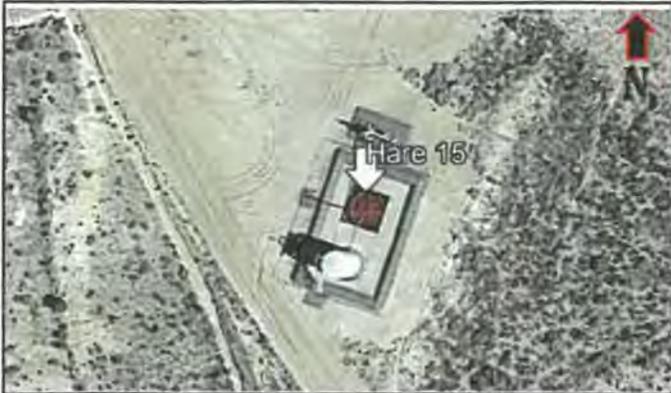
Boring Well Number: <b>BH04</b>		Project: <b>Hare 15</b>	
Date: <b>8-17-20</b>		Project Number: <b>017820018</b>	
Logged By: <b>Danny Burns</b>		Drilled By: <b>MO-TE Drilling</b>	
Elevation: <b>5,830</b>	Detector: <b>PID</b>	Drilling Method: <b>Hollow Stem/Air Rotary</b>	Sampling Method: <b>Continuous</b>
Gravel Pack: <b>10-20 Silica Sand</b>		Seal: <b>Bentonite</b>	Grout: <b>Bentonite</b>
Casing Type: <b>Schedule 40 PVC 25'-SU + 5'-SU</b>		Diameter: <b>2"</b>	Length: <b>25', 5'</b>
Screen Type: <b>Schedule 40 PVC 35'-25' + 15'-5' Slot: 0.010"</b>		Diameter: <b>2"</b>	Length: <b>10' + 10'</b>
		Hole Diameter: <b>7'</b>	Depth to Liquid: <b>—</b>
		Total Depth: <b>38'</b>	Depth to Water: <b>—</b>

Penetration Resistance	Moisture Content	Vapor (ppm)	HC Staining?	Sample #	Depth (ft. bgs.)	Sample Run	Recovery	Soil/Rock Type	Lithology/Remarks	Well Completion
					0					
	Dry		No		1			SW-SM	Brown, med. sand w/ silt. well graded	DEEP Well Completion 9/14/2022
		1,207	strong HC odor		2				No stain.	
					3				strong HC odor.	
					4					
					5					
					6					
	Moist		No		7			SW-SM	Brown med. sand w/ silt. well graded.	
		969	strong HC odor		8				No stain. strong HC odor	
					9					
					10					
					11					
					12					
	Dry	1,101	strong odor		13			SW	Brown, tan, lt. gray med. -coarse sand. well graded.	
					14				No stain; strong HC odor	
					15

Penetration Resistance	Moisture Content	Vapor (ppm)	Staining	Sample #	Depth (ft. bgs.)	Sample Run	Recovery	Soil/Rock Type	Lithology/Remarks	Well Completion
					15					
					16					
					17					
	Dry	1,401	No		18			SW	Lt. gray + tan med-coarse dense sand. Well graded. No stain, strong sweet gassy HC odor.	
					19					
					20					
					21					
					22					
				BH04 @ 23-25	23			SW	SA A	
	Dry	1,448	No		24				Lt. gray to dark gray med-coarse sand. Well graded. mod. stain/odor.	
					25	15:15			Resume 8-20-20	
				BH04 @ 25-27	26			SW	Black coarse sand. Well gr. Strong s/o. Lig. cond.	
	sl. moist Wet	1,499	Yes Strong	0845	27					
					28			SM ML	Dark brown + gray fn sand w/ silt + silty sand. No stain. Mod odor.	
	Dry		No	BH04 @ 28-30	29					
				0850	30			ML	Gray v. fn. sandy silt. Dense compact fissile. No stain. silt. odor	
	Dry	102	No		31					
					32					
					33			SM ML	Lt. + DK. gray interbed sandy siltstn + silts. w/ silty sand. some cement but mostly fissile. No stain, silt. odor.

Refused @ 38'

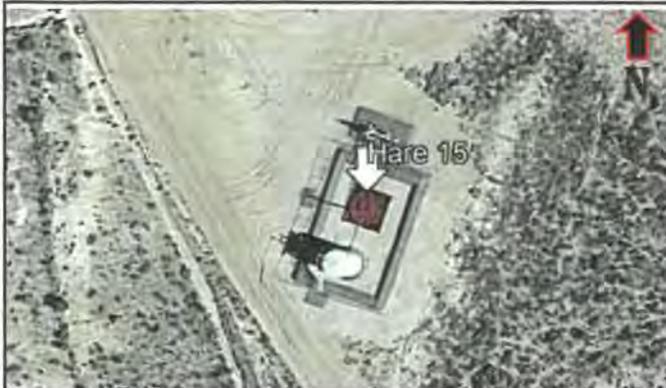
**BORING LOG/MONITORING WELL COMPLETION DIAGRAM**

Boring Well Number: <b>BH05</b>	Project: Hare 15
Date: <b>8-20-20</b>	Project Number: 017820018
Logged By: <b>Danny Burns</b>	Drilled By: <b>MO-TE Drilling</b>
Elevation: <b>5,830</b>	Detector: <b>PID</b>
Drilling Method: <b>Hollow Stem/Air Rotary</b>	Sampling Method: <b>Continuous</b>
Gravel Pack: <b>10-20 Silica Sand</b>	Seal: <b>Bentonite</b>
Casing Type: <b>Schedule 40 PVC</b>	Grout: <b>Bentonite</b>
Screen Type: <b>Schedule 40 PVC</b>	Diameter: <b>2"</b>
Slot: <b>0.010"</b>	Length: <b>—</b>
	Hole Diameter: <b>7"</b>
	Depth to Liquid: <b>—</b>
	Total Depth: <b>30'</b>
	Depth to Water: <b>—</b>

Penetration Resistance	Moisture Content	Vapor (ppm)	HC Staining?	Sample #	Depth (ft. bgs.)	Sample Run	Recovery	Soil/Rock Type	Lithology/Remarks	Well Completion
					0					
					1			SW	Lt. Brown fn-med sand w/ silt. well gr. No s/o.	Back-fill w/ cuttings
					2		-SM			
					3					
					4					
	Dry	22.0	No		5					
					6					
					7			SW-SM	Lt. Brown med. sand. w/ silt. No s/o	
					8					
					9					
	Dry	12.1	No		10					
					11					
					12				Lt. brown/tan med-med coarse sand. Some dense lenses, hard but still fissile. No stain/odor	
					13					
					14					
	Dry	9.3	No		15			SW

Penetration Resistance	Moisture Content	Vapor (ppm)	Staining	Sample #	Depth (ft. bgs.)	Sample Run	Recovery	Soil/Rock Type	Lithology/Remarks	Well Completion
					15					
					16					
					17					
	Sl. Moist	42.4	No		18			SW	Brown med-coarse sand. Well gr. No s/o	Back-fill w/ cuttings
					19					
				1025	20					
	Sl. Moist				21			SW	SAA. No s/o	
	Dry	62.6	No	BH05 @ 20-25	22			SW SM	Brown fn. silty sand sandy silt. No s/o	
	Dry				23					
					24			SM ML	Gray v. fn. sandy silt. Dense. No s/o	
				1030	25					
					26					
					27				SAA.	
					28					
	Dry	24.1	No	BH05 @ 25-30	29					
					30			ML	Gray + maroon v. fn. sandy silt.	
				1040	31				No well installed.	
					32				Back fill w/ cuttings	
					33					
					34					
					35					
					36					
					37

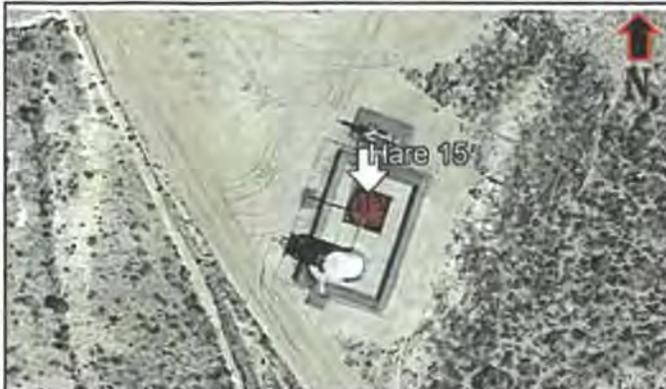
Boring Well Number: <b>BH06</b>	Project: <b>Hare 15</b>
Date: <b>8-21-20</b>	Project Number: <b>017820018</b>
Logged By: <b>Danny Burns</b>	Drilled By: <b>MO-TE Drilling</b>
Elevation: <b>5,830</b>	Detector: <b>PID</b>
Drilling Method: <b>Hollow Stem/Air Rotary</b>	Sampling Method: <b>Continuous</b>
Gravel Pack: <b>10-20 Silica Sand 30'-19'</b>	Seal: <b>Bentonite 19'-17'</b>
Casing Type: <b>Schedule 40 PVC 20'-5U</b>	Grout: <b>Bentonite 17'-0'</b>
Screen Type: <b>Schedule 40 PVC 30'-20' Slot: 0.010"</b>	Diameter: <b>2"</b> Length: <b>25'</b> Hole Diameter: <b>7"</b> Depth to Liquid: <b>—</b>
	Diameter: <b>2"</b> Length: <b>10'</b> Total Depth: <b>35'</b> Depth to Water: <b>—</b>

Penetration Resistance	Moisture Content	Vapor (ppm)	HC Staining?	Sample #	Depth (ft. bgs.)	Sample Run	Recovery	Soil/Rock Type	Lithology/Remarks	Well Completion
					0					
					1					
					2			SW	Lt. Brown / tan fin-med sand w/ silt. well gr. No stain/odor.	
					3			SM		
	Dry	8.3	No		4					
					5					
					6					
					7					
					8			SW	Tan med-coarse sand. well gr. No sfo	
	Dry	5.4	No		9					
					10					
					11					
					12				SAA. some oxidation.	
					13					
					14			SW	silty dense. but fissile.	
	SL Moist	2.6	No		15

Boring/Well # <b>BH06</b>						
				Project: <b>Hare 15</b>						
				Project # <b>017820018</b>						
				Date <b>8-21-20</b>						
Penetration Resistance	Moisture Content	Vapor (ppm)	Staining	Sample #	Depth (ft. bgs.)	Sample Run	Recovery	Soil/Rock Type	Lithology/Remarks	Well Completion
					15					
	SL. Moist				16					
			yes		17				Gray to dark gray	
			SL. to Mod.		18			SW	coarse sand well gr.

22.4			19				Mod stain. Silt. sweet odor.	
				1130	20				<del>DEgraded HC odor. or swampy organic material</del>	
					21					
	Dry			BH 06 @ 20'-25'	22				Dark brown + gray, dark gray

41.0	SL to mod		23			SW	med - coarse sand.	
					24				some dense.	
					25				Organic odor, degraded HC odor	
	SL Moist		SL to MOD	1140	26			SW	sl-mod stain.	
				BH 06 @ 25'-30'	27				SAA. SL-mod stain/organic degraded odor coarse sand.	
	Dry	17.1	NO		28			SW SM	Brown fn. silty sand	
					29				No s/o.	
					30			SM ML	Gray fn. sandy silt Dense.	
	Dry		NO	1150	31				No s/o.	
					32			ML	SAA No s/o

8.0			33					
	Dry		NO		34			ML	Gray + maroon v. fn. sandy silt.	
				1200	35				No s/o	
					36					
					37

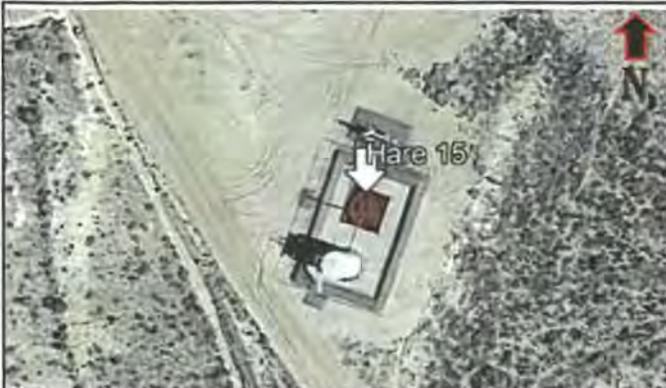
Boring Well Number: <b>6H07</b>		Project: <b>Hare 15</b>	
Date: <b>8-21-20</b>		Project Number: <b>017820018</b>	
Logged By: <b>Danny Burns</b>		Drilled By: <b>MO-TE Drilling</b>	
Elevation: <b>5,830</b>	Detector: <b>PID</b>	Drilling Method: <b>Hollow Stem/Air Rotary</b>	Sampling Method: <b>Continuous</b>
Gravel Pack: <b>10-20 Silica Sand 28'-12'</b>	Seal: <b>Bentonite 12'-10'</b>	Grout: <b>Bentonite 10'-0'</b>	
Casing Type: <b>Schedule 40 PVC 13'-SU.</b>	Diameter: <b>2"</b>	Length: <b>15'</b>	Hole Diameter: <b>7"</b>
Screen Type: <b>Schedule 40 PVC 28'13' 0.010"</b>	Diameter: <b>2"</b>	Length: <b>15'</b>	Total Depth: <b>35'</b>
			Depth to Liquid: <b>—</b>
			Depth to Water: <b>—</b>

Penetration Resistance	Moisture Content	Vapor (ppm)	HC Staining?	Sample #	Depth (ft. bgs.)	Sample Run	Recovery	Soil/Rock Type	Lithology/Remarks	Well Completion
					0					
					1					
					2					
					3					
	<b>SL Moist</b>	<b>9.2</b>	<b>No</b>		4			<b>SW SM</b>	<b>Brown med sand w/ silt well gr. No s/o</b>	
					5					
					6					
					7					
	<b>Dry</b>	<b>6.4</b>	<b>No</b>		8			<b>SW SM</b>	<b>SAA. No s/o</b>	
					9					
					10					
	<b>Dry</b>				11				<b>SAA, Lt. brown to Lt. gray coarse sand well gr. No s/o.</b>	
					12			<b>SW</b>		
					13					
					14				<b>Lt. gray, med. sand. Med stain/odor</b>	
	<b>Dry</b>	<b>2.314</b>	<b>YES slight</b>		15

Penetration Resistance	Moisture Content	Vapor (ppm)	Staining	Sample #	Depth (ft. bgs.)	Sample Run	Recovery	Soil/Rock Type	Lithology/Remarks	Well Completion
					15					
	Dry	2,402	Yes silt to Mod		16			SW	SAA. Lt. gray med-coarse sand. Mod stain/odor. Silt. degraded/organic	
				1235	17					
	Dry	1,665	Yes silty.		18			SW	SAA. Lt. gray/ tan med-coarse coarse sand. silt. s/o. V. swampy/degraded odor.	
					19					
	silt. moist				20					
	sl. moist				21					
	sl. moist				22					
	sl. moist				23					
	sl. moist				24					
	sl. moist				25					
	sl. moist				26			SW	SAA, dark gray coarse sand, wet w/ condensate strong stain/odor.	
	sl. moist				27			SW-SM	gray silty sand	
	sl. moist			1245	28					
	Dry	1,866	Yes		29			SM-ML	Lt. gray fn. sandy silt. No stain/odor. Dense.	
					30					
	Dry	174	No	BH07 28-30 1250	31					
					32					
	Dry	41.2	No		33			SM/ML	Gray fn. sandy silt. + siltstn. Dense. Interbedded silty fn. sand. No s/o. Fissile

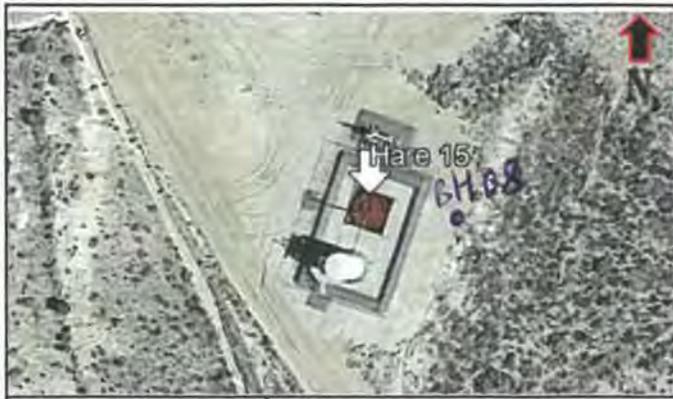
**BORING LOG/MONITORING WELL COMPLETION DIAGRAM**

Boring Well Number: <b>BH08</b>		Project: <b>Hare 15</b>	
Date: <b>8-21-20</b>		Project Number: <b>017820018</b>	
Logged By: <b>Danny Burns</b>		Drilled By: <b>MO-TE Drilling</b>	
Elevation: <b>5,830</b>	Detector: <b>PID</b>	Drilling Method: <b>Hollow Stem/Air Rotary</b>	Sampling Method: <b>Continuous</b>
Gravel Pack: <b>10-20 Silica Sand</b>	<b>35'-24'</b>	Seal: <b>Bentonite</b>	<b>24'-22'</b>
		Grout: <b>Bentonite</b>	<b>22'-0'</b>
Casing Type: <b>Schedule 40 PVC</b>	<b>25'-S.U.</b>	Diameter: <b>2"</b>	Length: <b>30'</b>
		Hole Diameter: <b>7"</b>	Depth to Liquid: <b>—</b>
Screen Type: <b>Schedule 40 PVC</b>	<b>35'-25'</b> Slot: <b>0.010"</b>	Diameter: <b>2"</b>	Length: <b>10'</b>
		Total Depth: <b>40'</b>	Depth to Water: <b>—</b>

Penetration Resistance	Moisture Content	Vapor (ppm)	HC Staining?	Sample #	Depth (ft. bgs.)	Sample Run	Recovery	Soil/Rock Type	Lithology/Remarks	Well Completion
					0					
					1					
					2					
					3			SW SM	Lt. Brown med. sand w/ silt. No s/o	
	Dry	7.3	No		4					
					5					
					6					
					7					
					8			SW SM	SAA. No s/o	
	Dry	3.3	No		9					
					10					
					11					
					12				SAA. No s/o	
					13					
					14			SP -SM	Lt. Brown med sand med fn -med sand w/ silt. No s/o	
	Dry	4.0	No		15

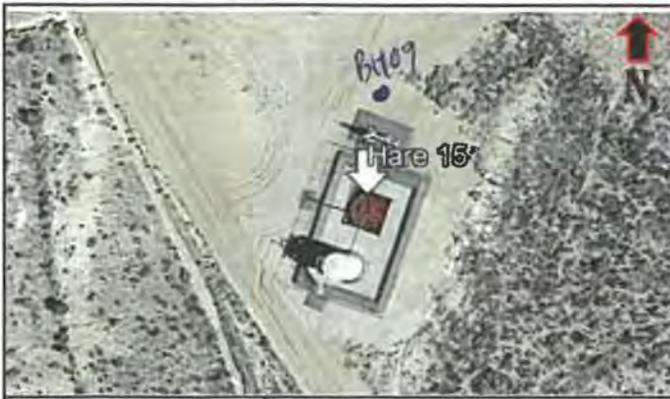
**BORING LOG/MONITORING WELL COMPLETION DIAGRAM**

Boring Well Number: <b>B109</b>		Project: <b>Hare 15</b>	
Date: <b>8-24-20</b>		Project Number: <b>017820018</b>	
Logged By: <b>Danny Burns</b>		Drilled By: <b>MO-TE Drilling</b>	
Elevation: <b>5,830</b>	Detector: <b>PID</b>	Drilling Method: <b>Hollow Stem/Air Rotary</b>	Sampling Method: <b>Continuous</b>
Gravel Pack: <b>10-20 Silica Sand 30'-24'</b>	Seal: <b>Bentonite 24'-22'</b>	Grout: <b>Bentonite 22'-0'</b>	
Casing Type: <b>Schedule 40 PVC 25'-S.U.</b>	Diameter: <b>2"</b>	Length: <b>30'</b>	Hole Diameter: <b>7"</b> Depth to Liquid:
Screen Type: <b>Schedule 40 PVC 30'-25'</b>	Slot: <b>0.010"</b>	Diameter: <b>2"</b>	Length: <b>5'</b> Total Depth: <b>35'</b> Depth to Water:

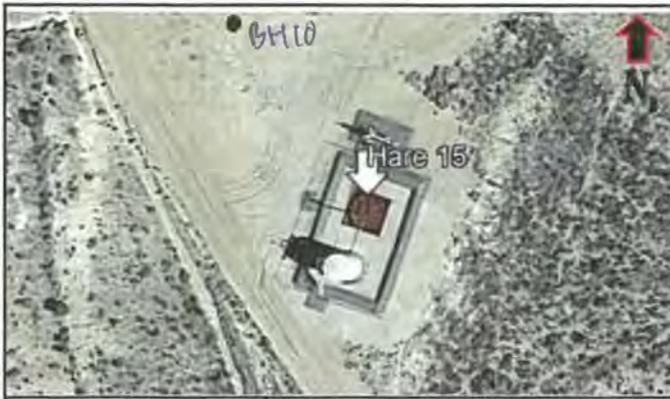
**BORING LOG/MONITORING WELL COMPLETION DIAGRAM**

Boring/Well Number: <b>BH10</b>		Project: <b>Hare 15</b>	
Date: <b>8-24-20</b>		Project Number: <b>017820018</b>	
Logged By: <b>Danny Burns</b>		Drilled By: <b>MO-TE Drilling</b>	
Elevation: <b>5,830</b>	Detector: <b>PID</b>	Drilling Method: <b>Hollow Stem/Air Rotary</b>	Sampling Method: <b>Continuous</b>
Gravel Pack: <b>10-20 Silica Sand 30'-19'</b>	Seal: <b>Bentonite 19'-17'</b>	Grout: <b>Bentonite 17'-0'</b>	
Casing Type: <b>Schedule 40 PVC 20'-SU</b>	Diameter: <b>2"</b>	Length: <b>25'</b>	Hole Diameter: <b>7"</b> Depth to Liquid: <b>—</b>
Screen Type: <b>Schedule 40 PVC 30'-20' Slot: 0.010"</b>	Diameter: <b>2"</b>	Length: <b>10'</b>	Total Depth: <b>35'</b> Depth to Water: <b>—</b>

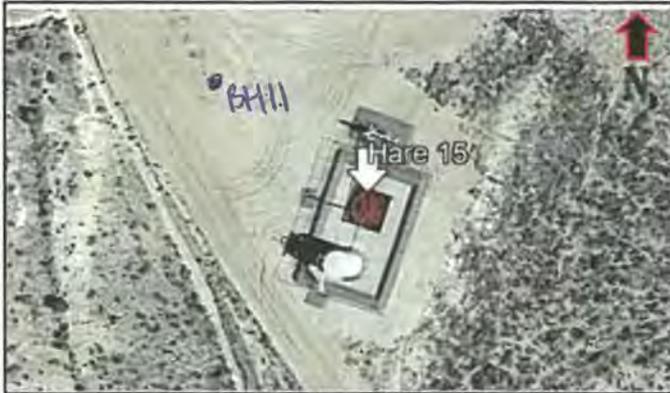
**BORING LOG/MONITORING WELL COMPLETION DIAGRAM**

Boring/Well Number: <b>BH11</b>	Project: <b>Harc 15</b>
Date: <b>8-24-20</b>	Project Number: <b>017820018</b>
Logged By: <b>Danny Burns</b>	Drilled By: <b>MO-TE Drilling</b>
Elevation: <b>5,830</b>	Detector: <b>PID</b>
Drilling Method: <b>Hollow Stem/Air Rotary</b>	Sampling Method: <b>Continuous</b>
Gravel Pack: <b>10-20 Silica Sand 30'-19'</b>	Seal: <b>Bentonite 19'-17'</b>
Casing Type: <b>Schedule 40 PVC 20'-SU.</b>	Grout: <b>Bentonite 17'-0'</b>
Screen Type: <b>Schedule 40 PVC 20'-20' slot: 0.010"</b>	Diameter: <b>2"</b> Length: <b>25'</b> Hole Diameter: <b>7"</b> Depth to Liquid: <b>—</b>
	Diameter: <b>2"</b> Length: <b>10'</b> Total Depth: <b>58.5'</b> Depth to Water: <b>—</b>

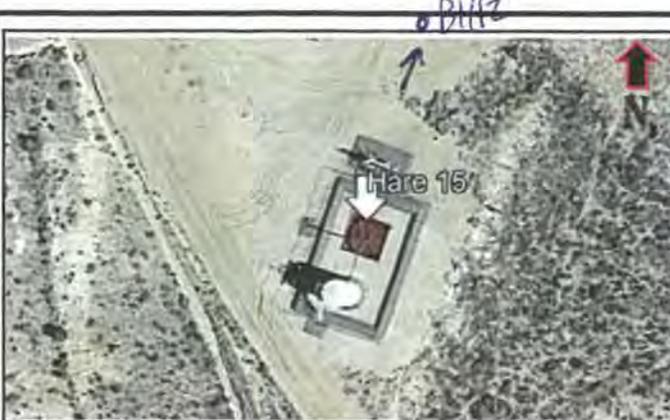
**BORING LOG/MONITORING WELL COMPLETION DIAGRAM**

Boring/Well Number: <b>BH12</b>		Project: <b>Hare 15</b>	
Date: <b>8-24-20</b>		Project Number: <b>017820018</b>	
Logged By: <b>Danny Burns</b>		Drilled By: <b>MO-TE Drilling</b>	
Elevation: <b>5,830</b>	Detector: <b>PID</b>	Drilling Method: <b>Hollow Stem/Air Rotary</b>	Sampling Method: <b>Continuous</b>
Gravel Pack: <b>10-20 Silica Sand</b>		Seal: <b>Bentonite</b>	Grout: <b>Bentonite</b>
Casing Type: <b>Schedule 40 PVC</b>		Diameter: <b>2"</b>	Length: <b>—</b>
Screen Type: <b>Schedule 40 PVC</b>		Slot: <b>0.010"</b>	Diameter: <b>2"</b>
		Hole Diameter: <b>7"</b>	Depth to Liquid: <b>—</b>
		Total Depth: <b>35'</b>	Depth to Water: <b>—</b>

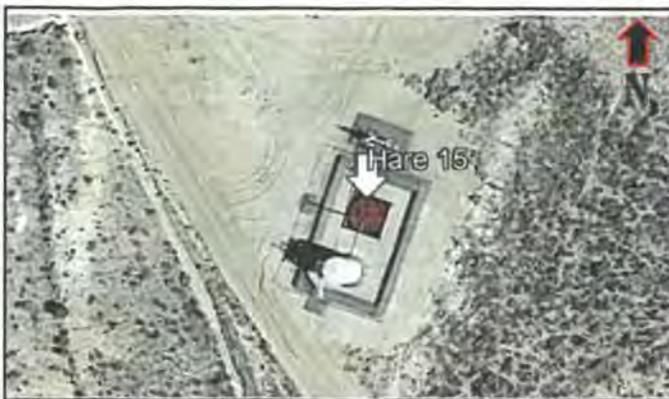
**BORING LOG/MONITORING WELL COMPLETION DIAGRAM**

Boring Well Number: **BH13** Project: **Hare 15**

Penetration Resistance	Moisture Content	Vapor (ppm)	Staining	Sample #	Depth (ft. bgs.)	Sample Run	Recovery	Soil/Rock Type	Lithology/Remarks	Well Completion
					15					
					16					
	Dry	24.9	No		17				Lt brown / tan. med-coarse sand. well gr.	
					18			SW	No stain.	
					19					
					20					
					21				Brown w/ oxidation	
			yes		22					
	Dry	532			23			SW	Lt. gray/dark gray to black Dense.	
					24				Lt. gray. med-coarse sand. silty dense. No stain, mod. deg. H <sub>2</sub> O odor.	
Mid COND	Wet.	1912	Yes	BH13 @ 25-27 1445	25					
					26			SW	Gray to black coarse sand. Strong s/o. Gas.	
					27					
	Dry		No		28			SM/ML	Grayish brown fn. sandy silt. & silty fn. sand. silt. odor	
					29					
	DM	39.4	No	BH13 @ 28-30 1450	30			ML	Gray fn sandy silt. No s/o	
					31					
					32				Gray sandy silt., silt str. cemented, fissile.	
	Dry	174	No	BH13 @ 30-35	33			ML	No s/o	
					34					
					35				Gray & maroon silt. No s/o

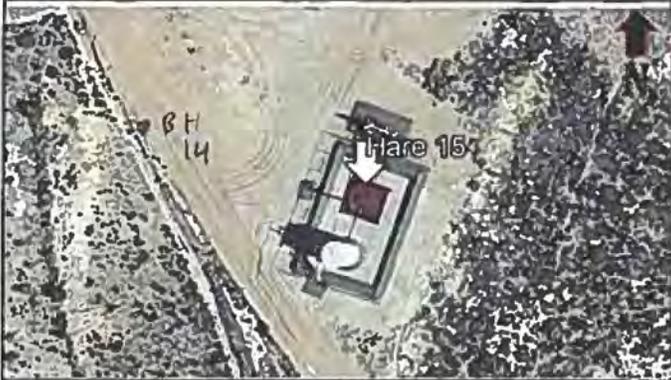
WSP USA INC 848 East 2nd Avenue Durango, CO 81301								
		<b>BORING LOG/MONITORING WELL COMPLETION DIAGRAM</b>								
		Boring/Well Number: <b>BH14</b>		Project: <b>Hare 15</b>						
		Date: <b>2-9-21</b>		Project Number: <b>017820018</b>						
Elevation: <b>5,830</b>		Detector: <b>PID</b>		Drilling Method: <b>Hollow Stem/Air Rotary</b>		Sampling Method: <b>Continuous</b>				
Gravel Pack: <b>10-20 Silica Sand</b>		Seal: <b>Bentonite</b>		Grout: <b>Bentonite</b>						
Casing Type: <b>Schedule 40 PVC</b>		Diameter: <b>2"</b>		Length: <b>7"</b>		Depth to Liquid:				
Screen Type: <b>Schedule 40 PVC</b>		Slot: <b>0.010" 30'-20'</b>		Diameter: <b>2"</b>		Length: <b>10'</b>				
				Total Depth: <b>35'</b>		Depth to Water:				
Penetration Resistance	Moisture Content	Vapor (ppm)	HC Staining?	Sample #	Depth (ft. bgs.)	Sample Run	Recovery	Soil/Rock Type	Lithology/Remarks	Well Completion
	Dry	0.6	No		0

1					
					2					
					3			SW	Lt. brown med sand.	
					4			-SM	Some silt.	
					5				No stain/odor.	
					6					
					7					
		318	No		8			SW	Tan, SAA, med, fn-med sand w/silt.	
	Dry				9			-SM	Lt. gray med sand, slight stain/odor.	
		2,162	Slight		10					
					11					
					12					
					13			SW	Tan, med sand Dense.	
					14			<del>SM</del>	Two small lenses (<2in.) of lt. gray slight stain/odor.	
	Dry	745			15

WSP USA INC 848 East 2nd Avenue Durango, CO 81301								Boring Well #	BH 14	
								Project:	Hare 15	
								Project #	017820018	
								Date	2-9-21	
Penetration Resistance	Moisture Content	Vapor (ppm)	Staining	Sample #	Depth (ft. bgs.)	Sample Run	Recovery	Soil/Rock Type	Lithology/Remarks	Well Completion
					15					
					16					
	Dry	45	No		17			SW	SAA	
					18			<del>SW</del>	Tan, lt. Brown med sand	
					19				Dense..	
					20				No stain/odor	
					21					
					22					
	Dry	2,962	No		23			SW	Tan, Dense med. sand.	
					24				No stain, but mod.	
					25				Sweet gassy odor.	
	Moist				26					
				BH 14 @ 25-27	27			SW	Gray to dark gray + black sand, med.	
	Wet	3204	Yes		28				Strong stain/odor. wet/sat.	
					29			SM		
	Dry	22	Yes slight	BH 14 @ 28'-30'	30			ML	lt. gray + gray dense fn. sandy silt No. s/o	
					31					
					32					
					33					
	Dry	20	No	BH 14 @ 30'-35'	34			SM ML	Gray fn sandy silt.	
					35				Dense, fissile

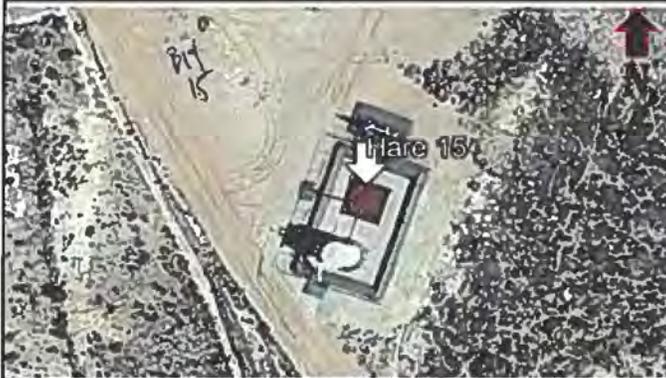
WSP USA INC 848 East 2nd Avenue Durango, CO 81301								
		<b>BORING LOG/MONITORING WELL COMPLETION DIAGRAM</b>								
Boring/Well Number: <b>BH15</b>		Project: <b>Hare 15</b>								
Date: <b>2-9-21</b>		Project Number: <b>017820018</b>								
Logged By: <b>Danny Burns</b>		Drilled By: <b>MO-TE Drilling</b>								
Elevation: <b>5,830</b>	Detector: <b>PID</b>	Drilling Method: <b>Hollow Stem/Air Rotary</b>	Sampling Method: <b>Continuous</b>							
Gravel Pack: <b>10-20 Silica Sand</b>		Seal: <b>Bentonite</b>	Grout: <b>Bentonite</b>							
Casing Type: <b>Schedule 40 PVC</b>	Diameter: <b>2"</b>	Length: <b>15'</b>	Hole Diameter: <b>7"</b> Depth to Liquid:							
Screen Type: <b>Schedule 40 PVC</b>	Slot: <b>0.010"</b>	Diameter: <b>2"</b>	Length: <b>15'</b> Total Depth: <b>35'</b> Depth to Water:							
Slot: <b>0.010"</b>		Diameter: <b>2"</b>								
Screen Type: <b>Schedule 40 PVC</b>		Length: <b>15'</b>

Total Depth: <b>35'</b>		Depth to Water:								
Penetration Resistance	Moisture Content	Vapor (ppm)	HC Staining?	Sample #	Depth (ft. bgs.)	Sample Run	Recovery	Soil/Rock Type	Lithology/Remarks	Well Completion
					0					
					1					
	sl. Moist				2			SW	Brown, tan med sand w/ silt.

WSP USA INC 848 East 2nd Avenue Durango, CO 81301				Boring/Well # BH15		Project: Harc 15		Project # 017820018		Date 2-9-21	
Penetration Resistance	Moisture Content	Vapor (ppm)	Staining	Sample #	Depth (ft. bgs.)	Sample Run	Recovery	Soil/Rock Type	Lithology/Remarks	Well Completion	
					15						
					16				* No continuous sampler used center plug to get to 20'. Cuttings: Brown med coarse sand. No s/o		
					17						
					18						
	Dry	18	No		19		NA				
					20						
					21				Lt. gray + tan coarse sand. Silt. stain, gassy degraded HC odor.		
					22						
			Silt.		23			SW			
	Dry	1,490	No		24						
					25						
					26				SAA. Dense. med-coarse sand. silt - mud stain/odor moist @ 30'		
					27						
	Dry		Yes	BH 25'-30'	28			SW			
		3055			29						
	Moist			1245	30						
					31				gray, dense sandy silt <del>fine</del> , No s/o. gray silt, some fm. sand No s/o. Dense Fissile		
					32						
	Dry		No	BH 15 @ 30'-35'	33			SM-ML

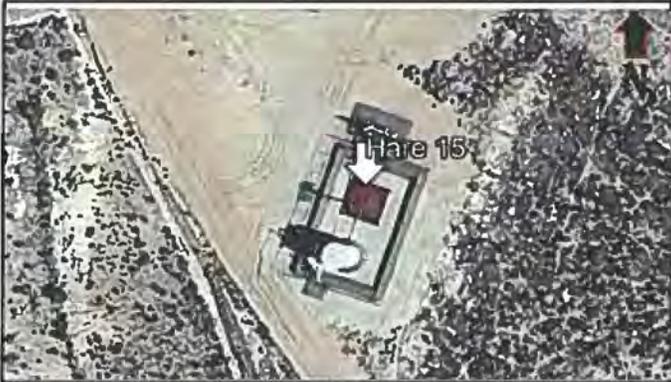
WSP USA INC								
		848 East 2nd Avenue								
		Durango, CO 81301								
		<b>BORING LOG/MONITORING WELL COMPLETION DIAGRAM</b>								
Boring/Well Number: <b>BH16</b>		Project: <b>Hare 15</b>								
Date: <b>2-9-21</b>		Project Number: <b>017820018</b>								
Logged By: <b>Danny Burns</b>		Drilled By: <b>MO-TE Drilling</b>								
Elevation: <b>5,830</b>	Detector: <b>PID</b>	Drilling Method: <b>Hollow Stem/Air Rotary</b>	Sampling Method: <b>Continuous</b>							
Gravel Pack: <b>10-20 Silica Sand</b>		Seal: <b>Bentonite</b>	Grout: <b>Bentonite</b>							
Casing Type: <b>Schedule 40 PVC</b>		Diameter: <b>2"</b>	Length: <b>7'</b>							
Screen Type: <b>Schedule 40 PVC</b>		Slot: <b>0.010"</b>	Diameter: <b>2"</b>							
		Length: <b>10'</b>	Total Depth: <b>35'</b>							
			Depth to Liquid: <b>---</b>							
			Depth to Water: <b>---</b>							
Penetration Resistance	Moisture Content	Vapor (ppm)	HC Staining?	Sample #	Depth (ft. bgs.)	Sample Run	Recovery	Soil/Rock Type	Lithology/Remarks	Well Completion

0					
					1					
	SL Moist	4.1	No		2			SW	Brown med sand w/ silt.	
					3			-SM	No s/o	
					4					
					5					
					6					
					7					
	Dry	0.0	No		8			SW	Lt. Brown, tan sand, med. loose.	
					9				No s/o	
					10					
					11					
					12					
					13					
	Dry	0.0	No		14			SW	tan med-coarse sand. silt-dense.	
					15				No s/o

WSP USA INC 848 East 2nd Avenue Durango, CO 81301								Boring Well #	BH16	
								Project:	Hare 15	
								Project #	017820018	
								Date	2-9-21	
Penetration Resistance	Moisture Content	Vapor (ppm)	Staining	Sample #	Depth (ft. bgs.)	Sample Run	Recovery	Soil/Rock Type	Lithology/Remarks	Well Completion
					15					
					16					
					17					
	Dry	0.0	No		18				2AA - Tan coarse, med. sand. Dense.	
					19				No s/o.	
					20					
					21				Using center plug, continuous sampler refusal.	
					22				Logging cuttings.	
	Dry	13	No		23				Brown, coarse + med sand. No s/o.	
					24					
					25				Resume continuous sampler.	
	Dry		No		26					
					27					
	SL. moist	2332	SL. Yes	BH @ 14 25-30' 1600	28				tan to lt. gray dense med. coarse sand.	
					29				silt stain/odor.	
	Wet		Yes		30				coarse gray sand, wet, silt. sheen.	
					31					
					32					
	Dry	212	No	BH @ 38 -35' 16-15	33				gray, sandy silt. No s/o

34				LT. gray silt. No s/o	
					35				TD. 33.5' after pulling out	
					36					
					37
