Site Name Hare 15	Site Type Well
Date Release Discovered 7/15/2020 @ 3:15pm	API# 3004508646

On July 15, 2020, vandalism of an aboveground storage tank (AST) caused a failure and release of approximately 115 barrels (bbls) of natural gas condensate. The release occurred on the well pad and remained inside the secondary containment. Upon discovery, Hilcorp removed the liquids remaining from inside of the AST; however, no other liquids were recovered during initial emergency response efforts. Hilcorp reported the release to the New Mexico Oil Conservation Division (NMOCD) by submitting a *Release Notification and Corrective Action Form C-141* (Form C-141) on July 27, 2020. The release was assigned Incident Number NRM2020945060.

Hare 15  
 Hilcorp Energy Company  
 36.749188, -107.877461  
 San Juan County, NM  
 PROJECT NUMBER: 07A1988006

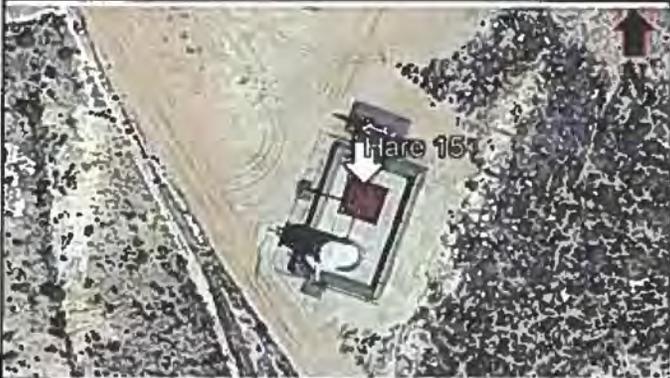
WSP USA INC 848 East 2nd Avenue Durango, CO 81301						
				<b>BORING LOG/MONITORING WELL COMPLETION DIAGRAM</b>						
				Boring/Well Number: <b>BH17</b>			Project: <b>Hare 15</b>			
				Date: <b>2-10-21</b>			Project Number: <b>017820018</b>			
Logged By: <b>Danny Burns</b>			Drilled By: <b>MO-TE Drilling</b>							
Elevation: <b>5,830</b>		Detector: <b>PID</b>		Drilling Method: <b>Hollow Stem/Air Rotary</b>		Sampling Method: <b>Continuous</b>				
Gravel Pack: <b>10-20 Silica Sand</b>				Seal: <b>Bentonite</b>		Grout: <b>Bentonite</b>				
Casing Type: <b>Schedule 40 PVC</b>				Diameter: <b>2"</b>		Length: <b>0</b>				
Screen Type: <b>Schedule 40 PVC</b>				Slot: <b>0.010"</b>		Diameter: <b>2"</b>				
						Hole Diameter: <b>7"</b>				
						Depth to Liquid: <b>—</b>				
						Total Depth: <b>30</b>				
						Depth to Water: <b>—</b>				
Penetration Resistance	Moisture Content	Vapor (ppm)	HC Staining?	Sample #	Depth (ft. bgs.)	Sample Run	Recovery	Soil/Rock Type	Lithology/Remarks	Well Completion

0					
					1					
					2					
	Dry	1.7	No		3			SW	Brown, lt brown/tan fn-med sand w/ silt. Loose. No stain or odor.	No Well set
					4			-SM		
					5					
					6					
					7					
	Dry	1.0	No		8			SW	SAA. Tan fn. to med. coarse sand w/ silt. well gr. No s/o	
					9			-SM		
					10					
					11					
					12					
	Dry	1.2	No		13			SW	SAA. No s/o	
					14			-SM		
					15

WSP USA INC 848 East 2nd Avenue Durango, CO 81301					Boring/Well #	BH17				
					Project:	Hare 15				
					Project #	017820018				
					Date	2-10-21				
Penetration Resistance	Moisture Content	Vapor (ppm)	Staining	Sample #	Depth (ft. bgs.)	Sample Run	Recovery	Soil/Rock Type	Lithology/Remarks	Well Completion
					15					
					16			SW	SAA. Tan med sand	
					17			-SM	w/ silt. No s/o	
	Dry	0.7	No		18				Lt. Brown / Lt. tan med.	
					19			SW	coarse sand. Tr. silt.	
					20				No stain/odor.	
					21					
					22					
	Dry	1.8			23				Tan, coarse sand.	
					24			SP	Some oxidation.	
					25				No s/o	
					26					
					27					
					28			SM	Lt grayish tan v. fn	
					29				sand + silt to	
	Dry	0.3			30			ML	sandy silt. Dense.	
					31				No s/o.	
					32					
					33					
					34					
					35					
					36					
					37

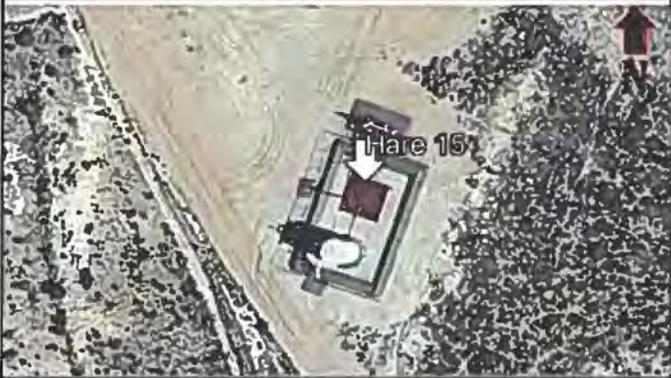
WSP USA INC 848 East 2nd Avenue Durango, CO 81301						
				<b>BORING LOG/MONITORING WELL COMPLETION DIAGRAM</b>						
				Boring/Well Number: <b>BH18</b>			Project: <b>Hare 15</b>			
				Date: <b>2-10-21</b>			Project Number: <b>017820018</b>			
Logged By: <b>Danny Burns</b>			Drilled By: <b>MO-TE Drilling</b>							
Elevation: <b>5,830</b>		Detector: <b>PID</b>		Drilling Method: <b>Hollow Stem/Air Rotary</b>		Sampling Method: <b>Continuous</b>				
Gravel Pack: <b>10-20 Silica Sand</b>				Seal: <b>Bentonite</b>		Grout: <b>Bentonite</b>				
Casing Type: <b>Schedule 40 PVC</b>				Diameter: <b>2"</b>		Length: <b>7'</b>				
Screen Type: <b>Schedule 40 PVC</b>				Slot: <b>0.010"</b>		Diameter: <b>2"</b>				
				Length: <b>5'</b>		Total Depth: <b>30</b>				
						Depth to Liquid: <b>—</b>				
						Depth to Water: <b>—</b>				
Penetration Resistance	Moisture Content	Vapor (ppm)	HC Staining?	Sample #	Depth (ft. bgs.)	Sample Run	Recovery	Soil/Rock Type	Lithology/Remarks	Well Completion

0					
					1					
					2					
	Dry	0.0	No		3			SW	Lt Brown med sand	
					4			-SM	w/ silt. No s/o	
					5			SM	Dense.	
					6				coarse silty sand. No s/o	
					7					
					8			SW	Lt. brown + tan	
	Dry	0.0	No		9			SM	fin-med. silty sand.	
					10				Dense. No s/o	
					11					
					12				- center plug. cuttings:	
					13			SW-	SAA.	
	SL moist	0.0	No		14			SM	No s/o	
					15

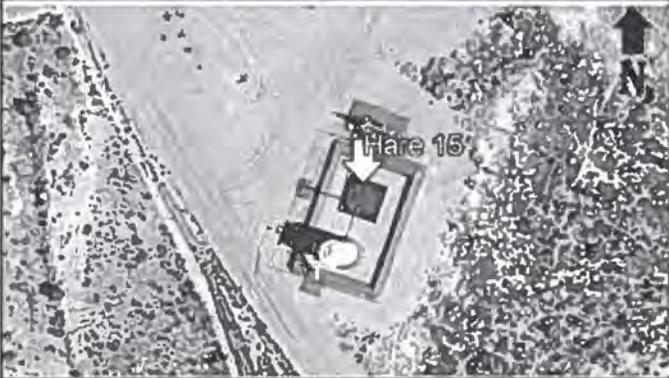
WSP USA INC								
		848 East 2nd Avenue								
		Durango, CO 81301								
		<b>BORING LOG/MONITORING WELL COMPLETION DIAGRAM</b>								
Boring/Well Number: <b>BH27</b>		Project: <b>Hare 15</b>								
Date: <b>9-10-21</b>		Project Number: <b>017820018</b>								
Logged By: <b>Danny Burns</b>		Drilled By: <b>MO-TE Drilling</b>								
Elevation: <b>5,830</b>	Detector: <b>PID</b>	Drilling Method: <b>Hollow Stem/Air Rotary</b>	Sampling Method: <b>Continuous</b>							
Gravel Pack: <b>10-20 Silica Sand</b>	<b>40'-28'</b>	Seal: <b>Bentonite</b>	<b>28'-26'</b>							
Casing Type: <b>Schedule 40 PVC</b>		Diameter: <b>2"</b>	Length: <b>30'</b>							
Screen Type: <b>Schedule 40 PVC</b>		Slot: <b>0.010"</b>	Length: <b>10'</b>							
Hole Diameter: <b>6"</b>		Depth to Liquid: <b>—</b>								
Total Depth: <b>40'</b>		Depth to Water: <b>—</b>								
Penetration Resistance	Moisture Content	Vapor (ppm)	HC Staining?	Sample #	Depth (ft. bgs.)	Sample Run	Recovery	Soil/Rock Type	Lithology/Remarks	Well Completion

0					
					1					
					2					
				<b>BH27</b>	3					
	<b>Dry</b>	<b>3.6</b>	<b>No</b>	<b>0-5</b>	4			<b>SW</b>	<b>Tan, lt. brown med sand w/ fines</b>	
				<b>loss</b>	5			<b>-SM</b>	<b>No stain/odor</b>	
					6					
				<b>BH27</b>	7					
	<b>Dry</b>	<b>3.2</b>	<b>No</b>	<b>e</b>	8					
				<b>5-10</b>	9			<b>SU</b>	<b>Tan - lt. Brown fine-med sands w/ fines</b>	
				<b>1100</b>	10			<b>-SM</b>	<b>no stain/odor</b>	
					11					
				<b>BH27</b>	12					
				<b>e</b>	13					
				<b>10-15</b>	14					
	<b>Dry</b>	<b>9.0</b>	<b>No</b>	<b>1100</b>	15			<b>SW</b>	<b>tan - lt. Brown med-course sand w/ some fines</b>	
								<b>-SM</b>	<b>no stain/odor</b>

Mudst	0.5	0.05	35-40	38					
					39					
				1170	40			SM		
					41				TD-40, slough to 38-39.	
					42					
					43					
					44					
					45					
					46					
					47					
					48					
					49					
					50					
					51					
					52					
					53					
					54					
					55					
					56					
					57					
					58					
					59

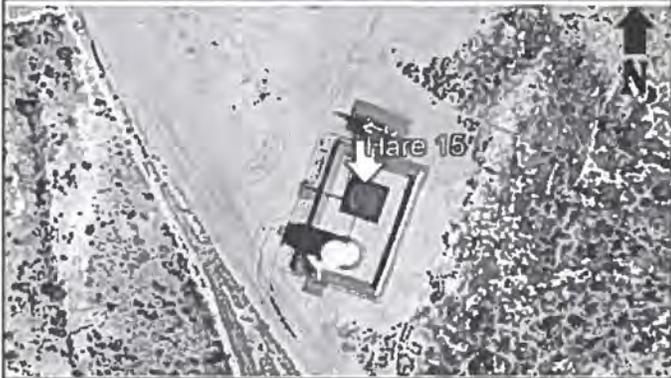
WSP USA INC								
		848 East 2nd Avenue								
		Durango, CO 81301								
		<b>BORING LOG/MONITORING WELL COMPLETION DIAGRAM</b>								
Boring/Well Number: <b>BH 28</b>		Project: <b>Harc 15</b>								
Date: <b>9-10-21</b>		Project Number: <b>017820018</b>								
Logged By: <b>Danny Burns</b>		Drilled By: <b>MO-TE Drilling</b>								
Elevation: <b>5,830</b>	Detector: <b>PID</b>	Drilling Method: <b>Hollow Stem/Air Rotary</b>	Sampling Method: <b>Continuous</b>							
Gravel Pack: <b>10-20 Silica Sand</b>	<b>40'-28'</b>	Seal: <b>Bentonite 28-26</b>	Grout: <b>Cement Grout, Bentonite 26-0</b>							
Casing Type: <b>Schedule 40 PVC</b>	<b>29-0+</b>	Diameter: <b>2"</b> Length: <b>30'</b>	Hole Diameter: <b>6"</b> Depth to Liquid: <b>—</b>							
Screen Type: <b>Schedule 40 PVC</b>	Slot: <b>0.010" 39-29'</b>	Diameter: <b>2"</b> Length: <b>10'</b>	Total Depth: <b>40'</b> Depth to Water: <b>—</b>

Penetration Resistance	Moisture Content	Vapor (ppm)	HC Staining?	Sample #	Depth (ft. bgs.)	Sample Run	Recovery	Soil/Rock Type	Lithology/Remarks	Well Completion
					0					
					1					
					2					
					3					
	<b>Dry</b>	<b>1.3</b>	<b>N</b>		4		<b>SW-SM</b>	<b>SW-SM</b>	<b>tan silty-fine sand unconsolidated top 6" fine to medium slightly consolidated NO S/O</b>	
					5					
					6					
					7					
					8					
	<b>Dry</b>	<b>3.5</b>	<b>N</b>		9		<b>SW-SM</b>	<b>SW-SM</b>	<b>tan unconsolidated silty w/ fine-medium sand &amp; rare gravel pieces. NO S/O</b>	
					10					
					11					
					12					
					13		<b>SW-SM</b>	<b>SW-SM</b>	<b>tan unconsolidated fine to coarse, moderately sorted sand grains in silty matrix</b>	
	<b>Dry</b>	<b>1.2</b>	<b>N</b>		14					
					15
