Closure Report

Riverboat 12-1 W0PA & WOMD Battery (08.08.2020)

Incident ID: nRM2022644767

Produced Water Release

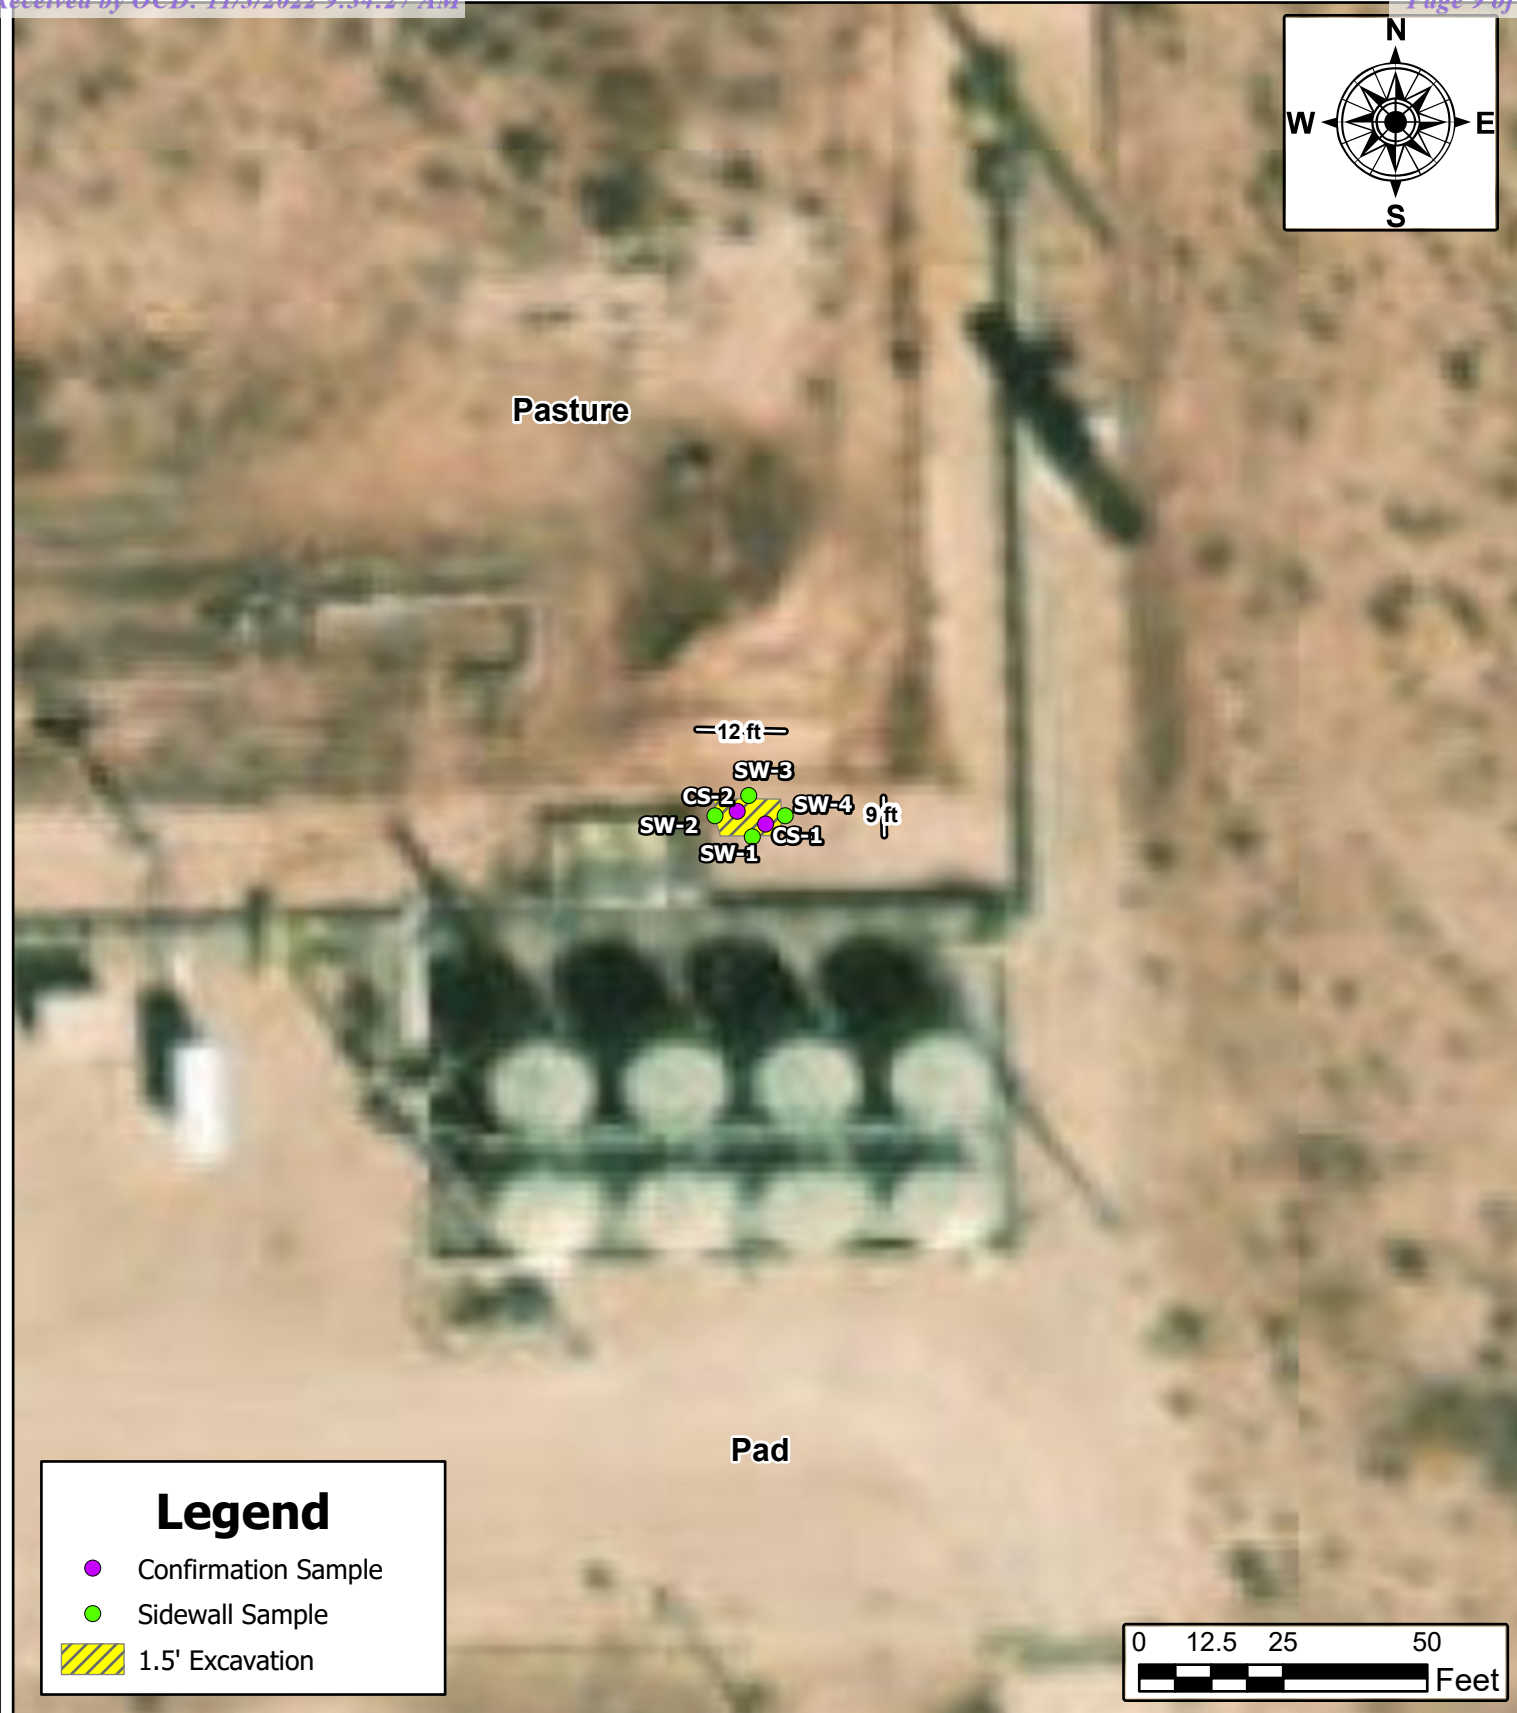
FIGURE 3

EXCAVATION DEPTH MAP
CIMAREX ENERGY CO.
 RIVERBOAT 12-1 WOPA & WOMB FED COM 1
 EDDY COUNTY, NEW MEXICO
 32.226418, -104.239252

Carmona Resources personnel were onsite on October 13, 2022, to supervise the remediation activities and collect confirmation samples. Before collecting composite confirmation samples, the NMOCD division office was notified via email on October 11, 2022, per Subsection D of 19.15.29.12 NMAC. See Appendix D. The areas of CS-1 through CS-2 were excavated to a depth 1.5' below the surface to remove all impacted soils. A total of two (2) confirmation floor samples were collected (CS-1 through CS-2), and four (4) sidewall samples (SW-1 through SW-4), were collected every 200 square feet to ensure the proper removal of the contaminated soils. All collected samples were analyzed for TPH analysis by EPA method 8015 modified, BTEX by EPA Method 8021B, and chloride by EPA method 300.0. Copies of laboratory analysis and chain-of-custody documentation are included in Appendix D. The results of the sampling are summarized in Table 1. The excavation depths and confirmation sample locations are shown in Figure 3.

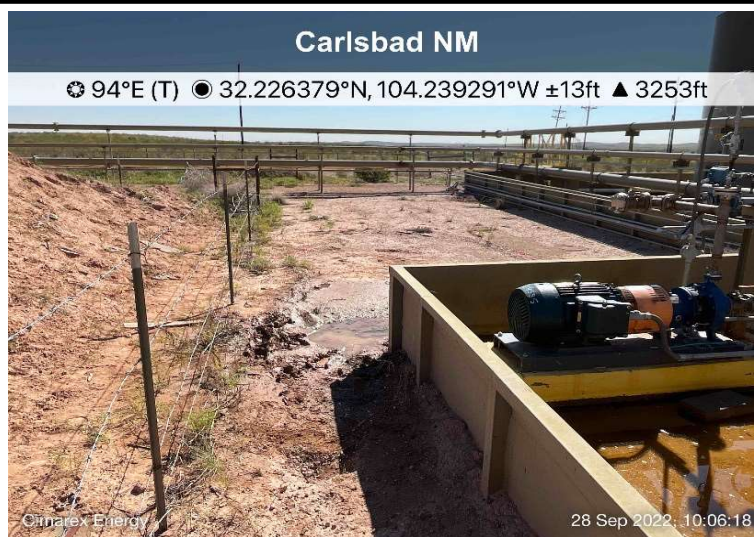
Photograph No. 2

View east, area of impact after recent rains.

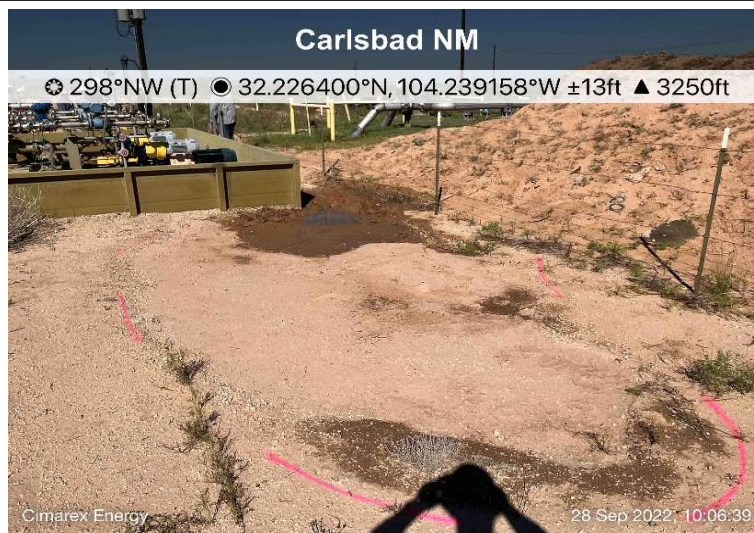
Photograph No. 3

View northwest, area of impact after recent rains.

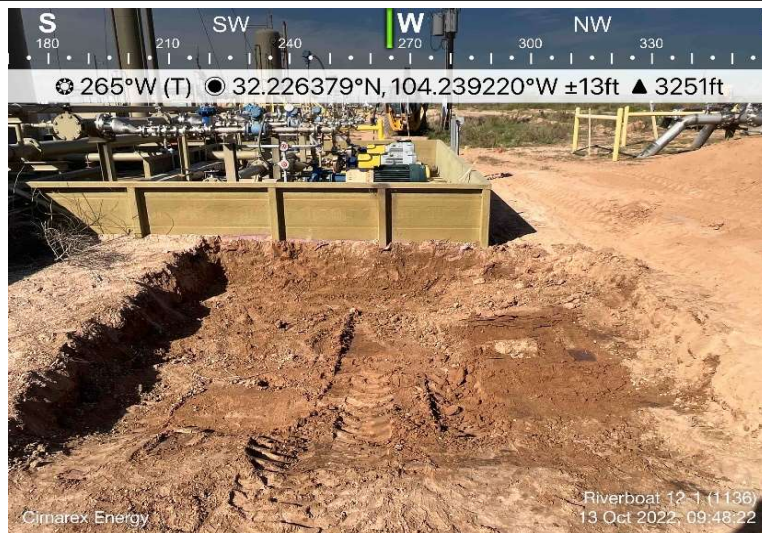
Photograph No. 6

View west, area of confirmation sample (CS-1 and CS-2).

All final confirmation samples were below the regulatory requirements for TPH, BTEX, and chloride. Refer to Table 1.
