**MONEY GRAHAM CTB
CLOSURE REQUEST**

**API NO. 30-015-46220
LEGALS: UNIT/L H, SECTION 32, TOWNSHIP 26S, RANGE 29E
EDDY COUNTY, NM**

**DATE OF RELEASE: 02/24/2022
INCIDENT NO. NAPP2205561125**

Subject: Closure Request for Tap Rock Operating – Money Graham CTB

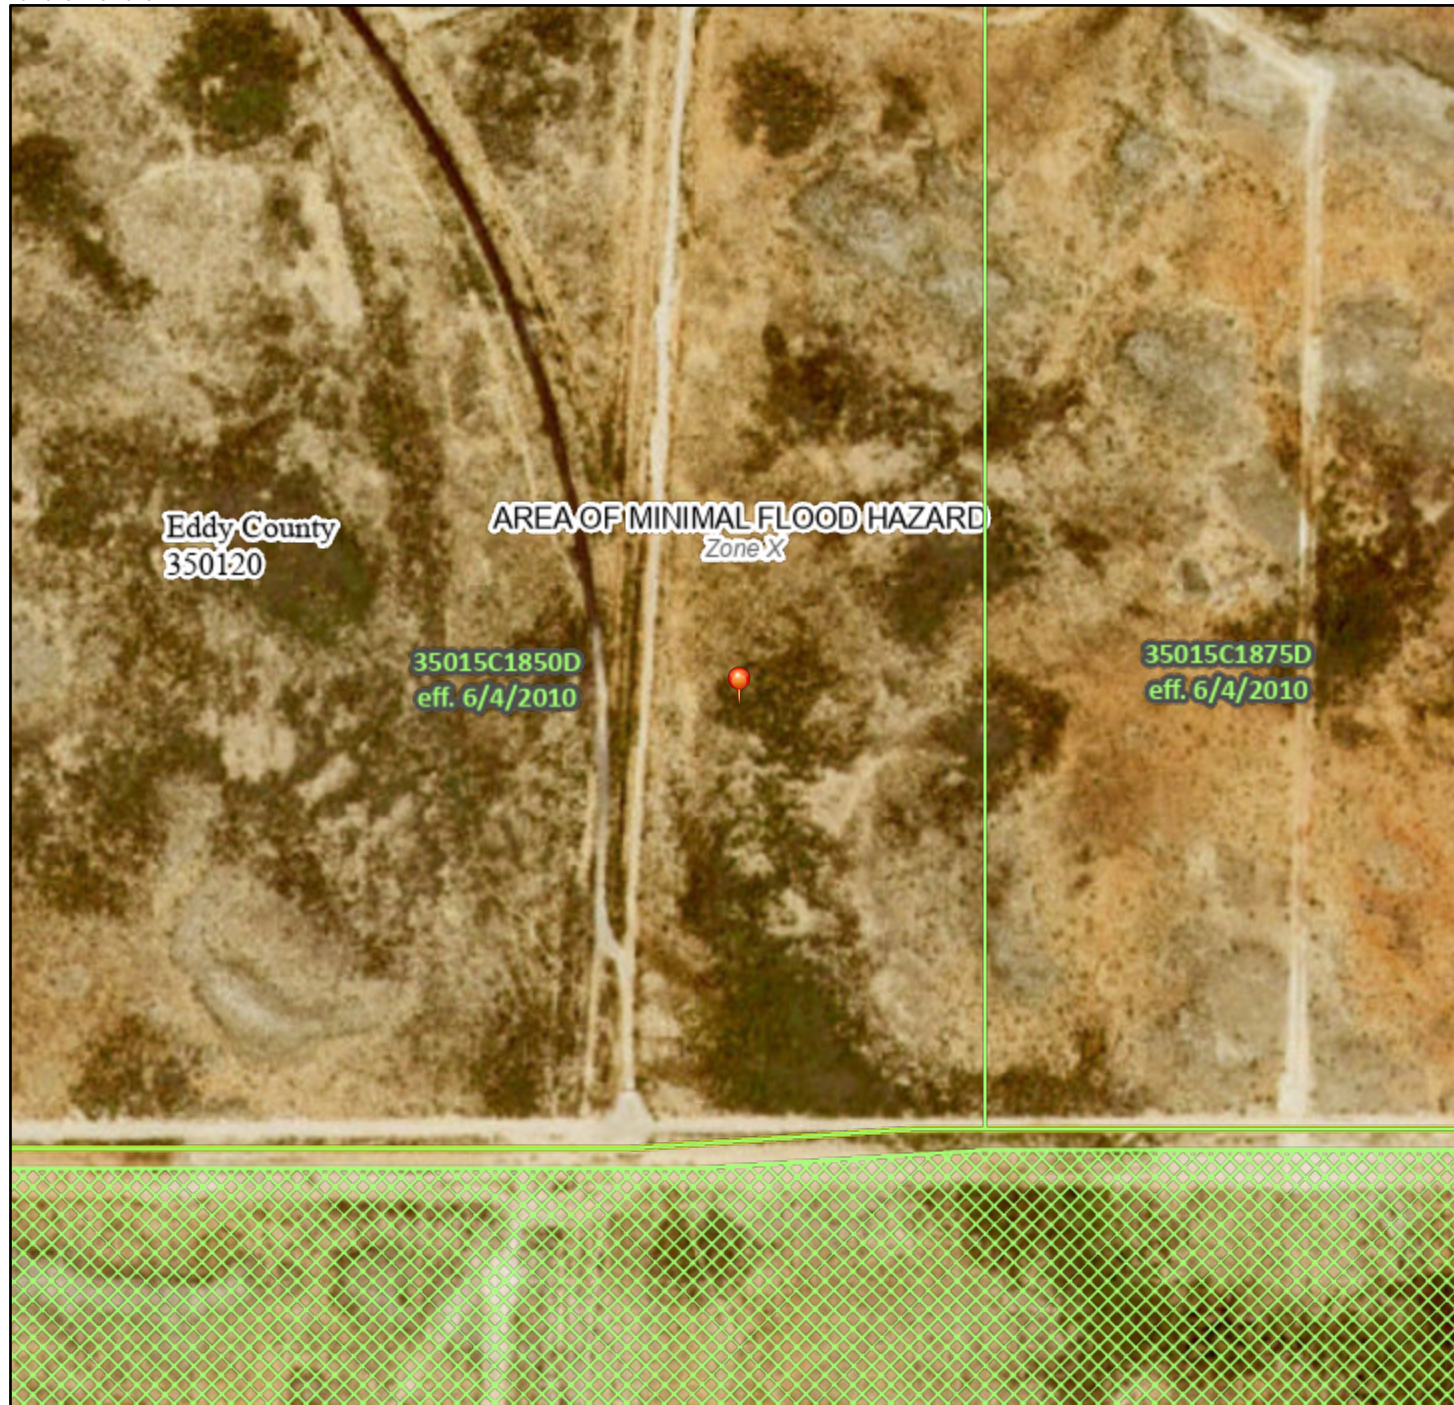
National Flood Hazard Layer FIRMette

The United States Department of Agriculture Natural Resources Conservation Services indicates that the soil type found in the area of the Money Graham consists of 100% RU-Russier-Ector Association, with 0 to 9 percent slopes. (Documentation attached). In the area of the Money Graham the *FEMA National Flood Hazard Layer*, indicates that there is 0.2% annual chance of a flood hazard in this area. (See map attached).

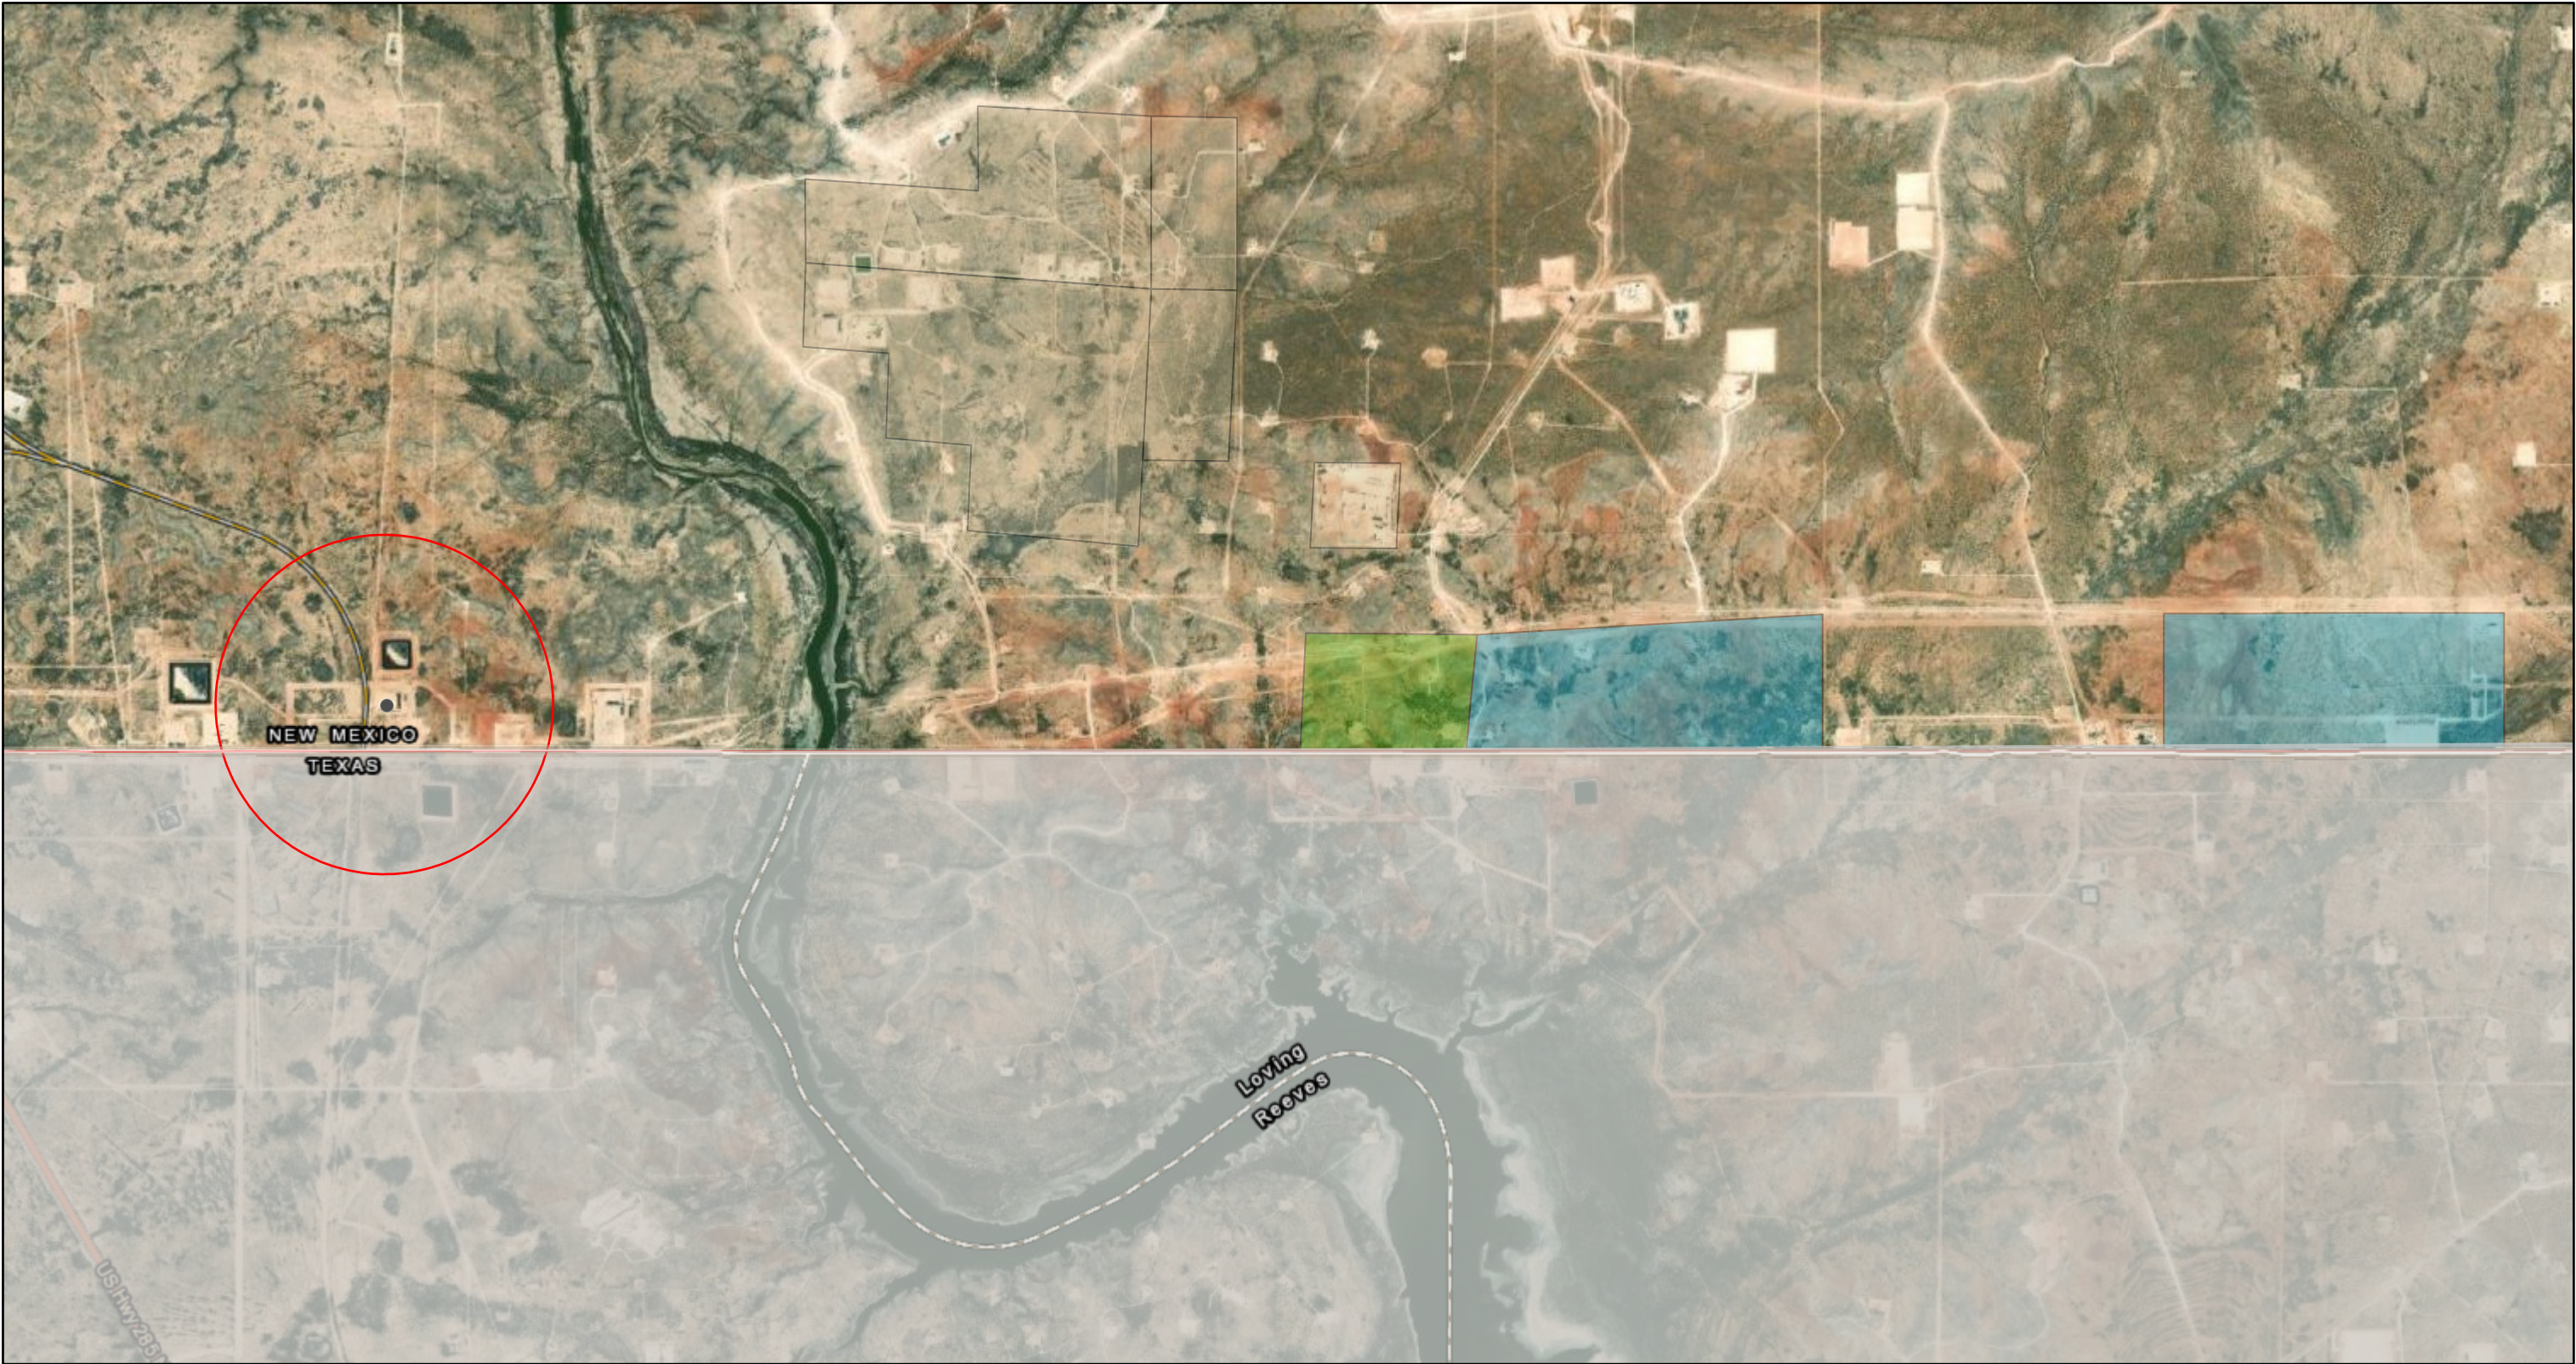
OSE POD Location Map

The nearest and most recent water well to the site according to the *New Mexico Office of the State Engineer* is C03605 POD1, which is located 2831' from the site and was drilled in 2013. The well was drilled to 45'bgs and no water was located or measured. The next verifiable water well is C04561 POD1, located 6006' from the site and drilled in 2021. This well was drilled to an unknown depth. C04022 POD2m, located 6501' from the site and was drilled in 2017. The well was drilled 250'bgs and water was encountered 145'bgs. Please find the groundwater data and map from the NMOSE wells attached herein. An extended groundwater search was conducted using the *OSE POD Location Mapping System*

and it has been determined that, no wells exist within a ½ a mile radius from the Money Graham. Please find the Ground Water Data attached herein.

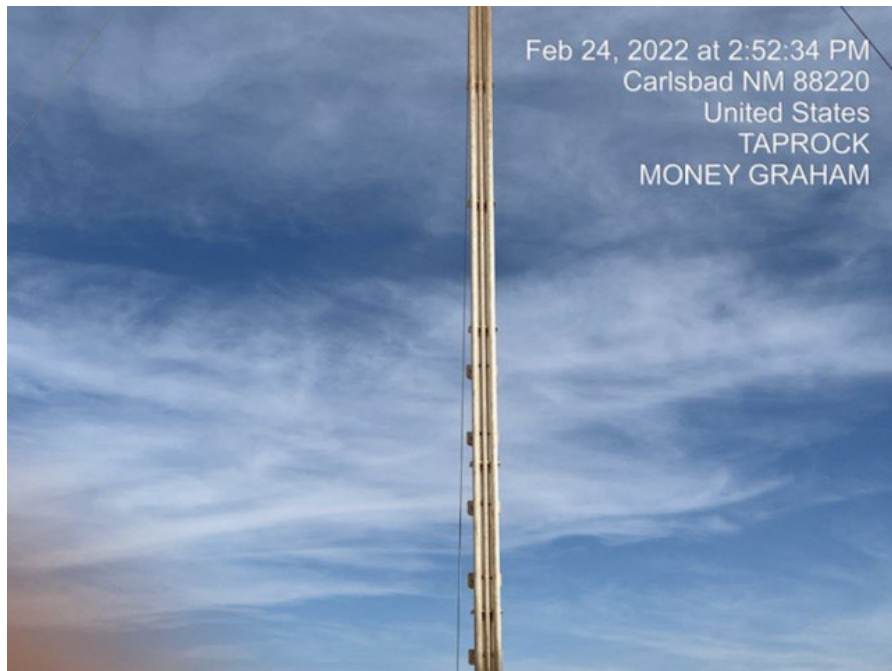
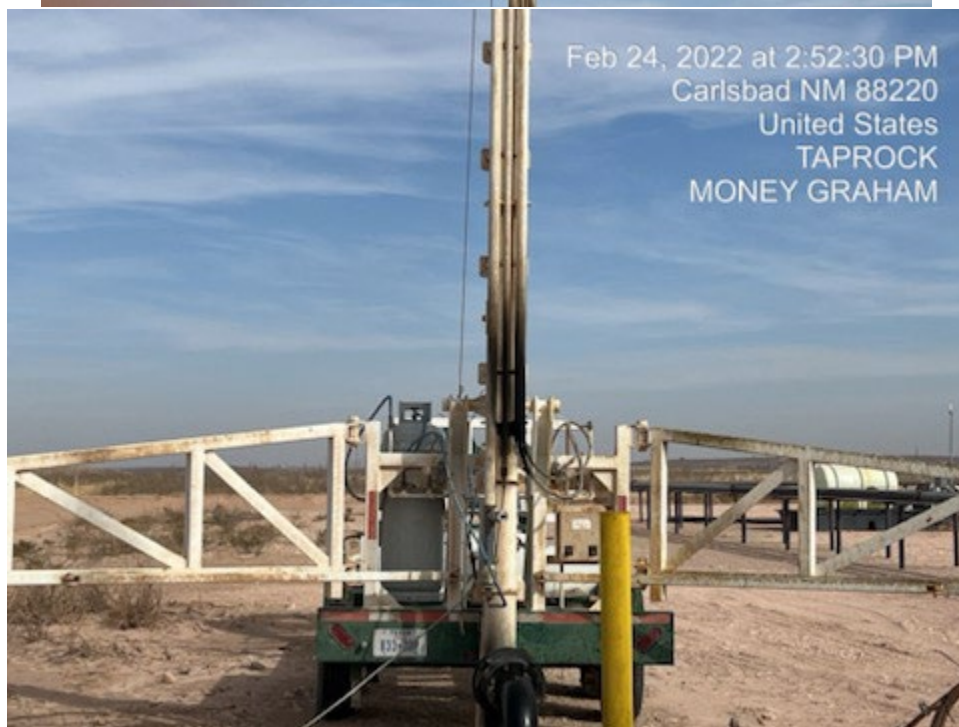
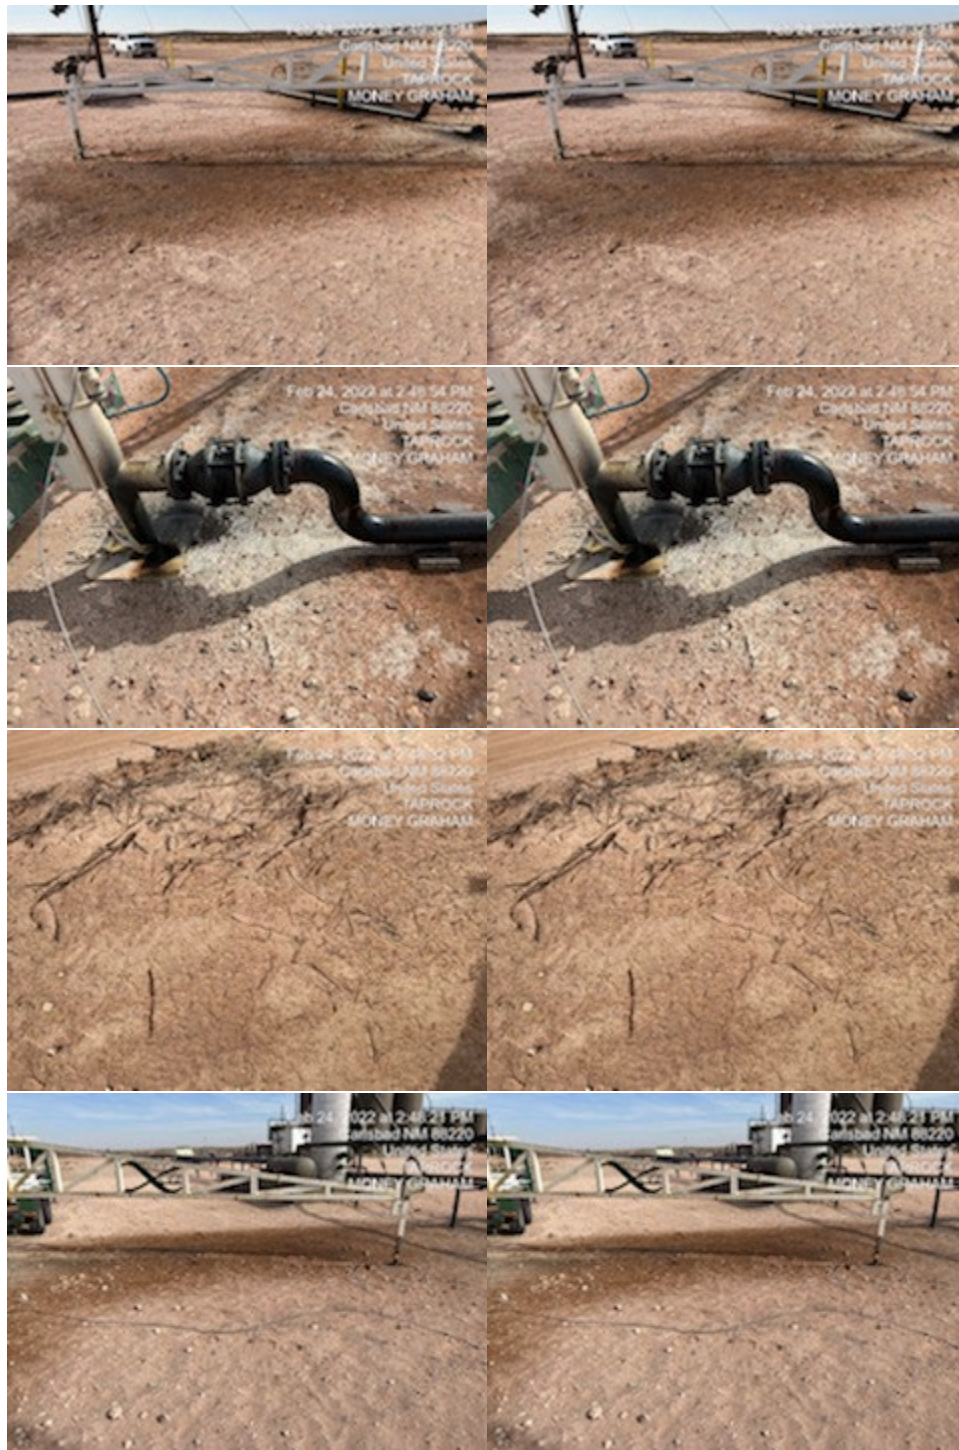
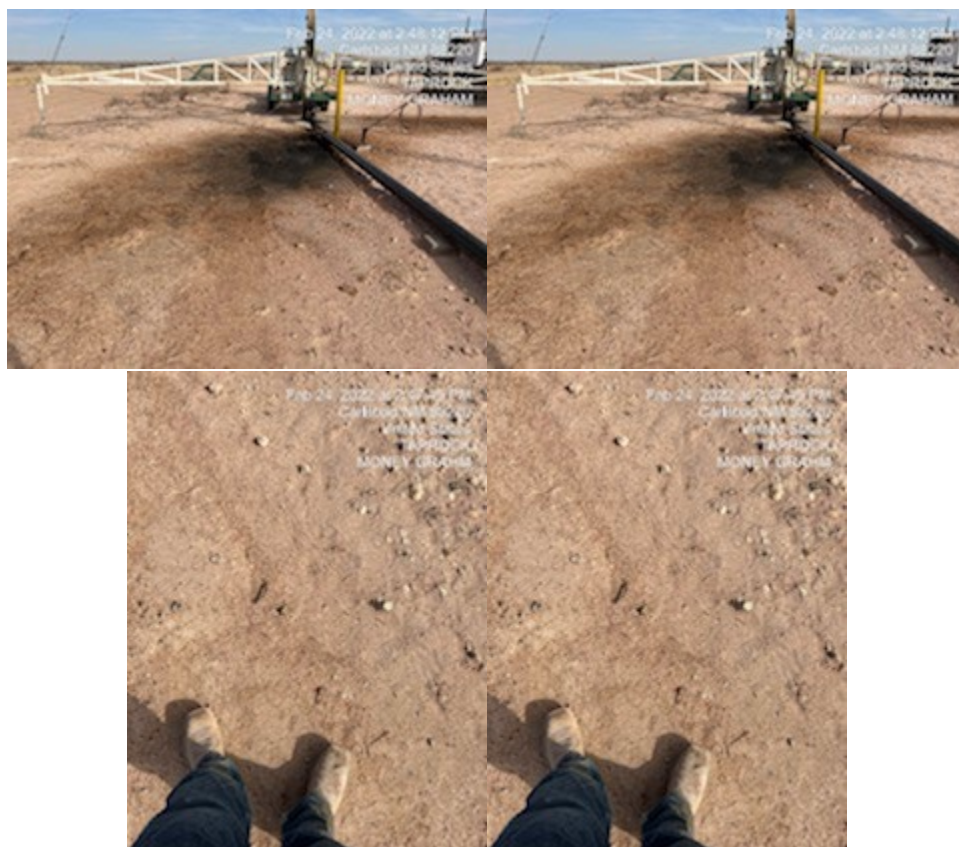
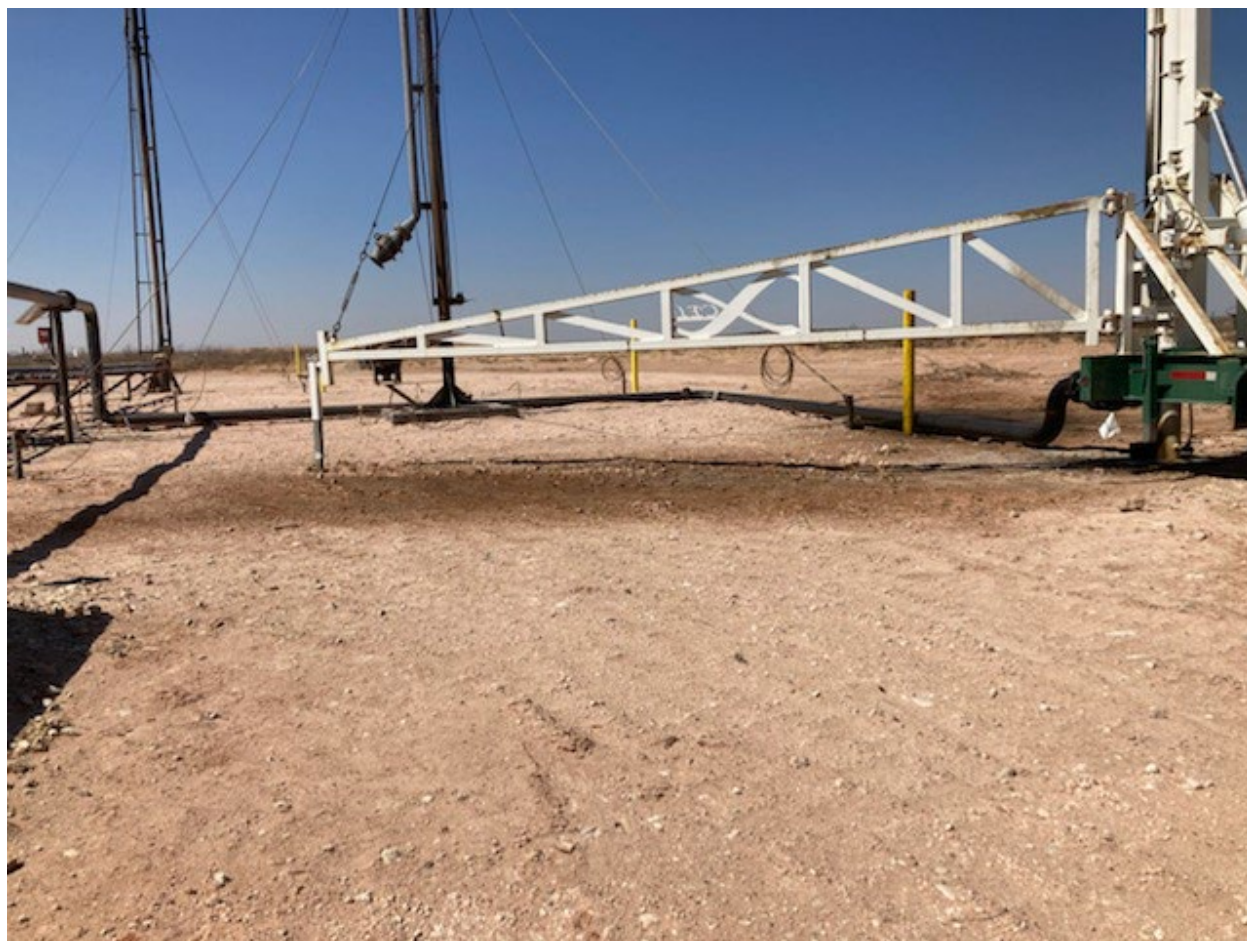
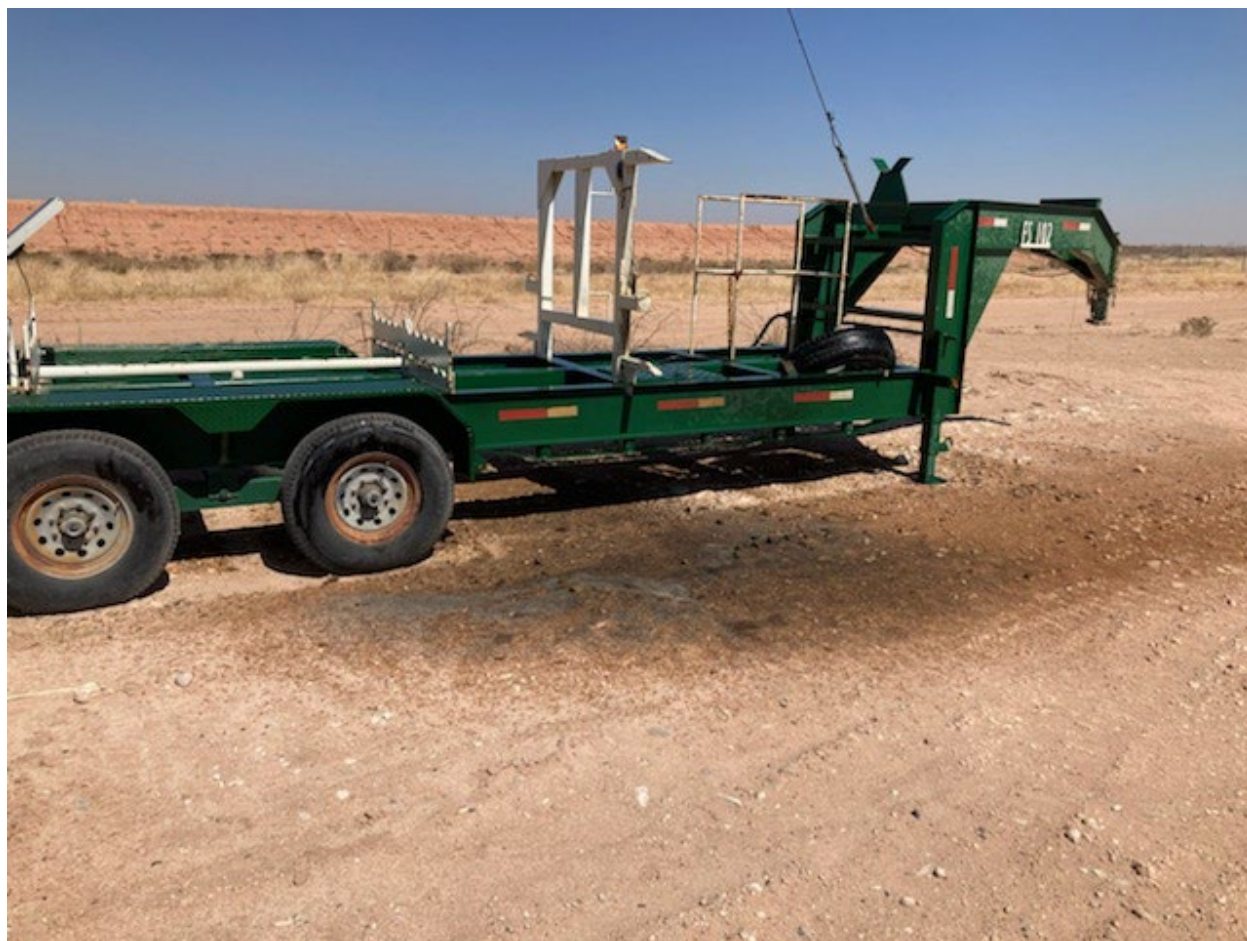
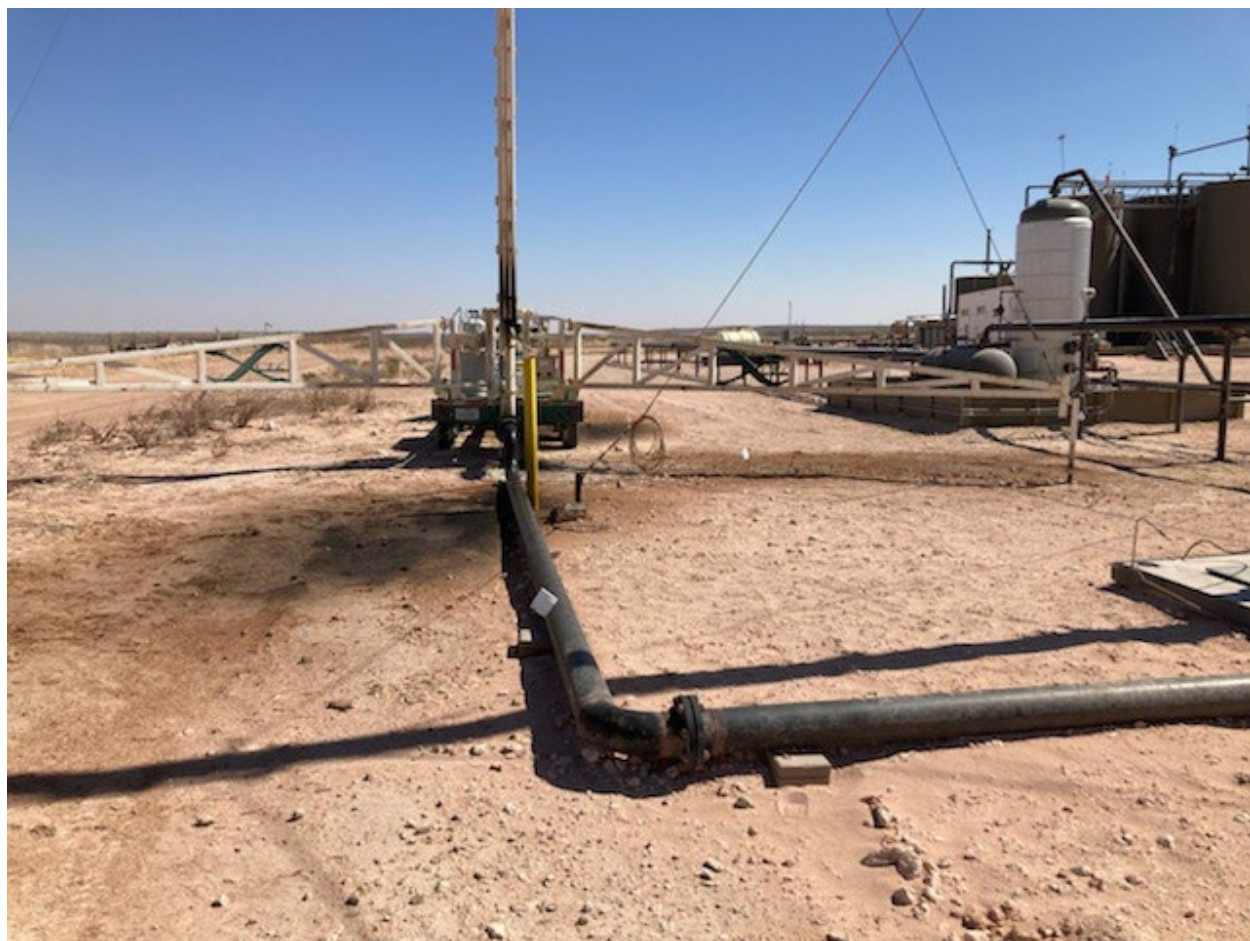
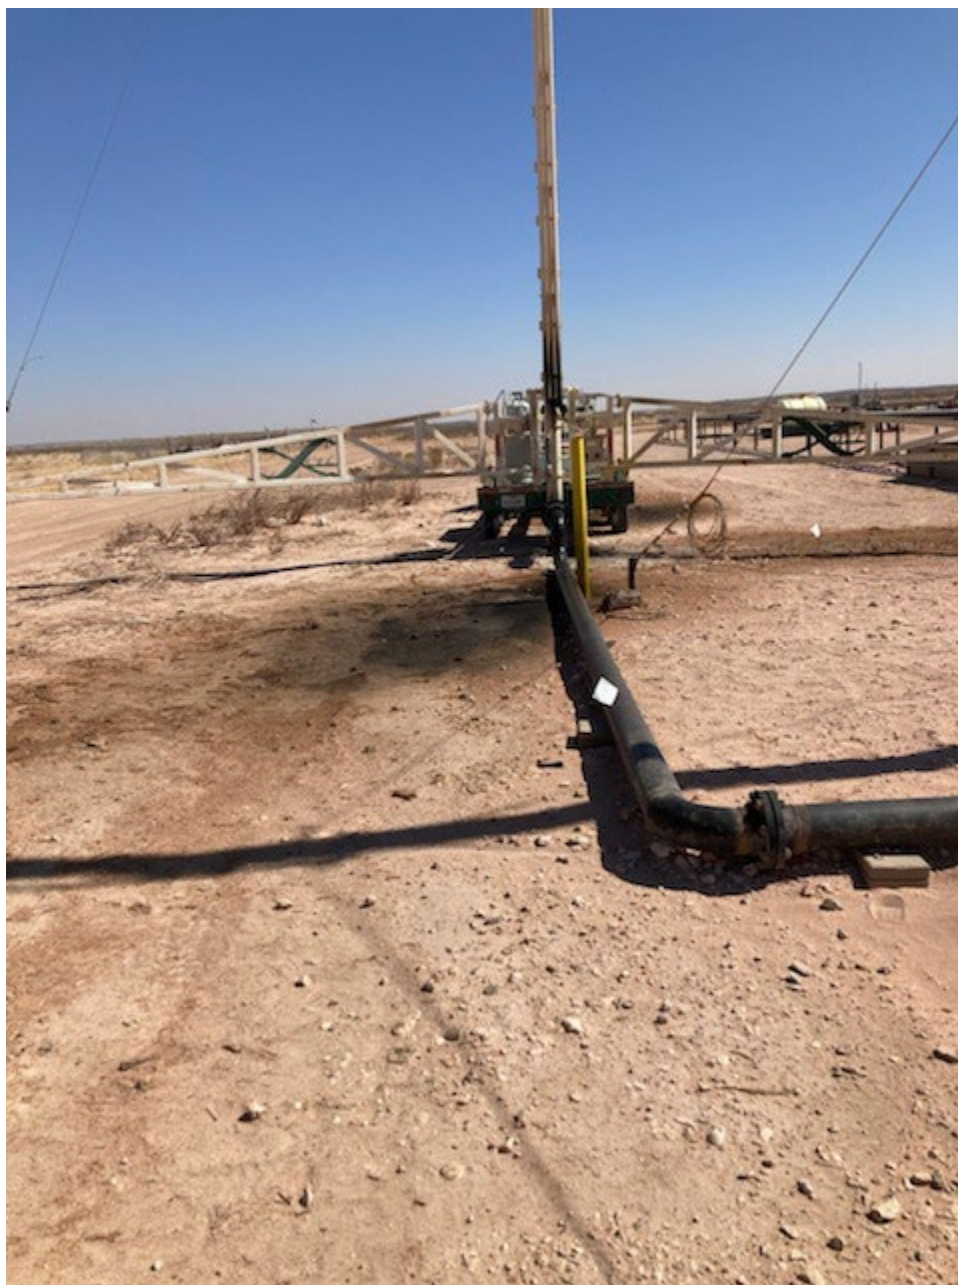
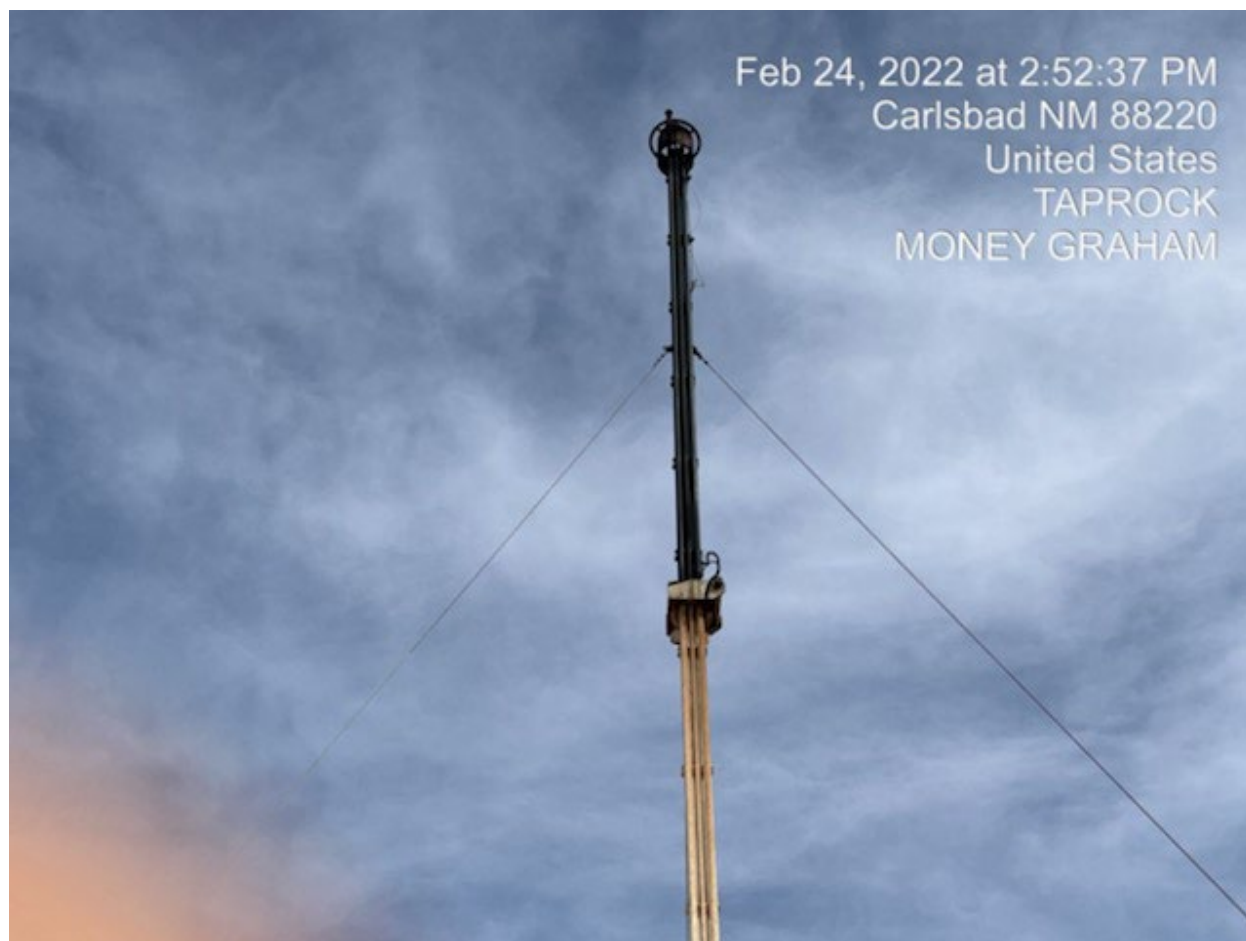
INITIAL SITE PHOTOS

On February 24th, ESS staff was dispatched out to the Money Graham, to complete a site assessment of the release and fire incident. Initial photos were obtained and the following information was found:

- The release from the flare had sprayed underneath the portable flare unit and had sprayed north and south of the line running to the flare unit.
- No standing fluid was present.
- No fluid entered the pasture area, road or surface playa, lakes, or other watercourses.
- The impacted area on the surface of the pad measured 990 sq. ft. (impact map attached)
- Crews were onsite to check the flare and to shut in production for repairs.

On March 9th, ESS crews pressure washed the flare and adjacent lines in the release area. Crews mapped out the sample point placements for the delineation process and obtained surface samples. A total of three vertical sample points and five horizontal sample points were placed and GPS'd. Samples were field assessed and submitted to Envirotech Laboratories for confirmation. Please find the delineation sample data, along with the confirmation lab analysis below and attached to this report.
