**Re: Site Assessment, Remediation, and Closure Report**  
**Rigel 20 Fed Com 1H**  
**API No. 30-015-39393**  
**GPS: Latitude 32.652235 Longitude -103.899075**  
**UL D, Sec. 20, T19S, R31E**  
**Eddy County, NM**  
**NMOCD Ref. No. NAPP2121530174**

Pima Environmental Services, LLC. (Pima) has been contracted by Devon Energy Production, LLC. (Devon) to perform a spill assessment, remediation, and submit this closure report for a Crude oil release that occurred at the Rigel 20 Fed Com 1H (Rigel). The initial C-141 was submitted on August 3, 2021 (Appendix C). This incident was assigned Incident ID NAPP2121530174 by the New Mexico Oil Conservation Division (NMOCD).

# Rigel 20 Fed Com 1H

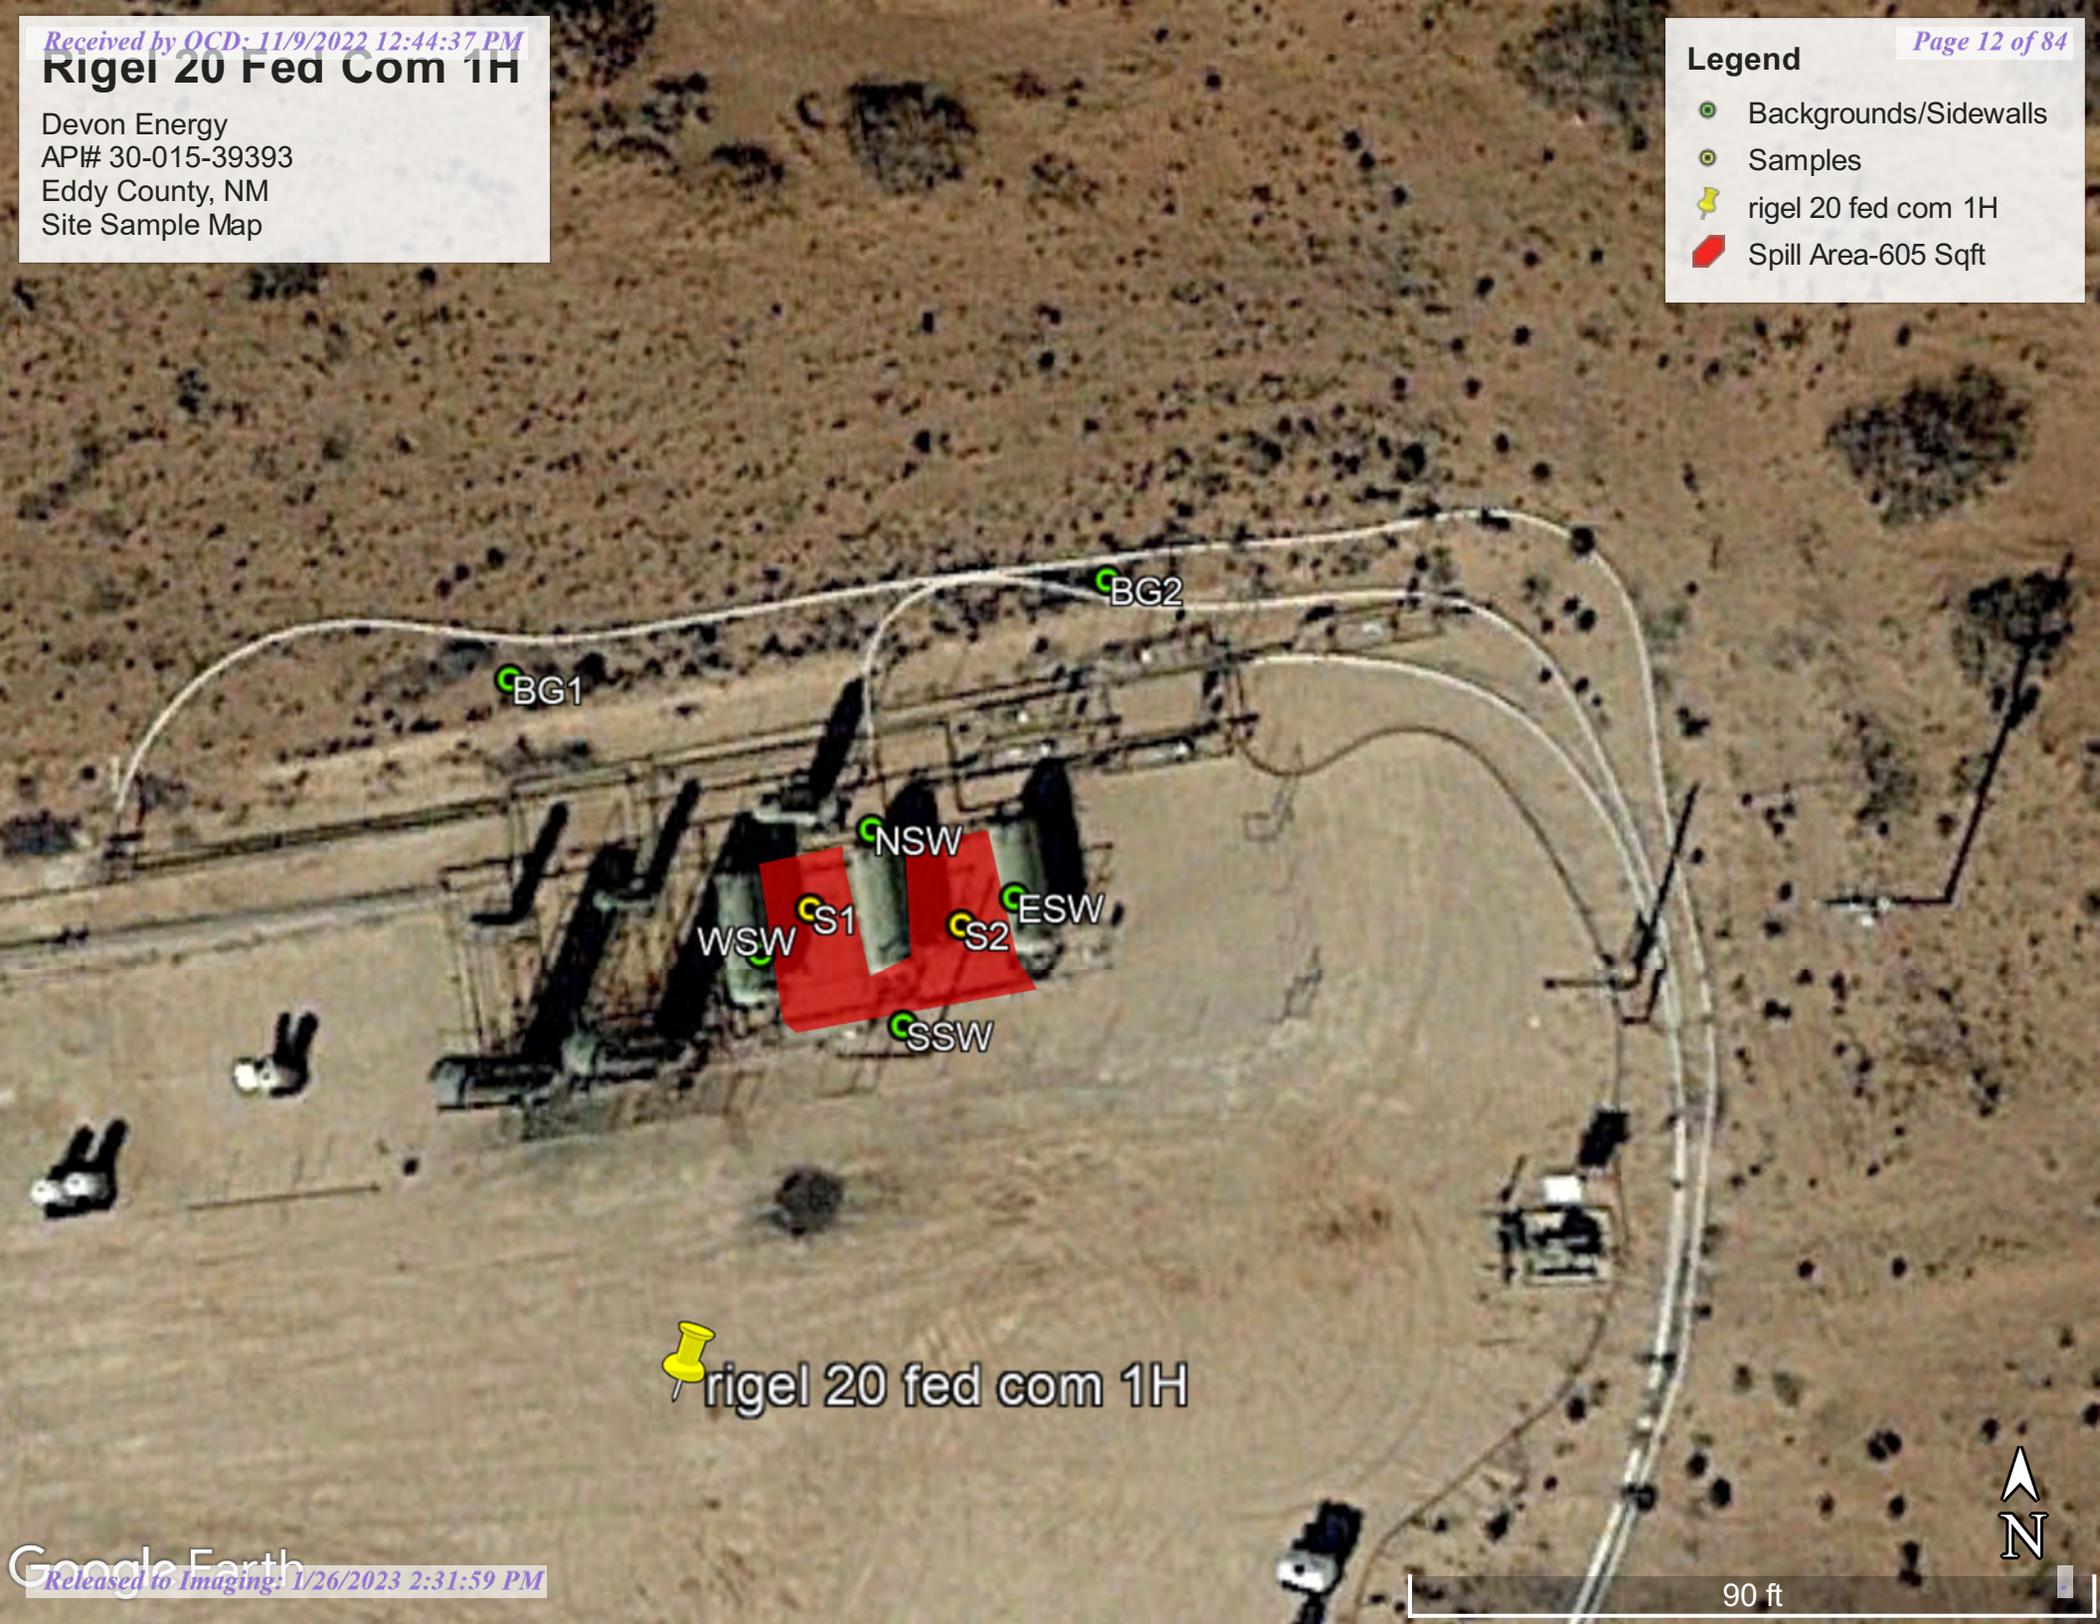
4-Site Map

On June 17, 2022, Pima mobilized personnel to the site to assess the area. We sampled the impacted area. Laboratory results of this sampling event can be found in the following data table. A Site Map can be found in Figure 4.

Devon Energy  
AP# 30-015-39393  
Eddy County, NM  
Site Sample Map

Spill Area-605 Sqft

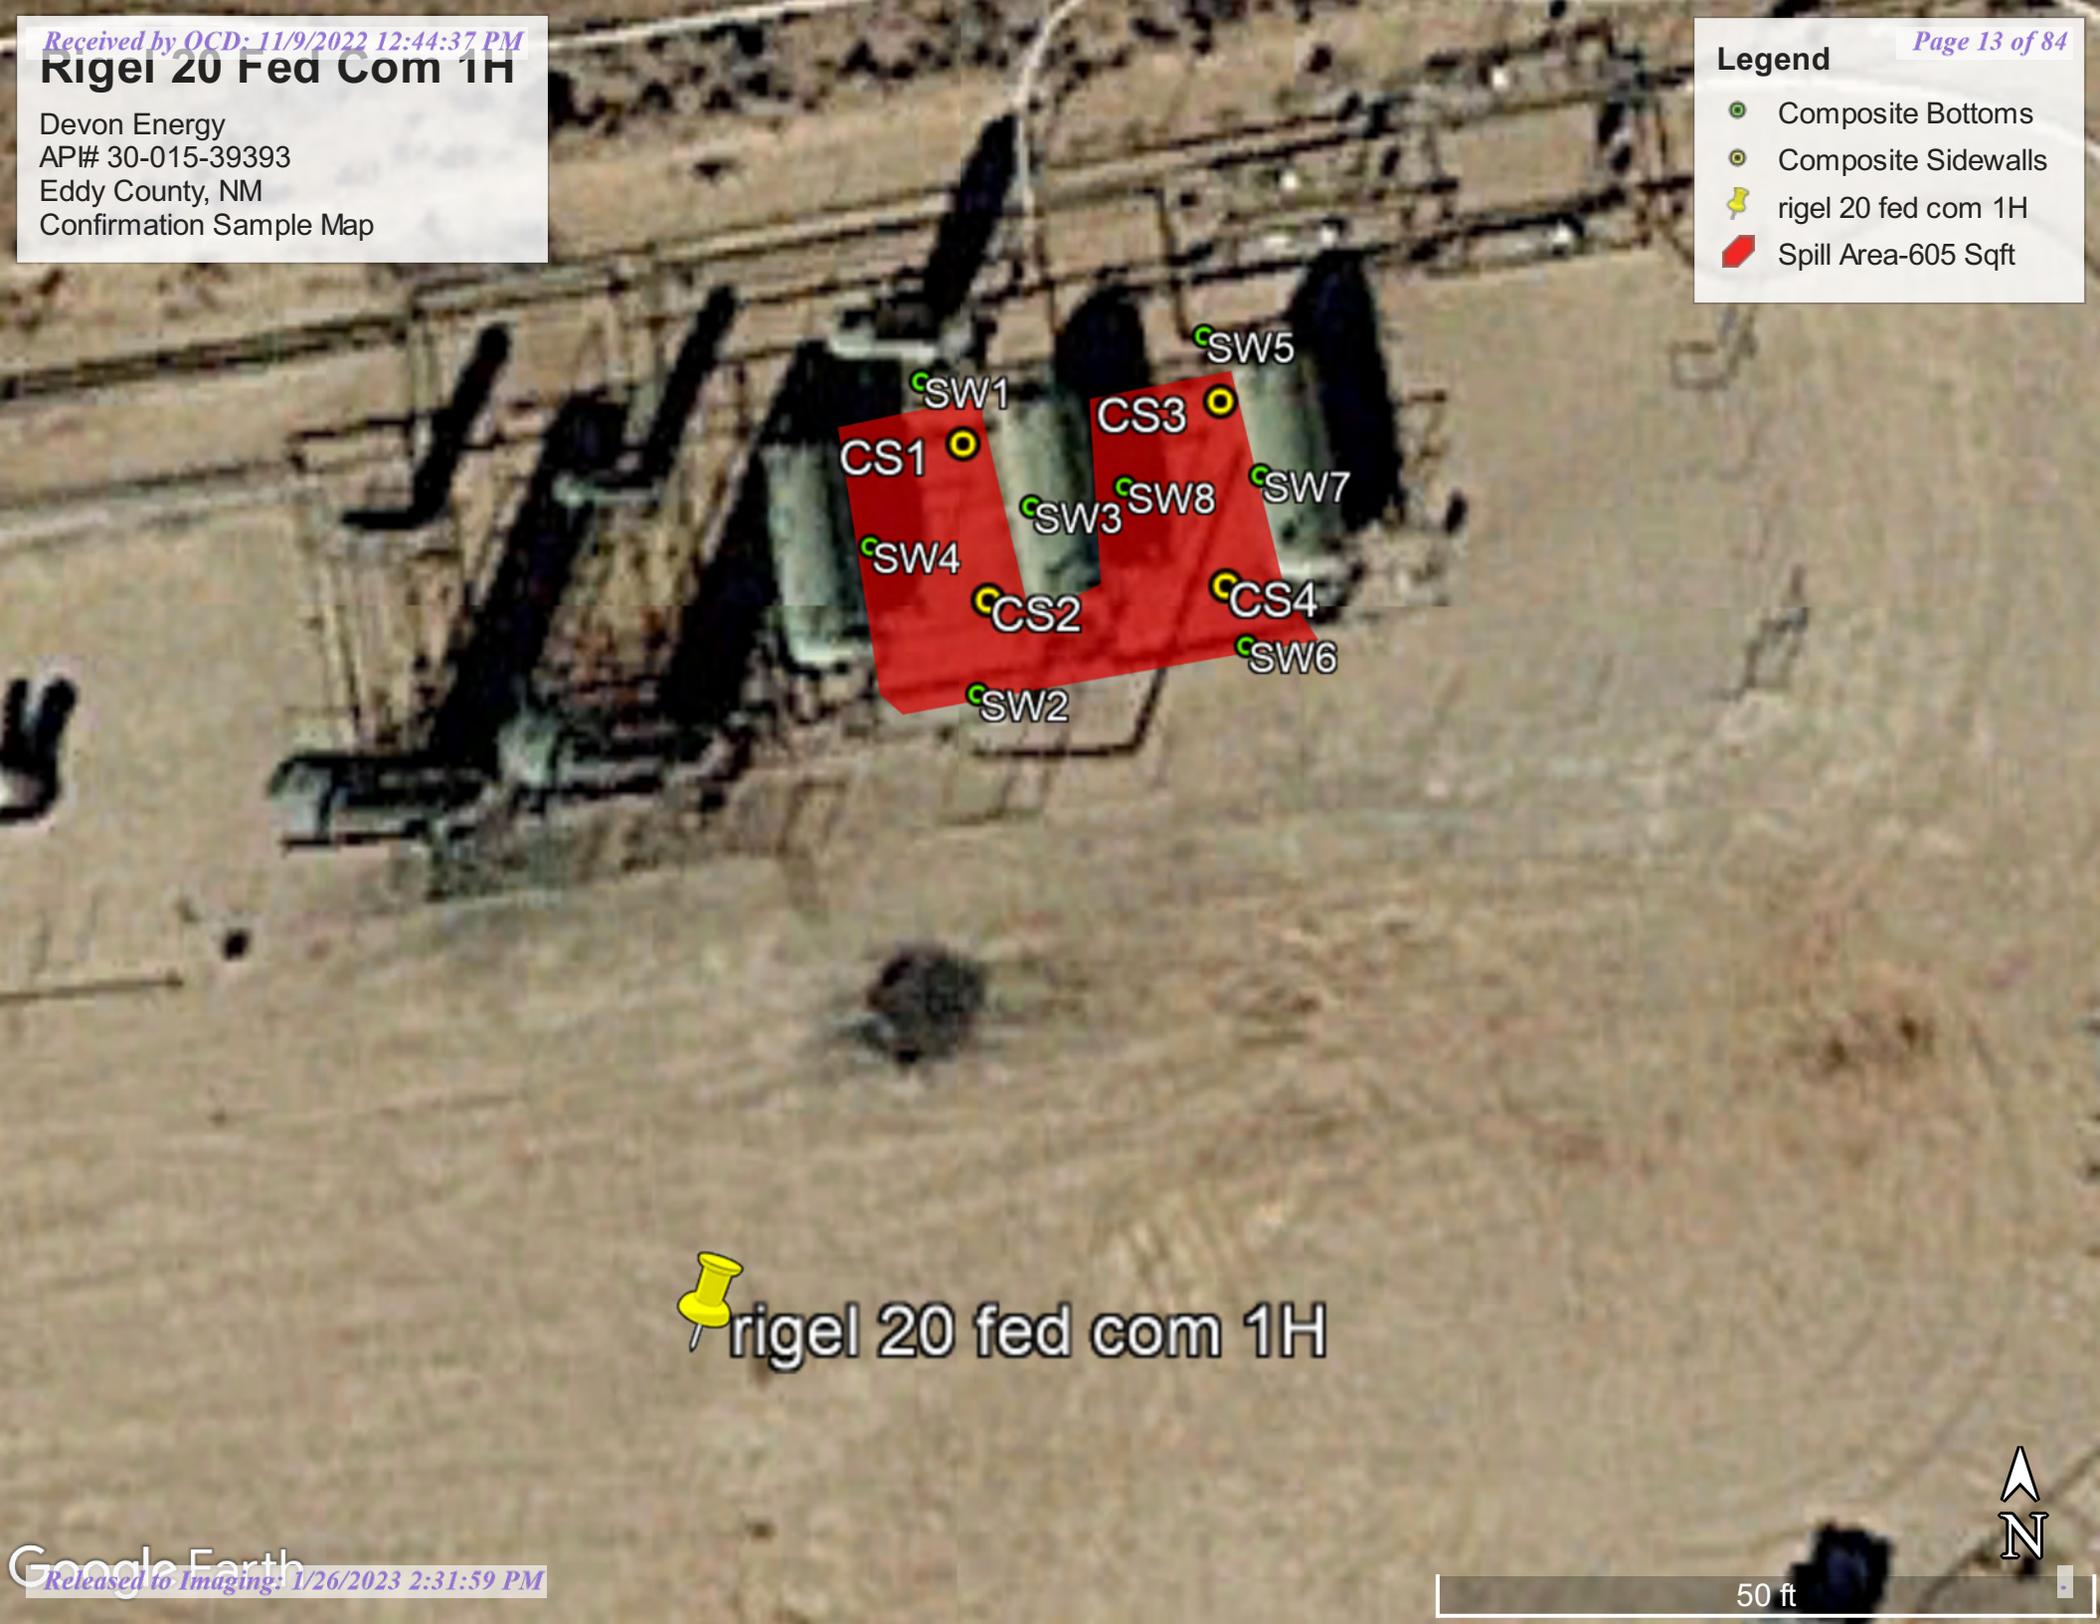
5-Confirmation Sample Map

On August 28, 2022, after sending a 48-hour notification (Appendix C), Pima collected confirmation samples of the excavated areas. Laboratory results of this sampling event can be found in the following data table. A Confirmation Sample Map can be found in Figure 5.

Devon Energy  
API# 30-015-39393  
Eddy County, NM  
Confirmation Sample Map

Spill Area-605 Sqft

Based on the sample results, the bottom and sidewalls were below NMOCD Closure Criteria 19.15.29 NMAC. The contaminated material was transported to Lea Land, an NMOCD approved disposal site. The excavation was then backfilled with clean like material, machine compacted and contoured to match the surrounding terrain. See Appendix D for Photographic Documentation.

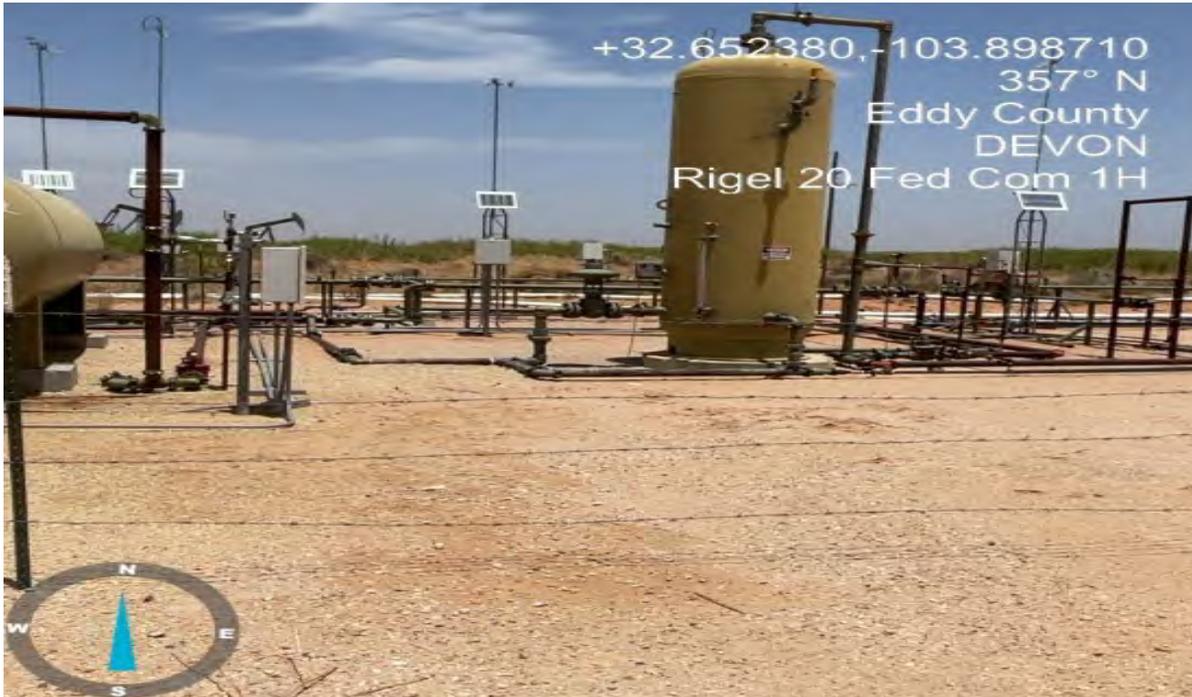
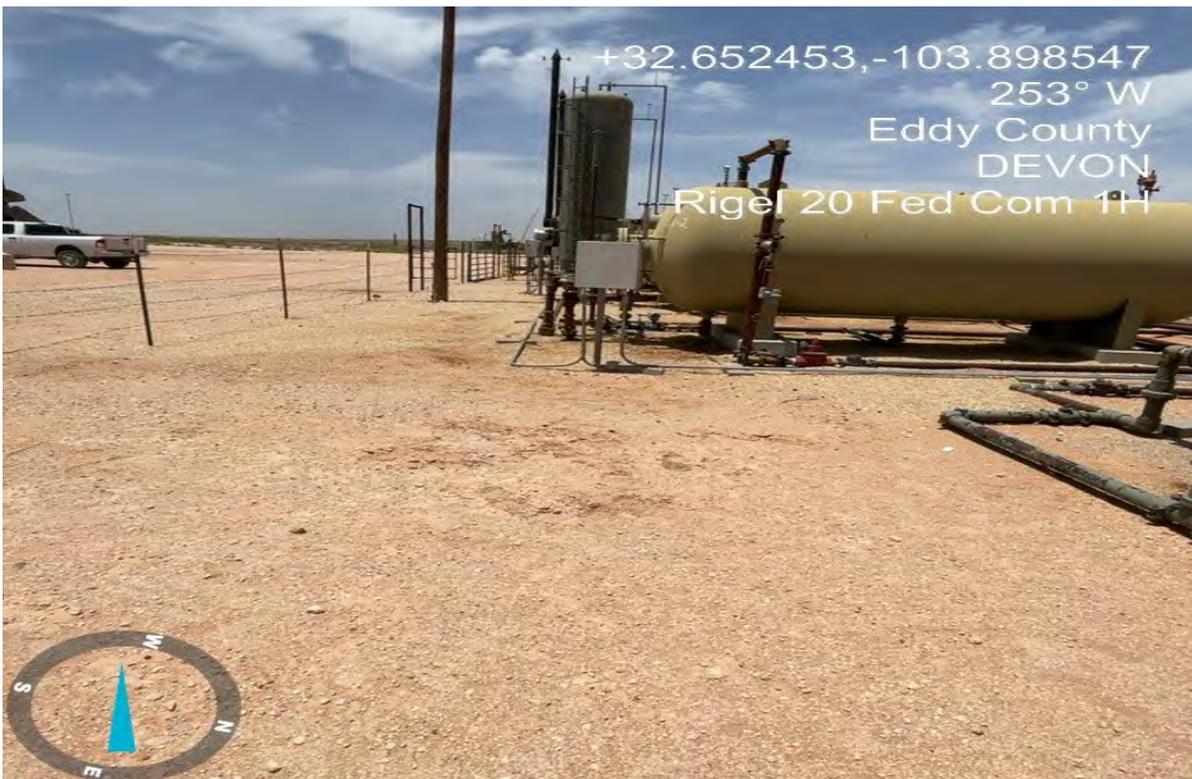
Pre-Remediation

**NAPP2121530174:** On July 7, 2021, a site glass broke on a 3-phase separator causing fluid release. The released fluids were calculated to be approximately 9 barrels (bbls) of crude oil and rainwater. No fluids were recovered.

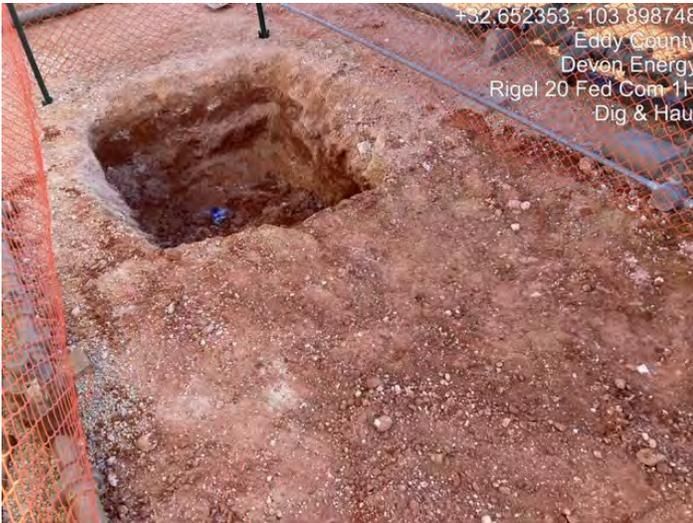
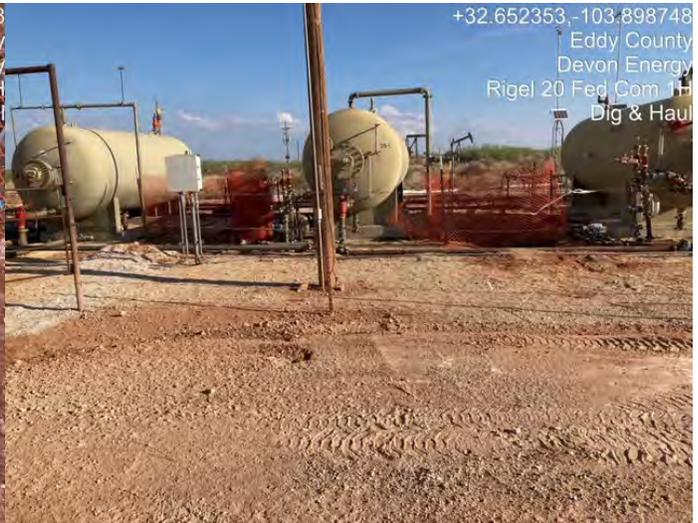
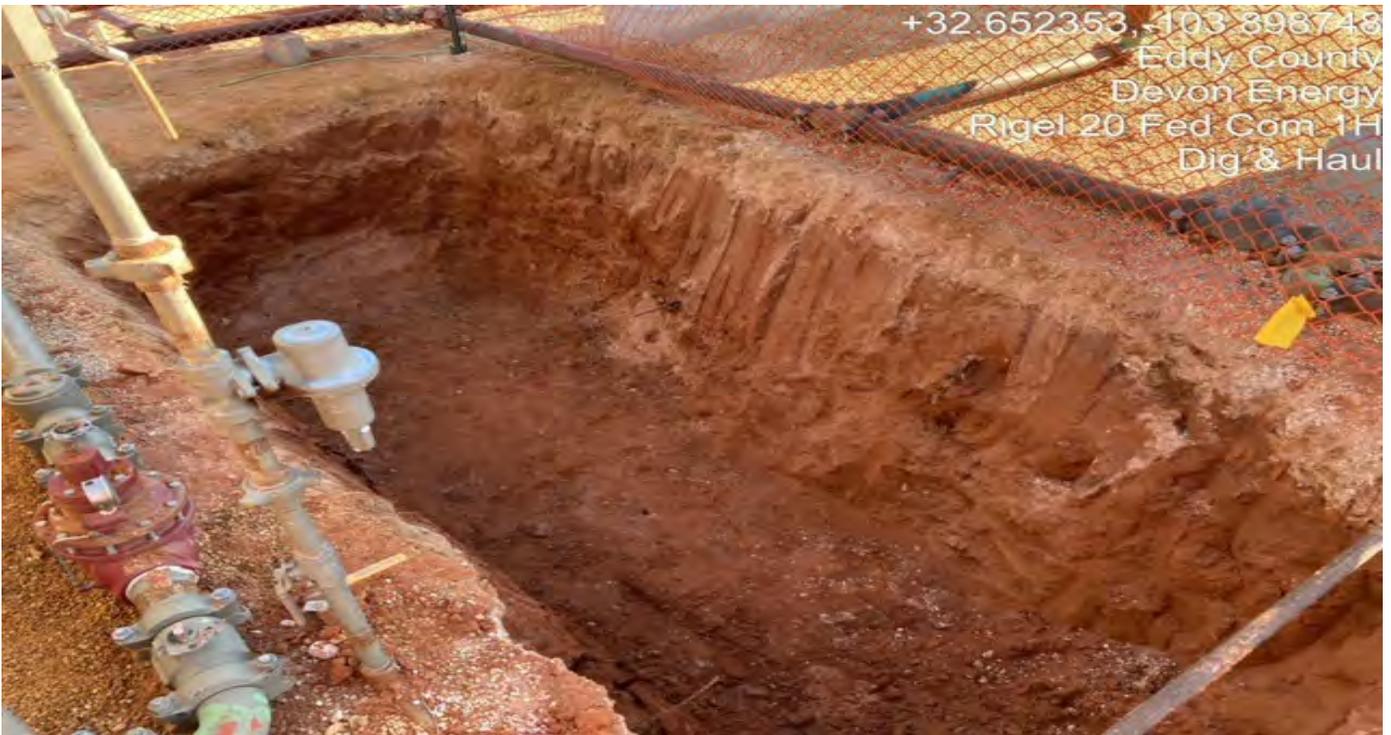
Remediation

On August 23, 2022, Devon Construction Department mobilized personnel and equipment to conduct remedial activities. They excavated the area to a depth of 5' BGS. Pima personnel collected samples to verify all contaminated soil had been removed. The contaminated soil was hauled to an approved, lined disposal facility and clean backfill material was brought in.
