## Reclamation and Closure Report

Aldabra 25 Federal Com #2H  
Eddy County, New Mexico  
API #30-015-38613  
2RP-4549

Subject: **Assessment and Closure Report**  
Aldabra 25 Federal Com 2H  
Eddy County, New Mexico  
API #30-015-38613  
2RP-4549

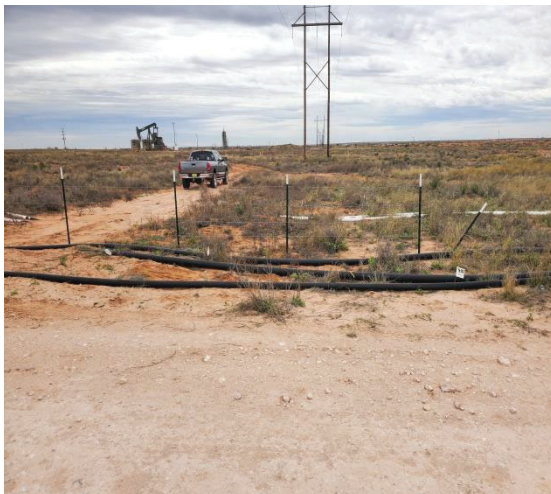
Impacted Area-Vegetation

Flowline (source)

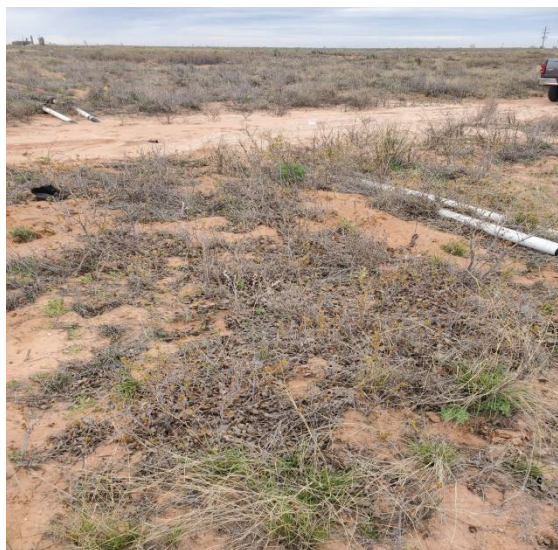
Pasture Area

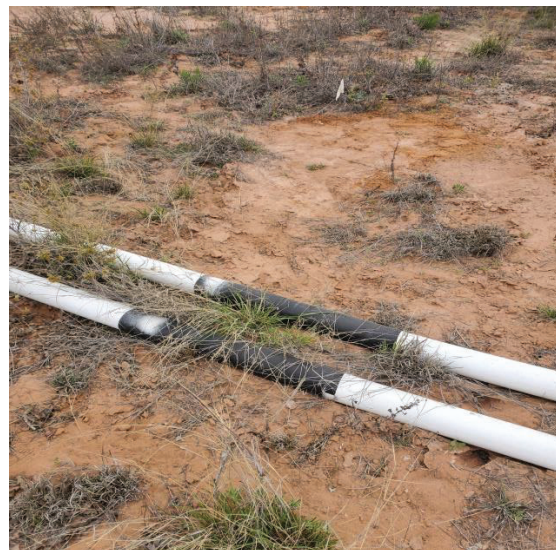
Repaired Lines

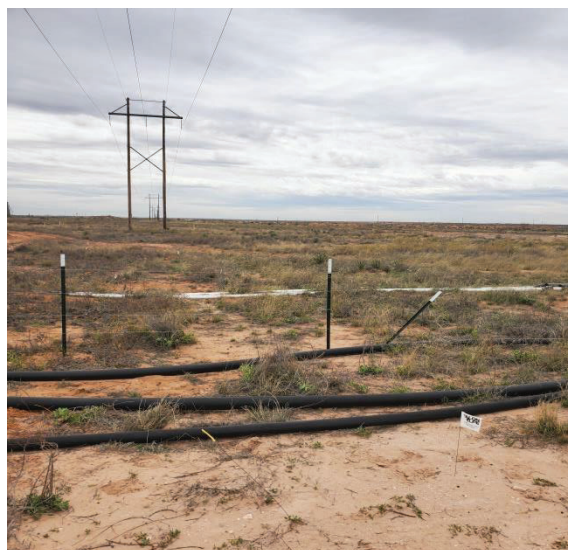
Sample Positions
