Site Assessment/Characterization

Closure

M&M Excavating, Inc. (MMX) has prepared this Remediation Closure Report for Devon Energy Production Company that describes the remediation of a release of liquids at the Thistle Unit 111H location. The site is in Unit A, Section 22, Township 23S, Range 33E, Latitude 32.296956, Longitude -103.552832, Lea County, New Mexico, on State land. Figure 1 provides the vicinity and site location on an USGS 7.5-minute quadrangle map.

Release Information and Closure Criteria			
Name	Thistle Unit 111H		
API Number	30-025-44418		
Incident Number	1RP-5161		
Source of Release	Frac tank		
Released Material	Produced Water	Released Volume	14.26 BBLS
Recovered Volume	0 BBLS	Net Release	14.26 BBLS
NMOCD Closure Criteria	>100 feet to groundwater

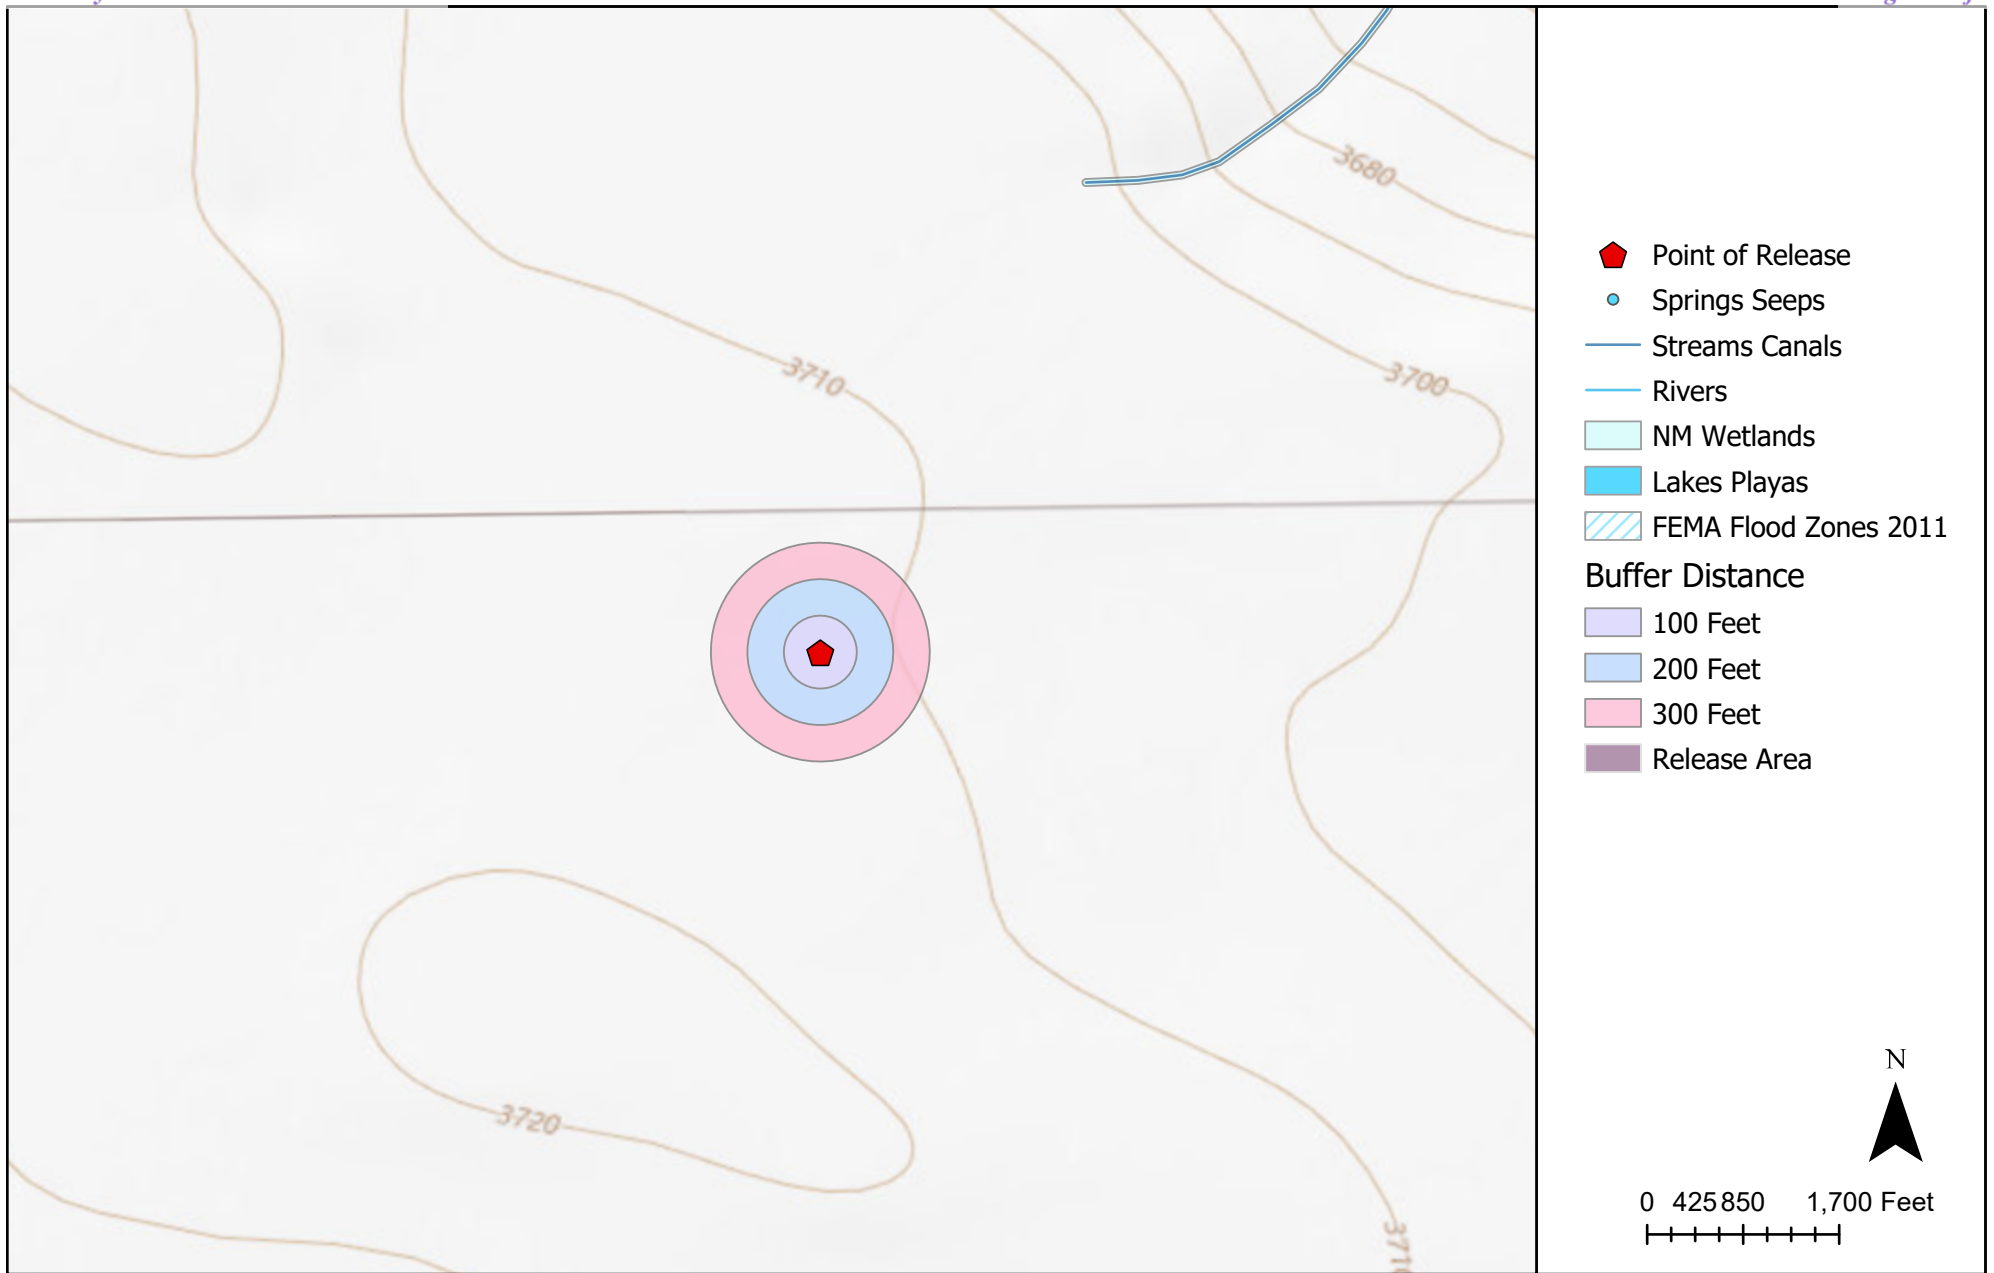
Figure 2

Based upon well water data. (Appendix B), depth to groundwater in the area is estimated to be between 195 and 267 feet below grade surface (bgs). There are no known water wells within ½ mile of the location, according to the New Mexico Office of the State Engineer (NMOSE) and the United States Geological Survey (USGS). The nearest significant watercourse is an unnamed intermittent stream located approximately 1,500 feet to the northeast.

Surface Water Protection Map
 Thistle Unit #111H - Devon Energy
 Sec 22 T23S R33E Lea County, New Mexico

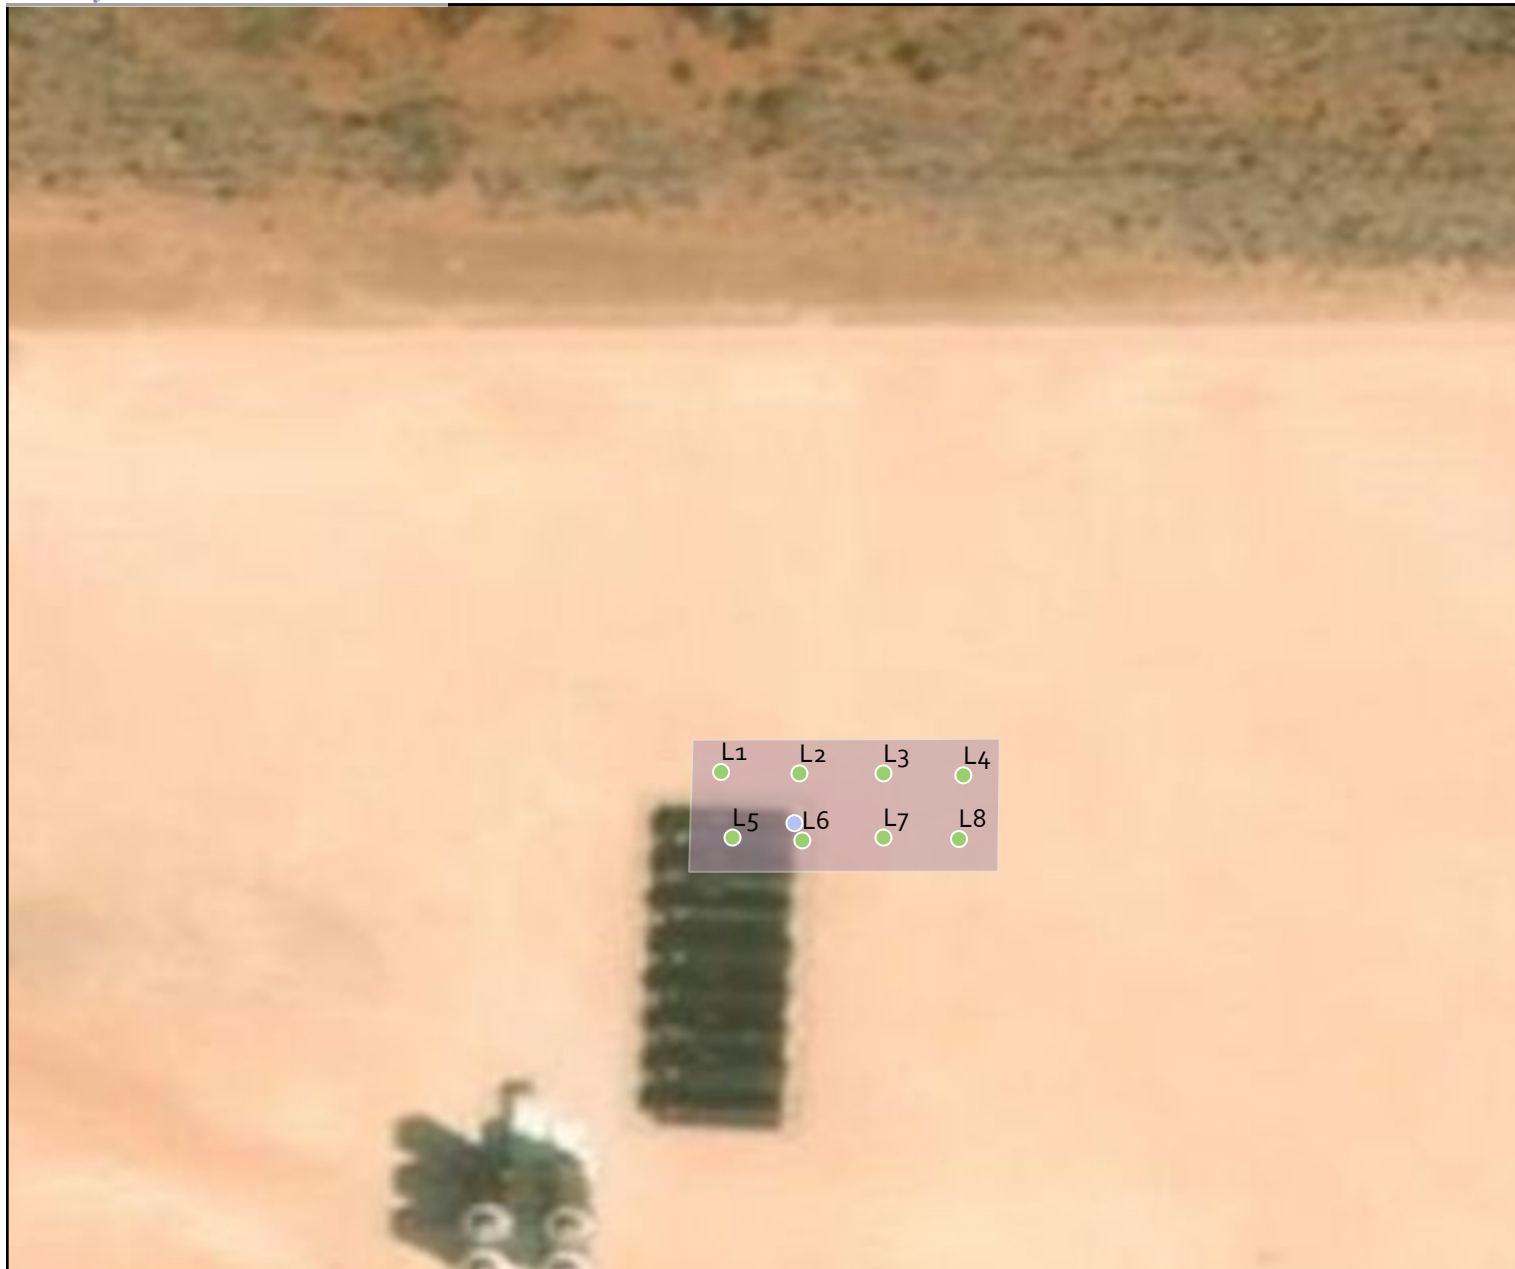
As summarized in Table 3, the results meet NMOCD Closure Criteria, as well as the NMOCD Reclamation Requirements for the location. Figure 3 shows the sample locations. Laboratory results are summarized in Table 3. All laboratory reports are included in Appendix C.

- Release Area
- Point of Release
- Sample Locations

Site & Sample Locations
 Thistle Unit 111H- Devon Energy
 Sec 22 T23S R33E Lea County, NM

On August 20, 2019, MMX personnel arrived on site in response to the release associated with Thistle Unit 111H. In order to assess existing site contamination, MMX collected soil samples around the 40-foot by 80-foot release. A total of eight (8) samples (L1-L8), were collected at the surface and at one (1) foot bgs for laboratory analysis for total chloride using EPA Method 300.0; benzene, toluene, ethylbenzene and total xylenes (BTEX) using EPA Method 8021B; and motor, diesel and gasoline range organics (MRO, DRO, and GRO) by EPA Method 8015D. Samples were placed into laboratory supplied glassware, labeled, and maintained on ice until delivery to Cardinal Laboratories in Hobbs, New Mexico (Appendix C).
