Re: Site Assessment, Remediation, and Closure Report
SV Big Bertha #001
API No. 30-025-33883
GPS: Latitude 32.9383888 Longitude -103.3277969
UL "F.," Sec. 11, T16S, R36E
Lea County, NM
NMOCD Ref. No. NGRL0916335520

Armstrong Energy Corporation have contracted Pima Environmental Services LLC (Pima) to perform a spill assessment, remediation activities, and submit this closure report for a produced water release that occurred at the SV Big Bertha #001. The initial C-141 was submitted on September 15th, 2022 (Appendix C). This incident was assigned Incident ID NGRL0916335520, by the New Mexico Oil Conservation Division (NMOCD).

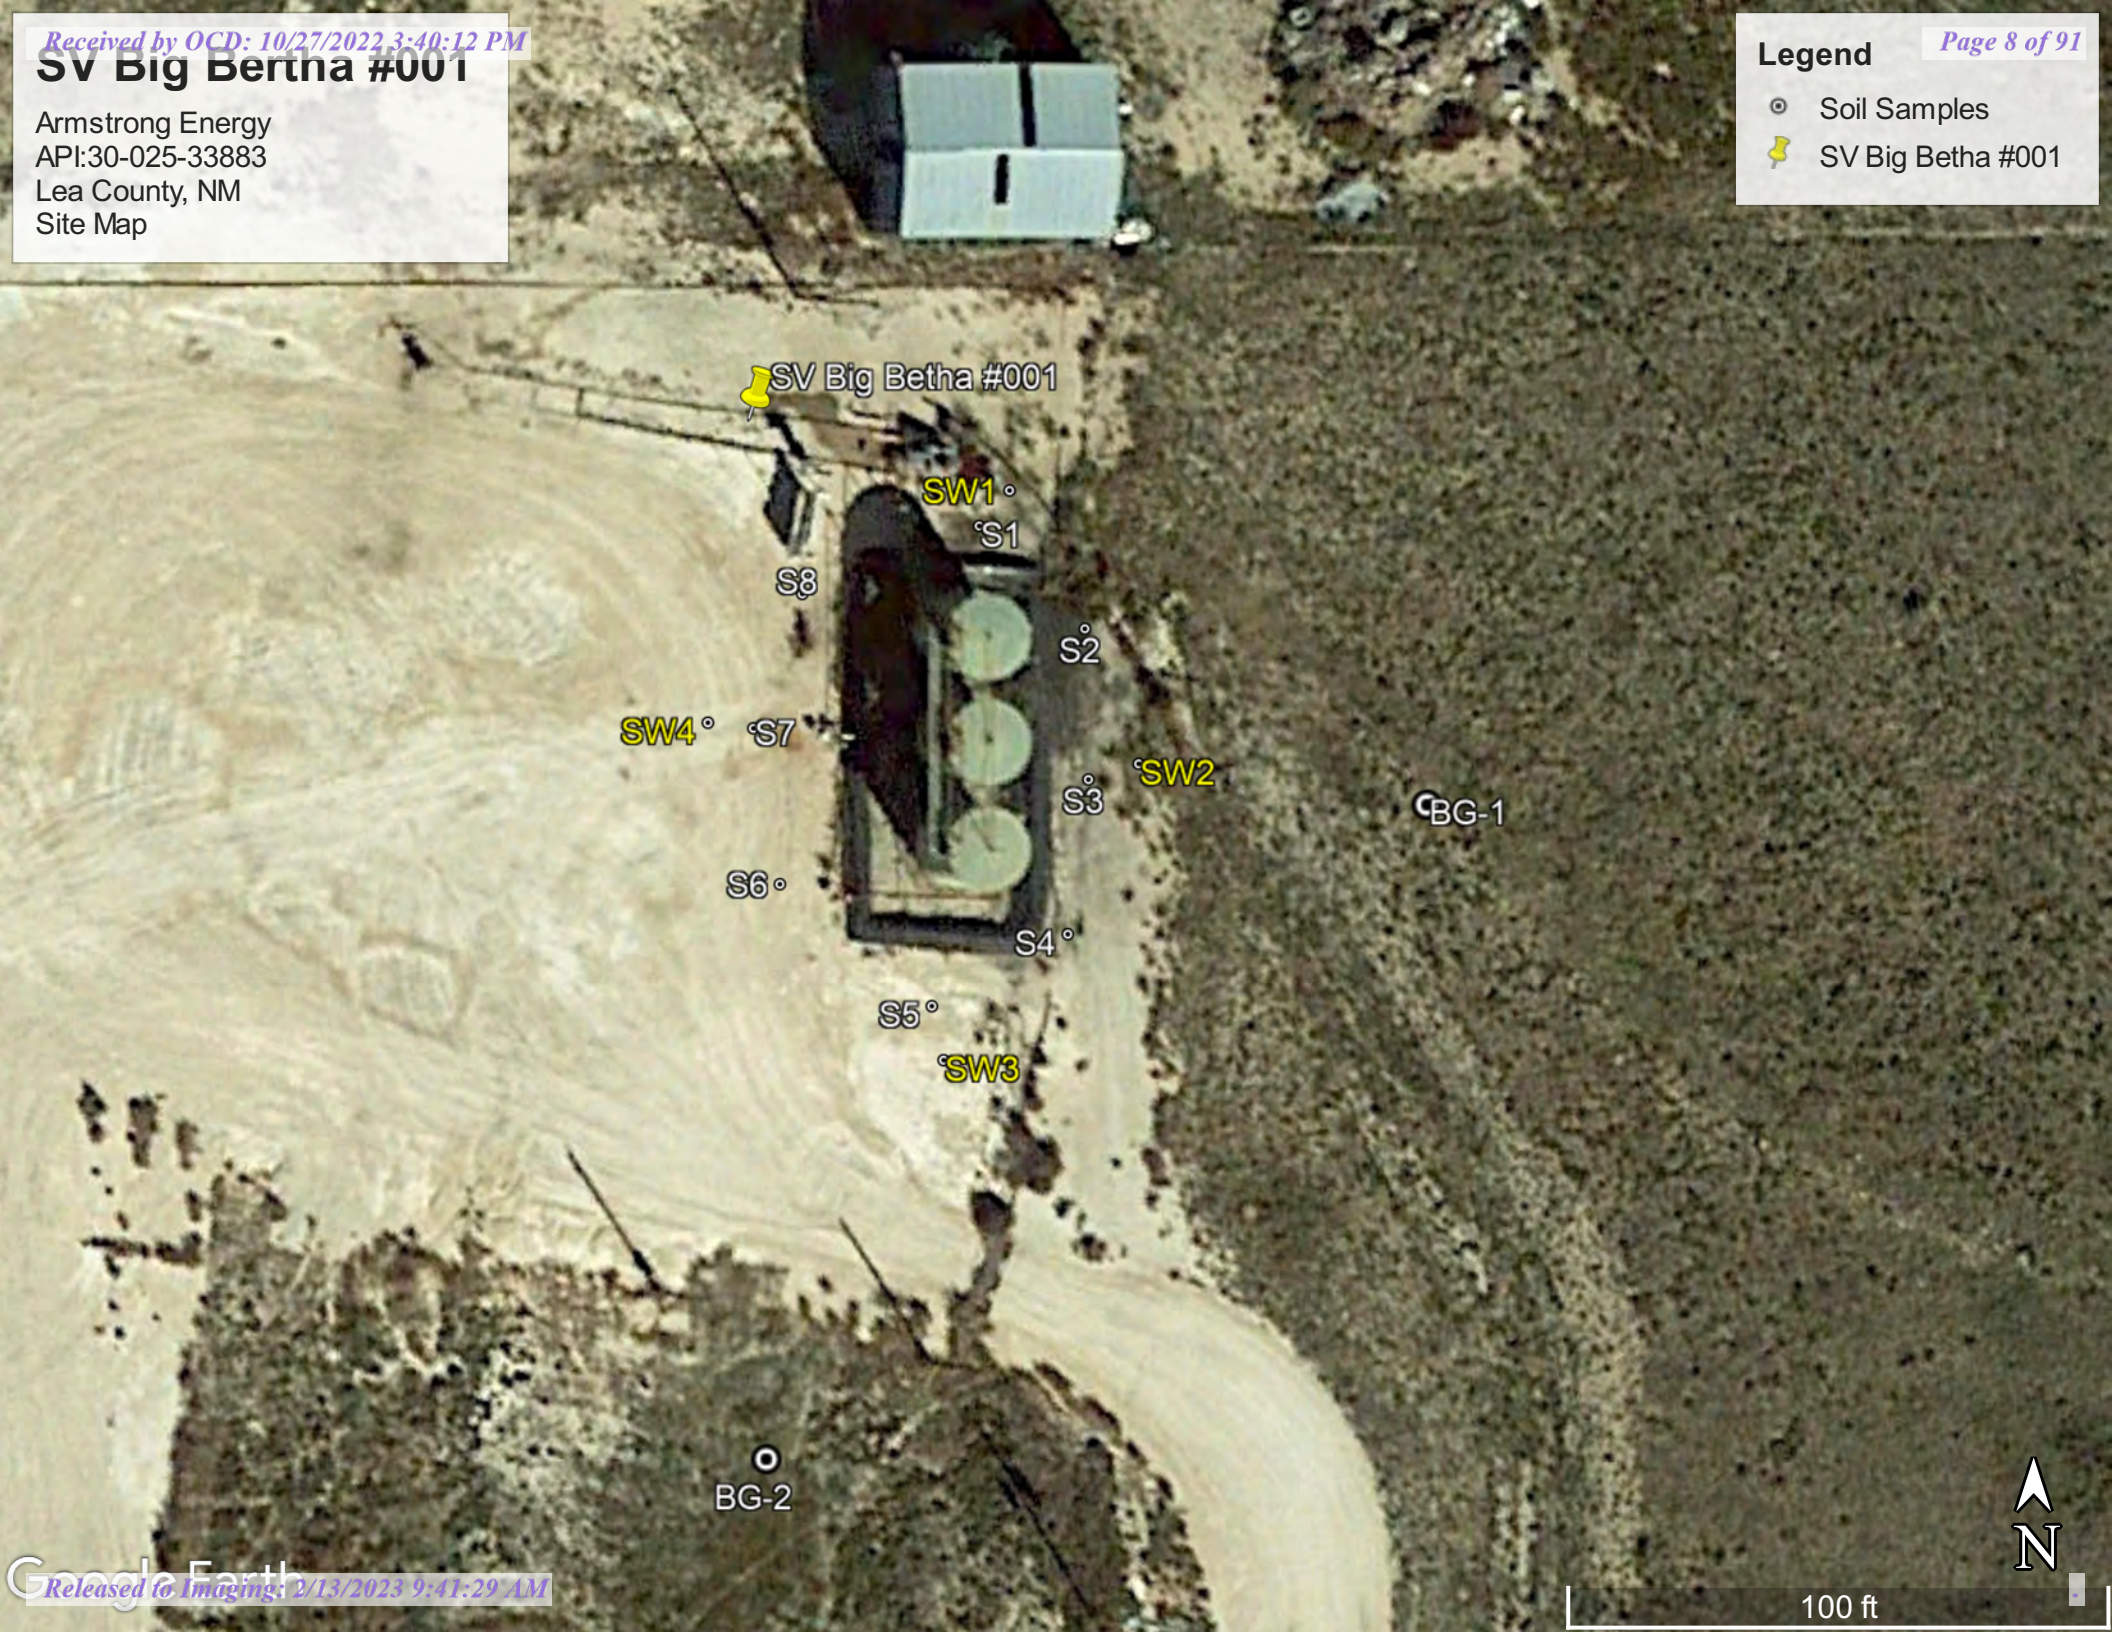
Armstrong Energy
API:30-025-33883
Lea County, NM
Site Map

On September 8th, 2022, Pima Environmental Services mobilized personnel to the site to conduct delineation activities. Pima sampled the area surrounding the tank battery containment. The following data table include the results of this sampling event.

- Soil Samples
- SV Big Bertha #001

On October 12th, 2022, Pima mobilized personnel and equipment to conduct remedial activities. We excavated the area overlapping soil samples (S-7) to a depth of two feet Bgs. All contaminated soil was removed and transported to a NMOCD approved landfill for disposal. Photographic documentation can be found in Appendix D.

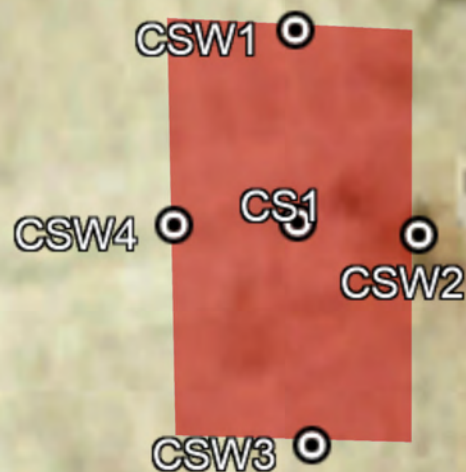
Armstrong Energy
API:30-025-33883
Lea County, NM
Confirmation Map

On October 14th, 2022, after submitting the 48-hour notification (Appendix C), Pima collected confirmation samples. The laboratory results of this sampling event can be found in the following data table. Clean material was brought in and used to backfill the affected area and returned to its previous contour.

- Confirmation Samples
- SV Big Betha #001

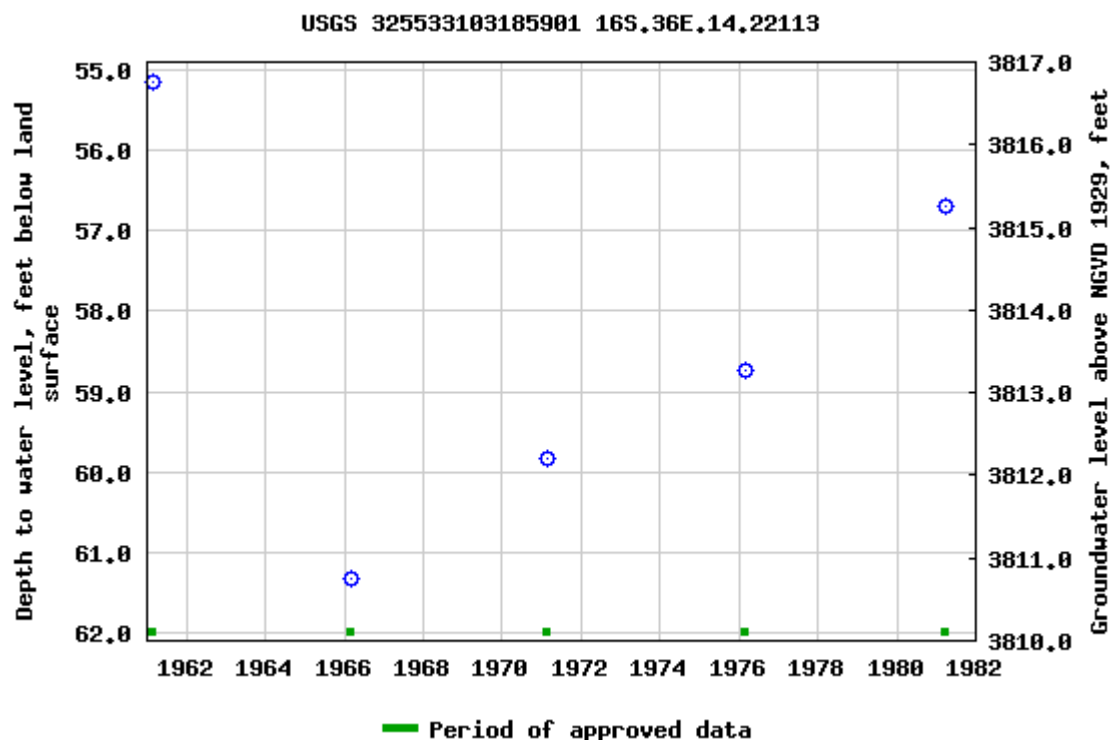
USGS 325533103185901 16S.36E.14.22113

The depth of the well is 84 feet below land surface.

This well is completed in the High Plains aquifer (N100HGHPLN) national aquifer.

This well is completed in the Ogallala Formation (121OGLL) local aquifer.

Breaks in the plot represent a gap of at least one year between field measurements.
