Re: Site Assessment, Remediation, and Closure Report
SV Chipshot #001
API No. 30-025-33466
GPS: Latitude 32.9354668 Longitude -103.3294525
UL "K", Sec. 11, T16S, R36E
Lea County, NM
NMOCD Ref. No. nGRL1004056899

Pima Environmental Services, LLC (Pima) has been contracted by Armstrong Energy Corporation to perform a spill assessment, remediation activities, and submit this closure report for a produced water release that occurred at the SV Chipshot #001. The initial C-141 was submitted on September 15th, 2022 (Appendix C). This incident was assigned Incident ID nGRL1004056899, by the New Mexico Oil Conservation Division (NMOCD).

10-4-22 Soil Sample Results

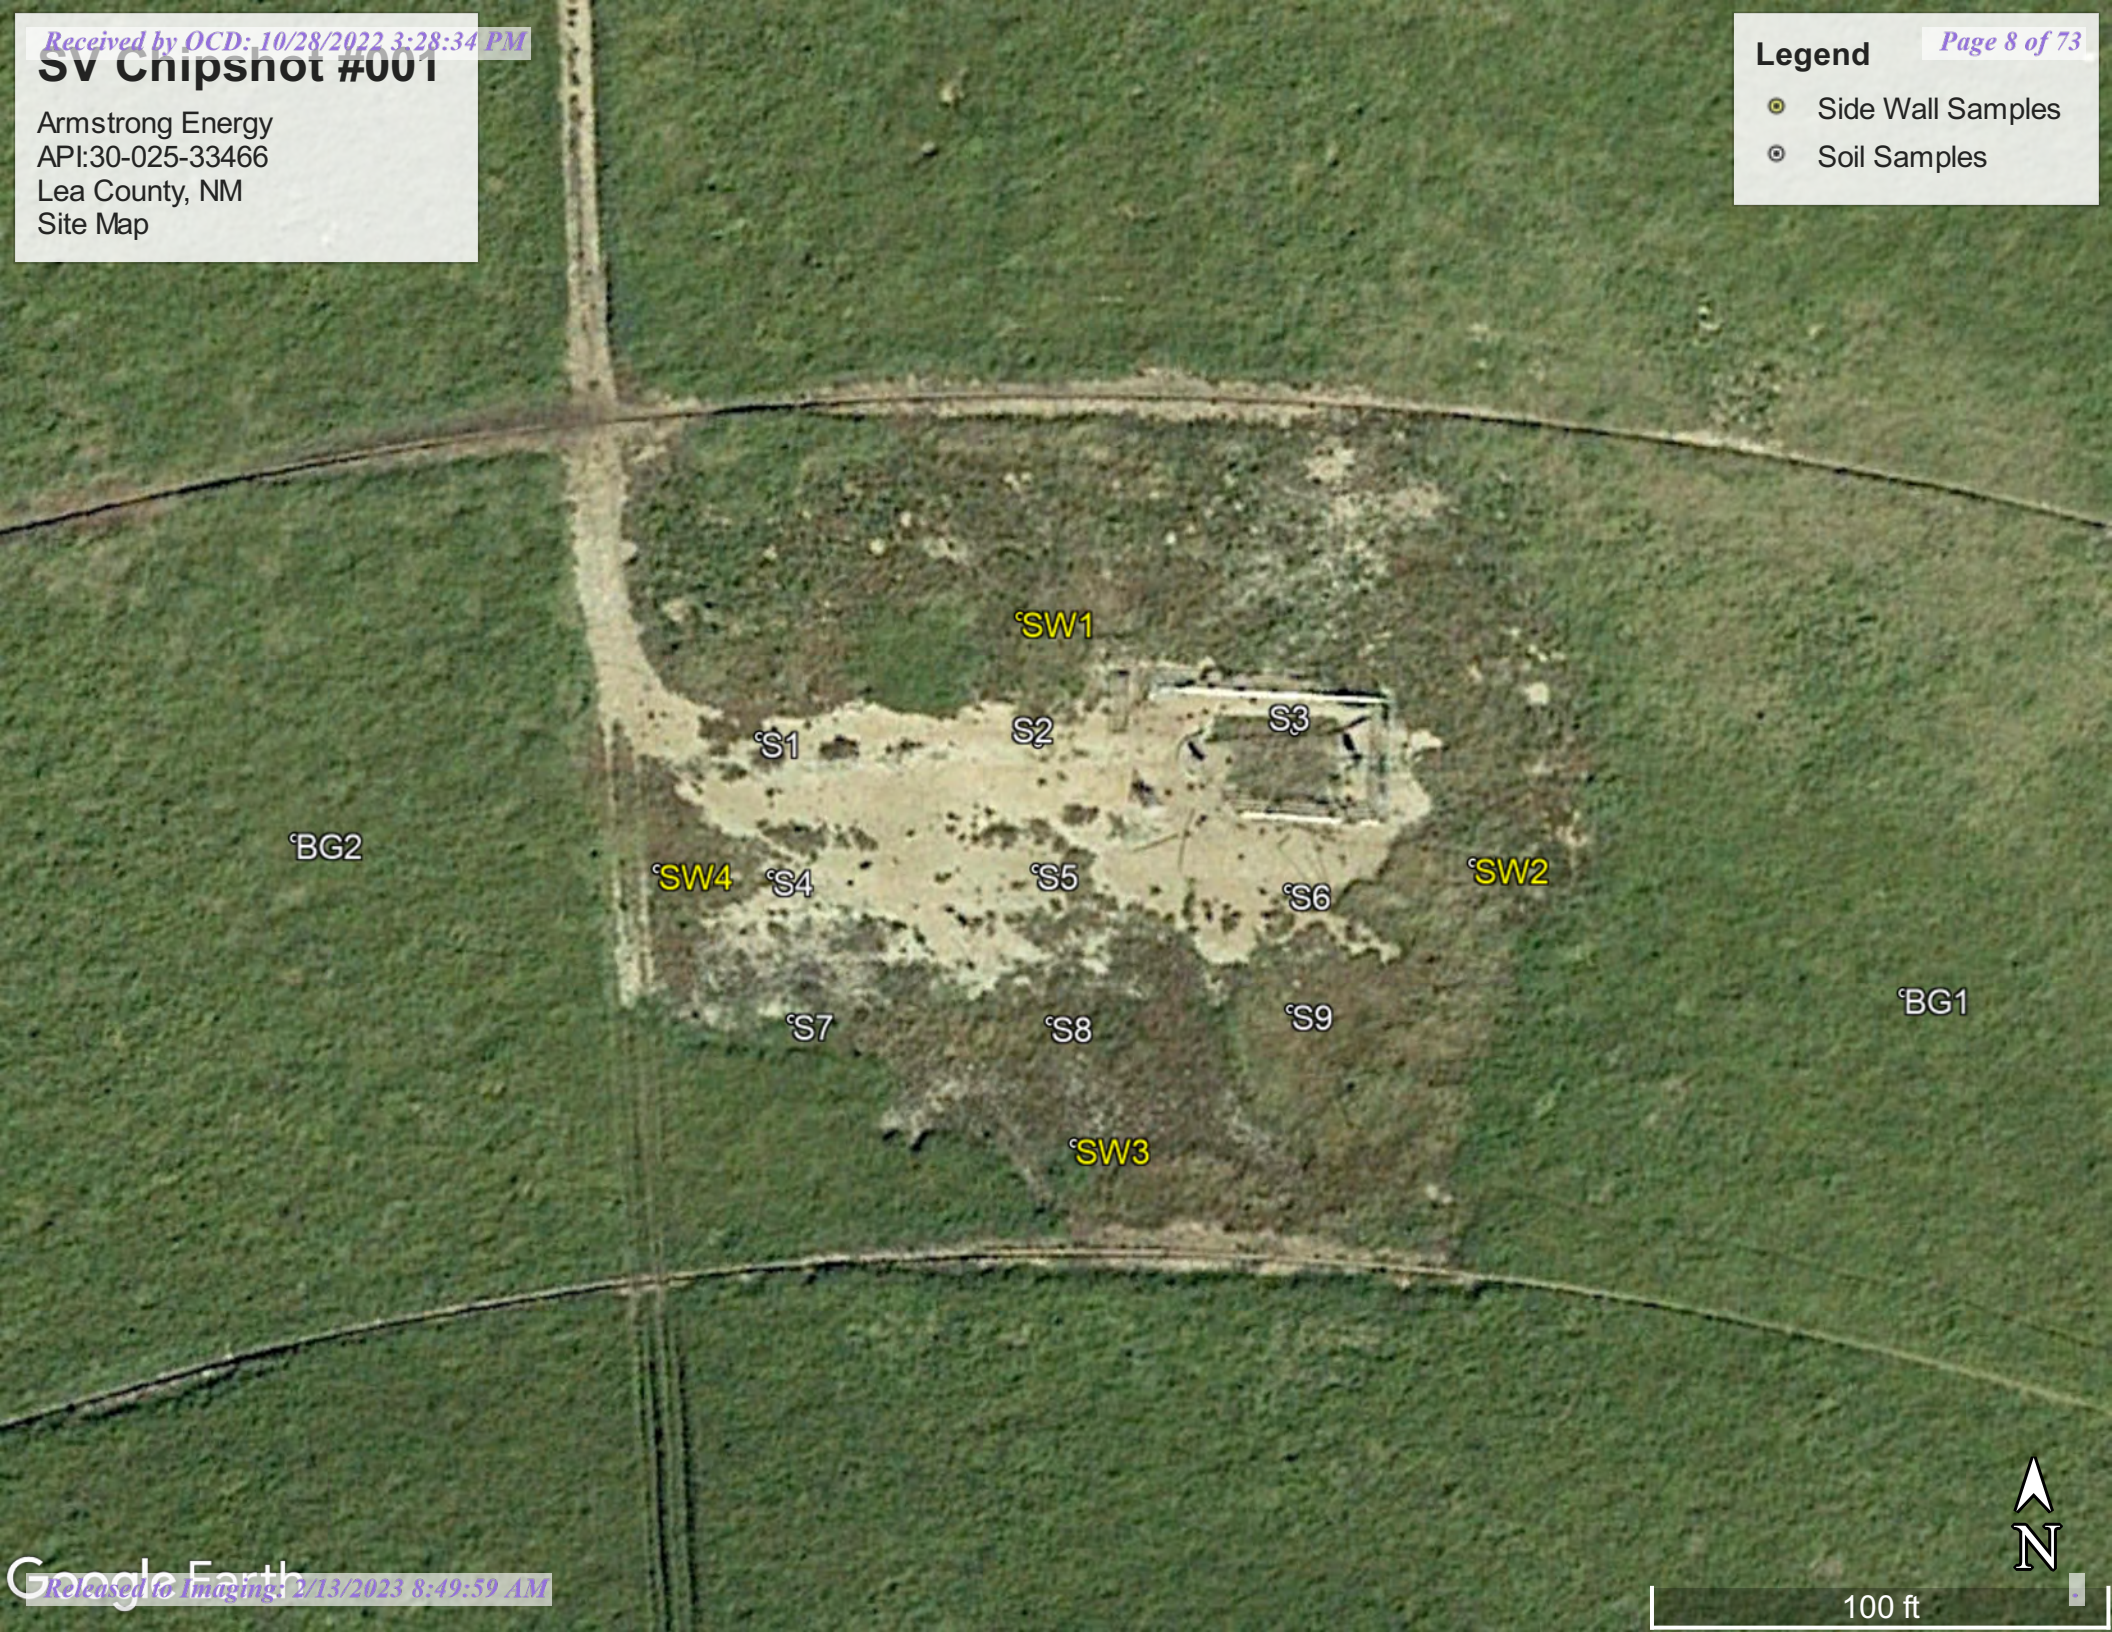
4-Site Map

On October 4th, 2022, Pima Environmental Services mobilized personnel to the site to conduct delineation activities. Pima sampled the area overlapping the reclaimed engineered pad. Laboratory results of this sampling event can be found in the following data table.

Armstrong Energy
API:30-025-33466
Lea County, NM
Site Map

- Side Wall Samples
- Soil Samples

Due to analytical levels falling below NMOCD closure criteria, no further immediate action is required.

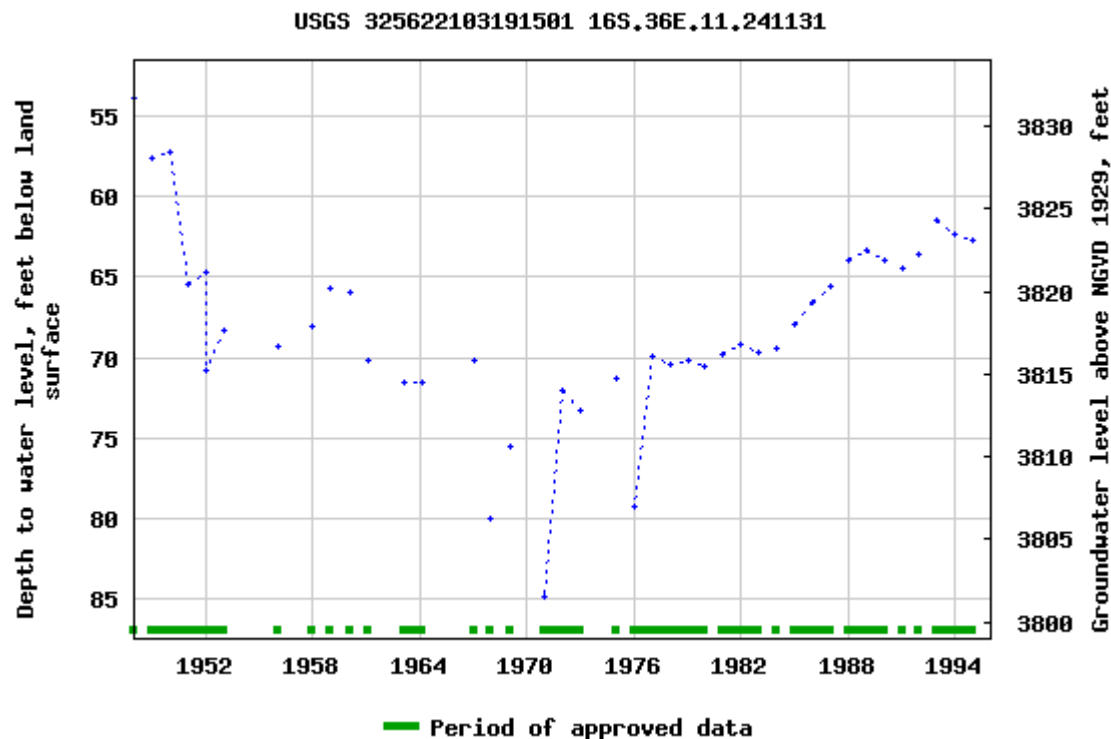
USGS 325622103191501 16S.36E.11.241131

The depth of the well is 100 feet below land surface.

This well is completed in the High Plains aquifer (N100HGHPLN) national aquifer.

This well is completed in the Ogallala Formation (121OGLL) local aquifer.

Breaks in the plot represent a gap of at least one year between field measurements.

According to the New Mexico Office of the State Engineer, depth to the nearest groundwater in this area is 64 feet below grade surface (BGS). According to the United States Geological Survey (USGS), the nearest groundwater is 62.7 feet BGS. The closest waterway is a manmade pond located approximately 0.92 miles to the east of this location. See Appendix A for referenced water surveys.
