Pima Environmental Services, LLC
5614 N. Lovington Hwy.
Hobbs, NM 88240
575-964-7740

October 19th, 2022

Re: Site Assessment, Remediation, and Closure Report
Superior Federal #5
API No. 30-025-21370
GPS: Latitude 32.6268463 Longitude -103.5211563
UL "M", Sec. 25, T19S, R34E
Lea County, NM
NMOCD Ref. No. NPRS0521739386

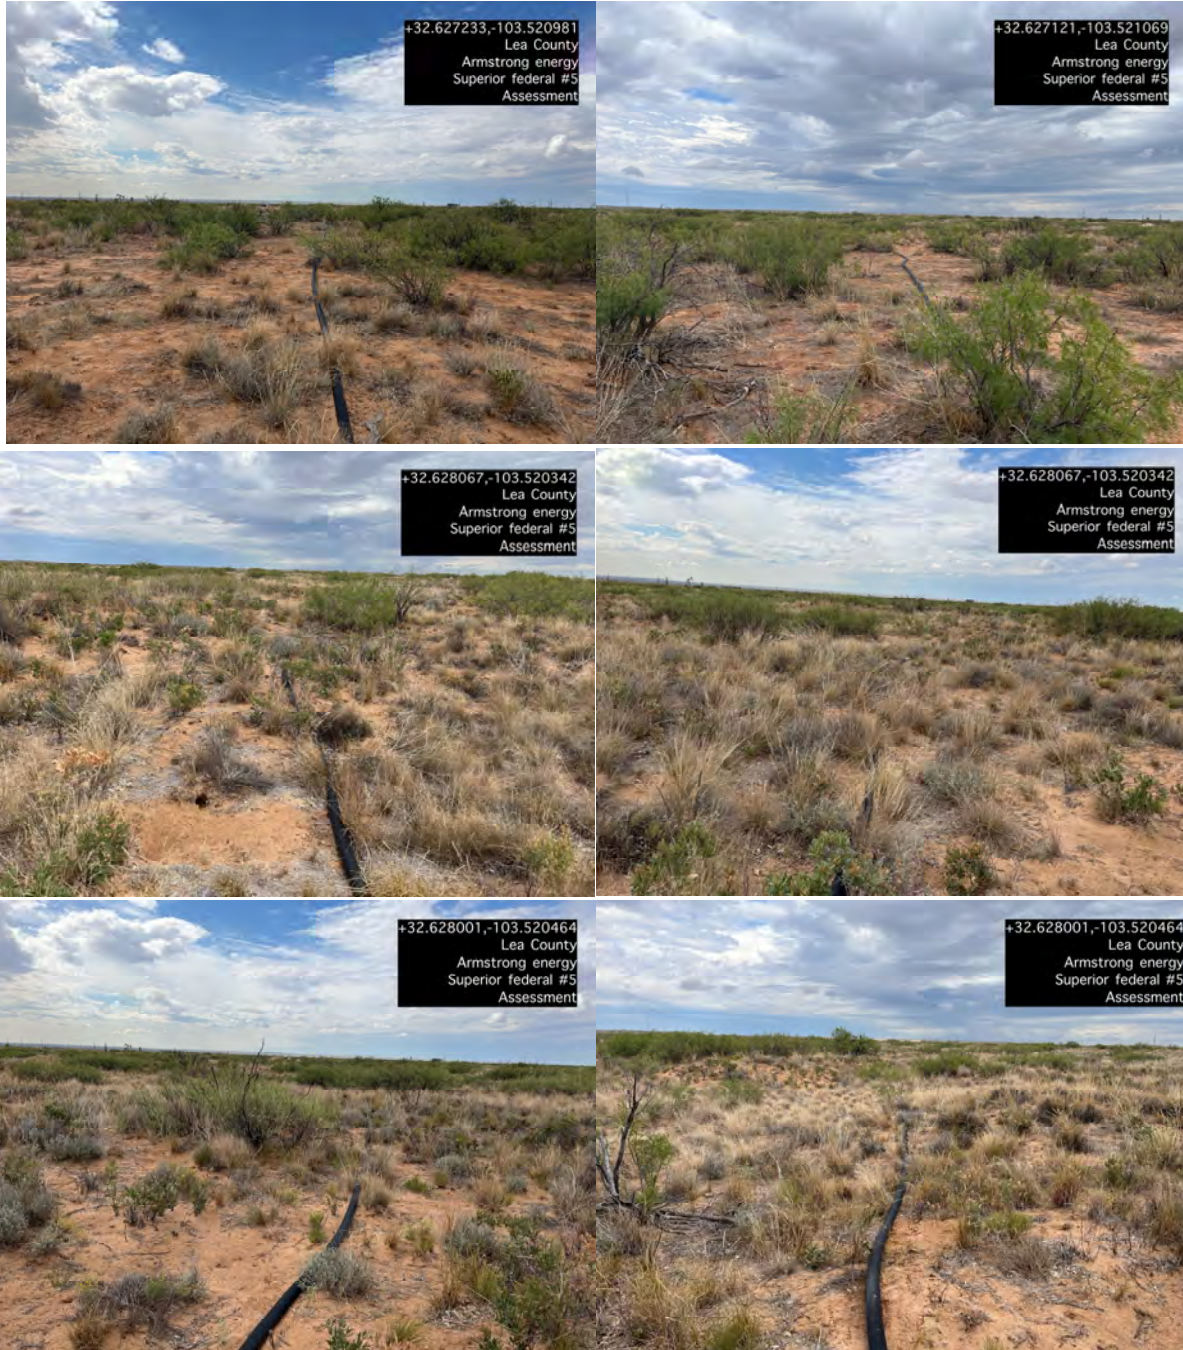
**SITE PHOTOGRAPHS
PIMA ENVIRONMENTAL
Superior Federal #005**

NPRS0521739386: On July 18th, 2005, a split developed in a four-inch poly flowline, spraying the surrounding area with a mixture of produced water and oil. Armstrong personnel replaced the flowline from the Superior Federal #5 to the tie-in point at the Superior Federal #4. An area approximately 50 feet by 25 feet was affected.

Equipment failure, flow line release. Split in black poly flowline sprayed the surrounding area with produced water and oil. Shut in and inspected flowline. Flowline had a groove along the axis of the line that provided a weak point for the line to fail.

Due to analytical levels falling below NMOCD closure criteria, no further immediate action is required.
