**Re:** Closure Report

GOVERNMENT AB #009 Colgate Production, LLC. Site Location: Unit A-10-20S-28E (Lat 32.5946274°, Long -104.1572189°) Eddy County, New Mexico Incident ID: NAB1800954389

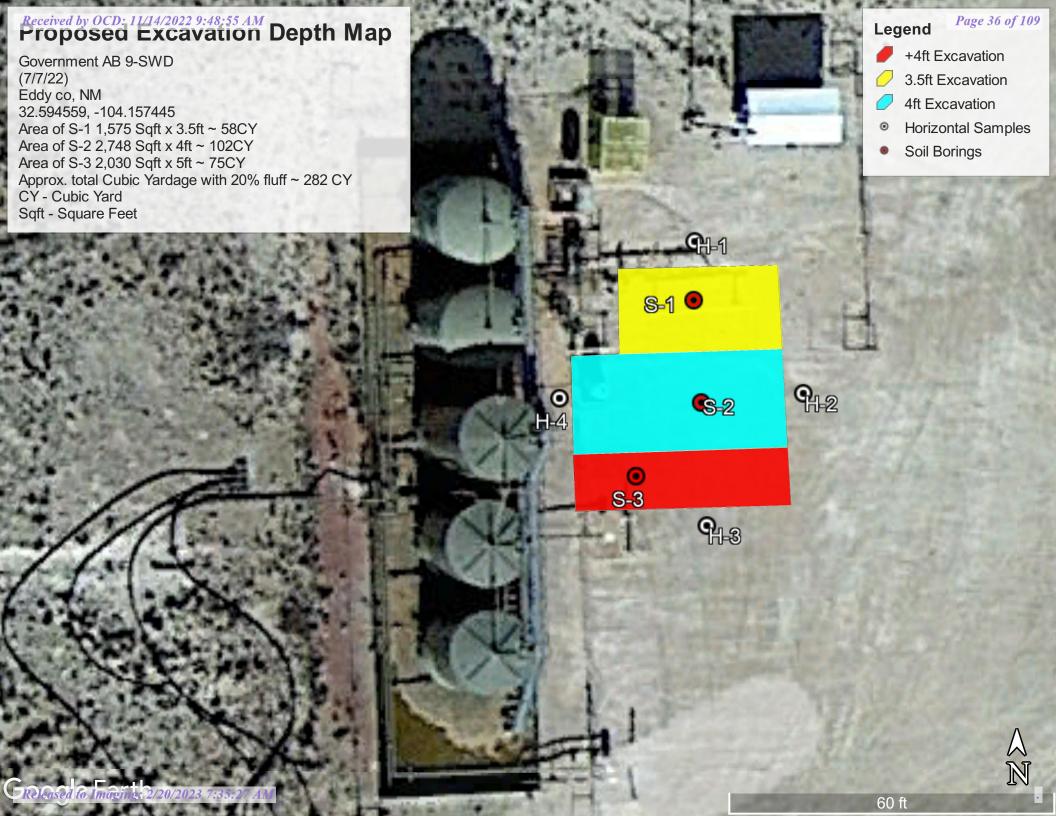
Based on the initial C-141 obtained from the New Mexico Oil Conservation Division (NMOCD), the release was discovered on January 2, 2018. The release was a result of a check valve failing which resulted in the release of approximately ten barrels (bbls) of produced water of which none were recovered. Upon discovery, the well was shut-in and the area was secured. The release is shown on Figure 3. The initial C-141 form is attached.

On June 22, 2022, NTGE conducted site assessment activities to assess the horizontal and vertical extent of impacts at the Site. A total of three sample points (S-1 through S-3) were installed within the release area to characterize and vertically delineate the potential impacts. Additionally, four horizontal delineation sample points (H-1 through H-4) were installed to define the horizontal extent of potential impacts. Soil samples were collected in 0.5 to 1 ft depth intervals and collected from soil borings advanced to depths ranging from 0-3.5 ft bgs with a geotechnical hand auger. The hand auger was decontaminated with Alconox and deionized water between soil borings to prevent cross-contamination. Sample locations are shown on Figure 3.

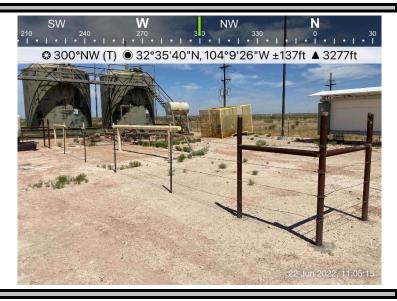
**Description:** Area of concern.

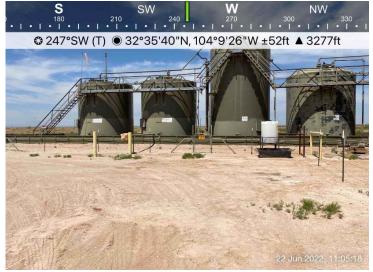
# Photograph No. 2

Area of concern.

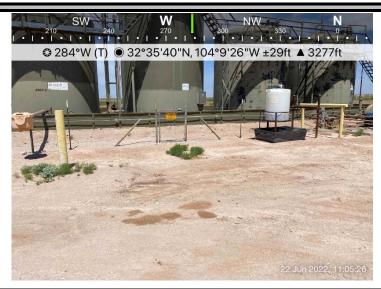
# Photograph No. 3

Area of concern.

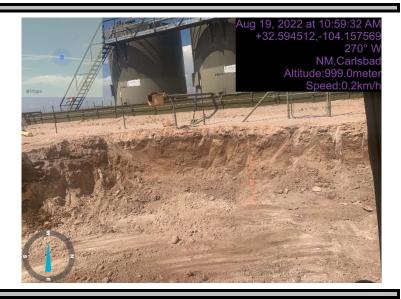
View of excavation.

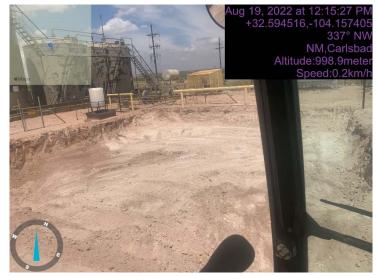
# Photograph No. 5

View of excavation.

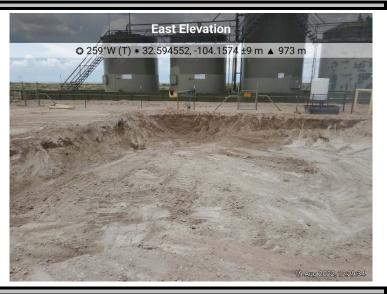
# Photograph No. 6

View of excavation.

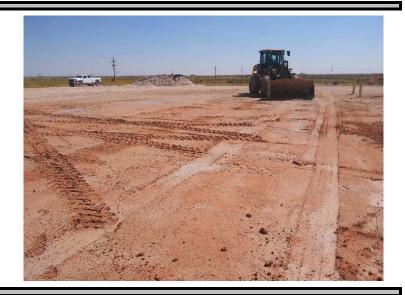
View of backfilled area.

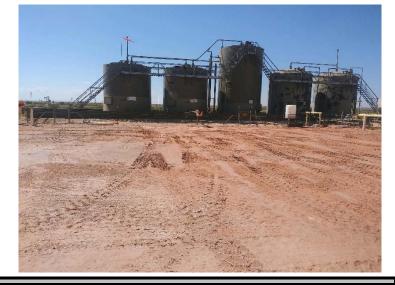
Photograph No. 8

View of backfilled area.

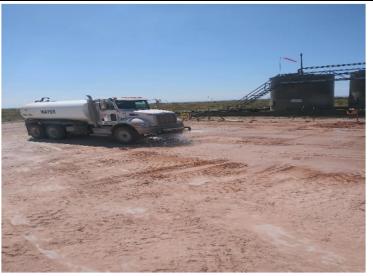
Photograph No. 9

View of backfilled area.
