**Re: Site Assessment, Remediation, and Closure Report
 Hawk 27 Fed #1
 API No. 30-015-29489
 GPS: Latitude 32.6297607 Longitude -104.4702301
 UL "J", Sec. 27, T19S, R25E
 Eddy County, NM
 NMOCD Ref. No. NAPP2105646145**

Paragon Environmental, LLC (Paragon) has been contracted by Spur Energy Partners (Spur) to perform a spill assessment and remediation activities for the Release Site known as the Hawk 27 Fed 1 (Hawk). Details of the release are summarized below:

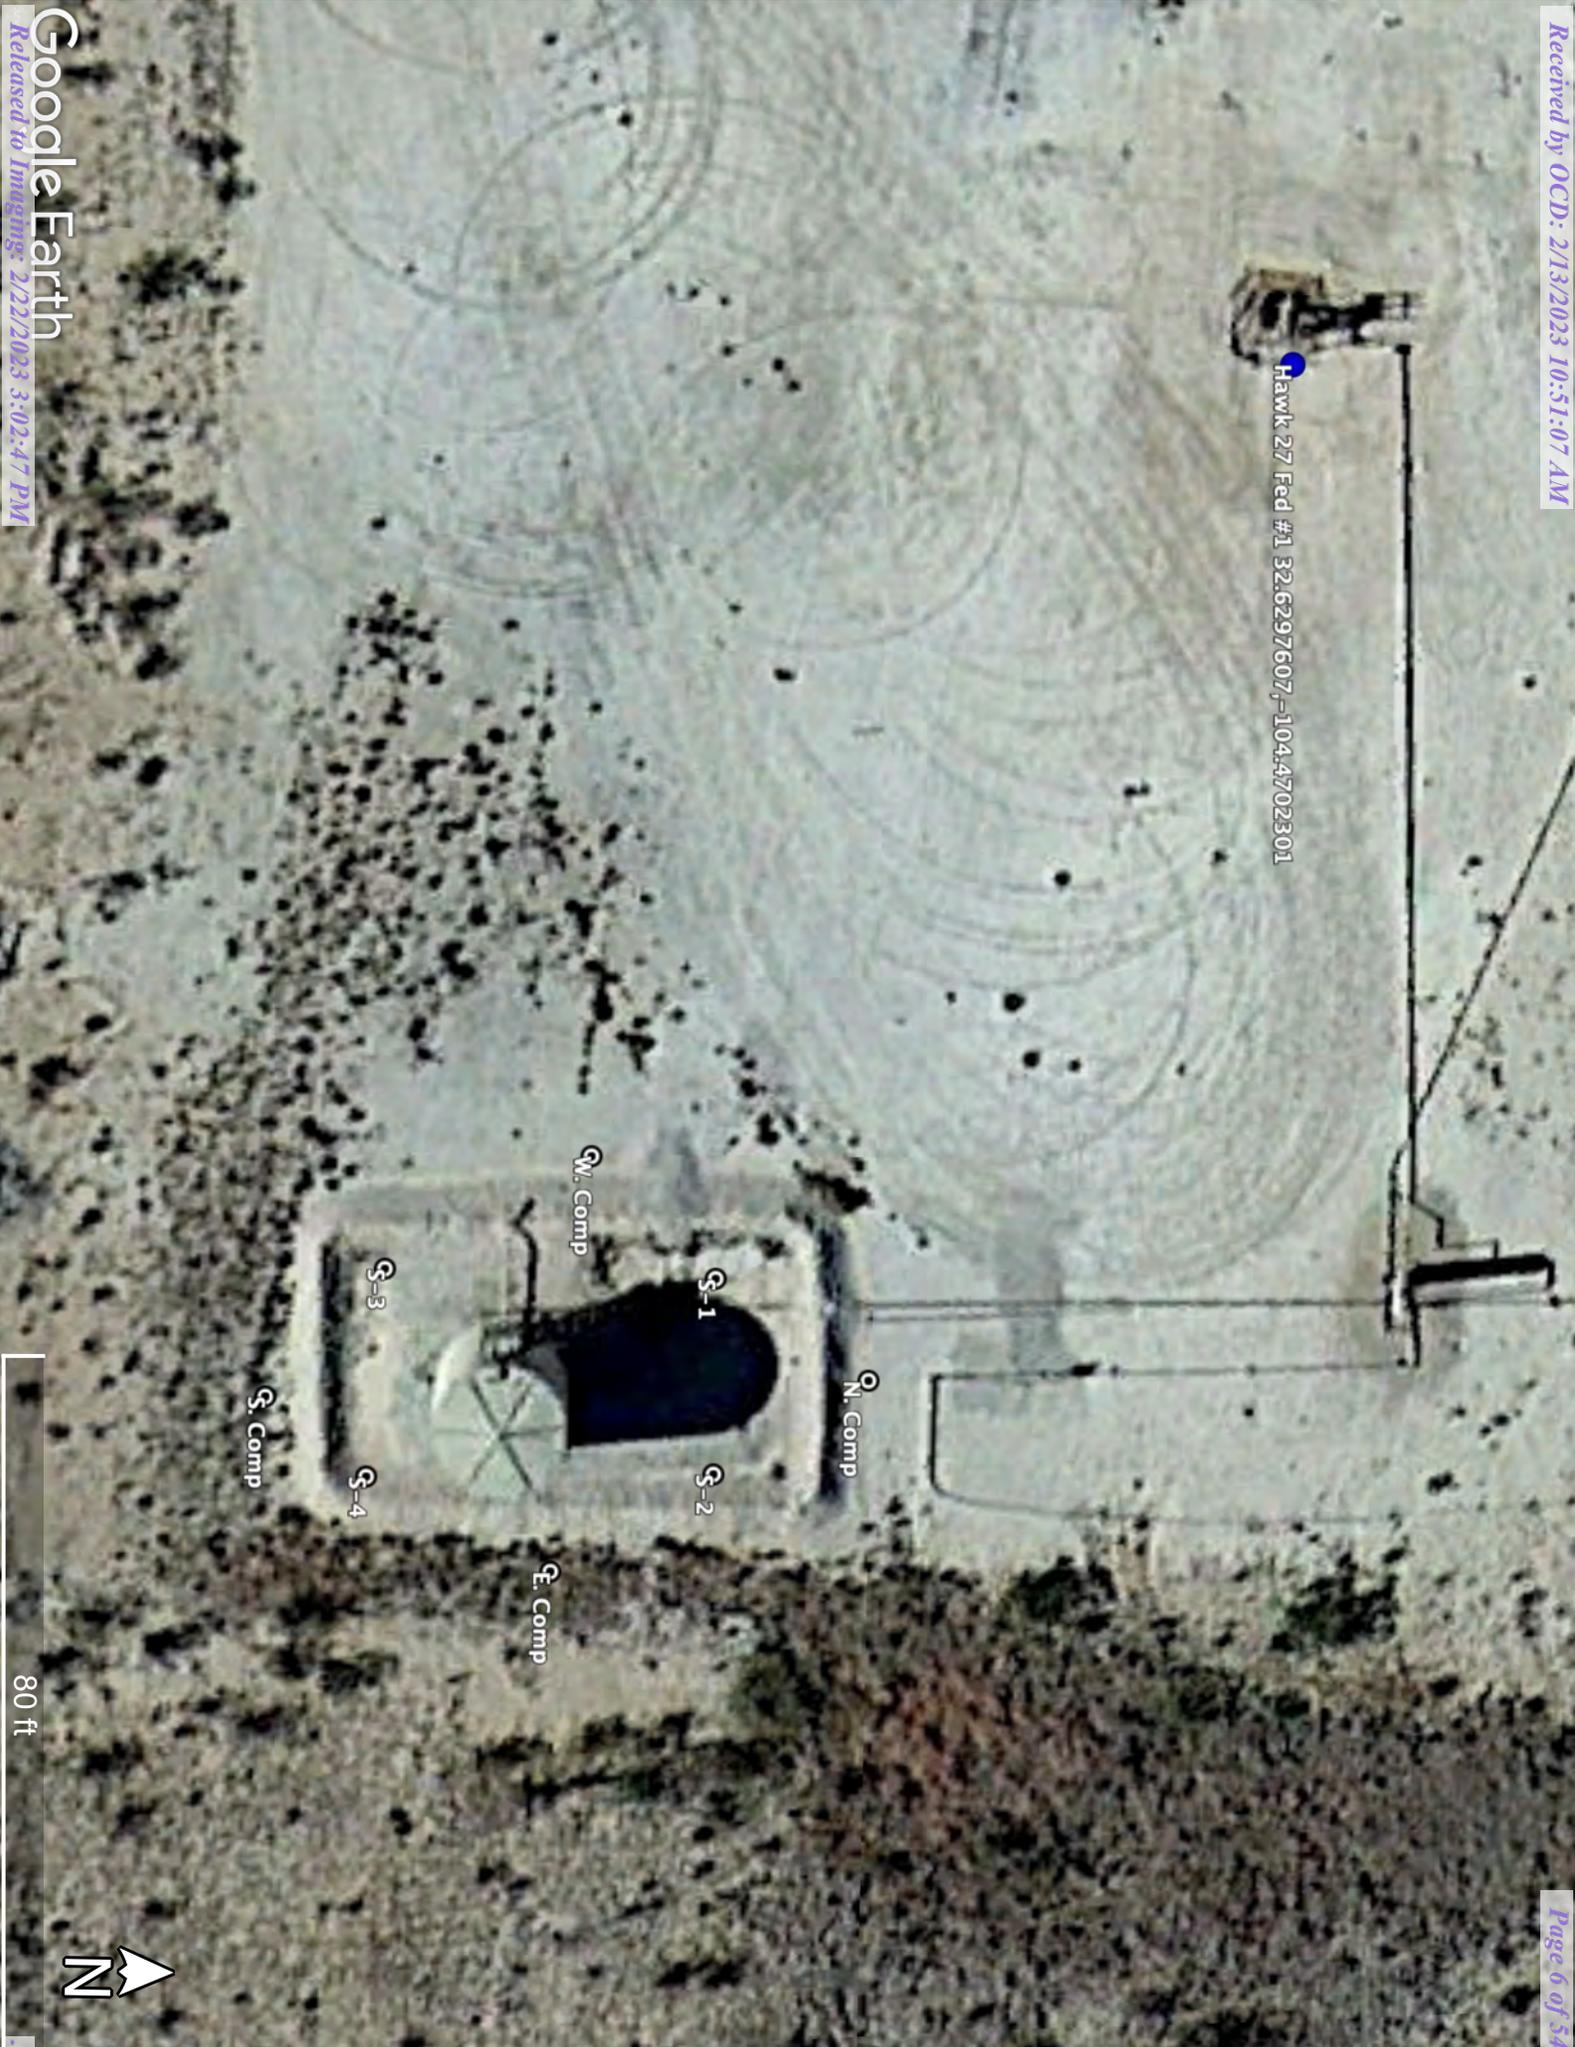
Hawk 27 Fed #1 32.6297607,-104.4702301

All Laboratory analytical reports are provided in Appendix E. A Site Map is provided in Figure #1.

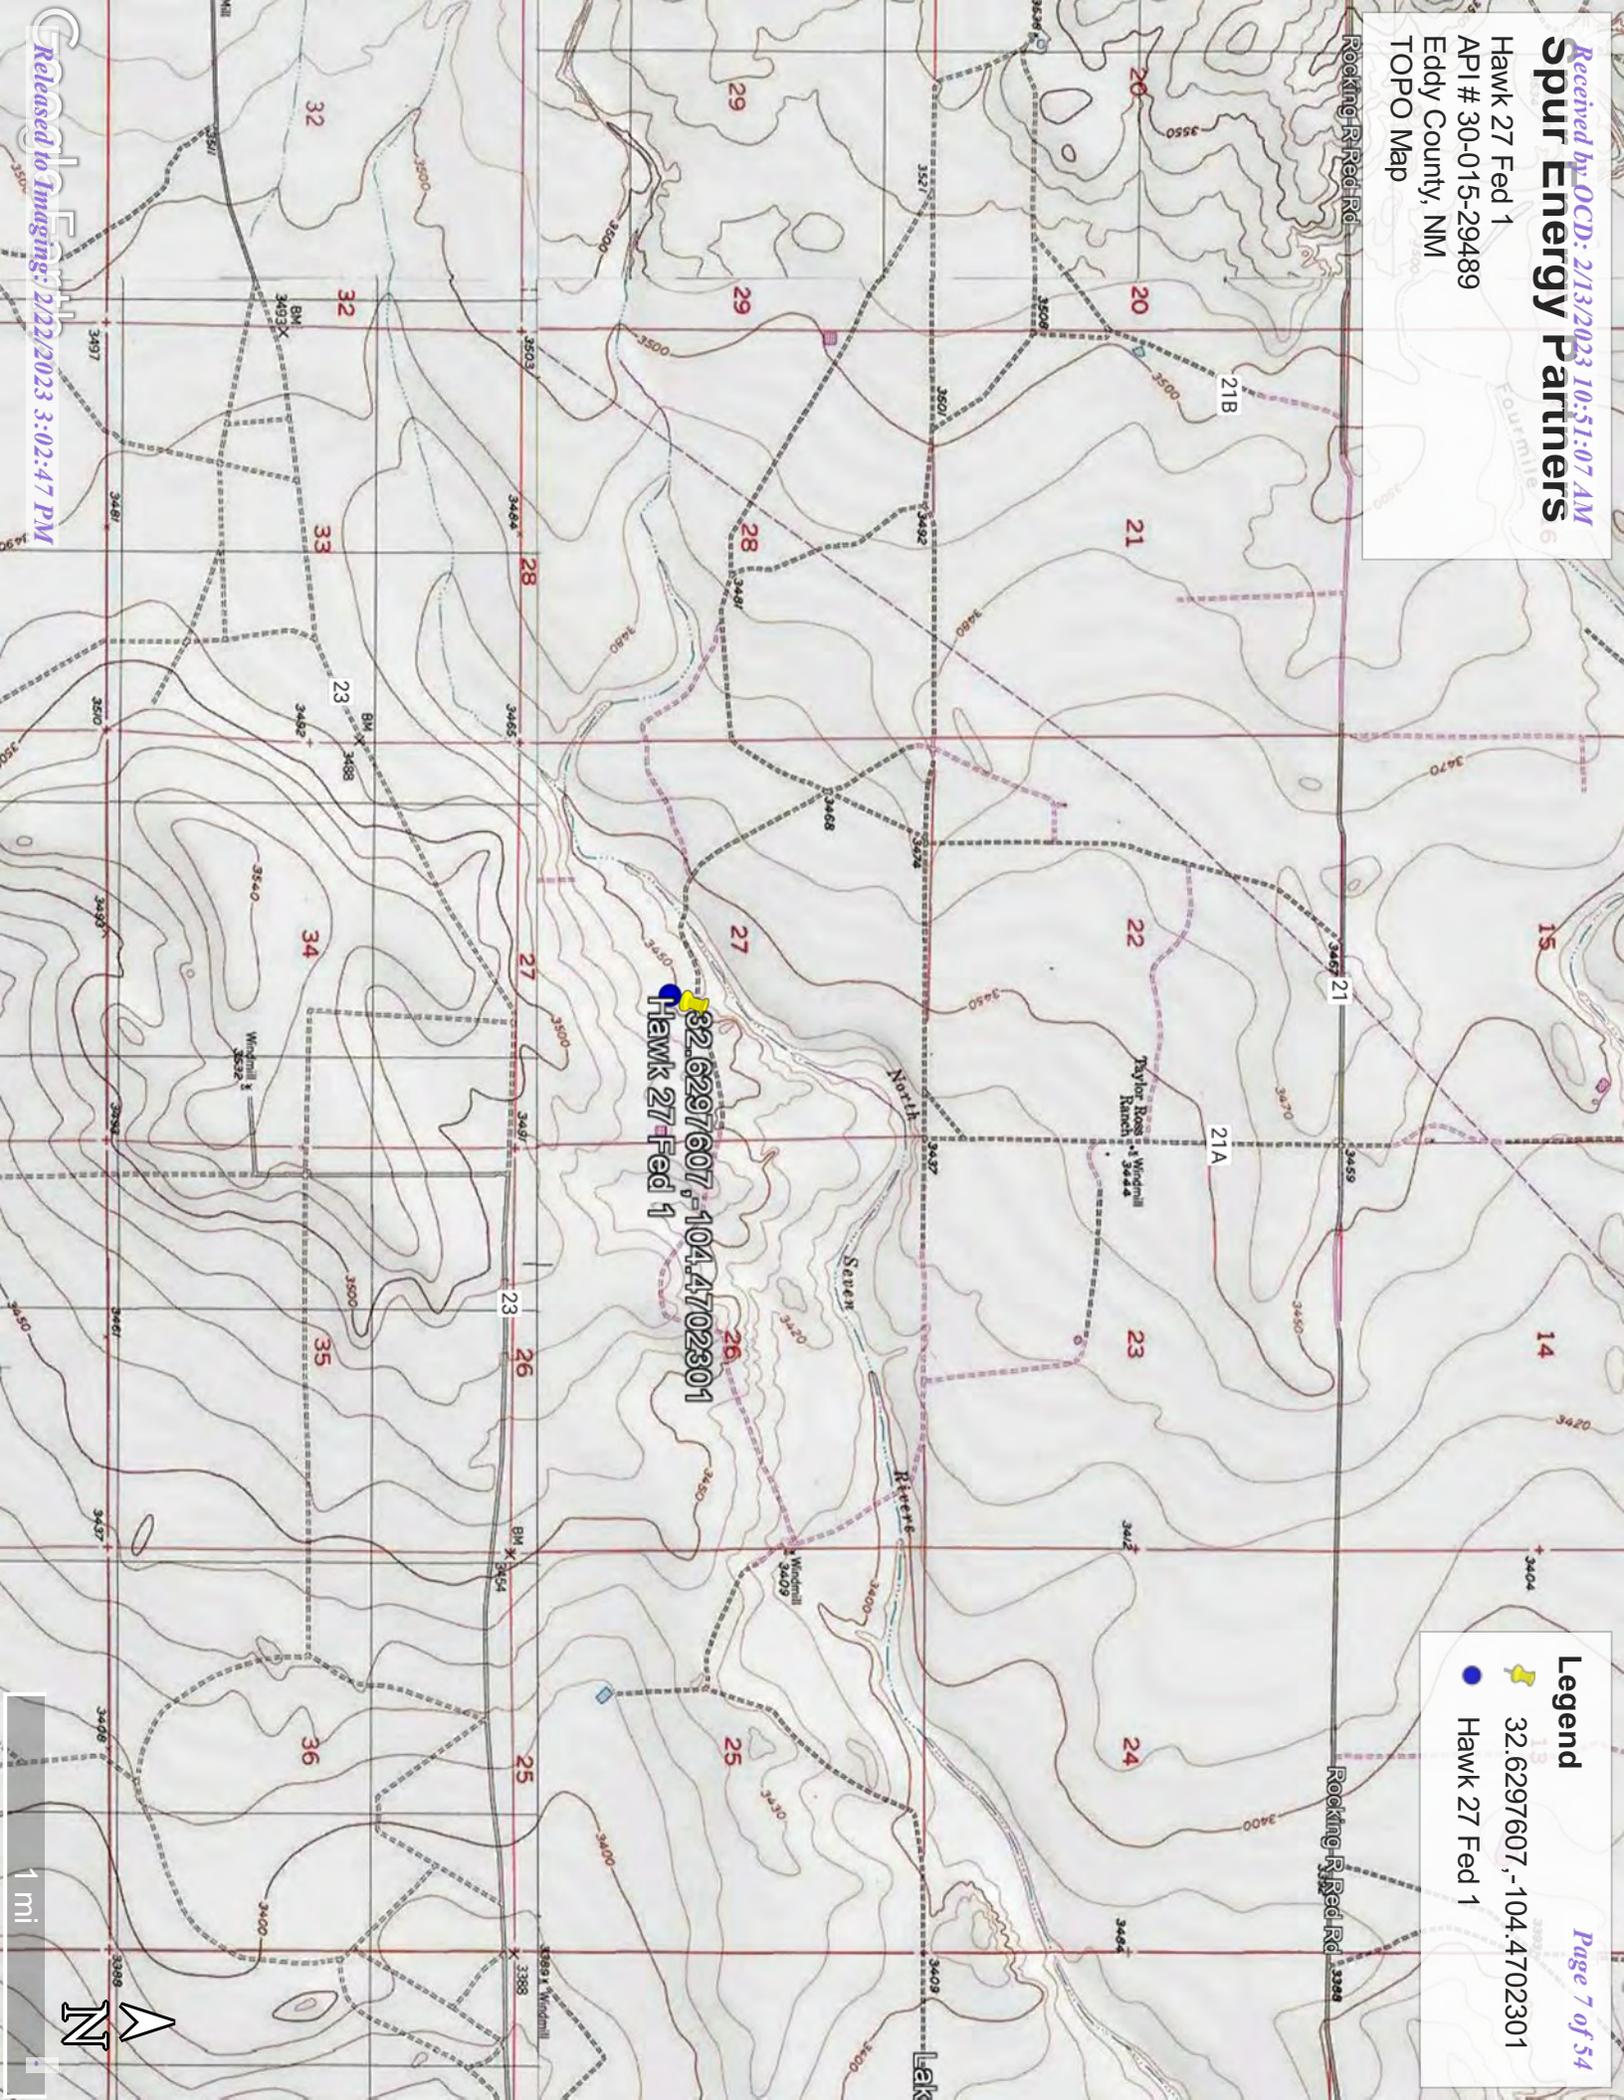
Hawk 27 Fed 1
API # 30-015-29489
Eddy County, NM
TOPO Map

Topographical and Aerial Maps are provided in Figures #3 and #5. A copy of the Initial Release Notification and Corrective Action (NMOCD Form C-141) can be found in Appendix C.

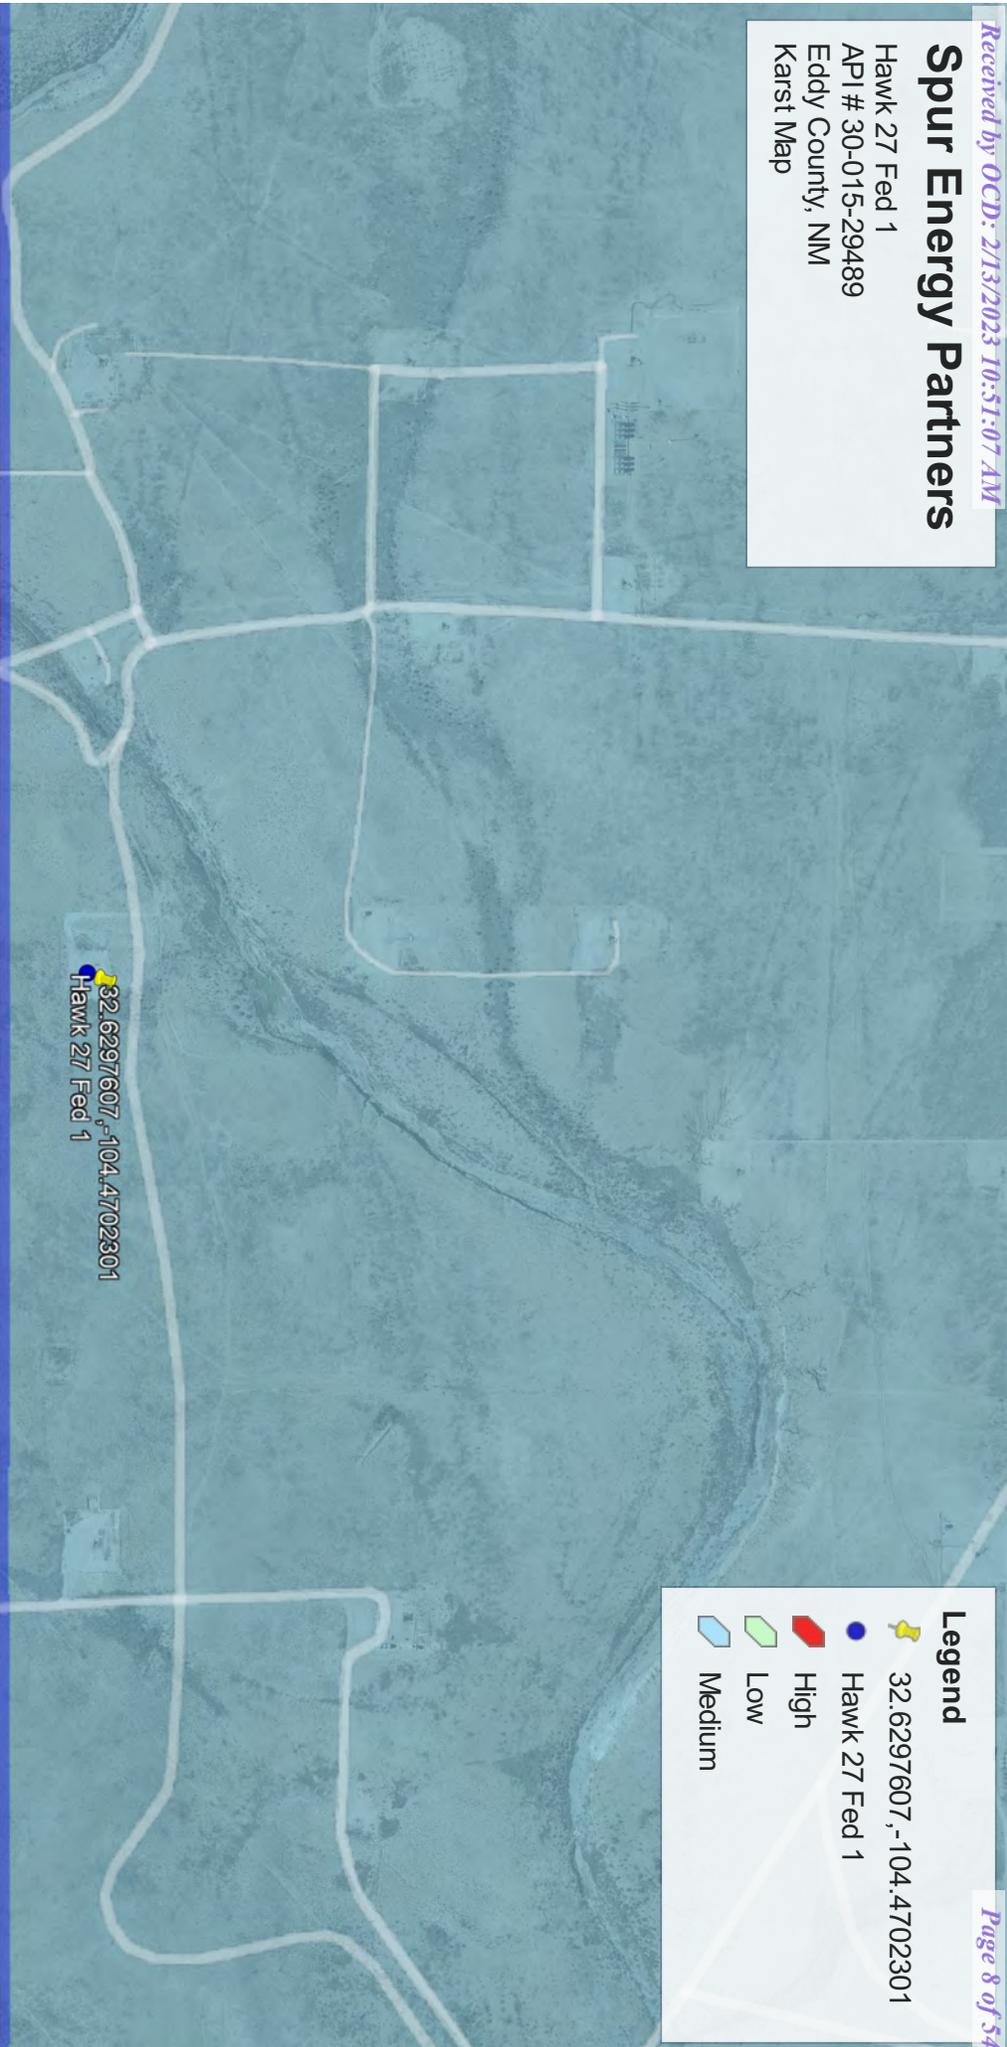
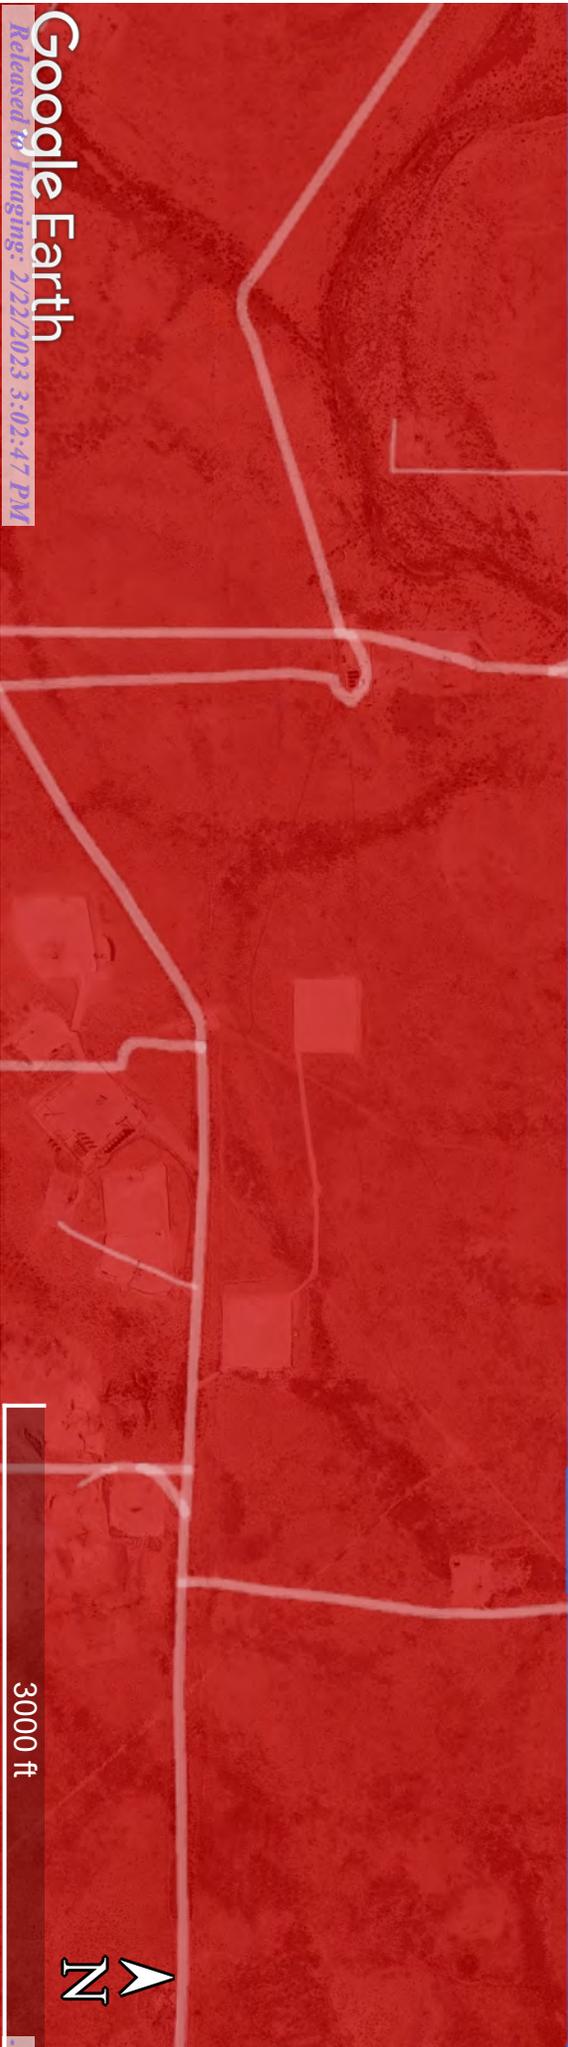
Hawk 27 Fed 1
API # 30-015-29489
Eddy County, NM
Karst Map

Per the New Mexico Bureau of Geology and Mineral Resources, the geology is in the Quaternary Formation- and is made up of Piedmont alluvial deposits (Holocene to lower Pleistocene)—Includes deposits of higher gradient tributaries bordering major stream valleys, alluvial veneers of the piedmont slope, and alluvial fans. May locally include uppermost Pliocene deposits (QP). The soil in this area is made up of Reagan-Upton Association, with 0 to 9 percent slopes, according to the United States Department of Agriculture Natural Resources Conservation Service. The drainage courses in this area are well-drained. There is NOT a high potential for karst geology to be present around the Hawk. (Figure #3).

The Soil Survey and FEMA Flood Map are provided in Appendix B. A Karst Map is provided in Figure #4.

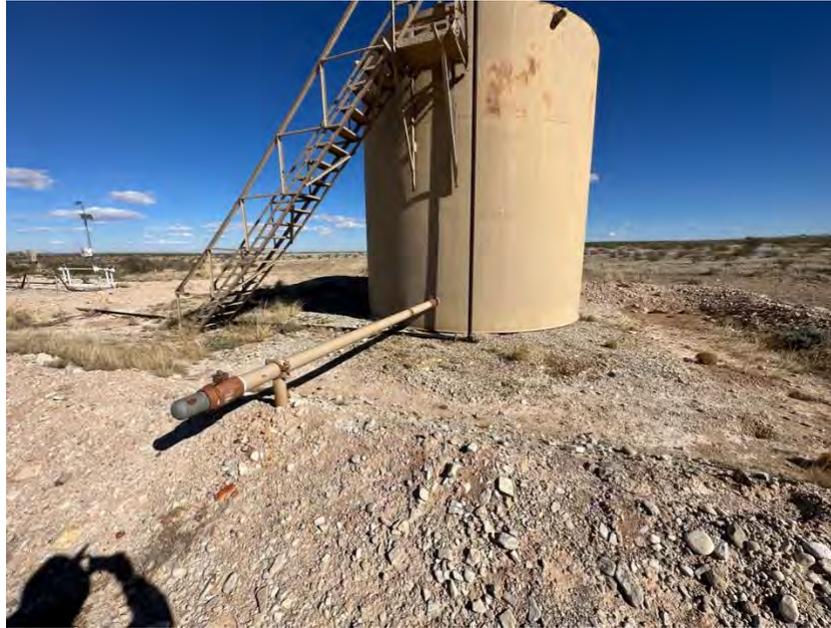
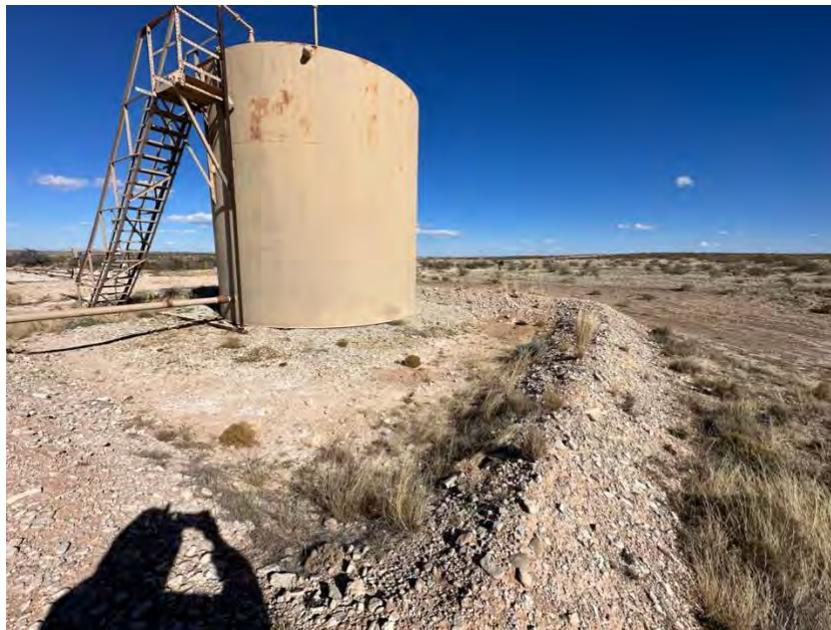
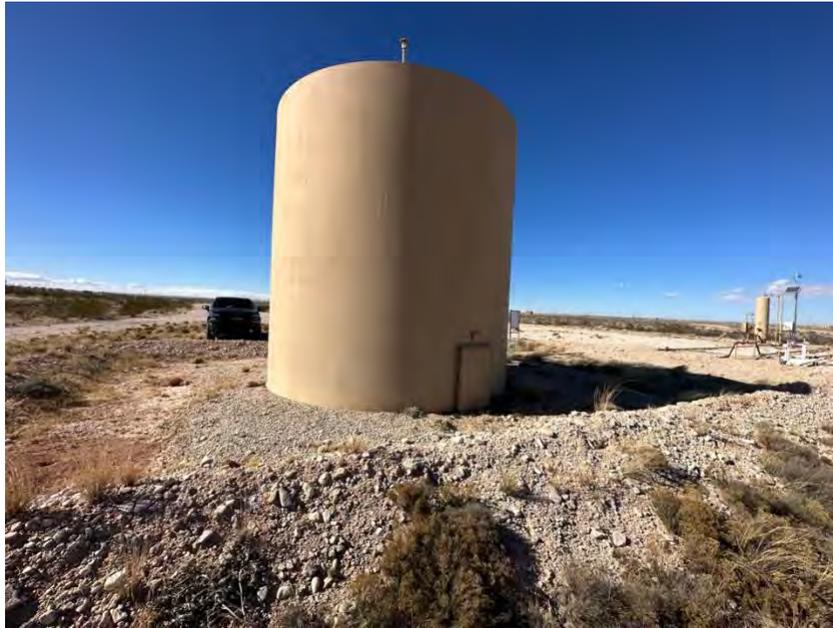
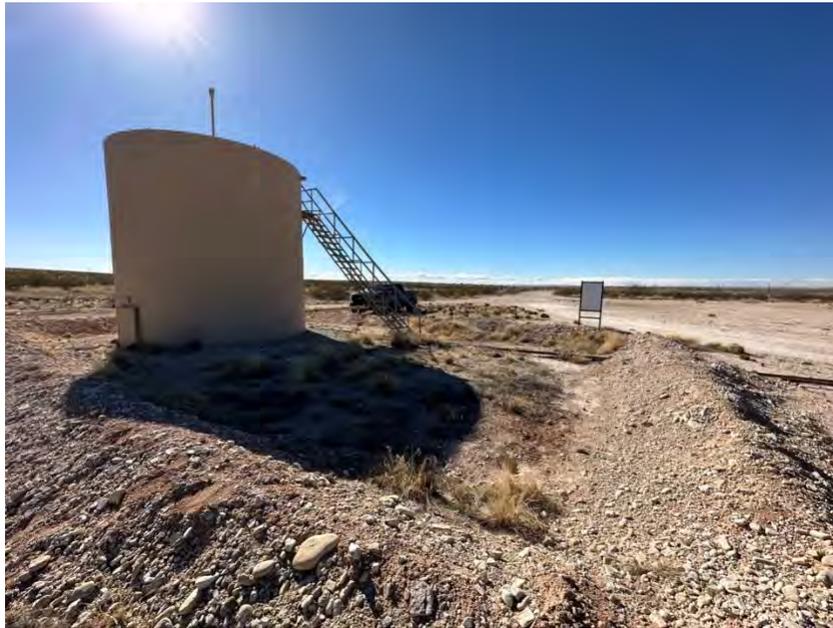
Photographic Documentation

Based on the lab results we received from Cardinal, it is our professional opinion that another company had already conducted remedial activities without submitting the closure report required. Due to the fact that the lab results were clean and under closure criteria, there was no further remediation required.
