RE: Liner Inspection and Closure Report
Fighting Okra 18 CTB 4
API No. N/A
GPS: Latitude 32.047988 Longitude -103.509655
UL- C, Section 18, Township 26S, Range 34E,
Lea County, NM
NMOCD Reference No. NAPP2104851838

Devon Energy Production Company (Devon) has contracted Pima Environmental Services, LLC (Pima) to perform a liner inspection and prepare this closure report for a produced water release that happened on the Fighting Okra 18 CTB 4 (Fighting Okra). An initial C-141 was submitted on February 17, 2021, and can be found in Appendix B. This incident was assigned Incident ID NAPP2104851838, by the New Mexico Oil Conservation Division (NMOCD).

**SITE PHOTOGRAPHS
DEVON ENERGY
FIGHTING OKRA 18 CTB 4**

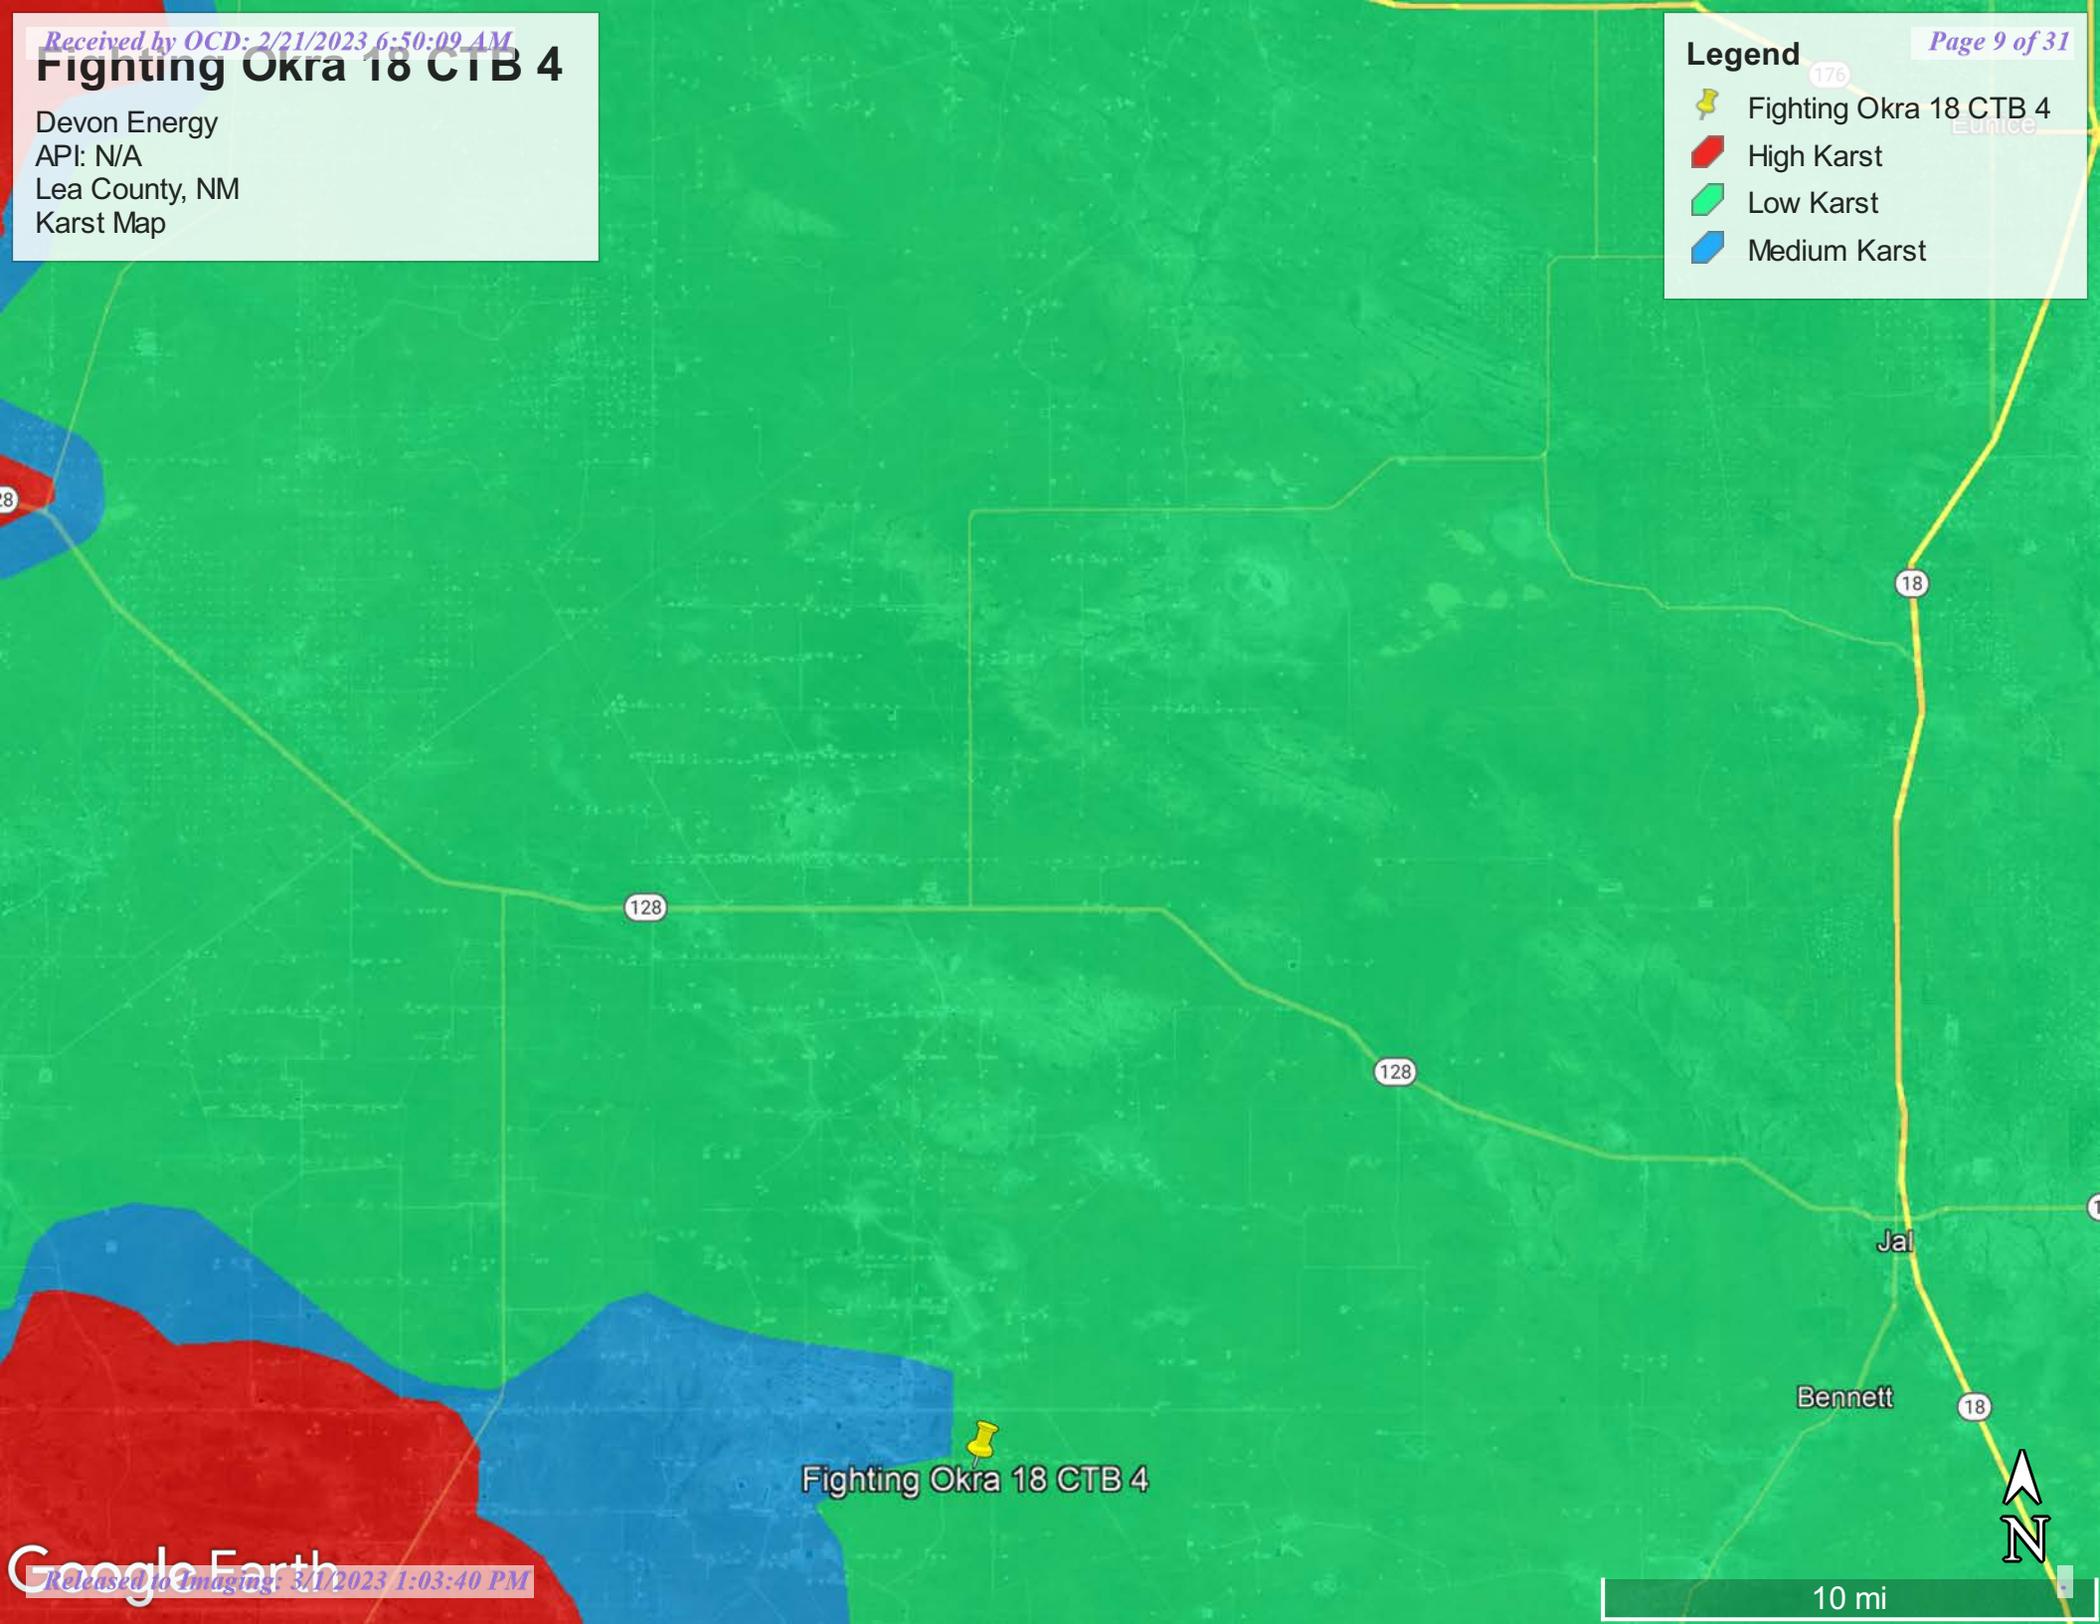
Devon Energy
API: N/A
Lea County, NM
Karst Map

Based upon New Mexico Office of the State Engineer well water data, depth to the nearest groundwater in this area is 200 feet below grade surface (BGS). According to the United States Geological Survey well water data, depth to the nearest groundwater in this area is greater than 123 feet BGS. See Appendix A for referenced water surveys. The Fighting Okra is in a low karst area.

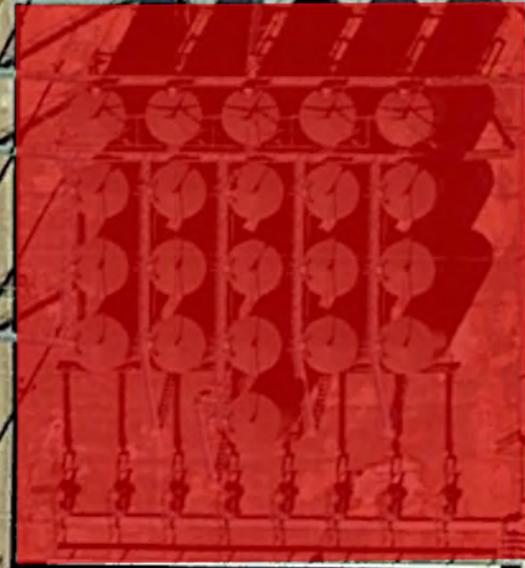
Devon Energy
Lea County, NM
Site Map

Spill Area

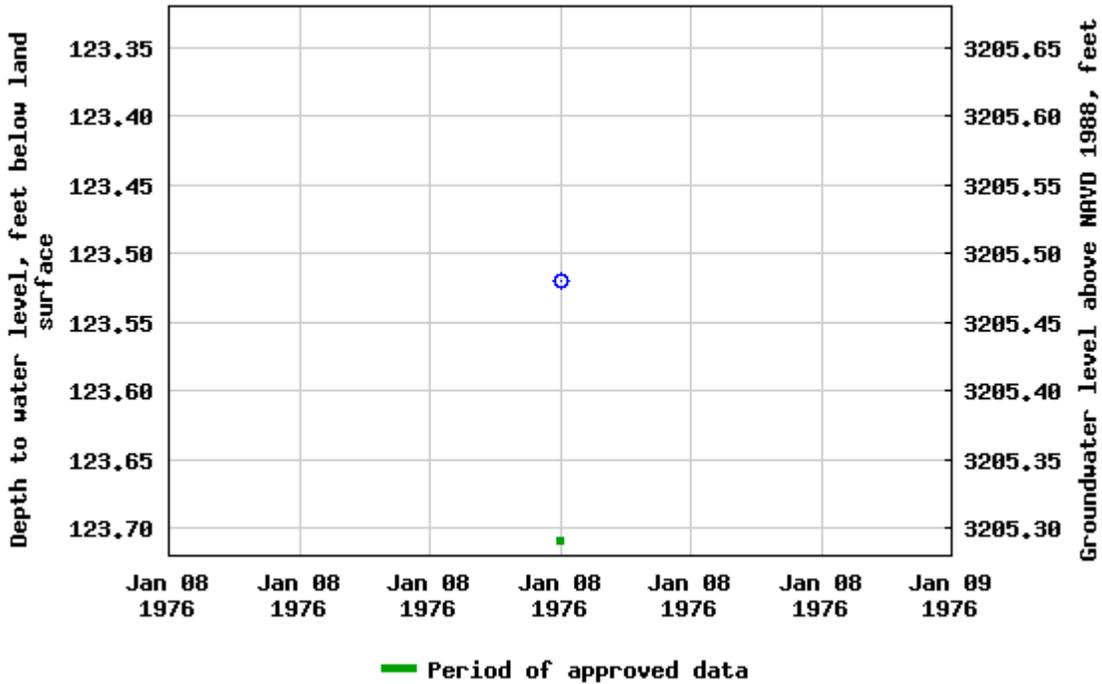
USGS 320419103302202 26S.34E.06.21414A

Breaks in the plot represent a gap of at least one year between field measurements.

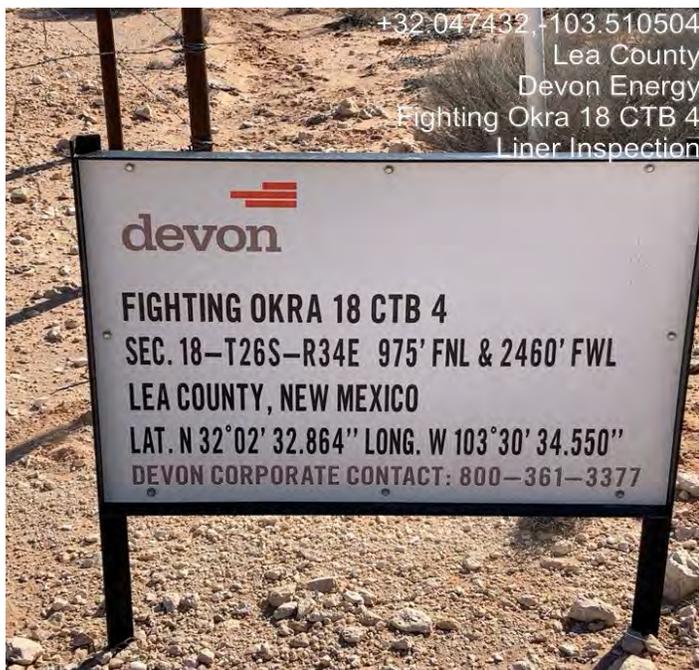
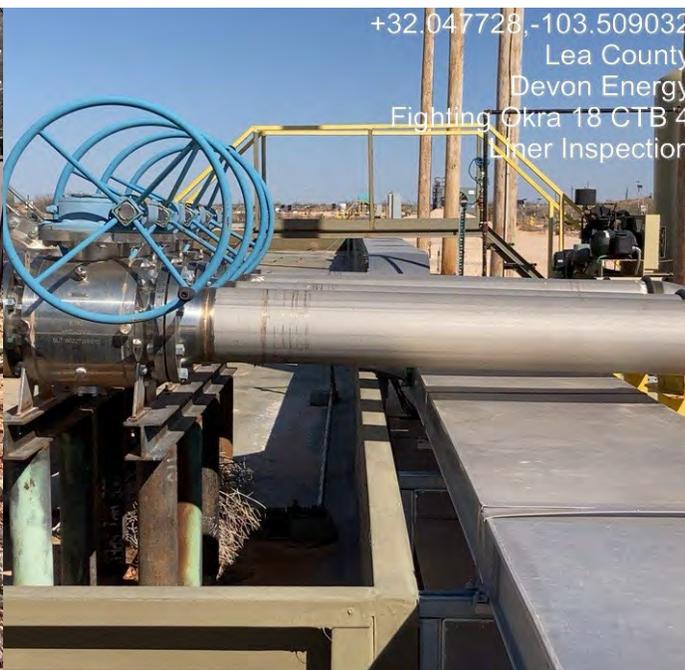
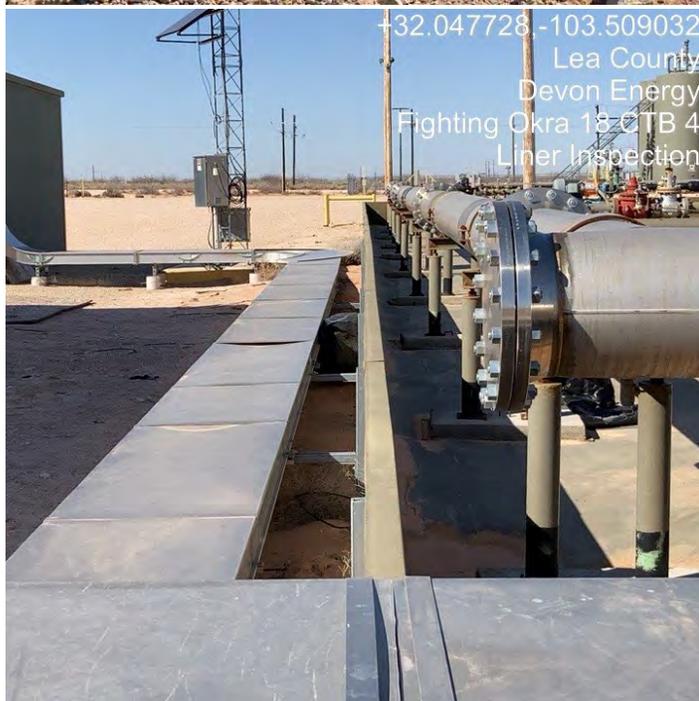
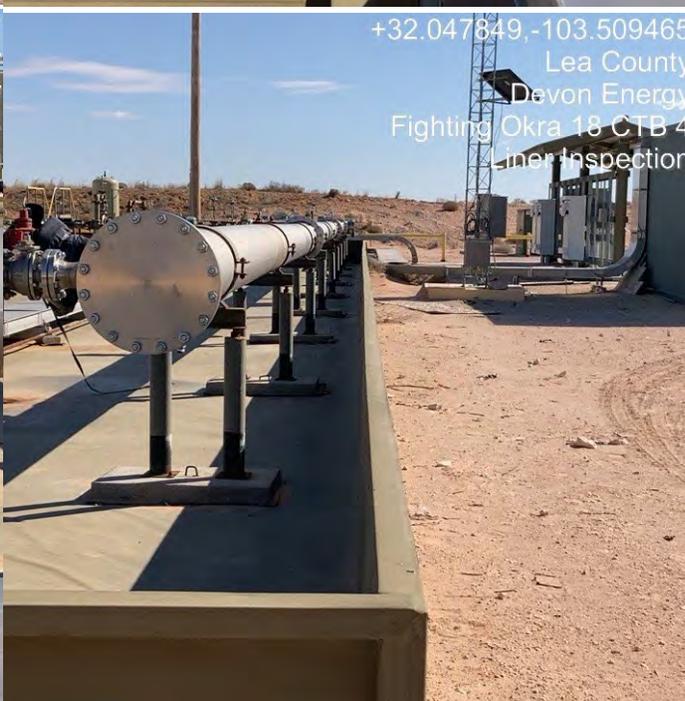
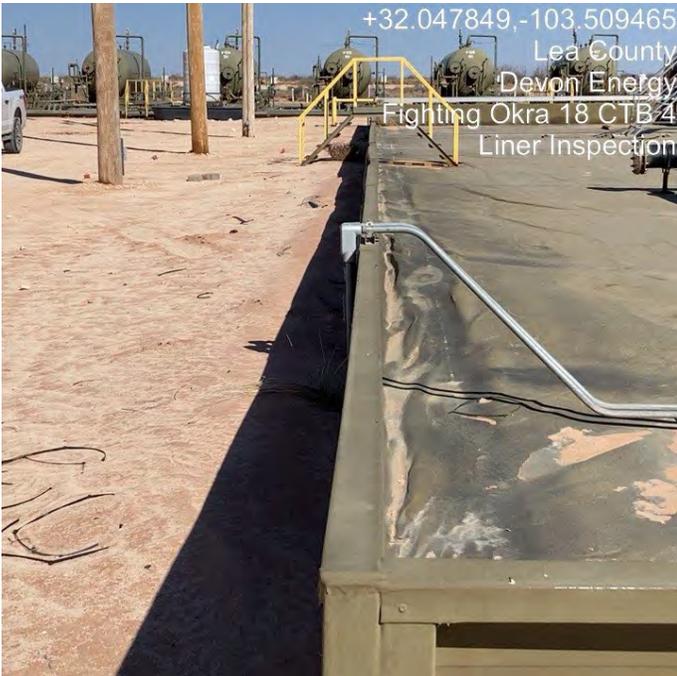
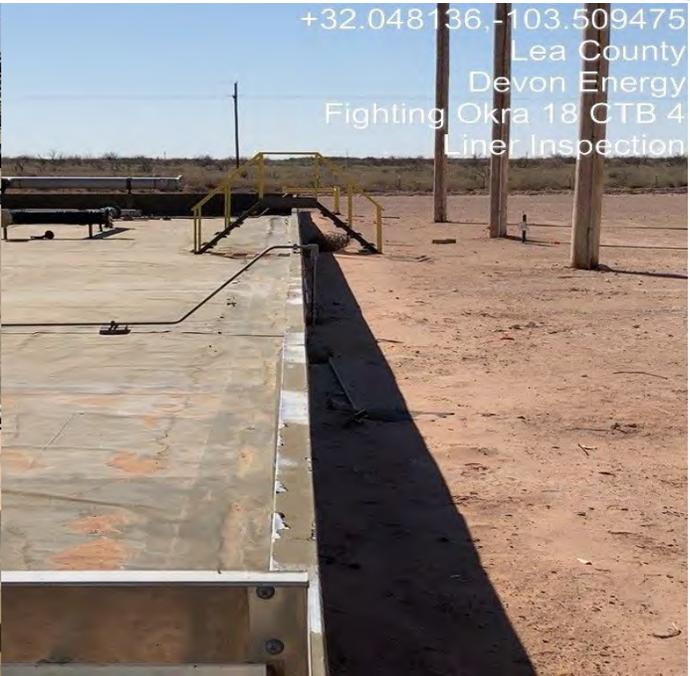
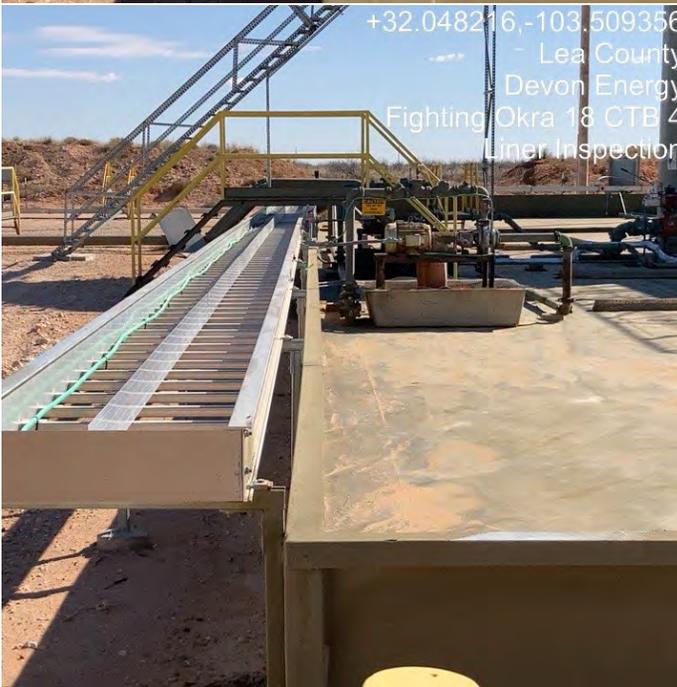
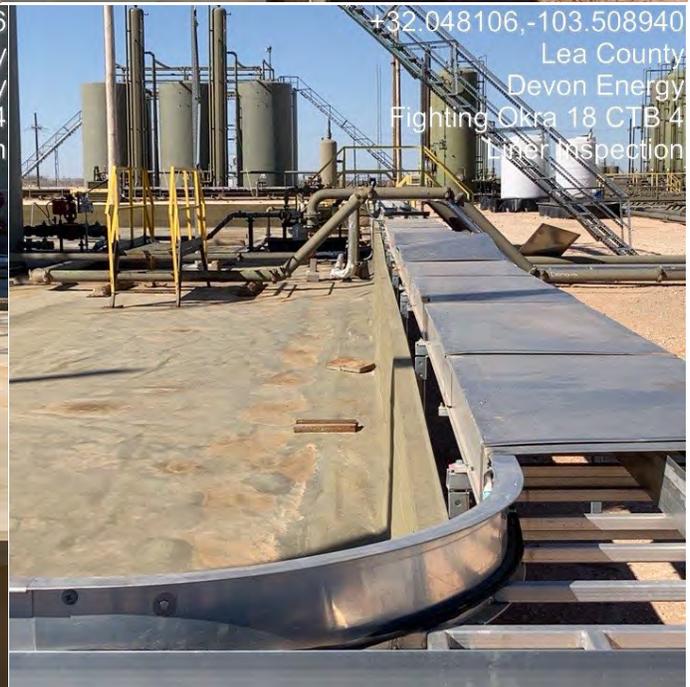
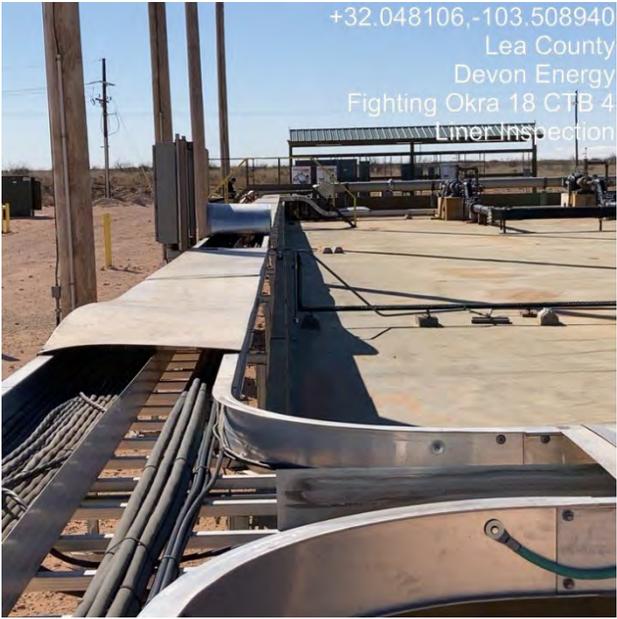
Liner Inspection

On February 11, 2023, after sending the 48-hour notification via email, Pima Environmental conducted a liner inspection at this location. We concluded that this liner and containment maintained its integrity and was able to retain the fluids. The liner inspection form and photographic documentation can be found in Appendix C.

Visualization	Yes	No	Comments
Is there a tear in the liner?		X	
Are there holes in the liner?		X	
Is the liner retaining any fluids?		X	
Does the liner have integrity to contain a leak?	X
