## Remediation Plan

## Release Notification

**Re: Deferral Request  
PLU Pierce Canyon 12 Battery  
Incident Number NAPP2222044186  
Eddy County, New Mexico**

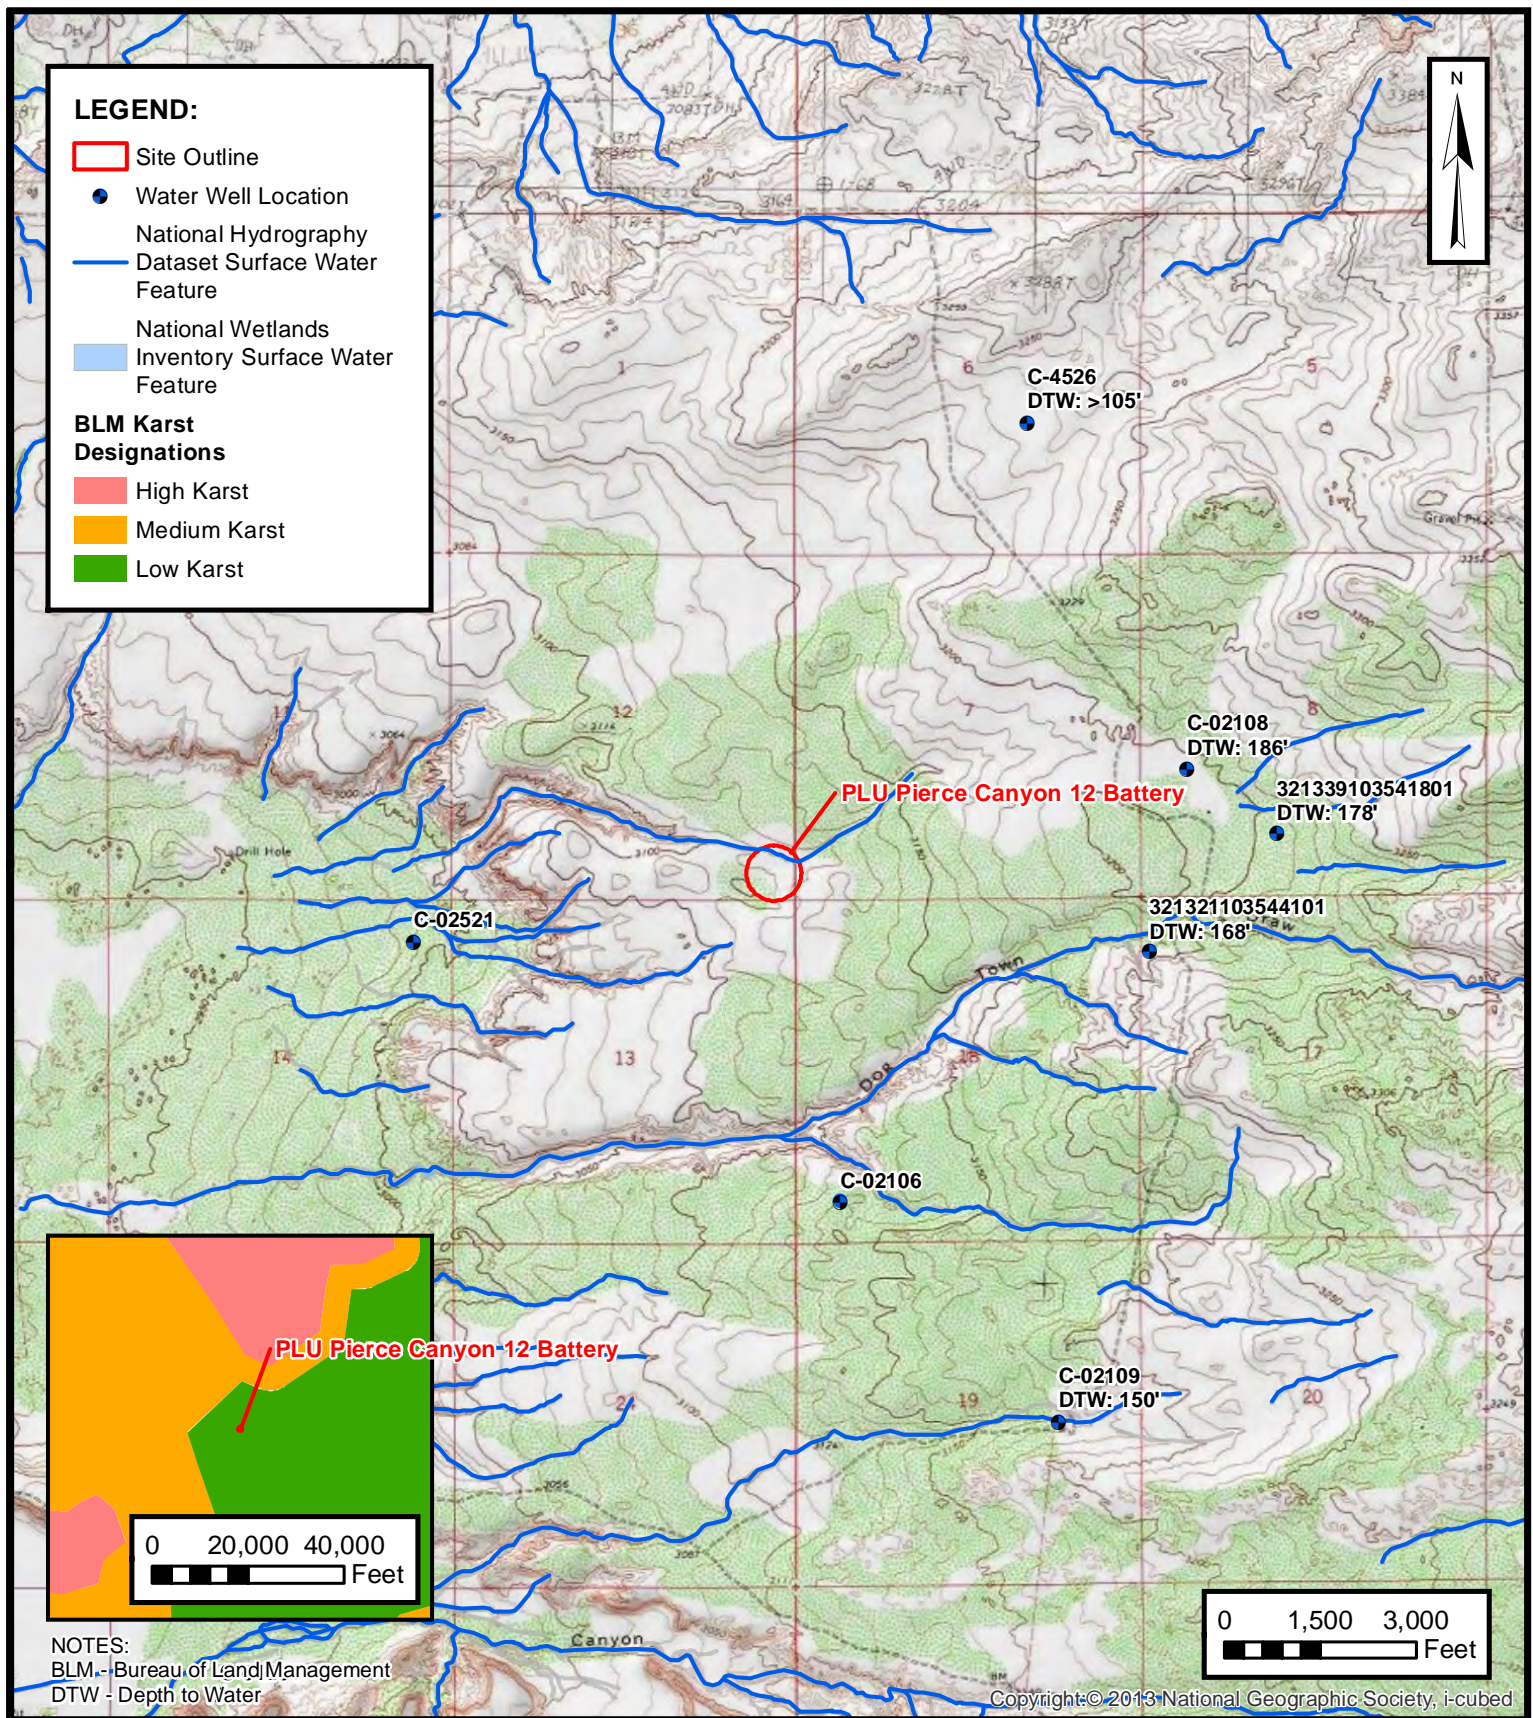
groundwater data is USGS well 321321103544101, located approximately 1.11 miles east of the Site. The groundwater well has a reported depth to groundwater of 168 feet bgs. The total depth of the well has not been recorded. Ground surface elevation at the groundwater well location is 3,192 feet above mean sea level (amsl), which is approximately 58 feet higher in elevation than the Site. All wells used to determine depth to groundwater are depicted on Figure 1. The Well Record and Log is included in Appendix A.

The closest continuously flowing or significant watercourse to the Site is a seasonal dry wash, located approximately 304 feet north of the Site. The Site is greater than 200 feet from a lakebed, sinkhole, or playa lake and greater than 300 feet from an occupied residence, school, hospital, institution, church, or wetland. The Site is greater than 1,000 feet from a freshwater well or spring and is not within a 100-year floodplain or overlying a subsurface mine. The Site is not underlain by unstable geology (low potential karst designation area). Potential site receptors are identified on Figure 1.

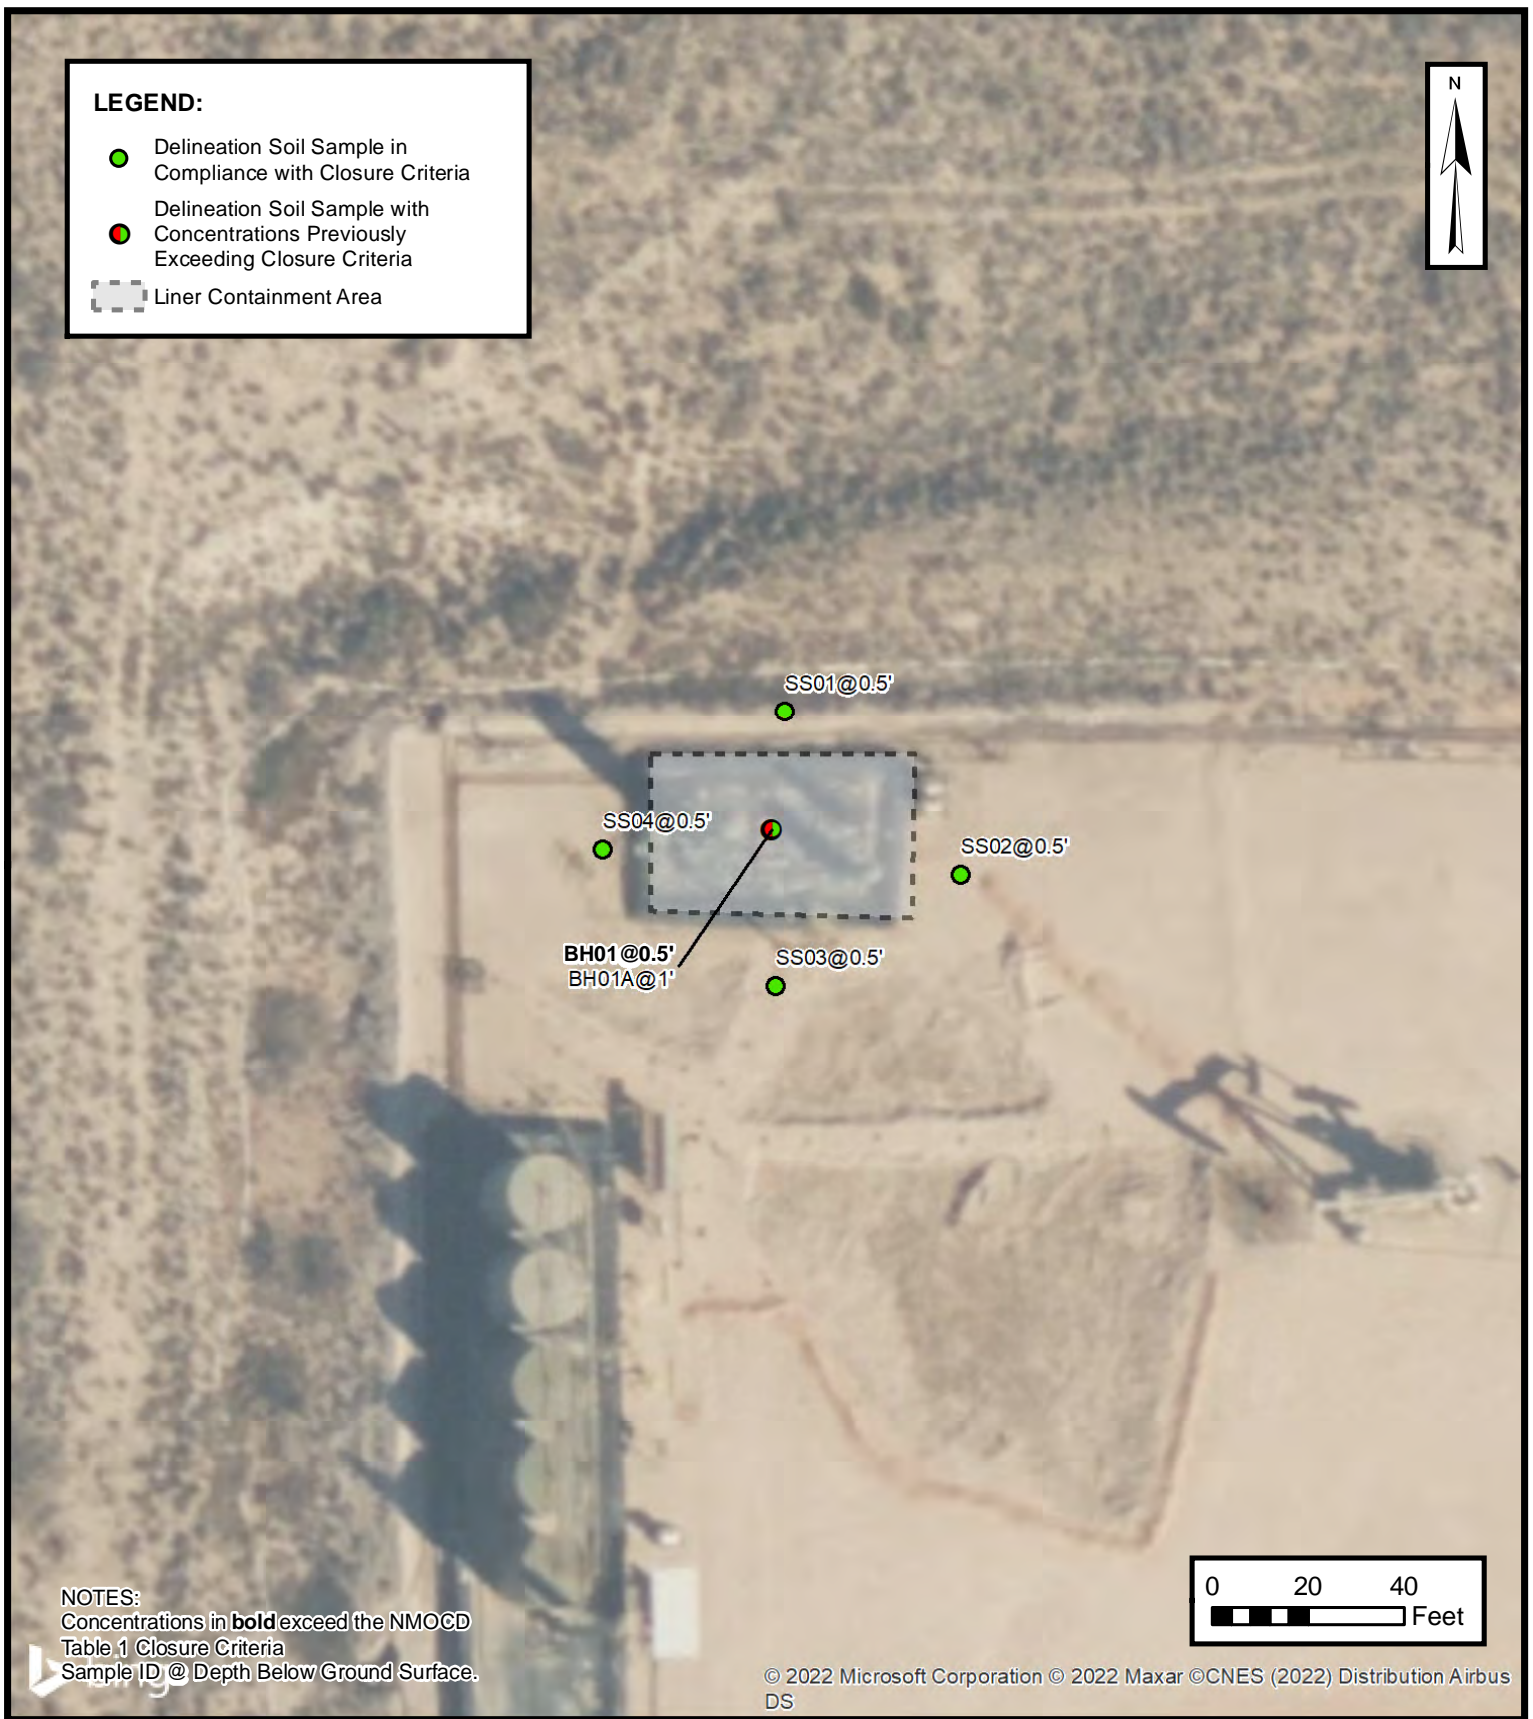
FIGURE

On August 31, 2022, site assessment activities were conducted to evaluate the release extent based on information provided on the Form C-141, liner inspection results, and visual observations. Ensolum personnel advanced one borehole (BH01) via hand auger at the location of the tear in the liner. Two discrete delineation soil samples (BH01/BH01A) were collected from the borehole at depths of approximately 0.5 feet and 1-foot bgs. The delineation soil samples were field screened for volatile organic compounds (VOCs) utilizing a calibrated photoionization detector (PID) and chloride using Hach® chloride QuanTab® test strips. Field screening results and observations from the borehole were documented on lithologic/soil sampling logs, which are included in Appendix B. The borehole BH01 was backfilled with the soil removed and XTO repaired the tear in the liner. Four additional assessment soil samples (SS01 through SS04) were collected around the lined containment at a depth of 0.5 feet bgs to confirm the lateral extent of the release. The release extent/containment and soil sample locations were mapped utilizing a handheld Global Positioning System (GPS) unit and are depicted on Figure 2. Photographic documentation is included in Appendix C.

### PRELIMINARY SOIL SAMPLE LOCATIONS

Laboratory analytical results for the delineation soil sample BH01 at 0.5 feet bgs indicated that GRO plus DRO concentrations exceeded the Closure Criteria. Laboratory analytical results for delineation soil sample BH01A collected at 1-foot bgs and lateral delineation soil samples SS01 through SS04 indicated COCs concentrations were compliant with the Site Closure Criteria and the most stringent Table 1 Closure Criteria. Laboratory analytical results are summarized in Table 1 and the complete laboratory analytical reports are included in Appendix D.

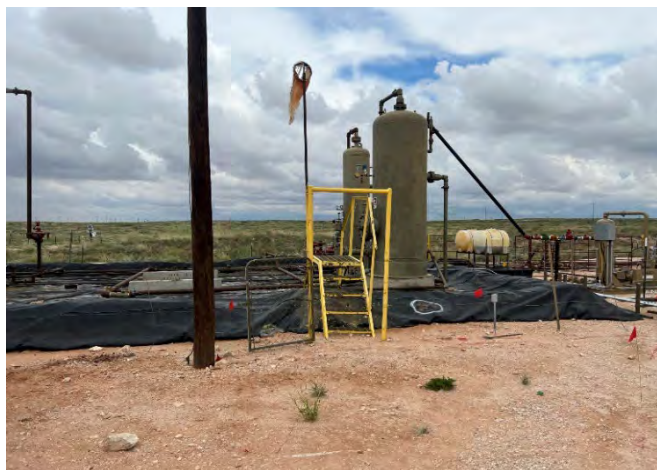
Photograph 1

Description: Liner containment area

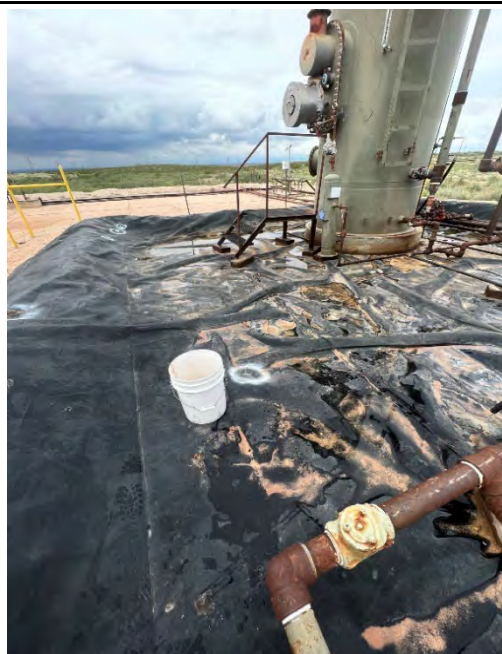
Photograph 2

Description: Liner containment area

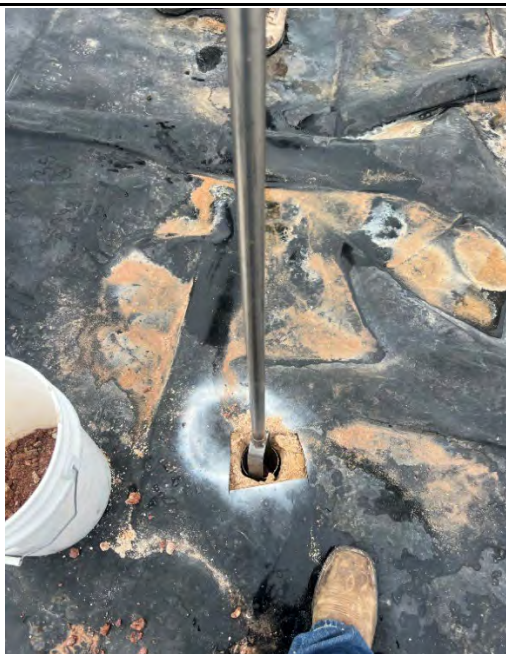
Photograph 3

Description: Delineation activities: BH01

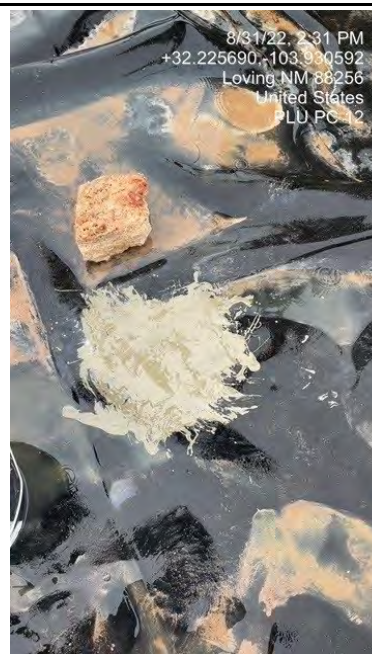
Photograph 4

Description: Liner patch: BH01

XTO does not believe deferment will result in imminent risk to human health, the environment, or groundwater. Depth to groundwater was determined to be greater than 100 feet bgs, the release was contained laterally by the lined containment, and the impacted soil remaining in place is limited to the area immediately beneath the liner. The liner has been repaired by XTO and will limit future vertical migration of residual impacts.
