LT Environmental, Inc.

November 6, 2019

**RE:   Deferral Request  
      Poker Lake Unit 89  
      Remediation Permit Number 2RP-3566  
      Eddy County, New Mexico**

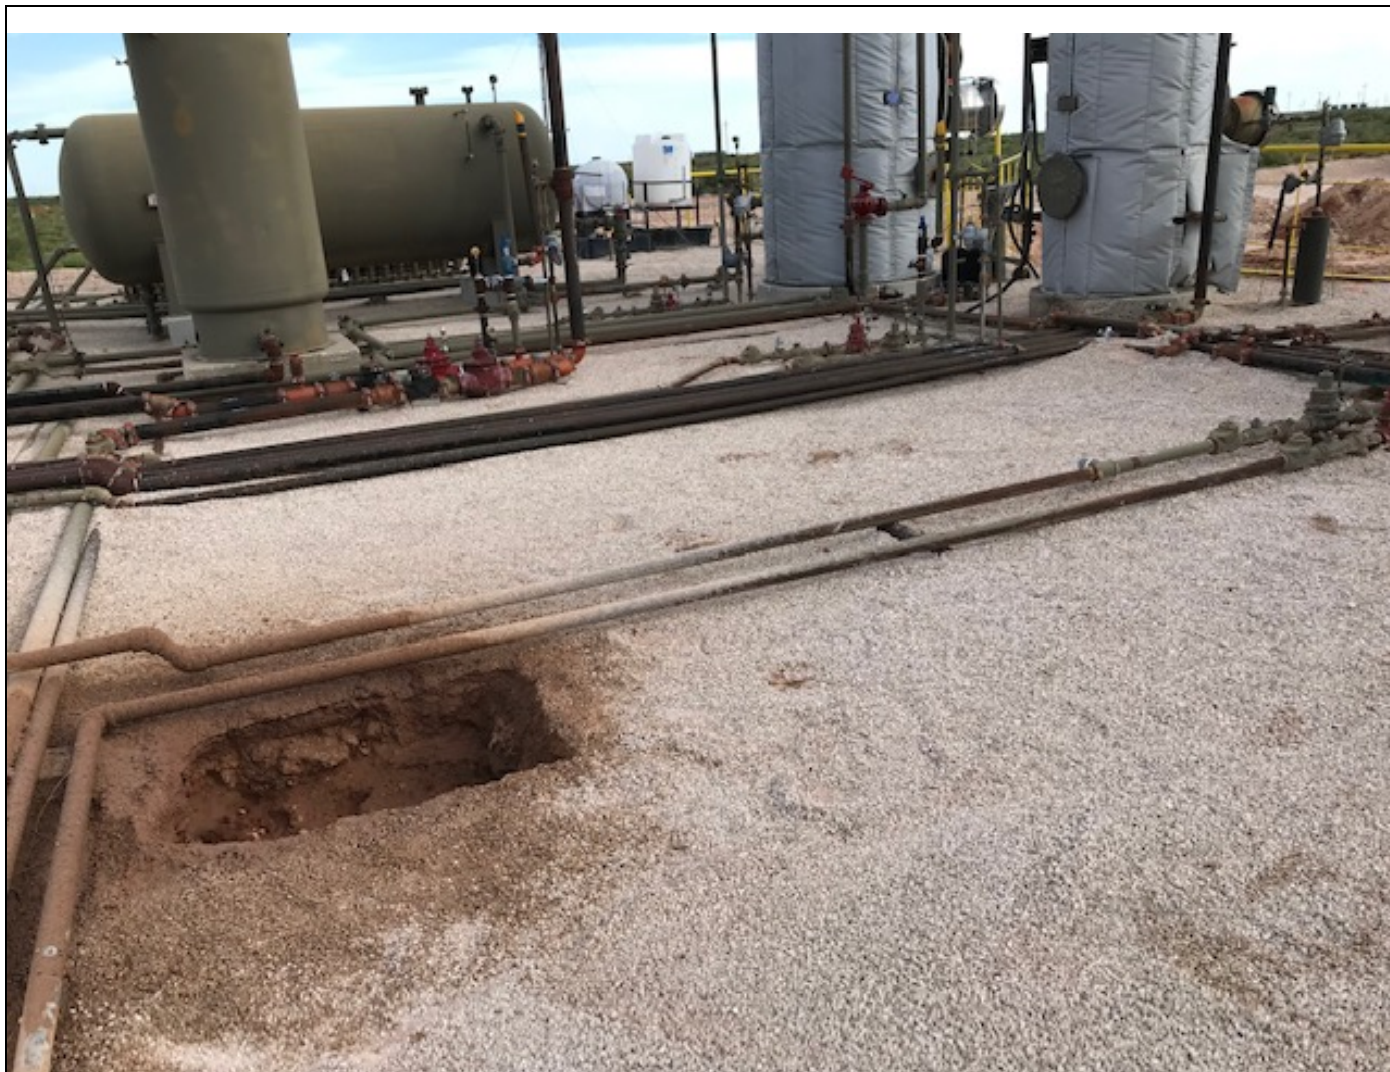
South facing view of release area during site assessment activities.

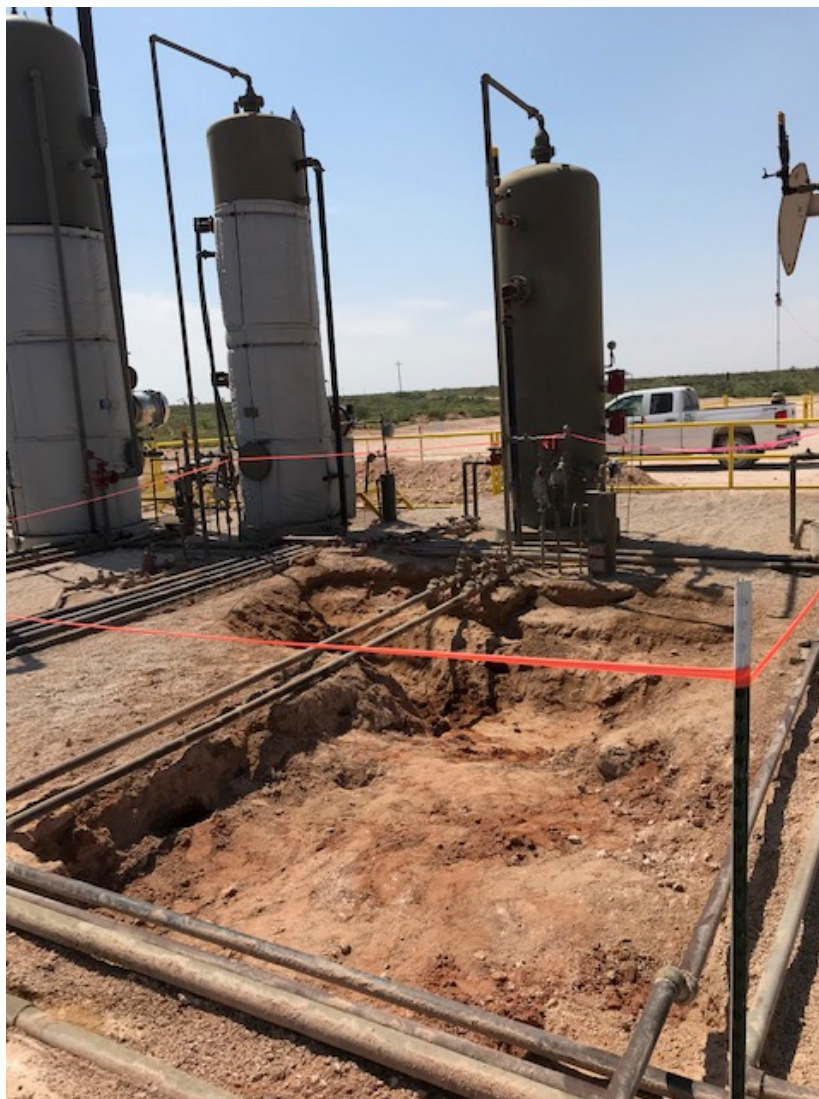
South facing view of the open excavation on the north side of the process equipment.

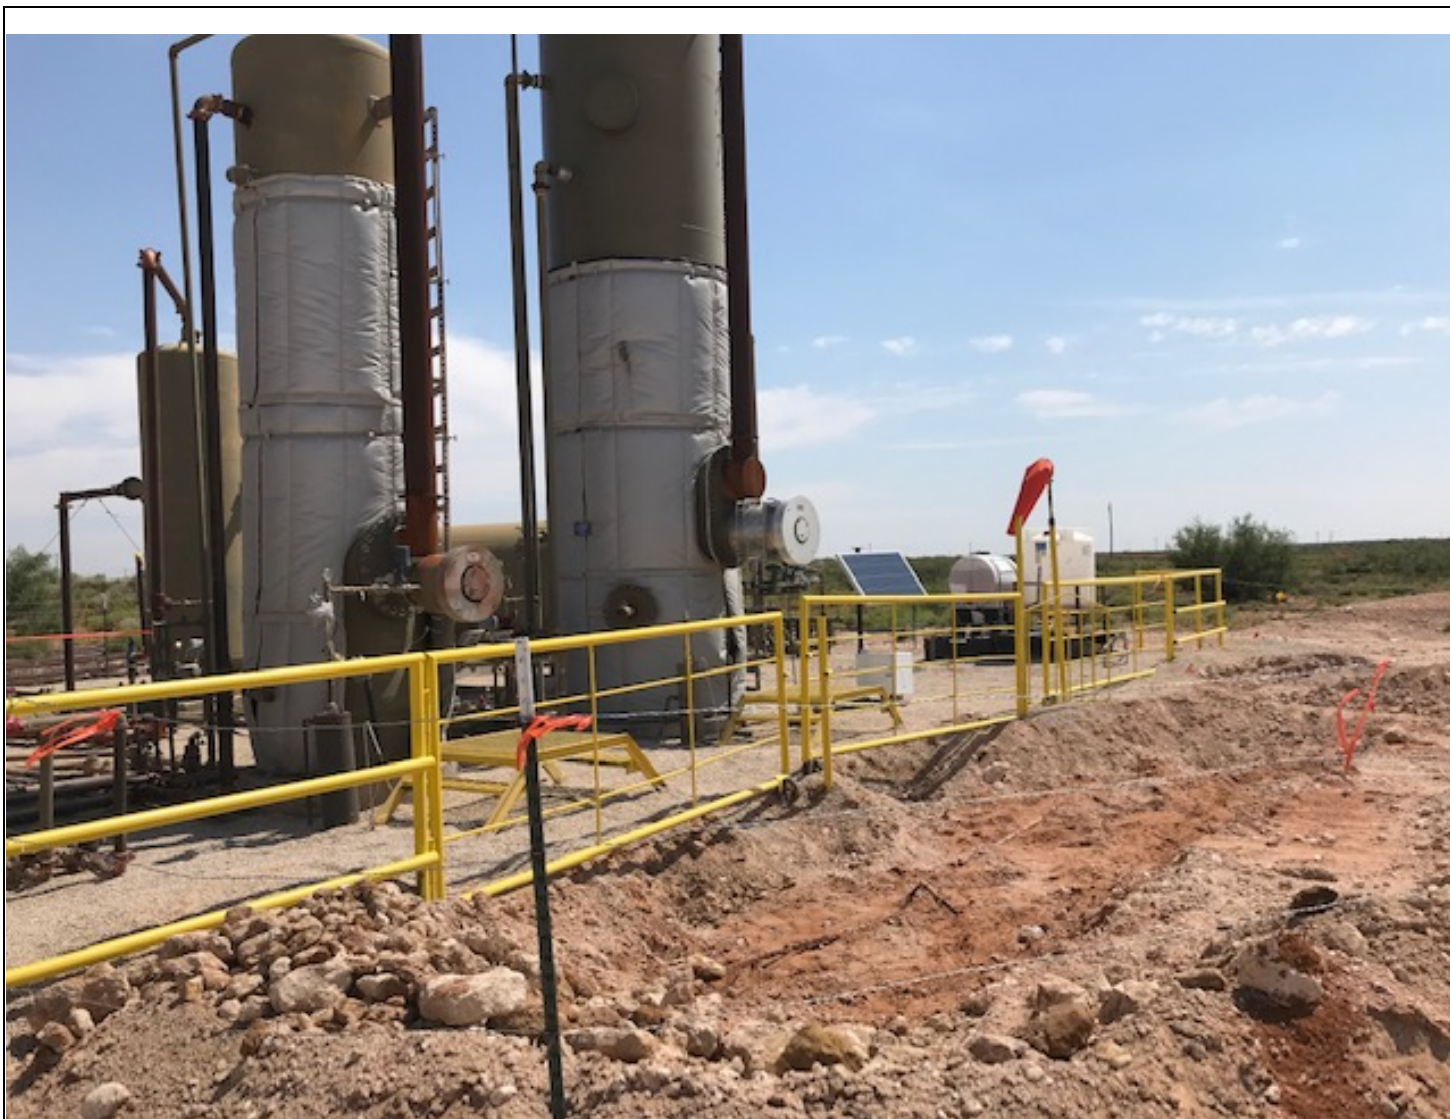
East facing view of the open excavation on the south side of the process equipment.
