Site Assessment/Characterization

Closure

Re: Site Assessment, Remediation, and Closure Report
Mad Dog 15 Federal Com #001
API No. 30-025-36778
GPS: Latitude 32.299202 Longitude -103.451499
UL -- P, Sec. 15, T23S, R34E
Lea County, NM
NMOCD Ref. No. NGRL1031435971

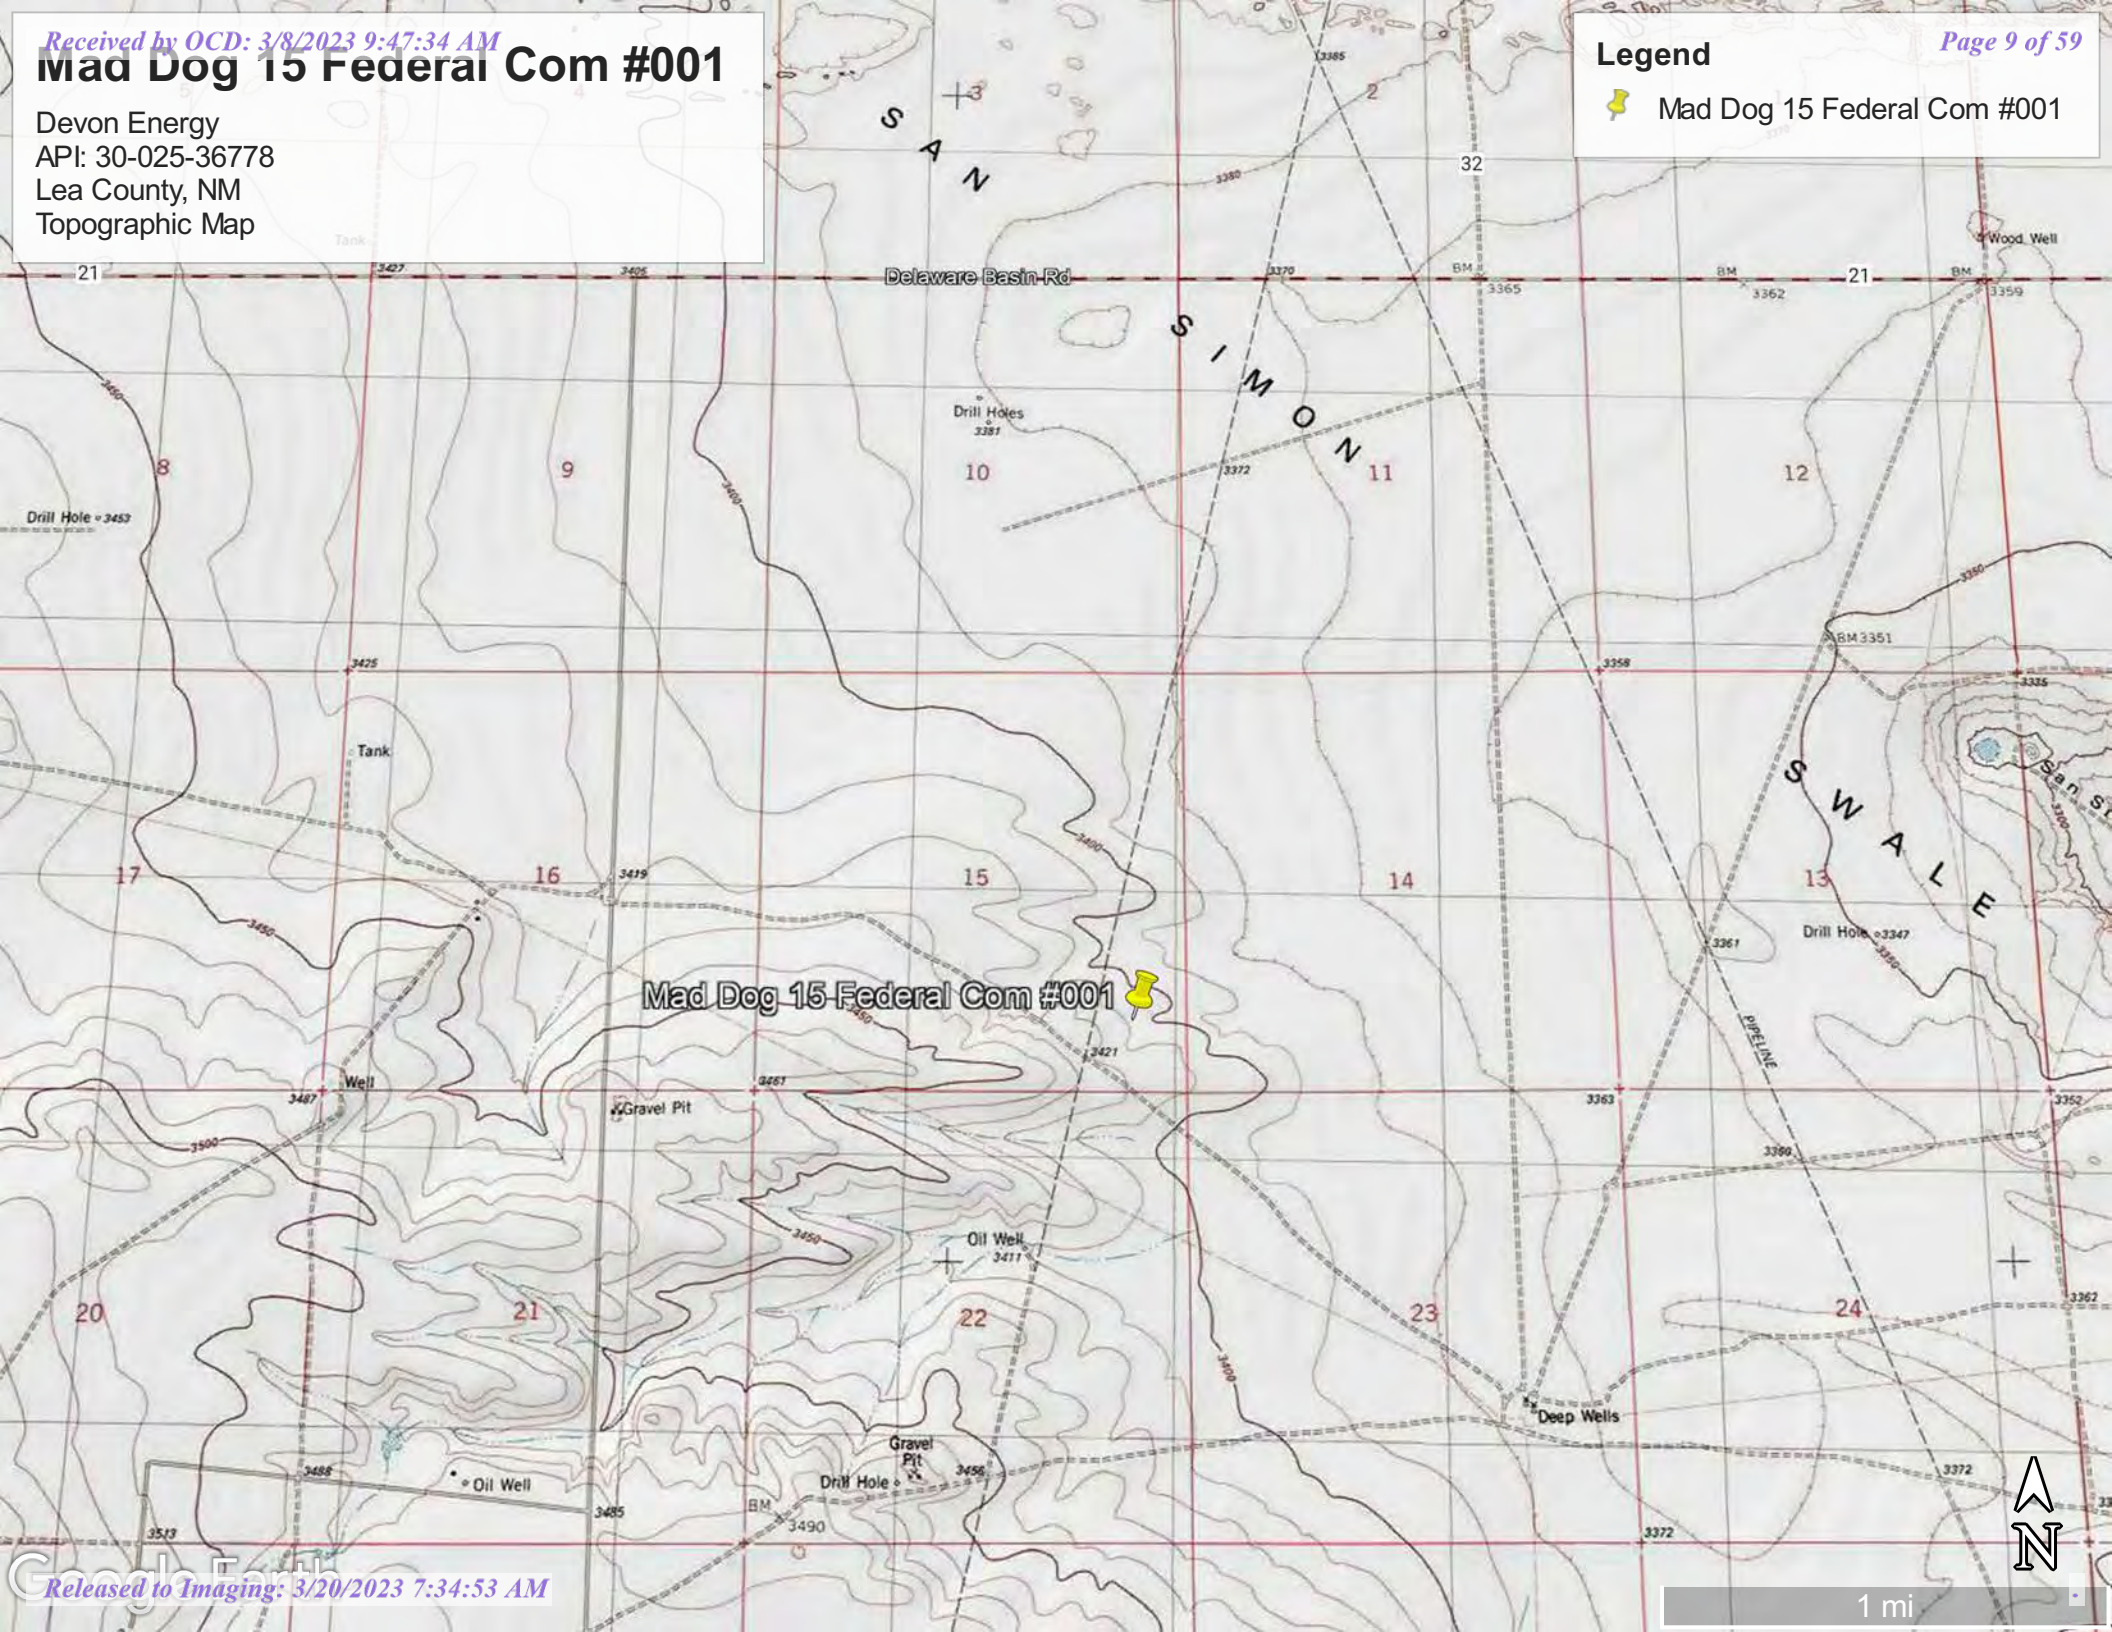
2-Topographic Map

Devon Energy
API: 30-025-36778
Lea County, NM
Topographic Map

Reference Figure 2 for a Topographic Map.

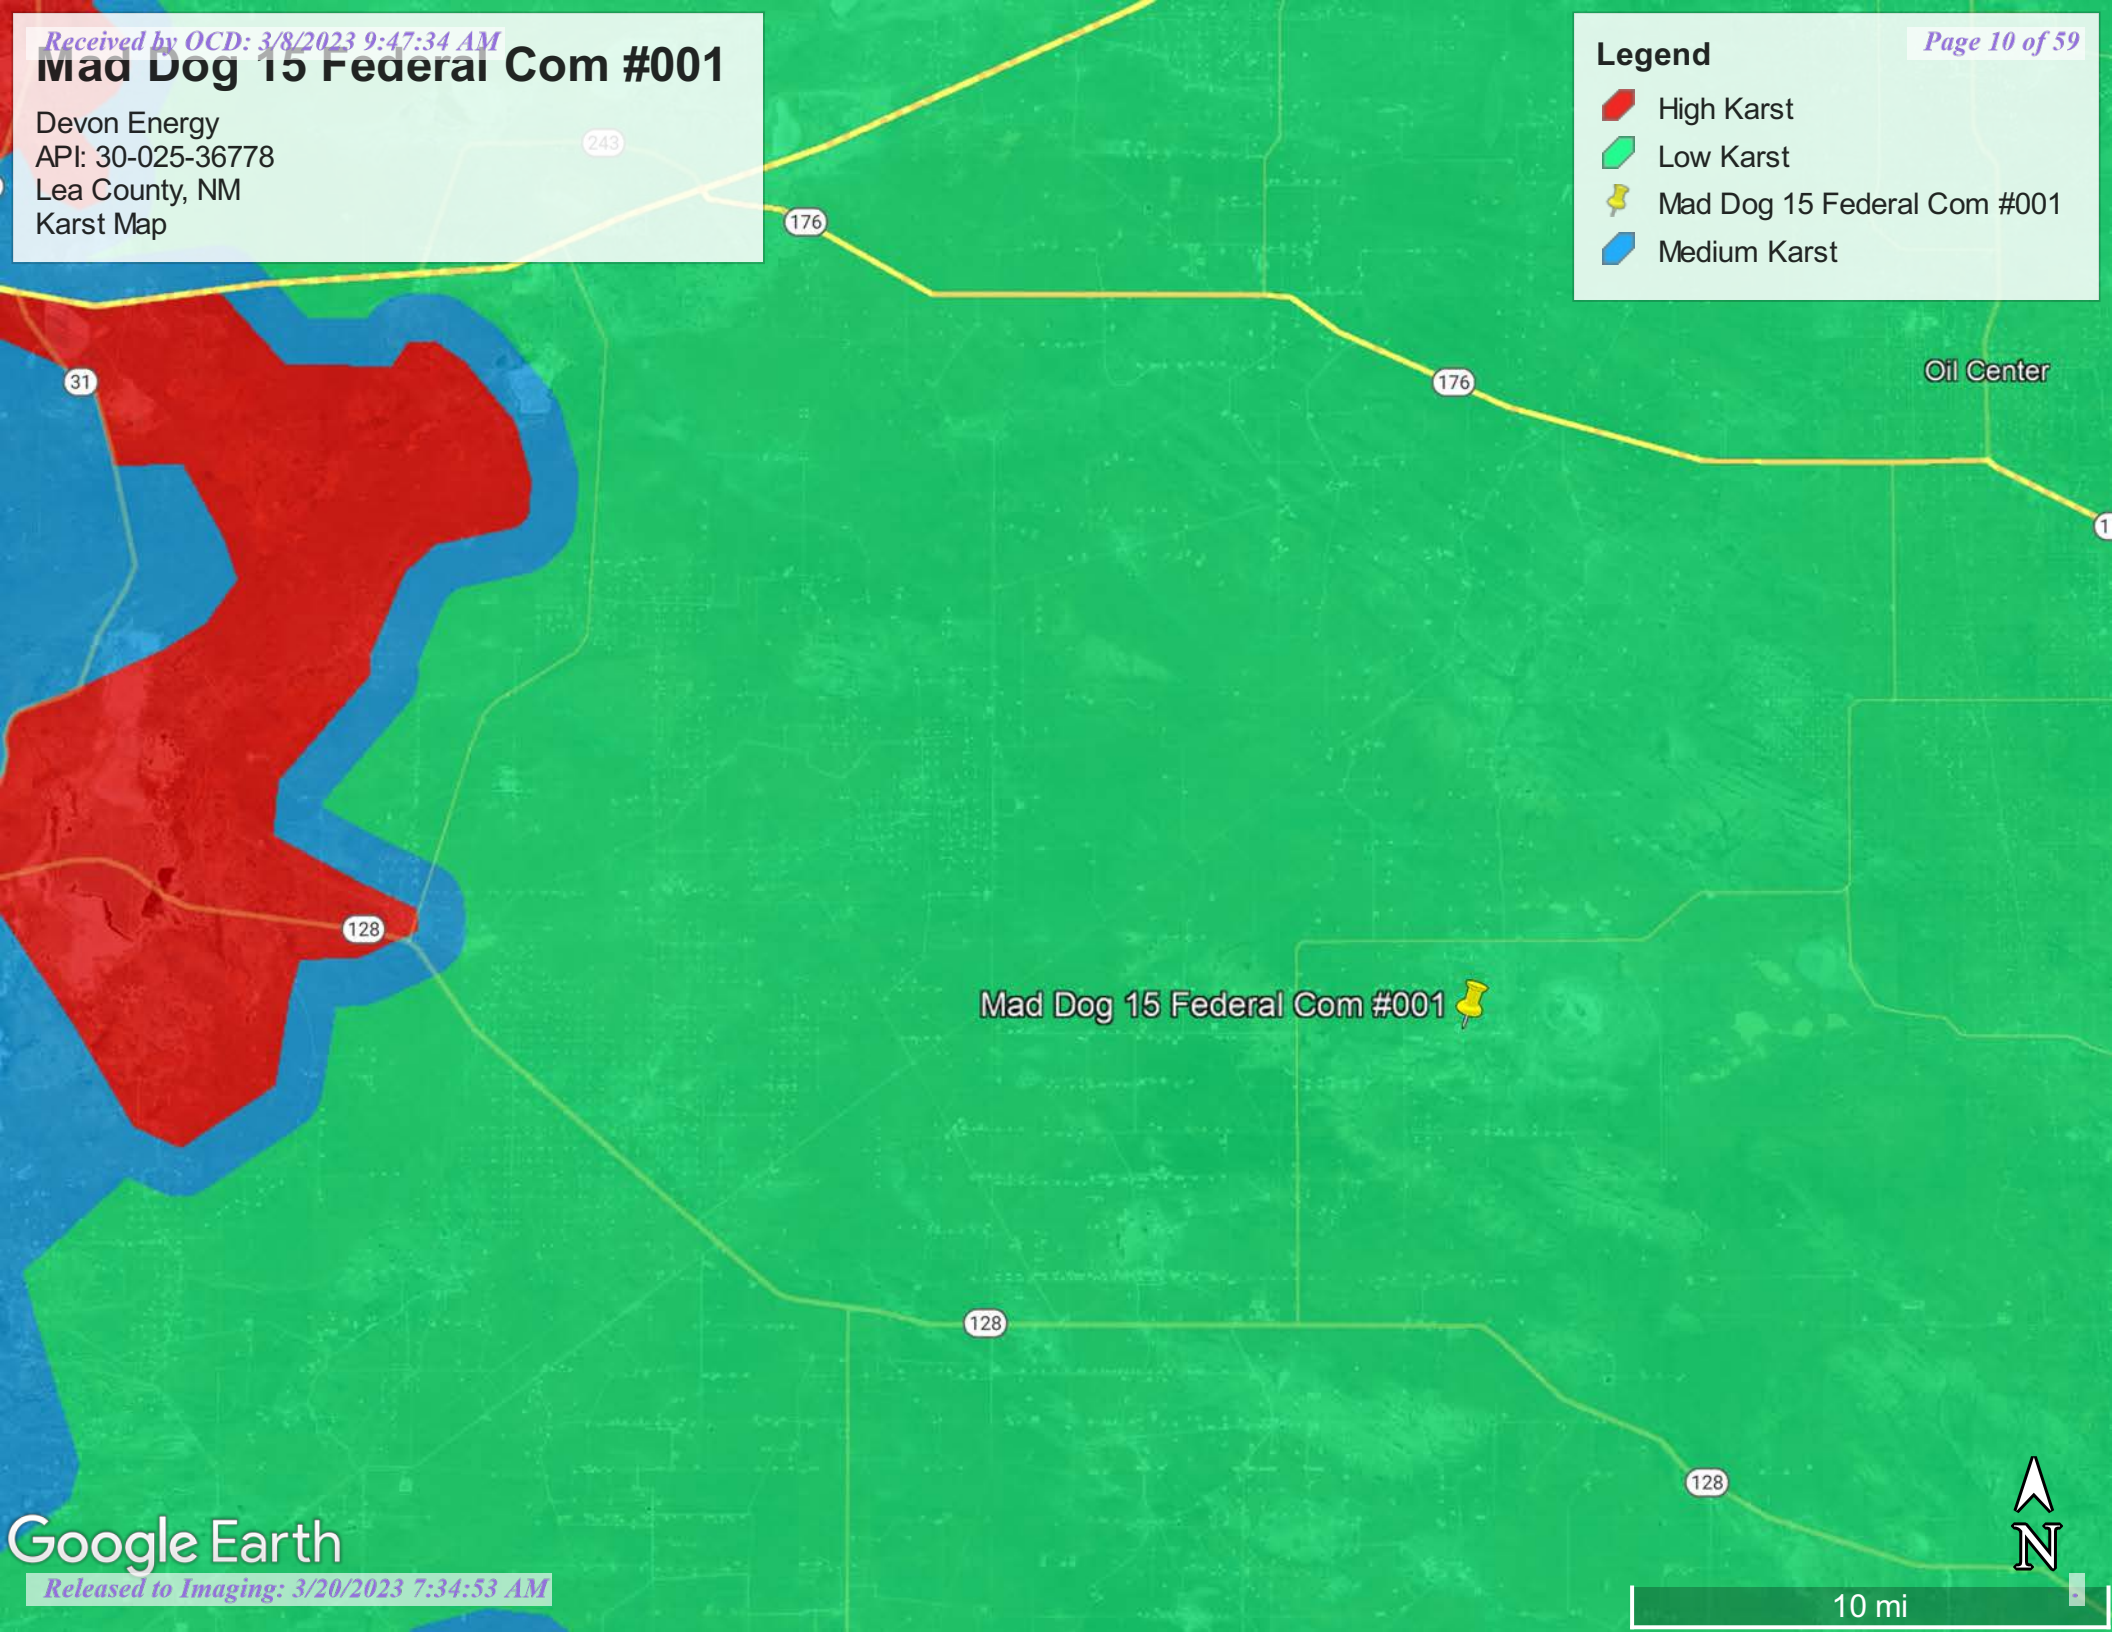
3-Karst Map

Per the New Mexico Bureau of Geology and Mineral Resources, the geology is in the Piedmont alluvial deposits (Holocene to lower Pleistocene). The soil in this area is made up of Simona fine sandy loam, 0 to 3 percent slopes according to the United States Department of Agriculture Natural Resources Conservation Service soil survey (Appendix B). The drainage courses in this area are well-drained. There is a low potential for karst geology to be present in the area of the Mad Dog (Figure 3).

Devon Energy
API: 30-025-36778
Lea County, NM
Karst Map

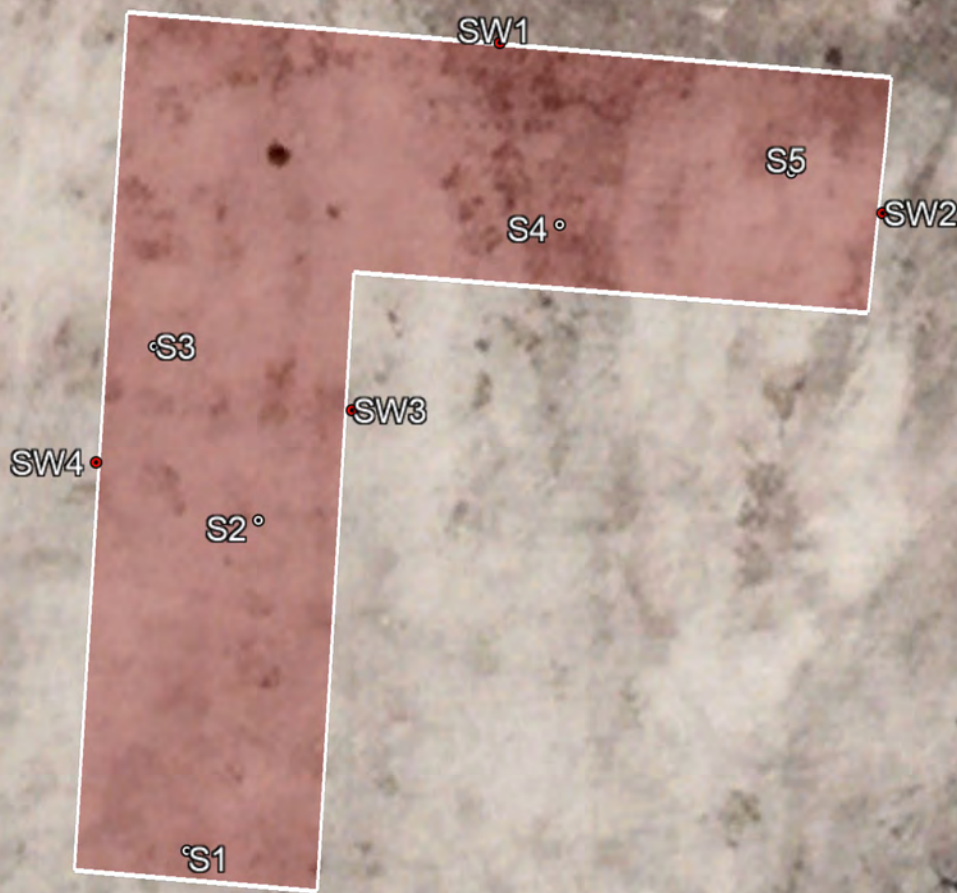
4-Site Map

NGRL1031435971: On June 1st, 2010, a hairline fracture developed in a transfer line releasing 15 bbls of produced water. The area impacted was 40 feet in diameter with some overspray.

On February 14th, 2023, Pima Environmental mobilized personnel to the now reclaimed site to assess the impacted area. Pima sampled the areas surrounding the flowline release and collected a total of fourteen soil samples for laboratory analysis. Five bottom samples (S1-S5) were collected at depths of 1 and 3 feet to determine vertical delineation. Additionally, side wall samples (SW1-SW4) were collected at a depth of 6 inches to determine horizontal delineation. An initial site map can be found in Figure 4.

Devon Energy
API: 30-025-36778
Lea County, NM
Site Map

Based on the sample results, the bottoms and sidewalls are below NMOCD Closure Criteria 19.15.29 NMAC. We believe the impacted area has been adequately remediated during the reclamation event. See Appendix D for Photographic Documentation.

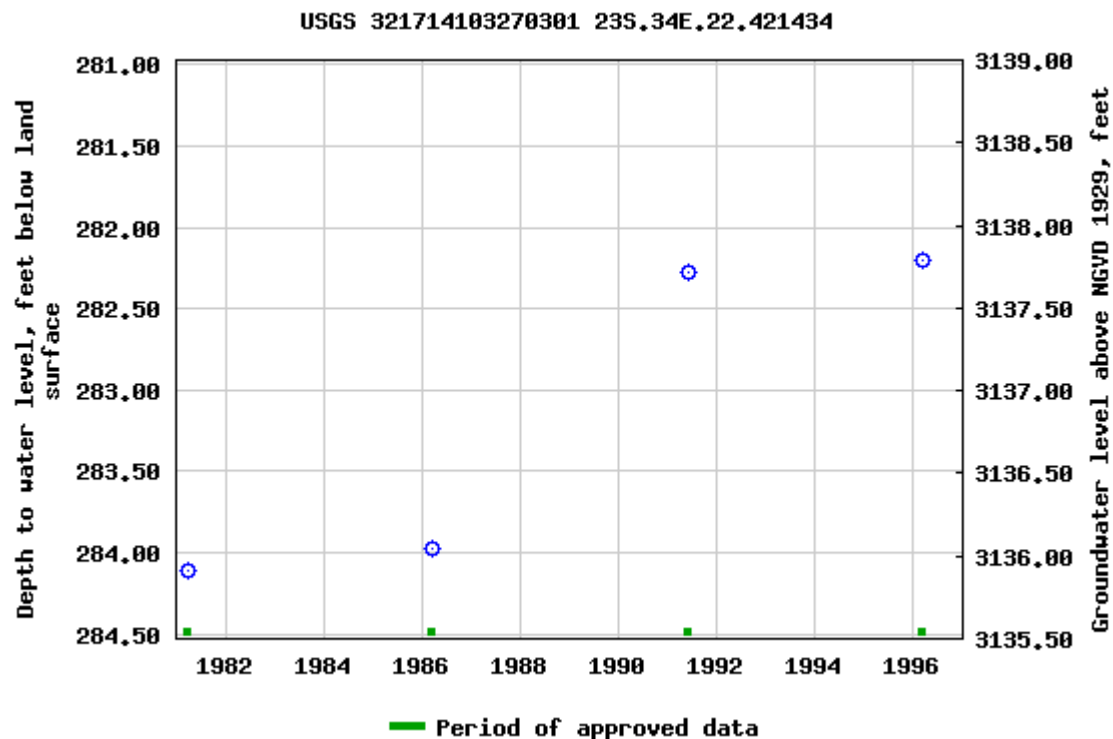
USGS 321714103270301 23S.34E.22.421434

The depth of the well is 428 feet below land surface.

Breaks in the plot represent a gap of at least one year between field measurements.
