**RE: Closure Request
 Big Eddy Unit #158
 Remediation Permit Number 2RP-2631 and 2RP-2662
 Eddy County, New Mexico**

LT Environmental, Inc. (LTE), on behalf of XTO Energy, Inc. (XTO), presents the following letter report detailing the excavation of impacted soil and confirmation soil sampling activities at the Big Eddy Unit (BEU) #158 (Site) in Unit J, Section 4, Township 22 South, Range 28 East, in Eddy County, New Mexico (Figure 1). The purpose of the excavation activities was to address impacts to soil after two separate events caused releases of crude oil and produced water in the tank battery containment area.

Big Eddy Unit #158
2RP-2631 & 2RP-2662
Photographs Taken: September 25, 2018

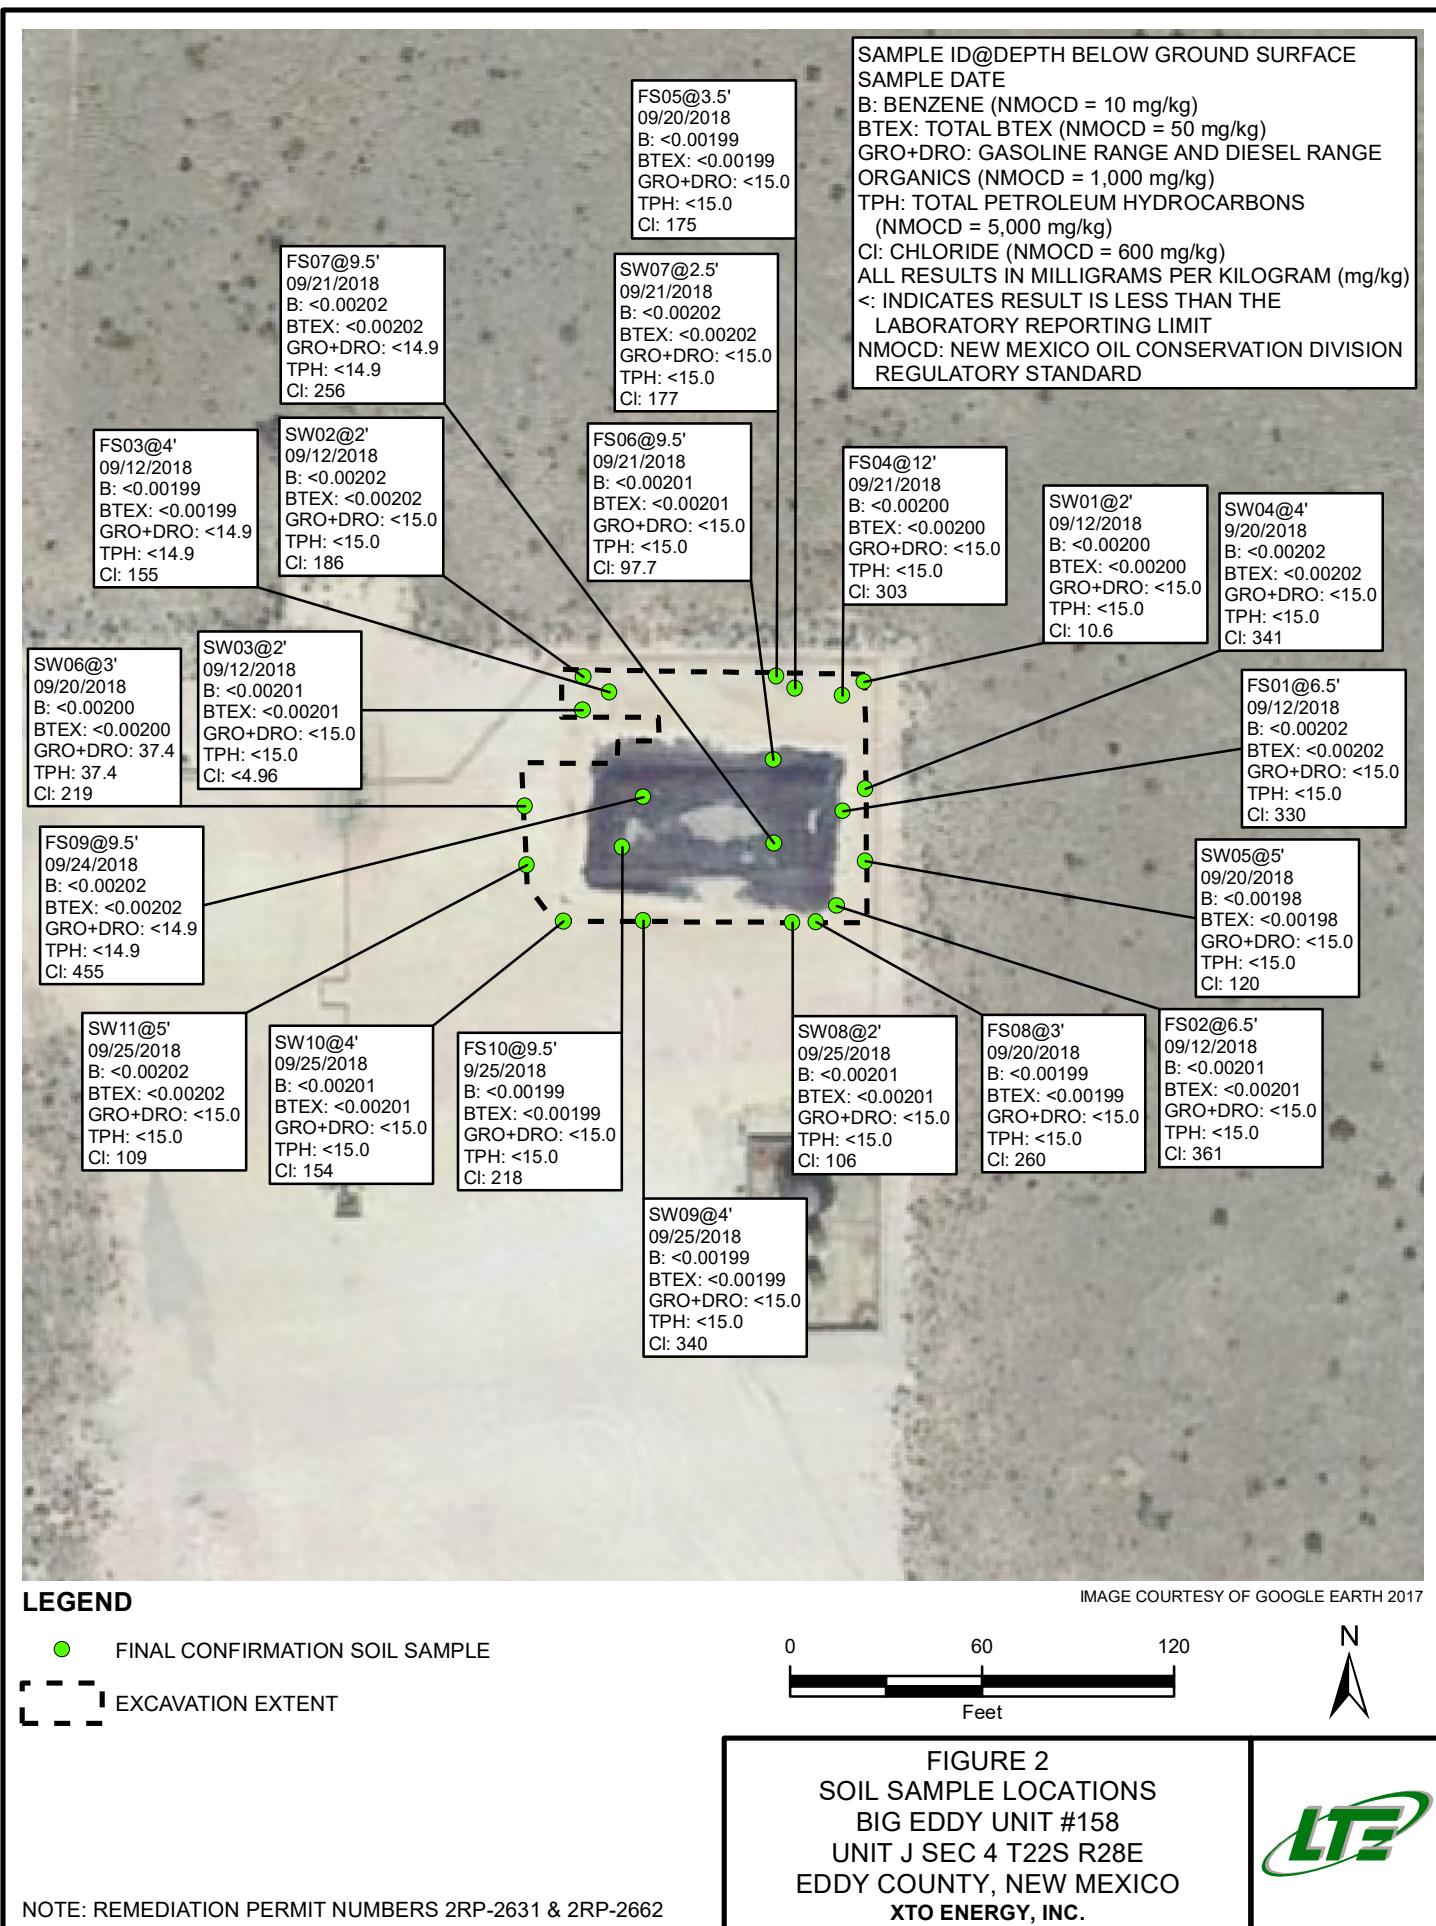
Figure 2 Soil Sample Locations

Because both releases were in the same location, one excavation was completed for the two releases. Upon completion of excavation activities, LTE collected discrete confirmation soil samples from the side walls (SW01 through SW11) and floor of the excavation (FS01 through FS10). The soil samples were collected and placed directly into pre-cleaned glass jars, labeled with the location, date, time, sampler, method of analysis, and immediately placed on ice. The soil samples were shipped at 4 degrees Celsius (°C) under strict chain-of-custody procedures to Xenco Laboratories in Midland, Texas, for analysis of BTEX by United States Environmental Protection Agency (USEPA) Method 8021B, TPH-gasoline range organics (GRO), TPH-diesel range organics (DRO), and TPH- oil range organics (ORO) by USEPA Method 8015M/D, and chloride by USEPA Method 300.

The excavation measured approximately 5,269 square feet around the former tank battery with depths ranging from 3 feet bgs in the southeast portion of the excavation up to 12 feet bgs in the northeast corner of the excavation. Approximately 1,585 cubic yards of impacted soil were removed from the excavation. The impacted soil was transported and properly disposed of at the R360 Landfarm, in Hobbs, New Mexico. A photographic log of the excavation is included as Attachment 3.

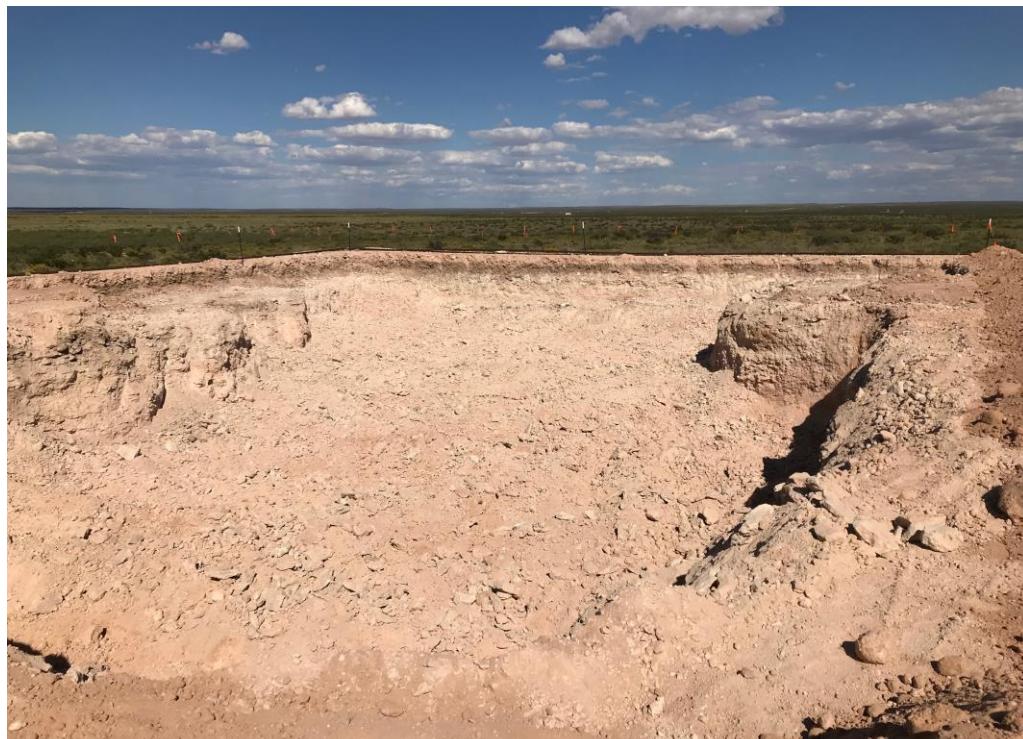
Photograph 1: View east of excavation.

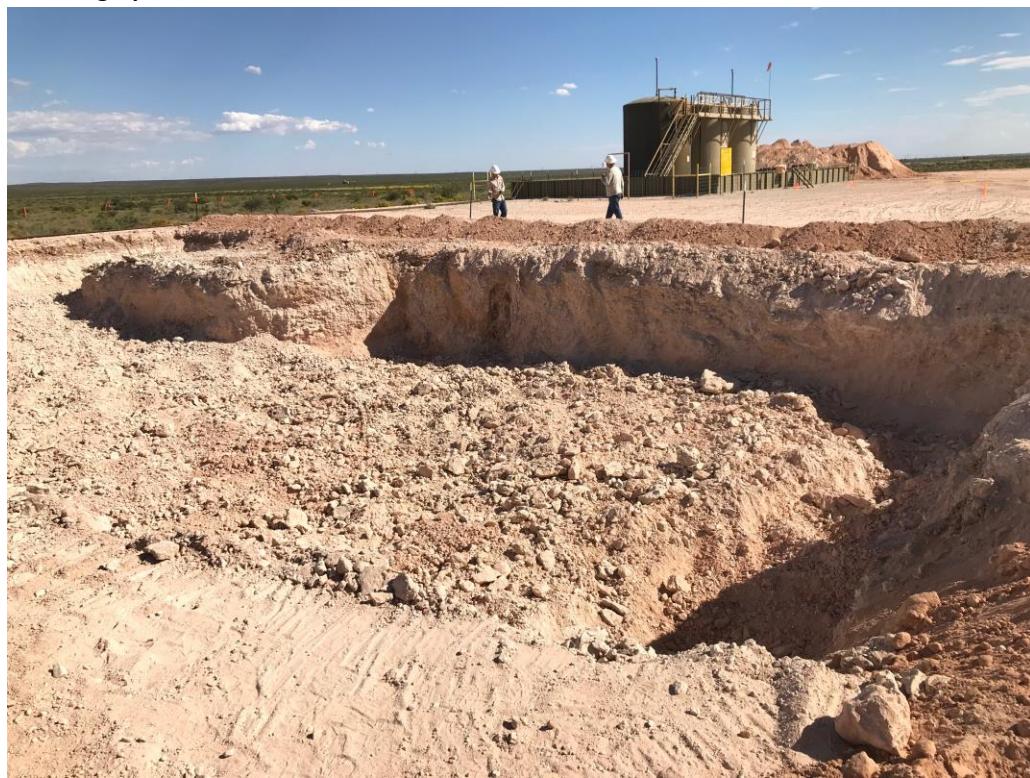
Photograph 2: View southeast of excavation and new tank battery.
