RE: Closure Request
James Ranch Unit 29 SWD Tank Battery
Remediation Permit Numbers 2RP-2726 and 2RP-4833
Eddy County, New Mexico

LT Environmental, Inc. (LTE), on behalf of XTO Energy, Inc. (XTO), presents the following report detailing the soil sampling activities at the James Ranch Unit (JRU) 29 Salt Water Disposal (SWD) Tank Battery (Site) in Unit K, Section 36, Township 22 South, Range 30 East, in Eddy County, New Mexico (Figure 1). The Site is located on same pad as the producing JRU #29 well. The purpose of the soil sampling activities was to assess impacts to soil after two separate events caused the release of produced water in the same area of the caliche well pad.

Project: 012918135	XTO Energy, Inc. James Ranch Unit 29 SWD Tank Battery

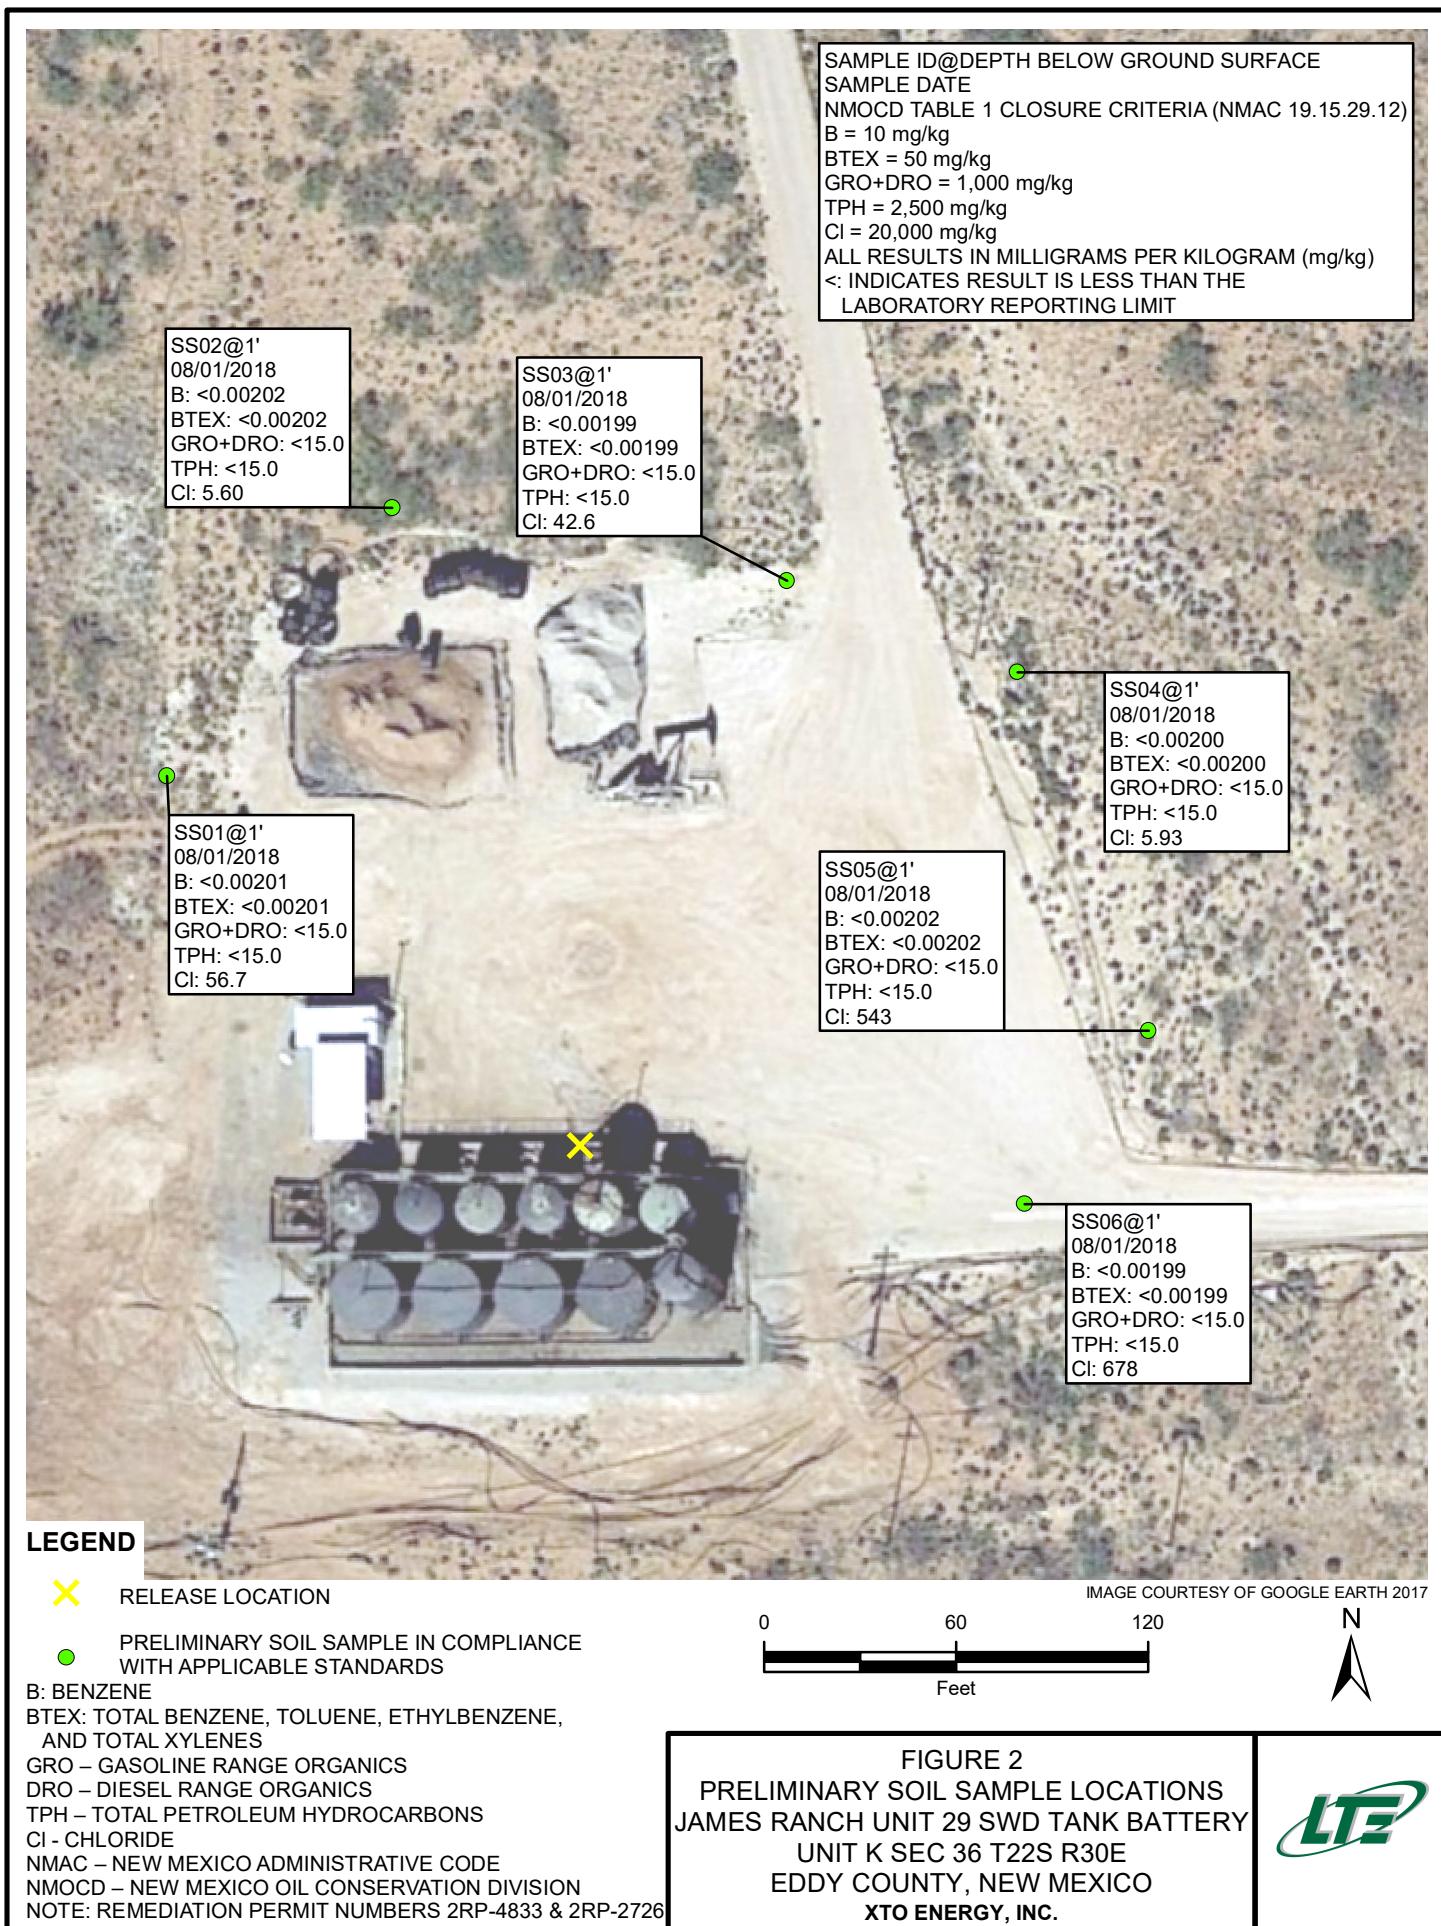
| Figure 2 | Preliminary Soil Sample Locations |

On August 1, 2018, an LTE scientist collected six preliminary soil samples (SS01 through SS06) around the perimeter of the pad to confirm the release did not impact the surrounding pasture. The soil sample locations, depicted on Figure 2, were selected based on information provided on the initial Form C-141s and field observations. To eliminate the effects from weathering and natural degradation of contaminants at the ground surface, the soil samples were collected from each sample location from a depth of 1 foot bgs. The soil samples were screened for volatile aromatic hydrocarbons and chlorides using a photo-ionization detector (PID) and Hach® chloride QuanTab® test strips. The soil samples were placed directly into pre-cleaned glass jars, labeled with the location, date, time, sampler, method of analysis, and immediately placed on ice. The soil samples were shipped at 4 degrees Celsius (°C) under strict chain-of-custody procedures to

Laboratory analytical results indicated that BTEX, GRO/DRO, TPH, and chloride concentrations were compliant with the NMOCD Table 1 closure criteria in preliminary soil samples SS01 through SS06 collected at 1 foot bgs. Additionally, chloride concentrations were below 600 mg/kg in soil

samples SS01 through SS05, collected from the pasture area surrounding the pad. The laboratory analytical results confirmed that the release events did not impact the surrounding pasture land.

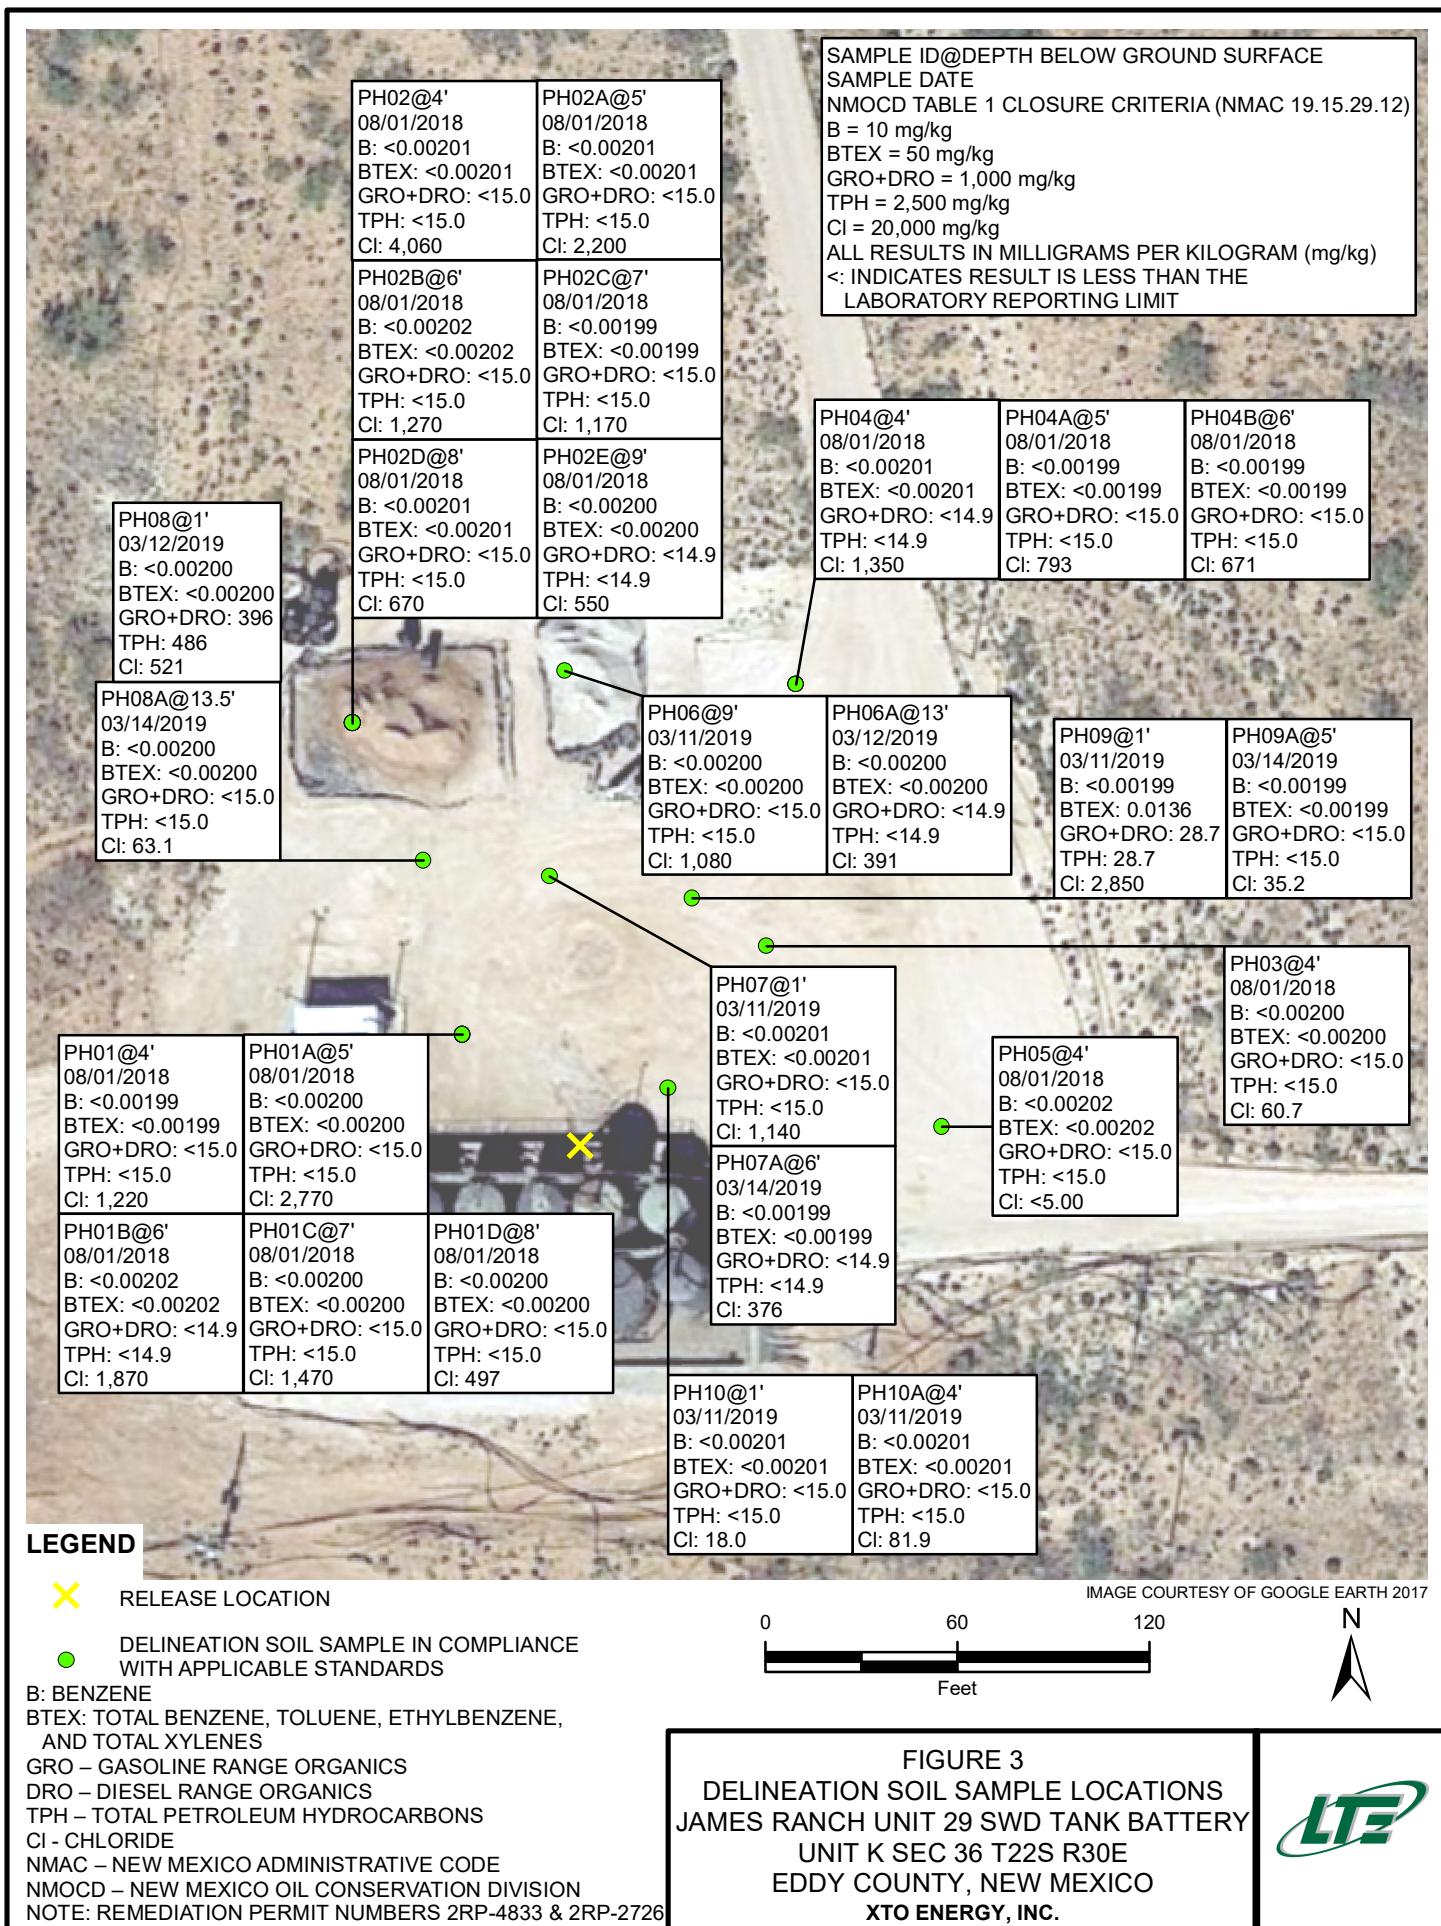
Figure 3 Delineation Soil Sample Locations

On August 1, 2018, LTE personnel were at the Site to oversee potholing activities to assess the vertical extent of impacted soil in the release area. Potholes PH01 through PH05 were advanced in the release area via backhoe to depths ranging from 4 feet to 9 feet bgs. Soil was field screened in the potholes using a PID and Hach® chloride QuanTab® test strips. Delineation soil samples were collected for laboratory analysis from each pothole PH01 through PH05. Five soil samples (PH01, PH01A, PH01B, PH01C, and PH01D) were collected from pothole PH01 from depths ranging from 4 feet to 8 feet bgs; six soil samples (PH02, PH02A, PH02B, PH02C, PH02D and PH02E) were collected from pothole PH02 from depths ranging from 4 feet to 9 feet bgs; three soil samples (PH04, PH04A, and PH04B) were collected from pothole PH04 from depths ranging from 4 feet to 6 feet bgs; and one soil sample was collected from each pothole PH03 and PH05 from a depth of 4 feet bgs.

During March 2019, LTE personnel returned to the Site to further assess the lateral and vertical extent of impacted soil in the release area via potholing. Potholes PH06 through PH10 were advanced in the release area via backhoe to depths ranging from 4 feet to 13.5 feet bgs. Soil was field screened in the potholes using a PID and Hach® chloride QuanTab® test strips. Two delineation soil samples were collected for laboratory analysis from each pothole PH06 through PH10 from depths ranging from 1 foot to 13.5 feet bgs. Soil samples PH06 and PH06A were collected from pothole PH06 from depths of 9 feet and 13 feet bgs; soil samples PH07 and PH07A were collected from pothole PH07 from depths of 1 foot and 6 feet bgs; soil samples PH08 and PH08A were collected from pothole PH08 from depths of 1 foot and 13.5 feet bgs; soil samples PH09 and PH09A were collected from pothole PH09 from depths of 1 foot and 5 feet bgs; and soil samples PH10 and PH10A were collected from pothole PH10 from depths of 1 foot and 4 feet bgs.

The pothole soil samples were collected, handled, and analyzed as described above and submitted to Xenco in Midland, Texas. The potholes were backfilled with the soil removed; no soil was removed from the Site for disposal. The pothole soil sample locations and depths are presented on Figure 3 and soil sample logs are included in Attachment 2.

Laboratory analytical results indicated that BTEX, GRO/DRO, TPH, and chloride concentrations were compliant with the NMOCD Table 1 closure criteria in all delineation soil samples collected from potholes PH01 through PH10 from depths ranging from 1 foot to 13.5 feet bgs. Based on the laboratory analytical results, no soil excavation was required. Laboratory analytical results are presented on Figure 2 and Figure 3 and summarized in Table 1, and the complete laboratory analytical reports are included as Attachment 3.

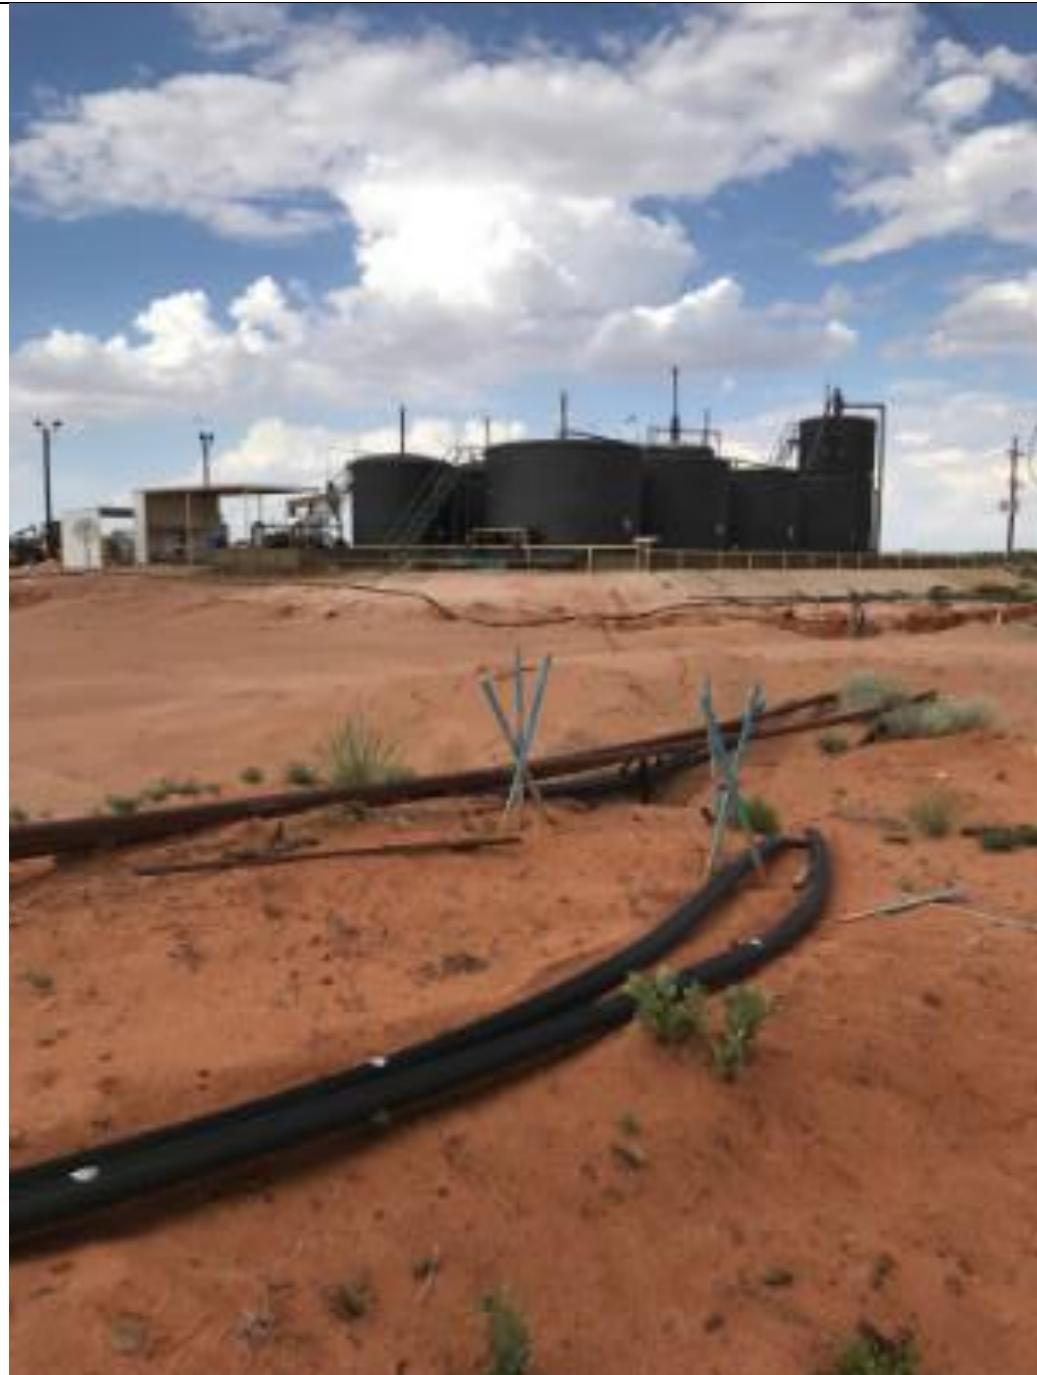
Northeastern view of the release area.

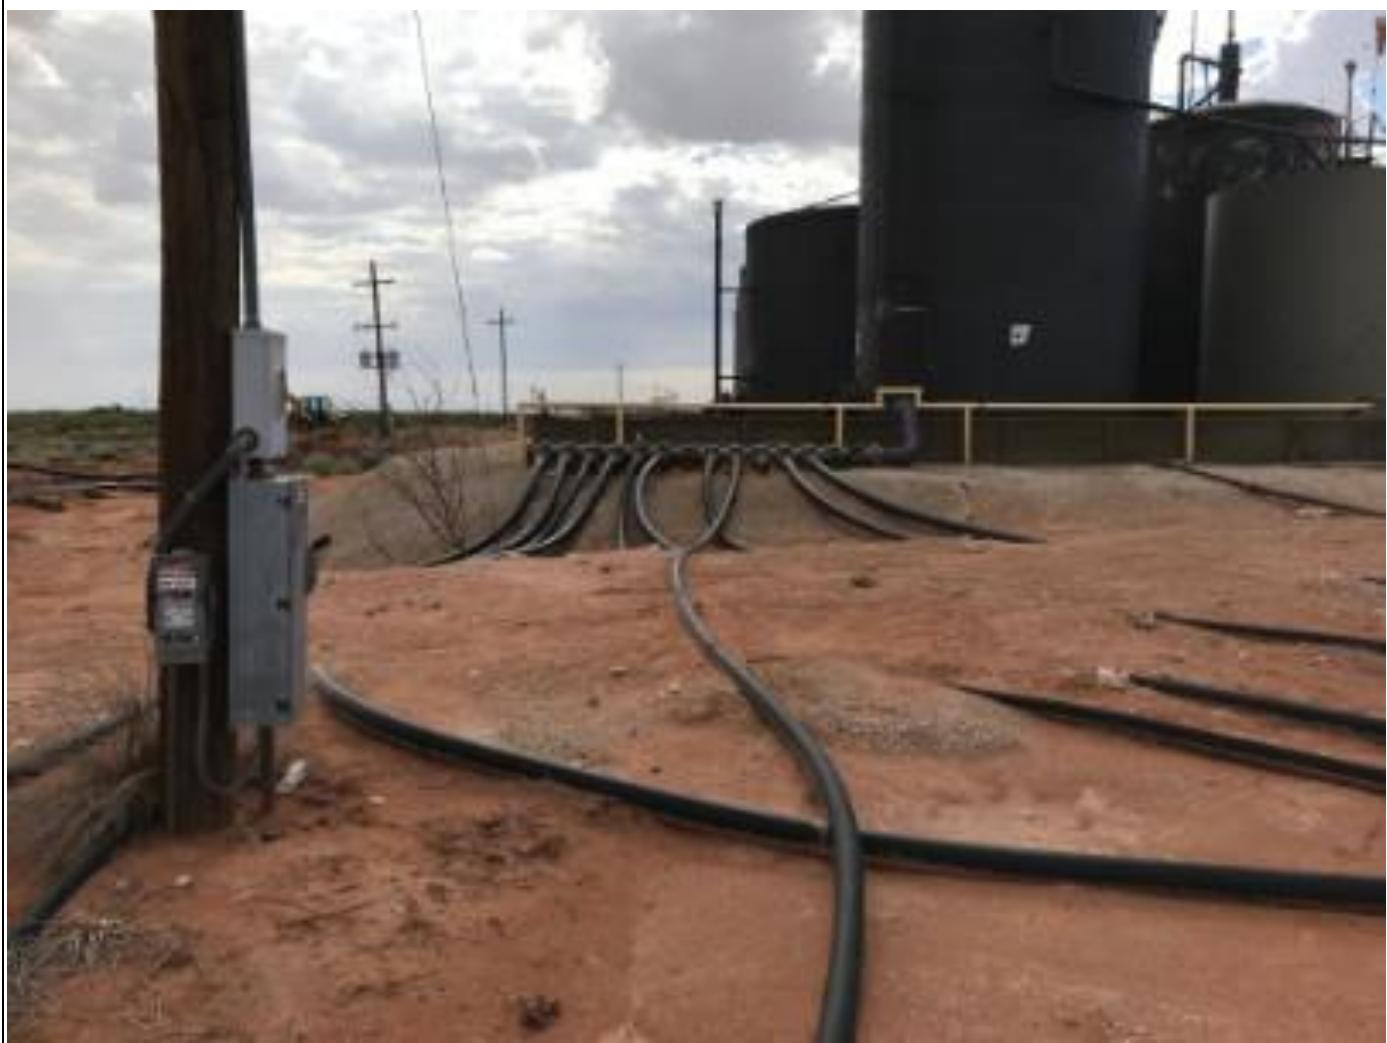
Western view of the release area.
