SUBJECT: SOIL REMEDIATION CLOSURE REPORT FOR THE GOLDEN D FEDERAL #004 (2RP-4551) RELEASE SITE, EDDY COUNTY, NEW MEXICO

On behalf of XTO Energy, Inc. (XTO), Souder, Miller & Associates (SMA) has prepared this CLOSURE REPORT that describes the assessment, initial delineation and remediation for a release associated with the Golden D Federal #004 (2RP-4551). The site is located in UNIT E, SECTION 16, TOWNSHIP 21S, RANGE 29E, NMPM, Eddy County, New Mexico, on Federal and State land. Figure 1 illustrates the vicinity and location of the site. Table 1, below, summarizes information regarding the release.

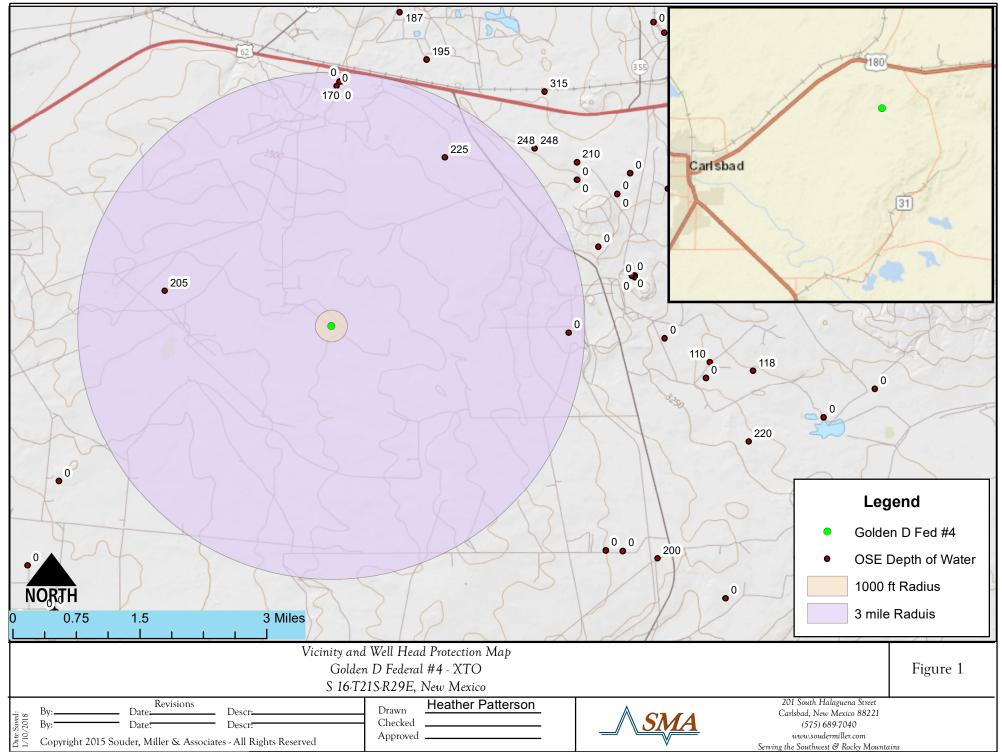
# FIGURE 1 VICINITY AND NMOSE DATA MAP

The release site is located approximately 13 miles east of Carlsbad, with an elevation of approximately 3,344 feet above sea level. SMA searched the New Mexico State Engineer's Office (NMOSE) online water well database for water wells in the vicinity of the release. Several wells are located within a three-mile radius of the site, all of which have a depth of groundwater greater than 100 feet. After further evaluation of the site using aerial photography and topographic maps, depth to groundwater is estimated to be greater than 100 feet below ground surface (bgs).

Recommended Remediation Action Levels (RRALs) are determined by the site ranking according to the NMOCD *Guidelines for Remediation of Leaks, Spills, and Releases* (1993). Below, Table 2 summarizes the remediation standards and the site ranking for this location. Justification for this site ranking is found in Figure 1 and Appendix B.

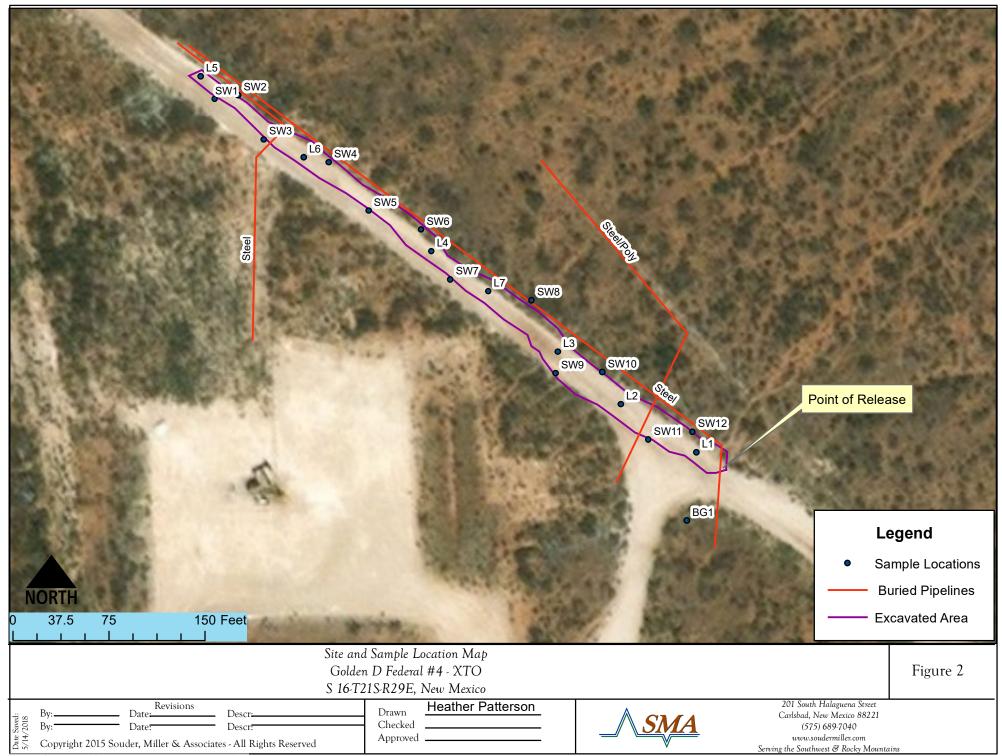
## FIGURE 2 SITE AND SAMPLE LOCATION MAP

On December 21, 2017, SMA field personnel assessed the release area and collected delineation samples. Four sample locations (L1-L4) along the flow path were augured by hand to a maximum depth of two feet bgs. Soil samples were field-screened for chlorides with a mobile titration unit (EPA 4500).

On January 15, 2018, SMA field personnel returned to the site to further delineate vertical contamination at sample locations L1 and L2. These locations were augured by hand to a maximum of three feet bgs due to the confining layer of caliche. The soil samples were again field-screened for chlorides with a mobile titration unit (EPA 4500).

On April 4 and 5, 2018 after approval from area utilities via 811, SMA personnel was on location to guide and oversee the remediation of impacted soils. The area surrounding sample points L1 and L2 was excavated to a total of 4 feet bgs, while the rest of the impacted area was excavated from 3 feet bgs to 0.5 feet bgs, as outlined in Table 3. Three additional locations were sampled (L5-L7), and each location was sampled from the bottom of the excavation. In addition, a total of 12 sidewall samples were collected to ensure horizontal delineation.

Contaminated soils were removed and replaced with clean backfill material to return the surface to previous contours. The contaminated soil was transported for proper disposal at an NMOCD permitted disposal facility.
