Subject: Closure Letter Report

ConocoPhillips

1RP-866

State F-1 Battery Tank Release

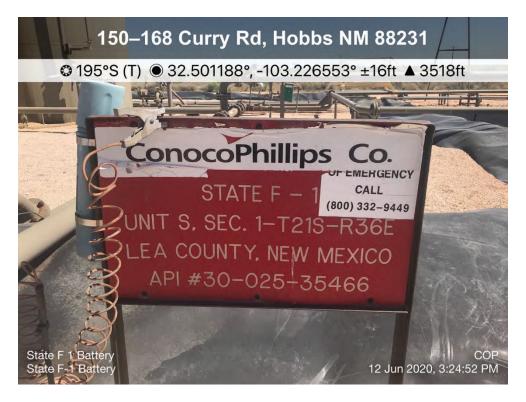
TETRA TECH, INC. PROJECT NO.	DESCRIPTION	View of site signage. Site Coordinates: 32.501188, -103.226553.	1
212C-MD-01796-20	SITE NAME	State F-1 Battery Tank Release	6/12/2020

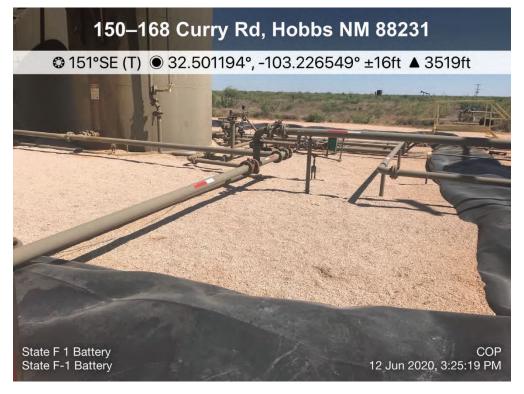
TETRA TECH, INC. PROJECT NO.	DESCRIPTION	View of clean gravel inside of lined, bermed area.	2
212C-MD-01796-20	SITE NAME	State F-1 Battery Tank Release	6/12/2020

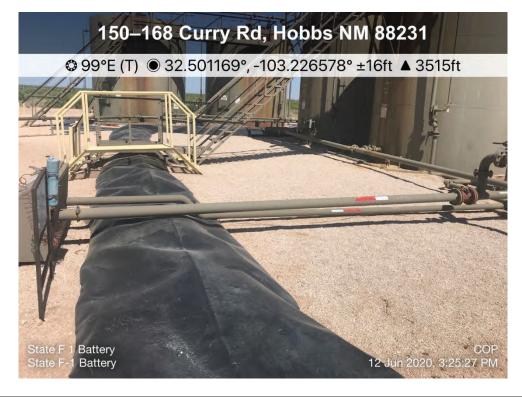
TETRA TECH, INC. PROJECT NO.	DESCRIPTION	View of clean gravel inside of lined, bermed area.	3
212C-MD-01796-20	SITE NAME	State F-1 Battery Tank Release	6/12/2020

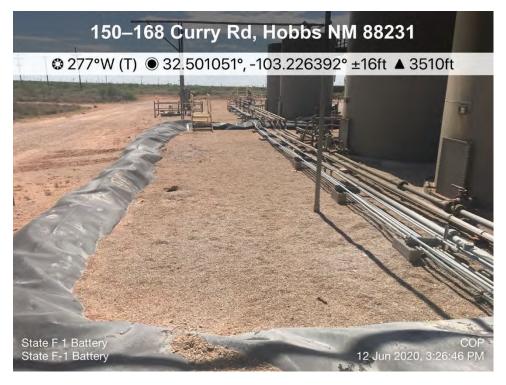
TETRA TECH, INC. PROJECT NO.	DESCRIPTION	View of clean gravel inside of lined, bermed area.	4
212C-MD-01796-20	SITE NAME	State F-1 Battery Tank Release	6/12/2020
