Closure Report

Site Name:	Bravo Dome Leg 7 4RP-11
Company:	Oxy USA Inc.
Legal Description:	U/L G, Section 22, T18S, R35E
County:	Union County, NM
GPS Coordinates:	N 35.76723 W-103.20273

Date of Release:	10/10/16
Type of Release:	Produced water
Source of Release:	Leak in 6" steel pipeline
Volume of Release:	6 bbls
Volume Recovered:	0 bbls

Oxy, Bravo Dome Leg 7
 Leak date: 10/10/16
 Union County, NM
 API# 30-059-20254
 4RP-11

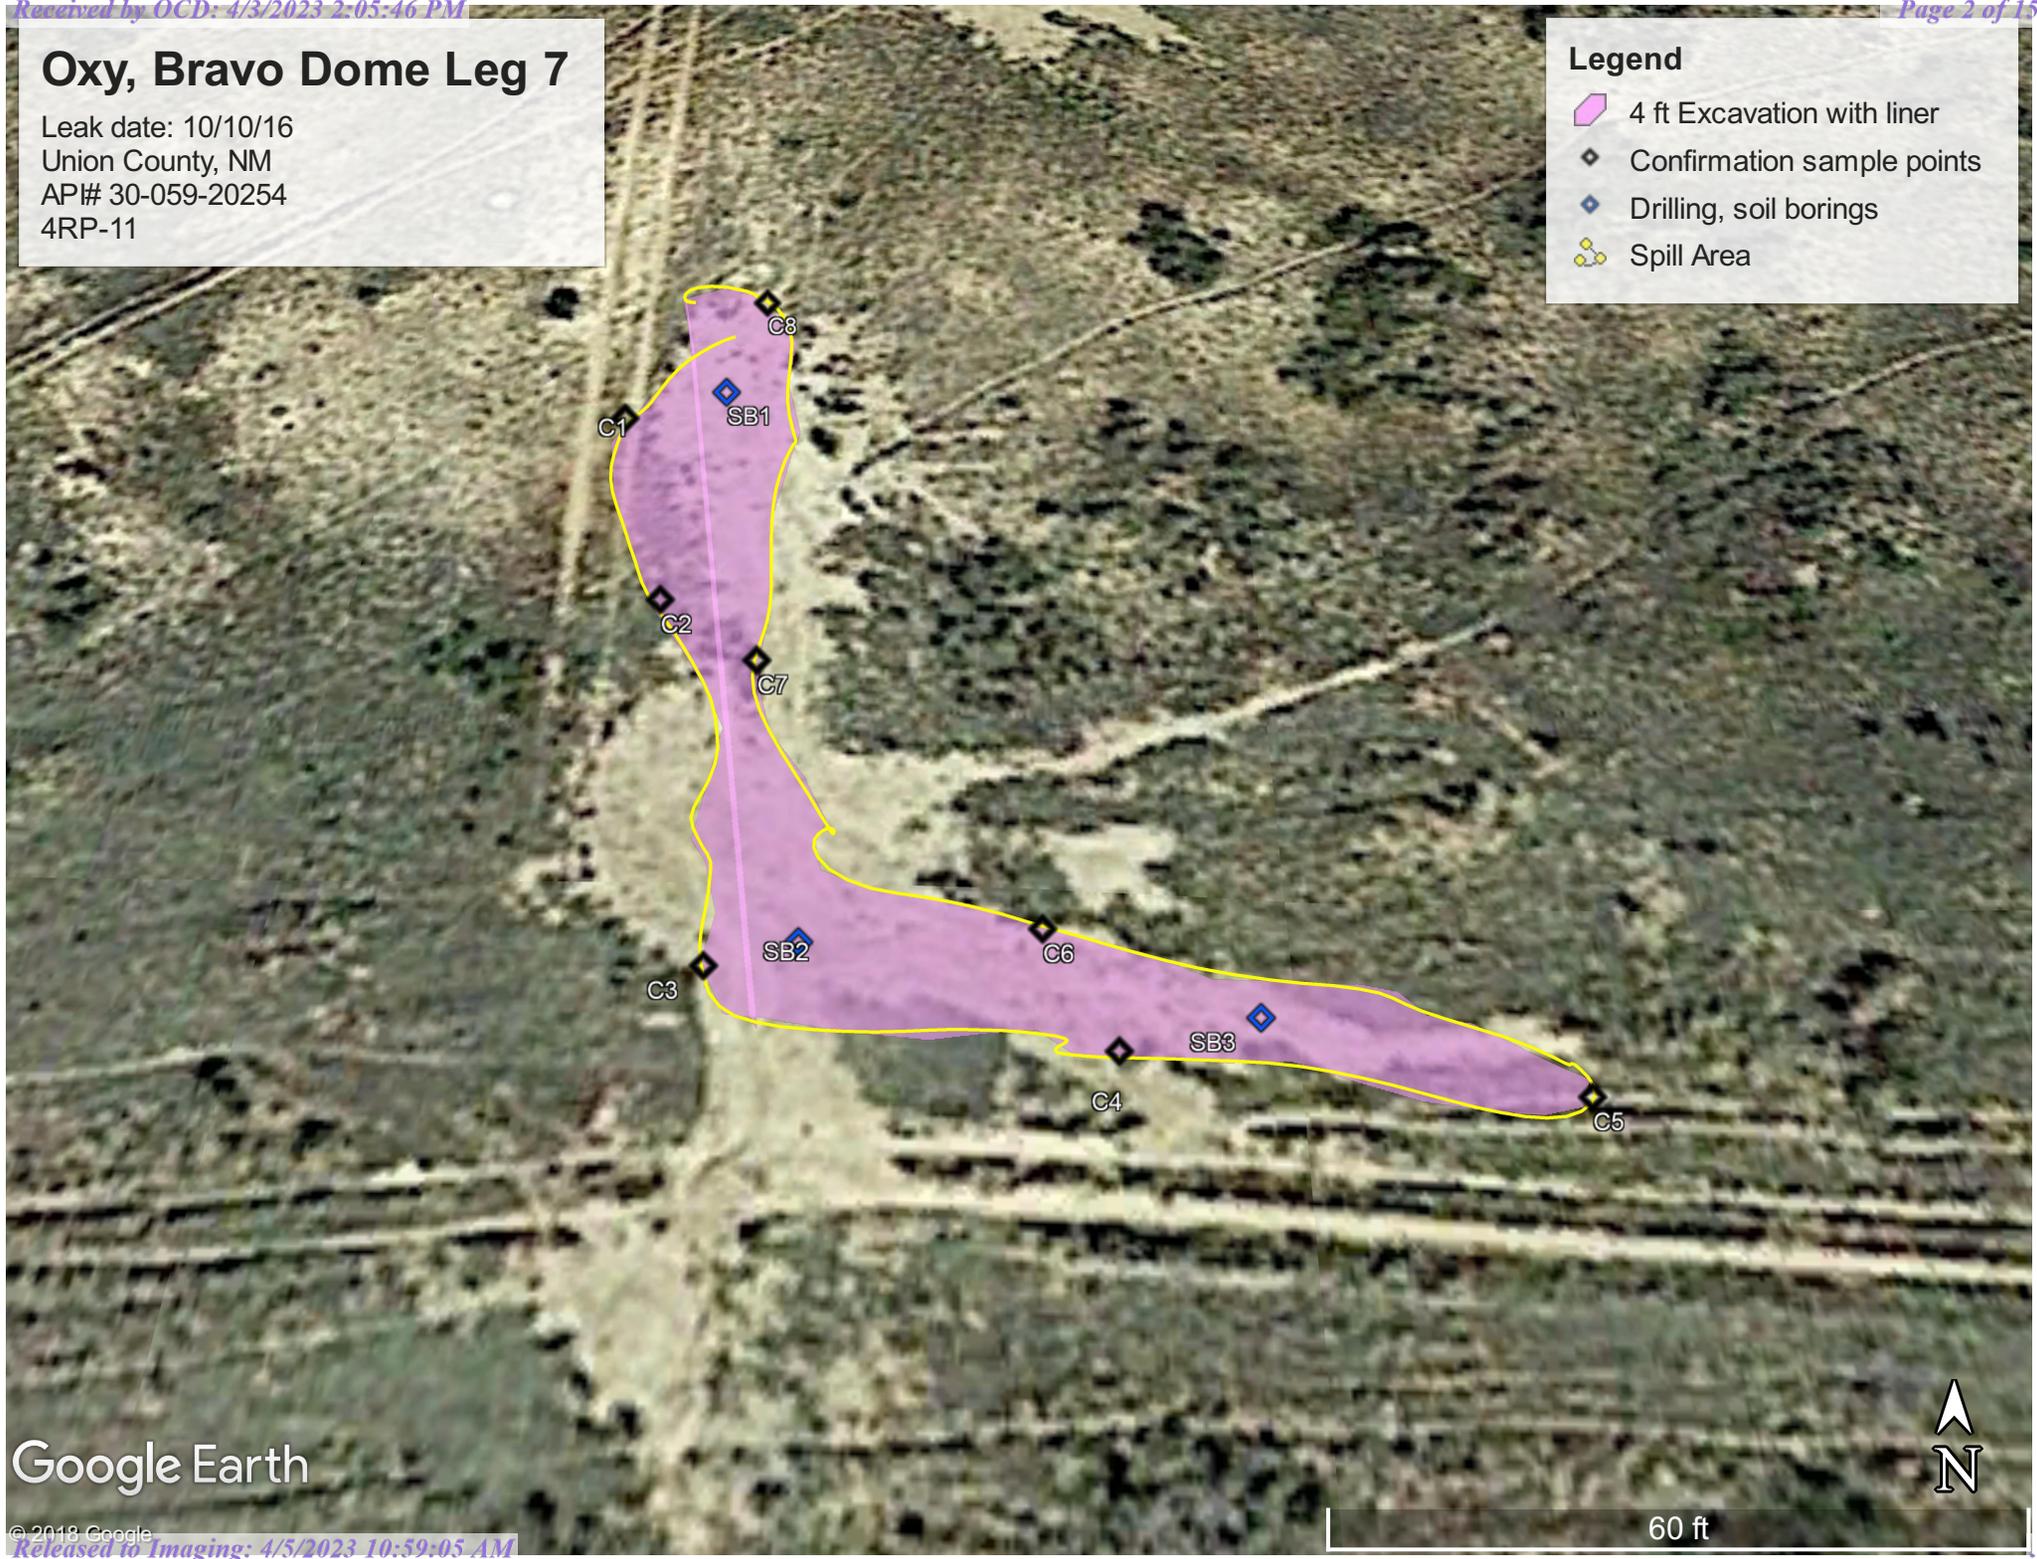
Legend

4 ft Excavation with liner
-

Confirmation sample points
-

Drilling, soil borings
-

Spill Area

Oxy, Bravo Dome Leg 7

Soil Borings, drilling

SB1, N 35.76721 W-103.20268

SB2, N 35.76699 W-103.20264

SB3, N 35.76697 W-103.20248

Confirmation sample points

C1, N 35.76720 W-103.20272

C2, N 35.76712 W-103.20270

C3, N 35.76698 W-103.20267

C4, N 35.76696 W-103.20253

C5, N 35.76695 W-103.20238

C6, N 35.76700 W-103.20256

C7, N 35.76709 W-103.20266

C8, N 35.76726 W-103.20267

Remediation Parameters:	Excavated the entire leak to a depth of 4 feet and placed an impermeable liner in the excavation. Confirmation sidewall samples were obtained to confirm a chloride concentration of less than 600 ppm. The site was then backfilled with clean soil.	
Remediation Activities:	5/6/19 to 5/14/19	
Plan Sent to OCD:	11/7/18	Email from Cliff Brunson to Randolph Bayliss
OCD Approval of Plan:	11/8/18	Email from Randolph Bayliss to Cliff Brunson
Plan Sent to BLM:	n/a	n/a
BLM Approval of Plan:	n/a	n/a

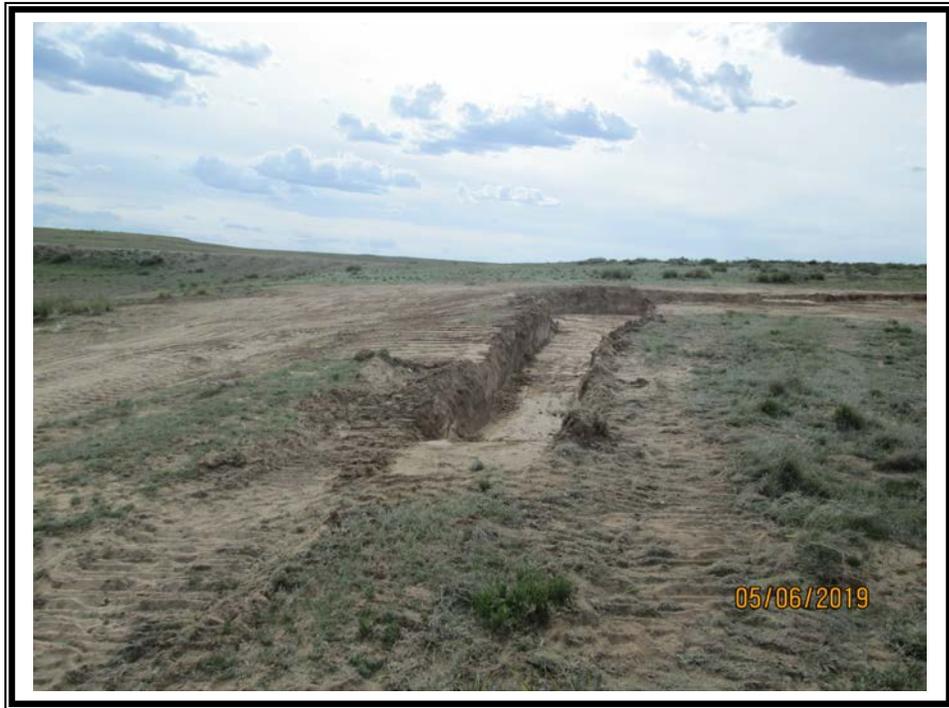
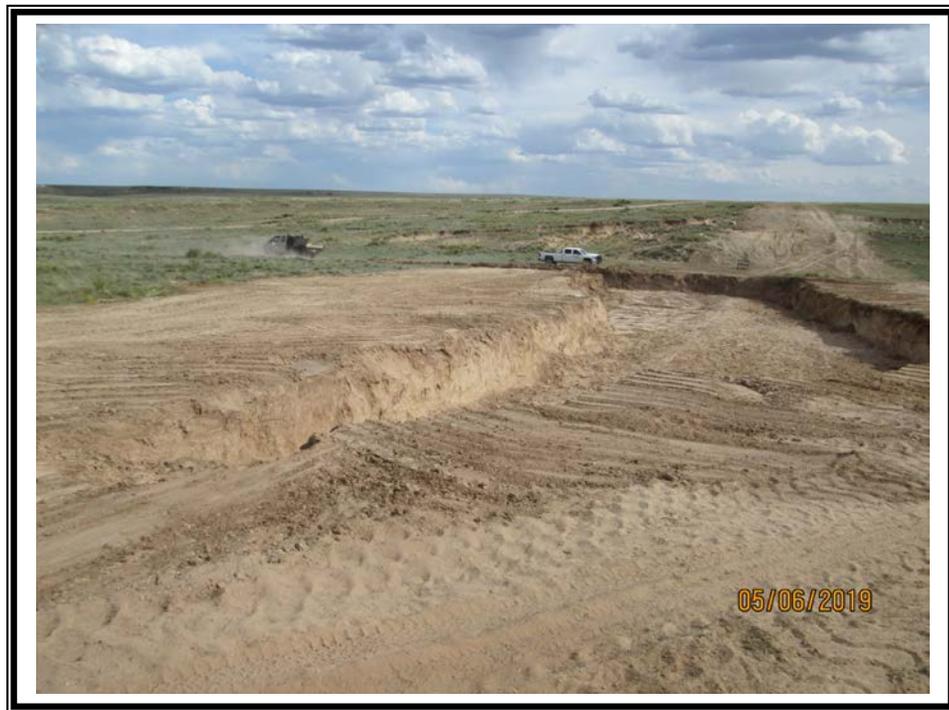
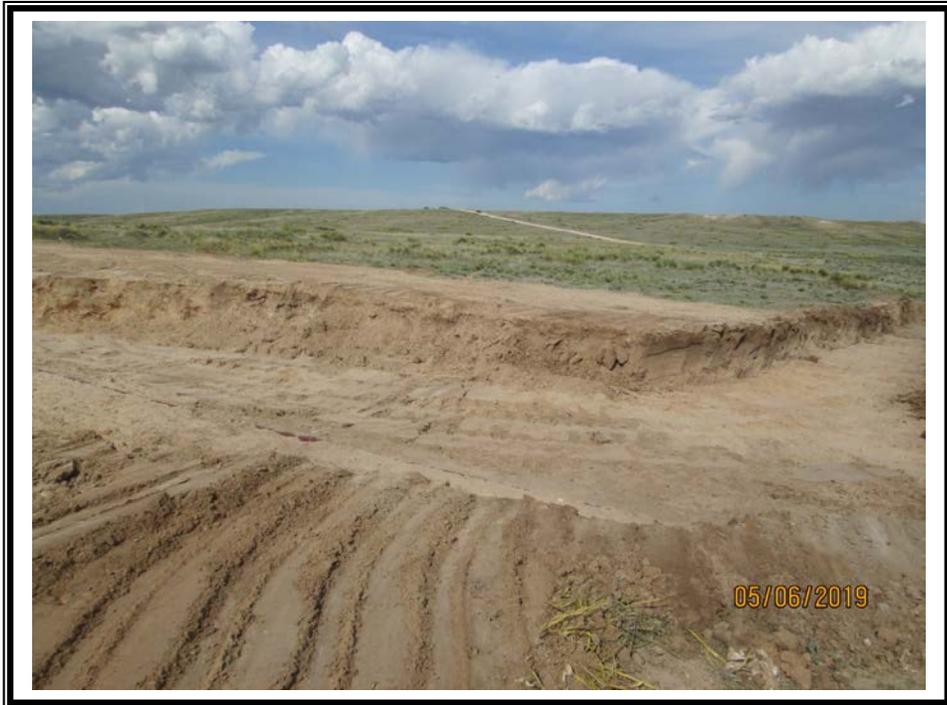
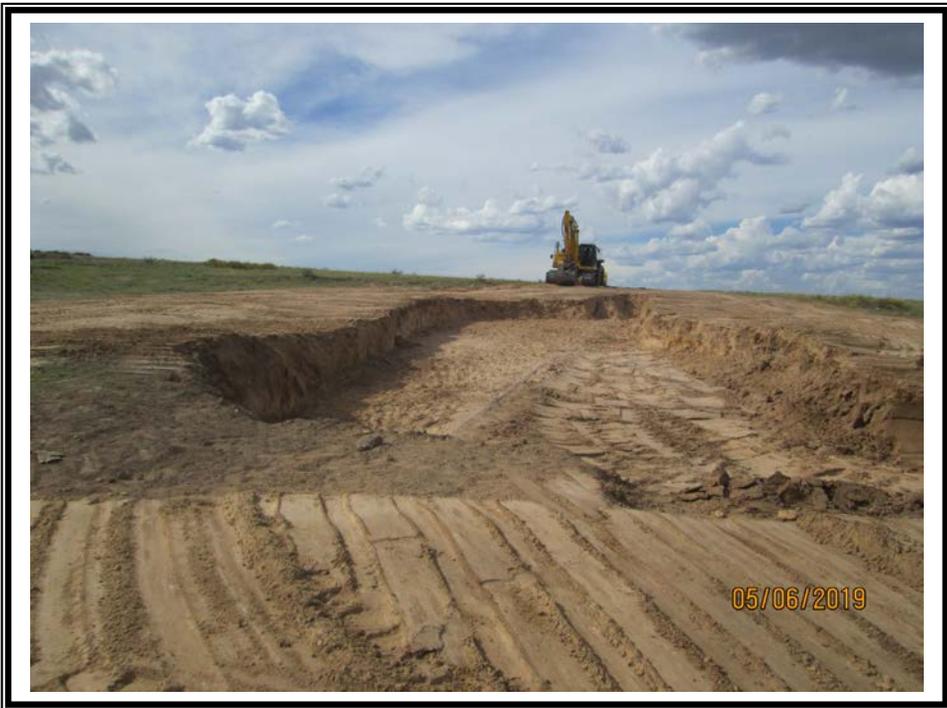
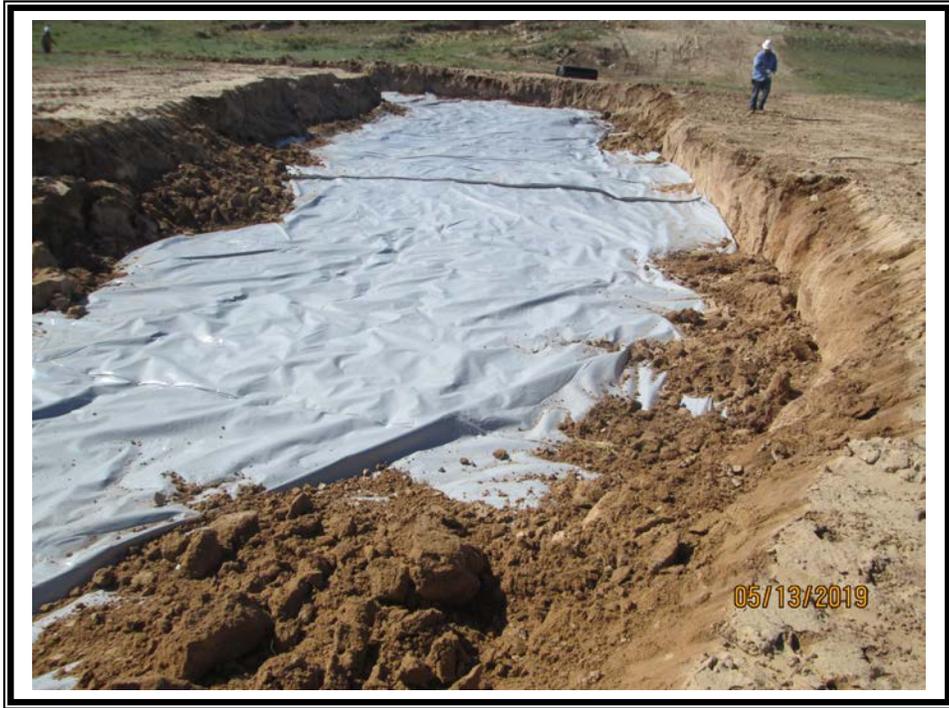
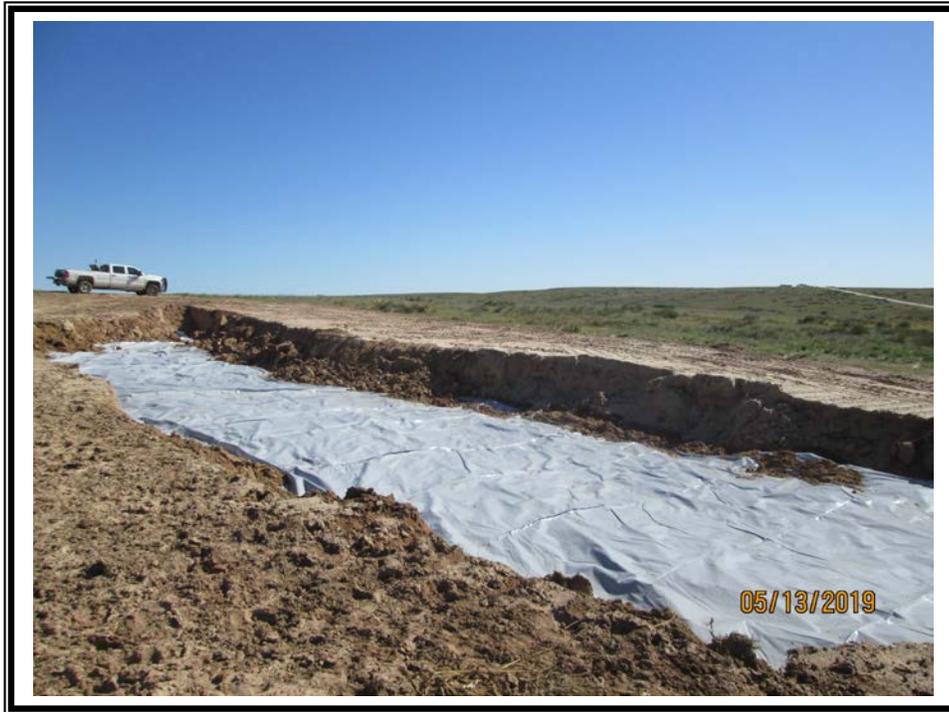
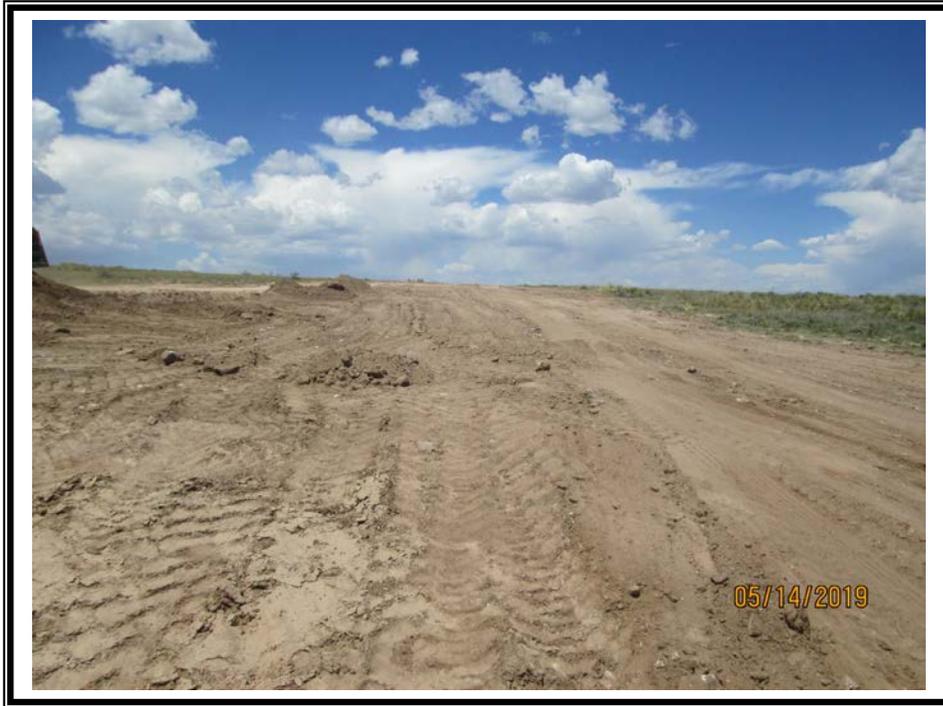
Initial C-141	Provided in the delineation workplan
C-141, page 6	Signed and included
Site Diagram	November 2018
Pictures	Remediation pictures prior to and after backfill
