**EOG Resources, Inc.**  
Artesia Division Office  
104 S. 4<sup>th</sup> Street  
Artesia, N. M. 88210

Re: Donahue Federal SWD #1  
30-015-00087  
Section 10, T20S-R24E  
Eddy County, New Mexico

# Figure 1

***Characterization Plan***

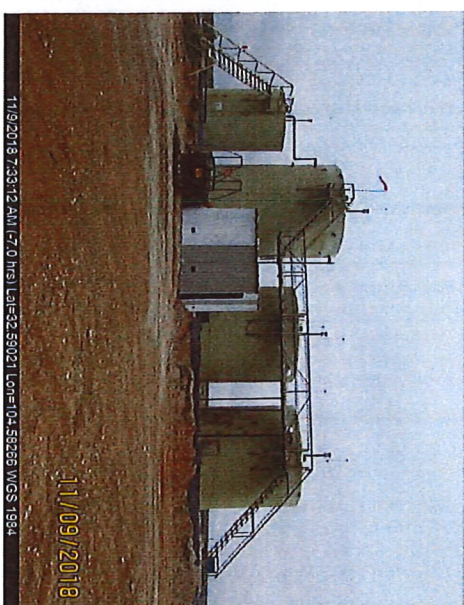
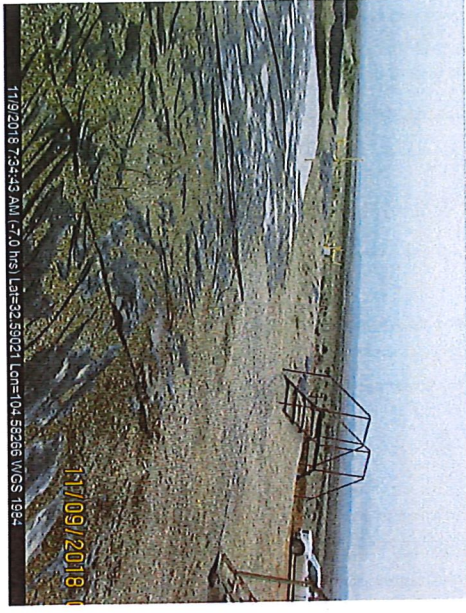
## Figure 2

EOG Y Resources, Inc. has visually inspected the liner where the release occurred and the liner remains intact and had the ability to contain the leak in question.

The release occurred within a lined containment area, EOG Y Resources, Inc. demonstrated liner integrity after affected material is removed and the affected area of the liner is exposed and is providing certification on form C-141.

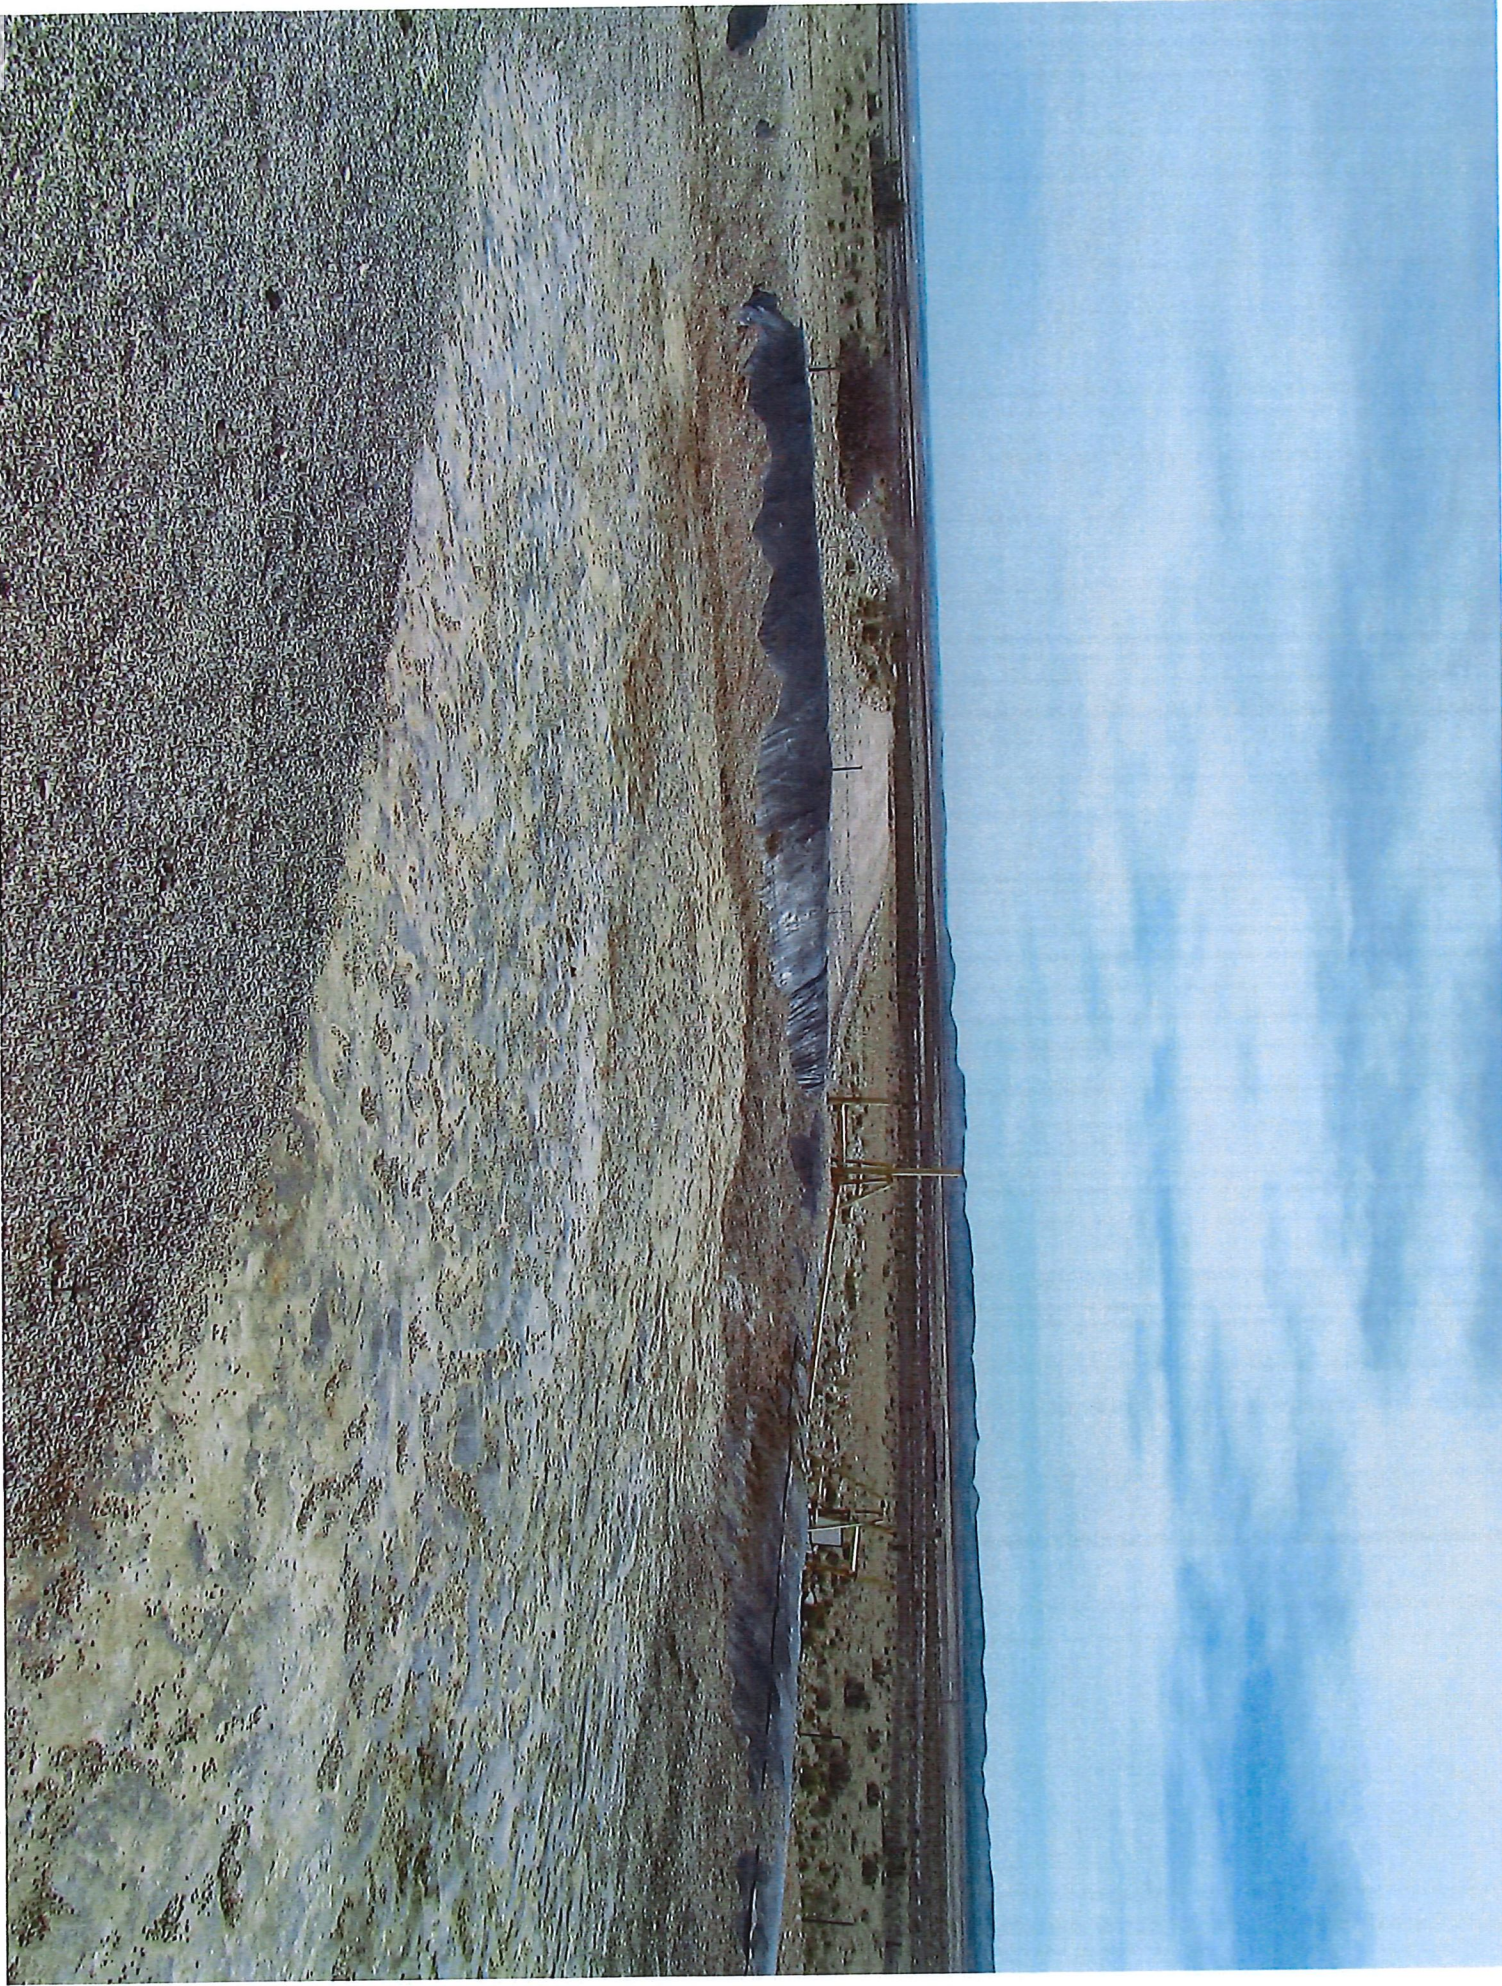
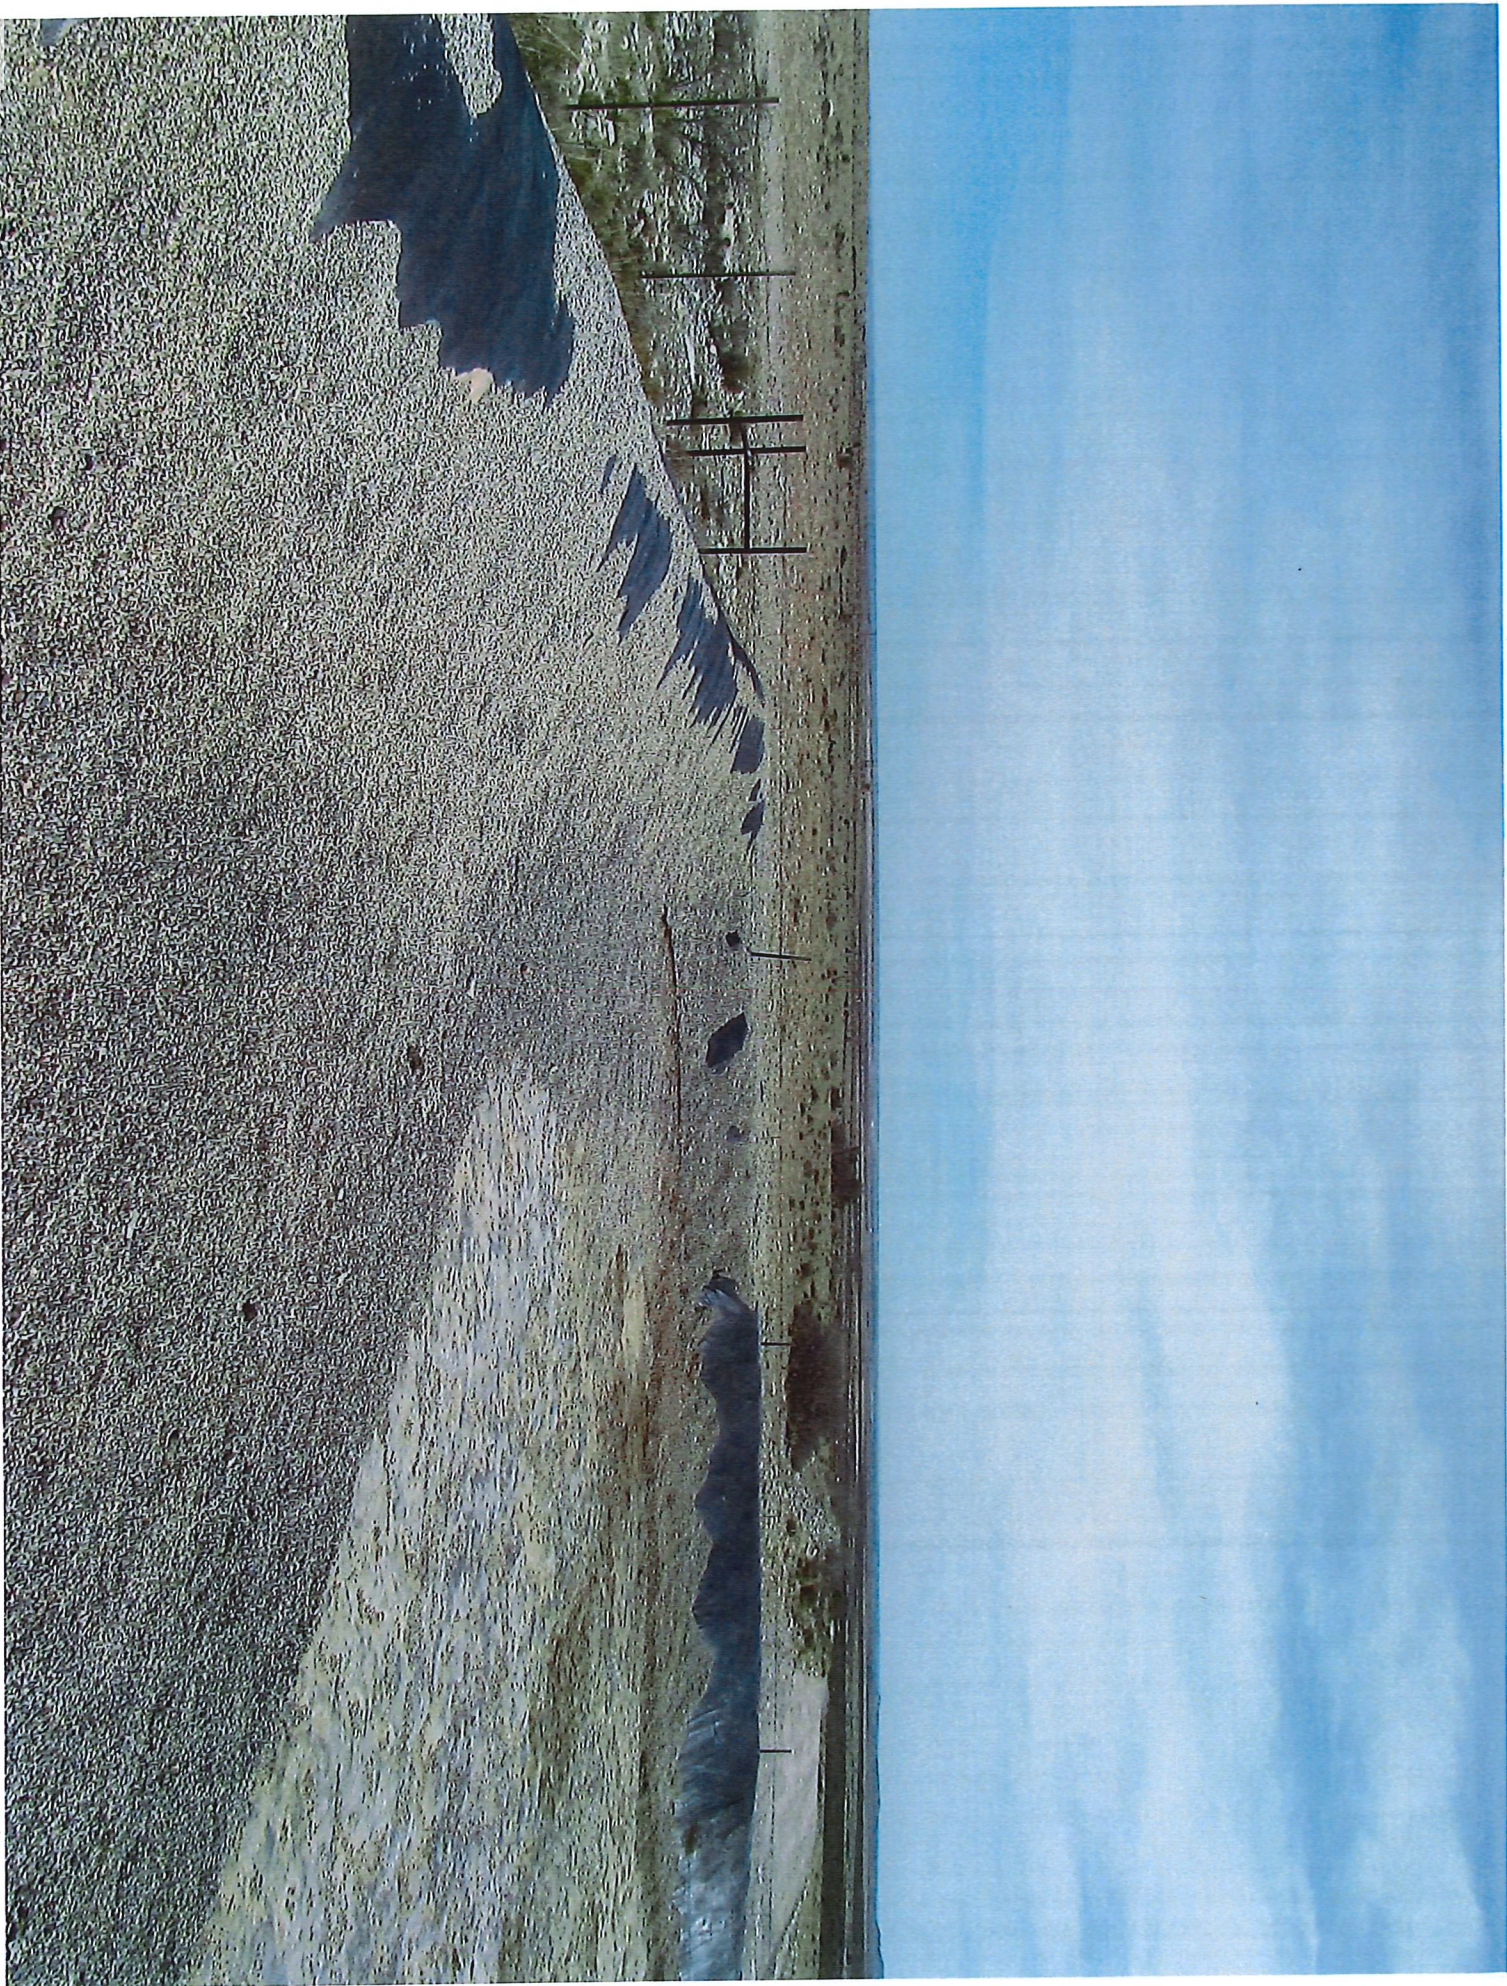
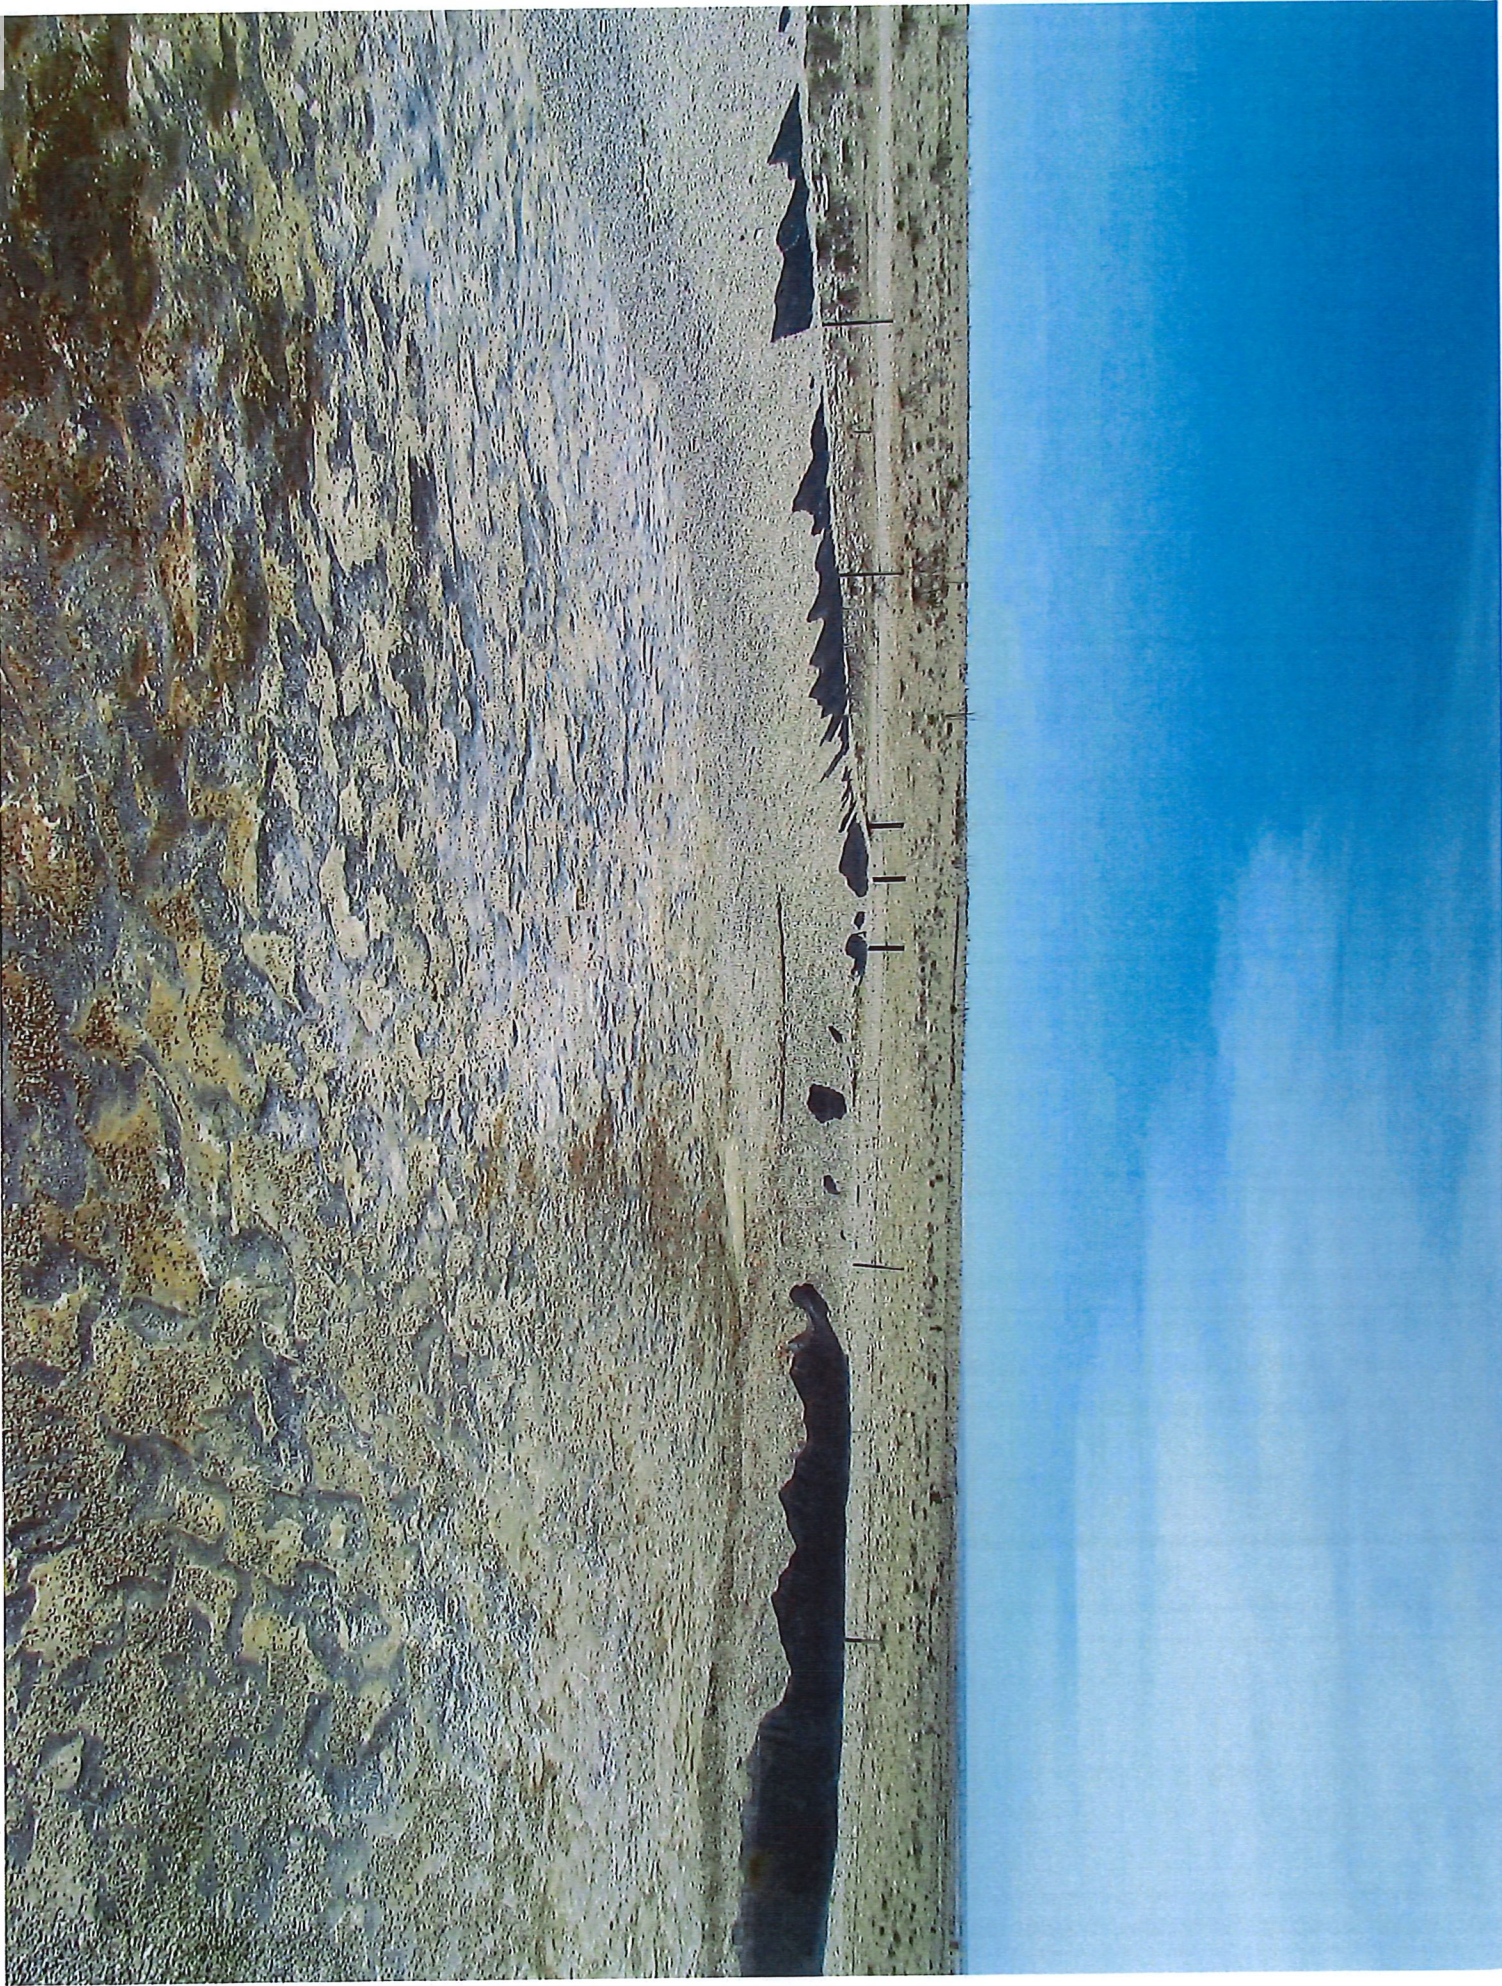
## Photos

DONAHUE #7  
"S W D"

Sec. 10 - T 20 S - R 24 E - Unit E

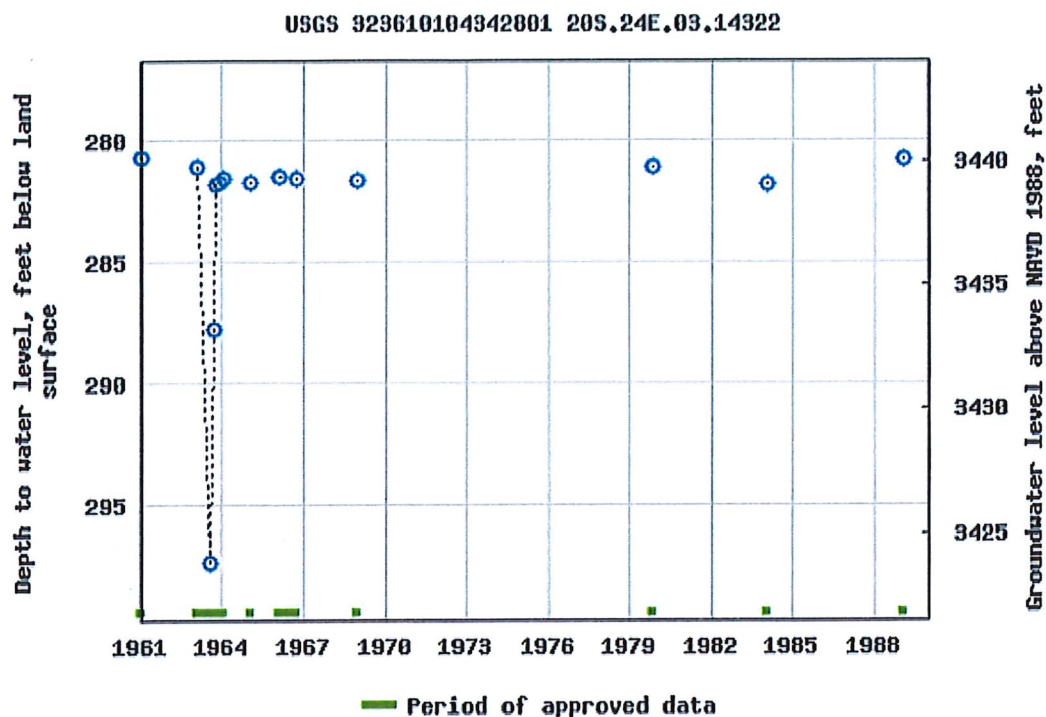
Breaks in the plot represent a gap of at least one year between field measurements.
