Remediation Summary & Closure Request

Property:
Concho Operating, LLC.
Cottonwood 36 State SWD #1
Eddy County, New Mexico
Unit Letter "K", Section 35, Township 25 South, Range 26 East
Latitude 32.0844536, Longitude -104.2486954
2RP-3695

December 2017

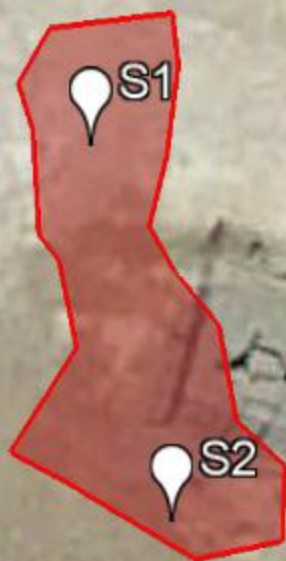
Figure 3

On June 15, 2016, COG personnel responded to a reportable release that occurred on May 6, 2016. Five (5) bbls of produced water were released directly to the ground caused when the threading collar above the master valve washed out on the wellhead. Three (3) bbls of the fluid was recovered. The release impacted approximately two hundred (200) square feet of production pad area (Figure 3).

Release Footprint
-

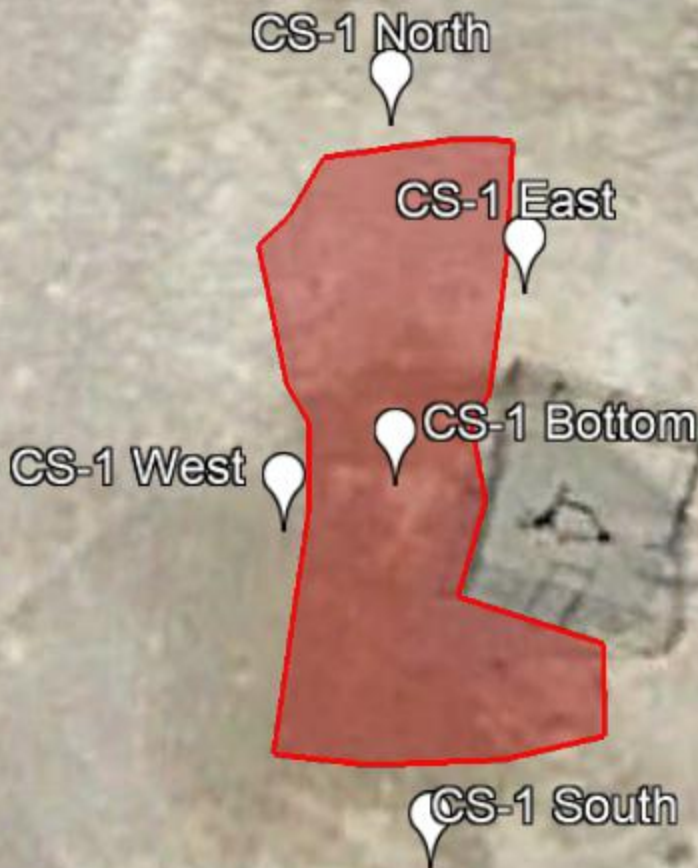
Figure 4 shows the approximate location of the sampling (i.e., Auger Hole, Sidewall and Trench) locations and dimensions of the previously excavated area in relation to pertinent land features and general Site boundaries, which is included in Appendix A.

1' Excavation
-

Confirmation sampling to confirm the horizontal extent of the release was conducted on November 21, 2017. A total of five (5) samples were collected, a horizontal delineation sample in each perspective cardinal direction (CS-1 North, CS-1 South, CS-1 East and CS-1 West) and an excavated bottom (CS-1 Bottom). The Confirmation samples were collected for Chloride, all confirmation samples were below NMOCD guidelines.
