## Site Assessment/Characterization

## Closure

**Re: Site Assessment and Closure Report**  
**Gaicho Unit 30 CTB 1**  
**API No. N/A**  
**GPS: Latitude 32.360399 Longitude -103.501803**  
**UL I, Sec. 30, T22S, R34E**  
**Lea County, NM**  
**NMOCD Ref. No. NAPP2123141845**

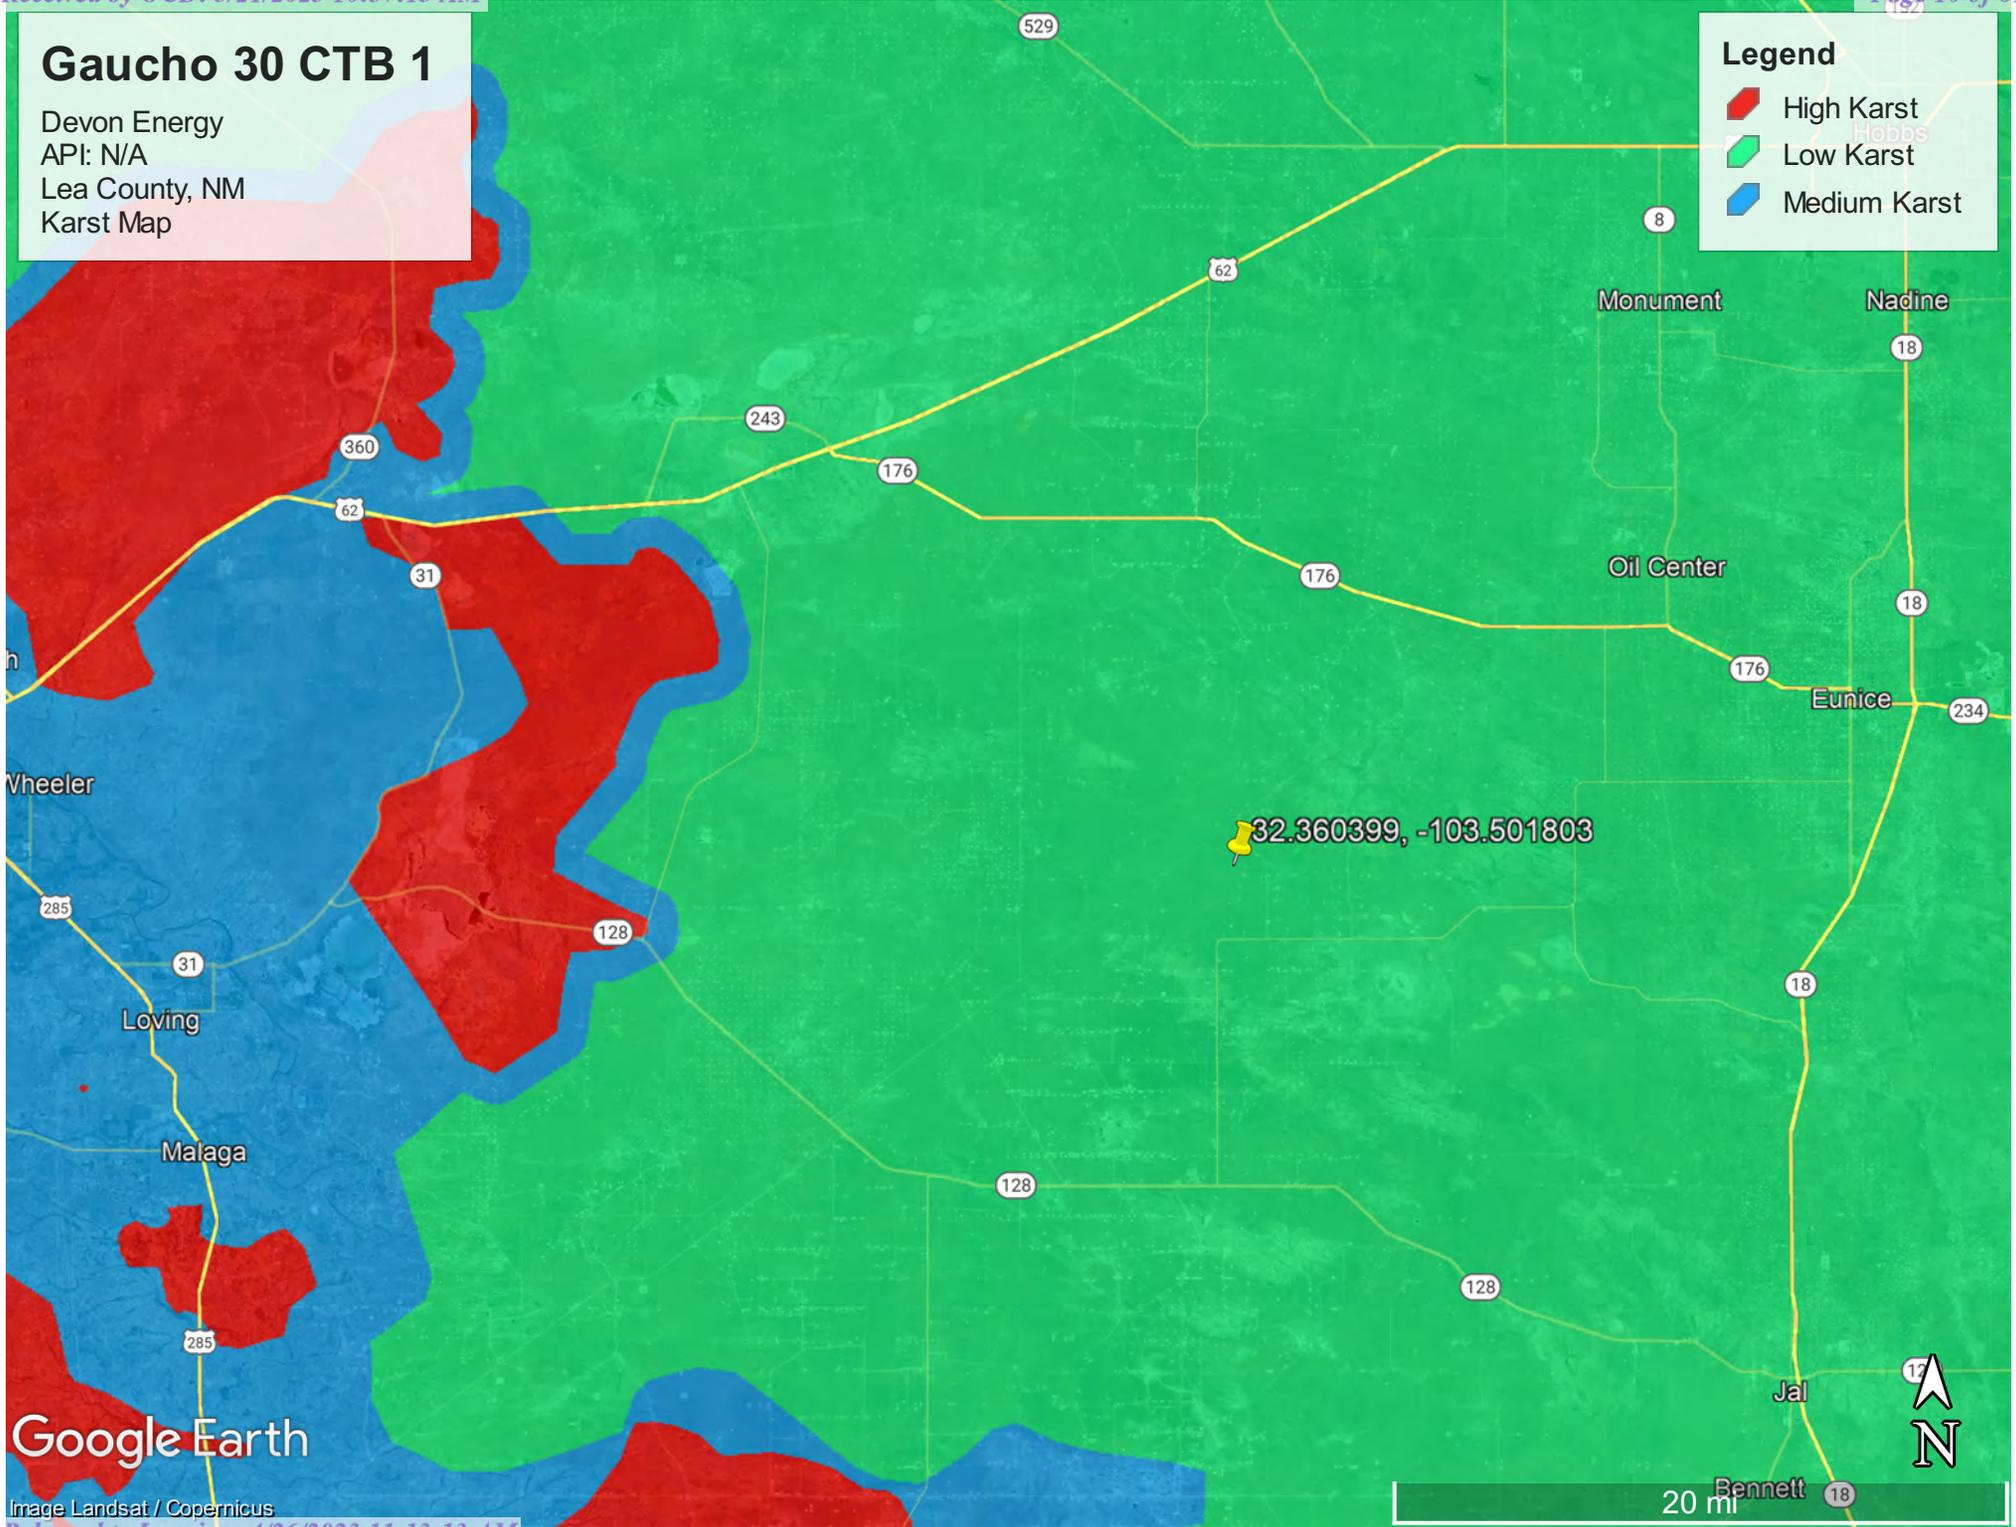
Devon Energy  
API: N/A  
Lea County, NM  
Karst Map

Per the New Mexico Bureau of Geology and Mineral Resources, the geology is made up of Interlayered eolian sands and piedmont-slope deposits along the eastern flank of the Pecos River valley, primarily between Roswell and Carlsbad. Typically capped by thin eolian deposits. May locally include uppermost Eolian and piedmont deposits. The soil in this area is made up of Wink Fine sand, 0 to 3 percent slopes according to the United States Department of Agriculture Natural Resources Conservation Service soil survey (Appendix B). The drainage courses in this area are well drained. There is a low potential for karst geology to be present around the Gaicho (Figure 3).

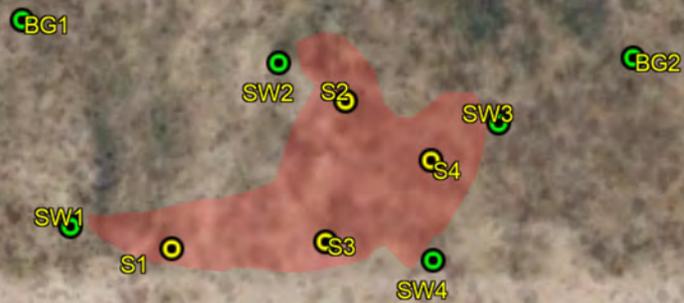
Devon Energy  
API# N/A  
Lea County, NM  
Sample Map  
NAPP2123141845

On July 14, 2022, Pima mobilized personnel to the site to assess the area. We sampled the impacted area. Laboratory results of this sampling event can be found in the following data table. A Site Map can be found in Figure 4.

Based on the soil sample results, the contamination levels are already less than the regulatory limits of the most stringent criteria in Table 1 of NMAC 19.15.29.1.

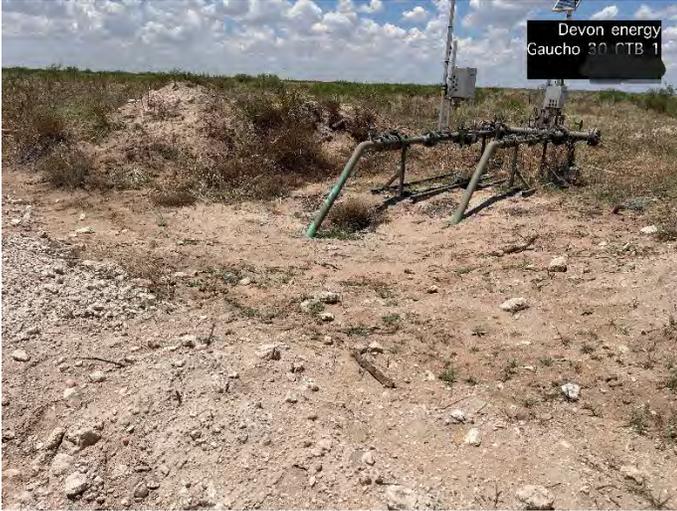
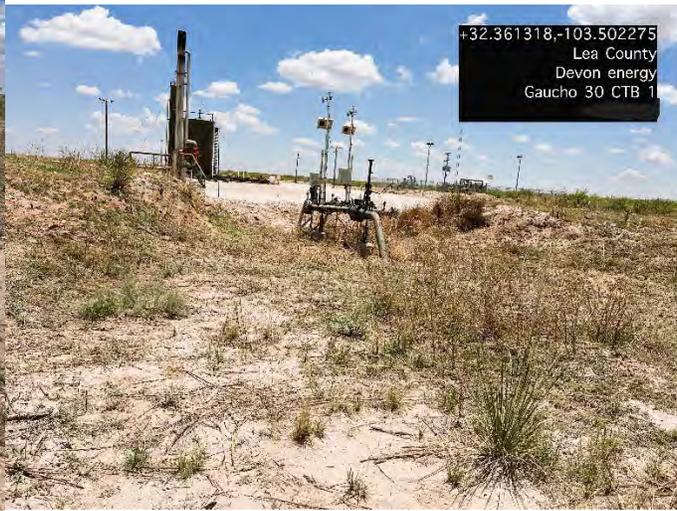
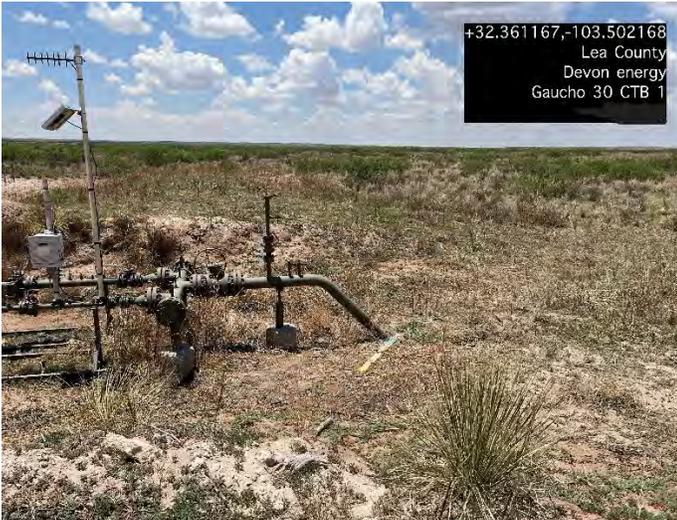
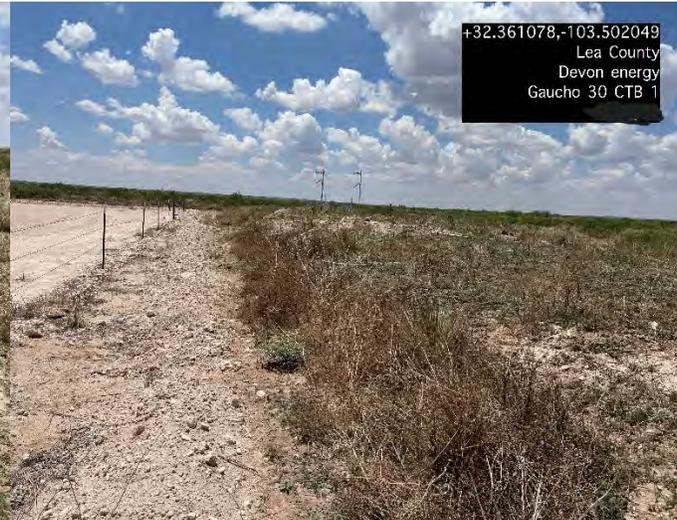
**SITE PHOTOGRAPHS  
DEVON ENERGY  
GAUCHO 30 CTB 1**

**NAPP2123141845:** On August 6, 2021, a water line developed a leak causing a fluid release. The released fluids were calculated to be approximately 6 barrels (bbls) of produced water and 2.46 barrels (bbls) of Crude Oil. A vacuum truck was able to recover approximately 5.46 bbls of total fluid from the impacted area.
