Closure Report
Red Hills Unit #21H
Incident ID: nAPP2302952170
Lea County, New Mexico
Unit A Sec 33 T25S R33E
32.09306°, -103.57151°

Crude Oil and Produced Water Release

Point of Release: Gasket failure on the 2" line on top of the wellhead compressor

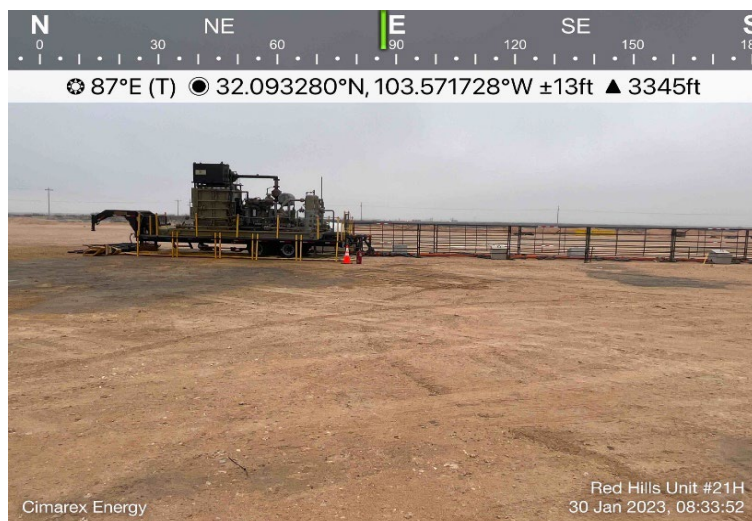
Photograph No. 1

View East, area of impact.

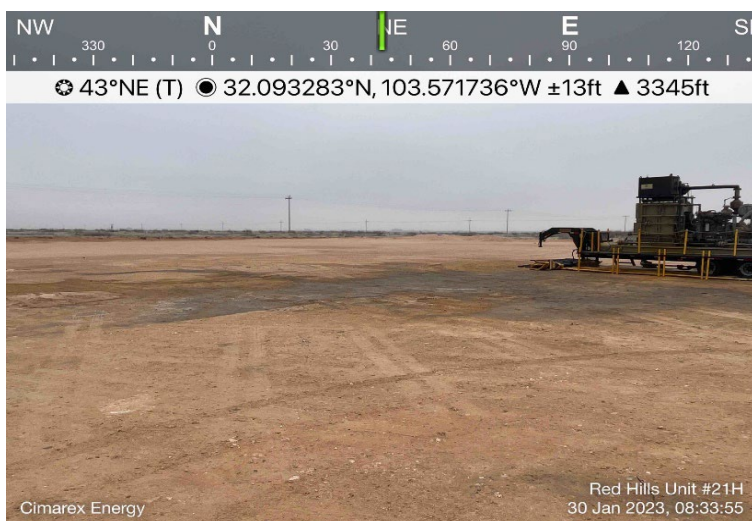
Photograph No. 2

View Northeast, area of impact.

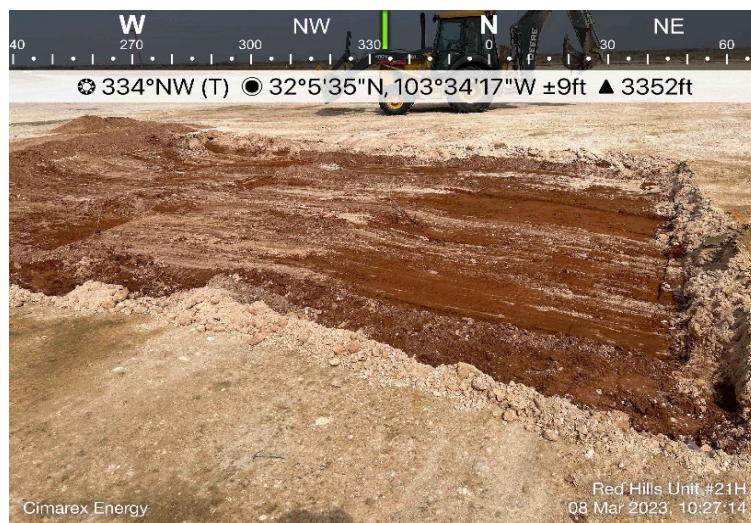
Photograph No. 3

View Northwest, area of CS-1 through CS-5.

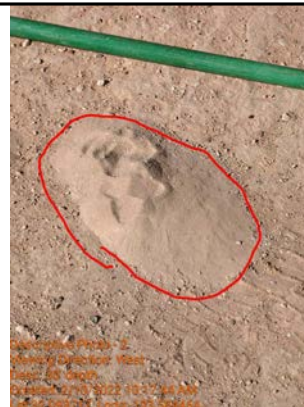
30' depth

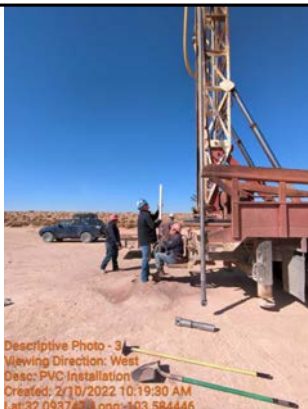
PVC Installation

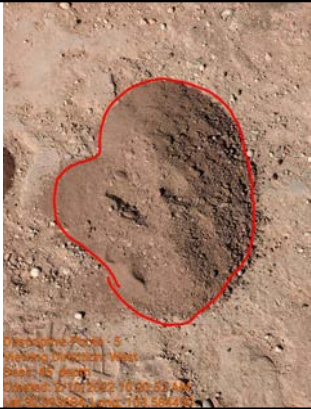
<p>Descriptive Photo - 5 Viewing Direction: West Desc: 45' depth Created: 2/10/2022 10:28:39 AM Lat: 32.053649 Long: -103.584455</p> <p>45' depth</p>	<p>Viewing Direction: West</p>

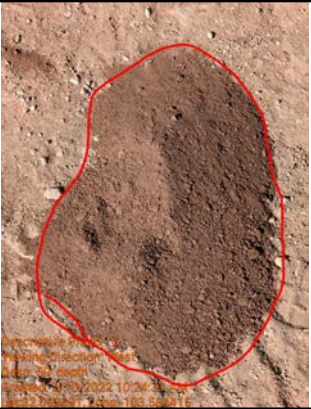
<p>Descriptive Photo - 6 Viewing Direction: West Desc: 50' depth Created: 2/10/2022 10:28:39 AM Lat: 32.053649 Long: -103.584455</p> <p>50' depth</p>
<p>Viewing Direction: West</p>

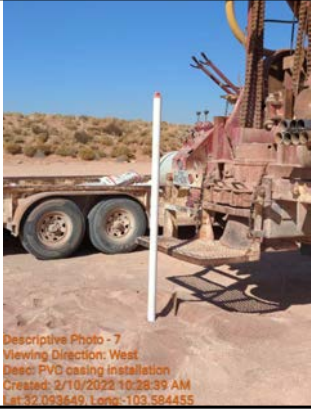
<p>Descriptive Photo - 7 Viewing Direction: West Desc: PVC casing installation Created: 2/10/2022 10:28:39 AM Lat: 32.053649 Long: -103.584455</p> <p>PVC casing installation</p>	<p>Viewing Direction: North</p>

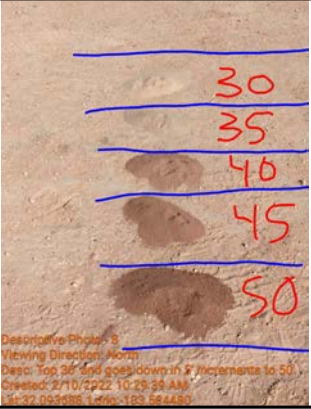
<p>Descriptive Photo - 8 Viewing Direction: North Desc: Top 30' and goes down in 5' increments to 50' Created: 2/10/2022 10:29:39 AM Lat: 32.053649 Long: -103.584455</p> <p>Top 30' and goes down in 5' increments to 50'</p>
