CLOSURE REPORT

Trunk 2C (09/30/22)
Unit Letter A, S10 T27N R11W
San Juan County, New Mexico

New Mexico EMNRD OCD Incident ID No. NAPP2227628237

Ensolum Project No. 05A1226215

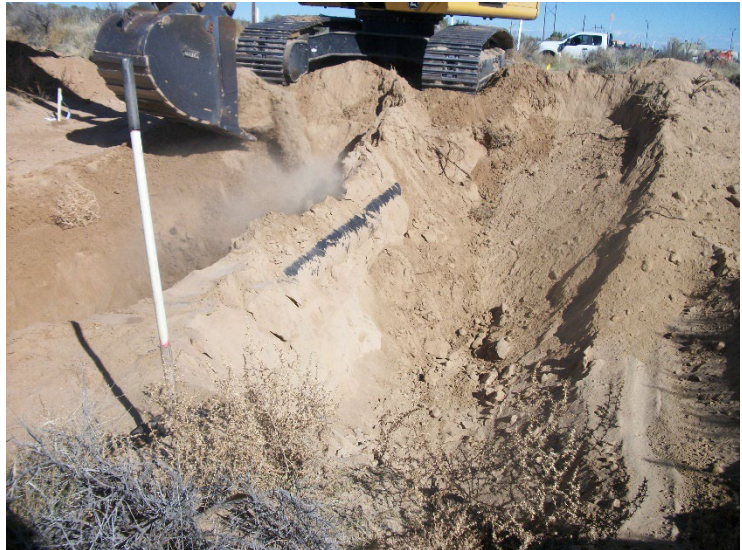
**Photograph 1**

Photograph Description: View of the in-process excavation activities.

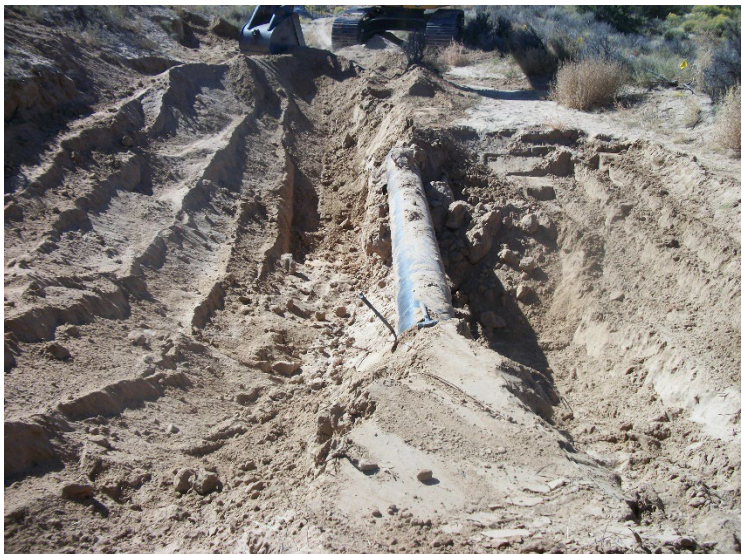
**Photograph 2**

Photograph Description: View of the in-process excavation activities.

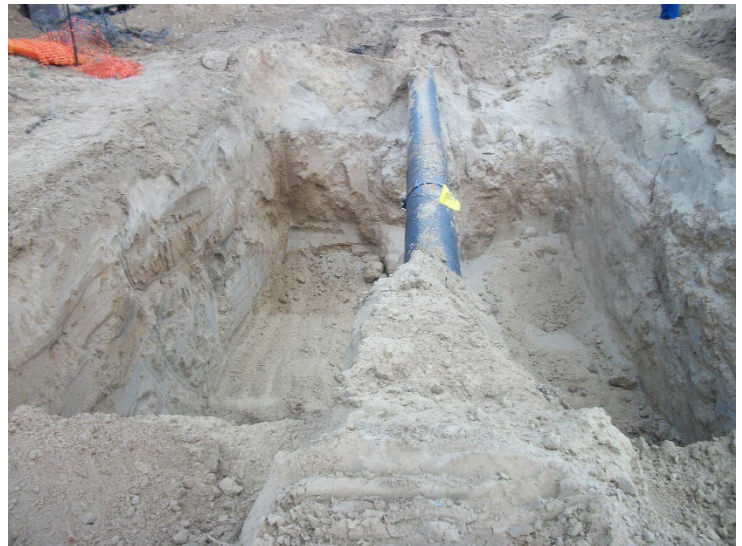
**Photograph 3**

The final excavation measured approximately 18 feet long and 18 feet wide at the maximum extents. The maximum depth of the excavation measured approximately eight feet bgs. The lithology encountered during the completion of remediation activities consisted primarily of silty sand.

Photograph Description: View of the final excavation.

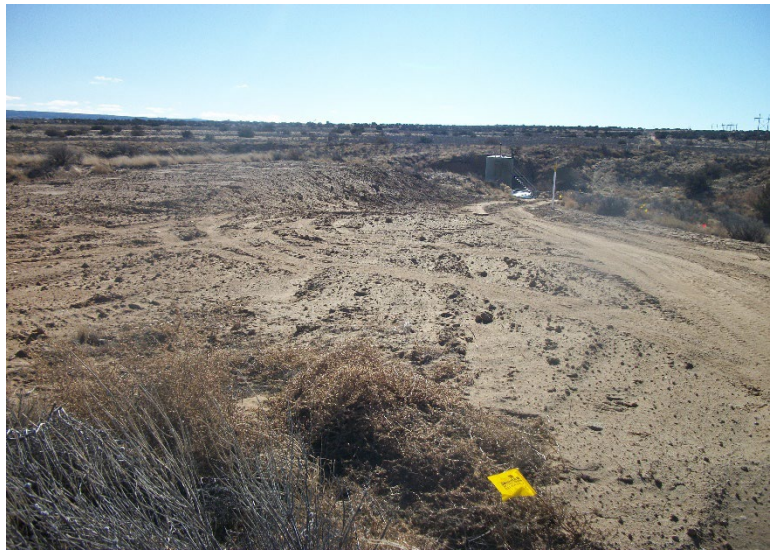
Photograph 4

Photograph Description: View of the site after initial restoration.

The excavation was backfilled with imported fill and then contoured to the surrounding topography. Enterprise will re-seed the Site with an approved seeding mixture.
