**Re: Liner Inspection and Closure Request  
ConocoPhillips (Heritage Concho)  
Airbonita Federal 12 #1H – Tank Battery Release  
Unit Letter P, Section 12, Township 22 South, Range 32 East  
Lea County, New Mexico  
Incident ID# NAPP2303039766**

Liner Inspection and Closure Report  
April 7, 2023

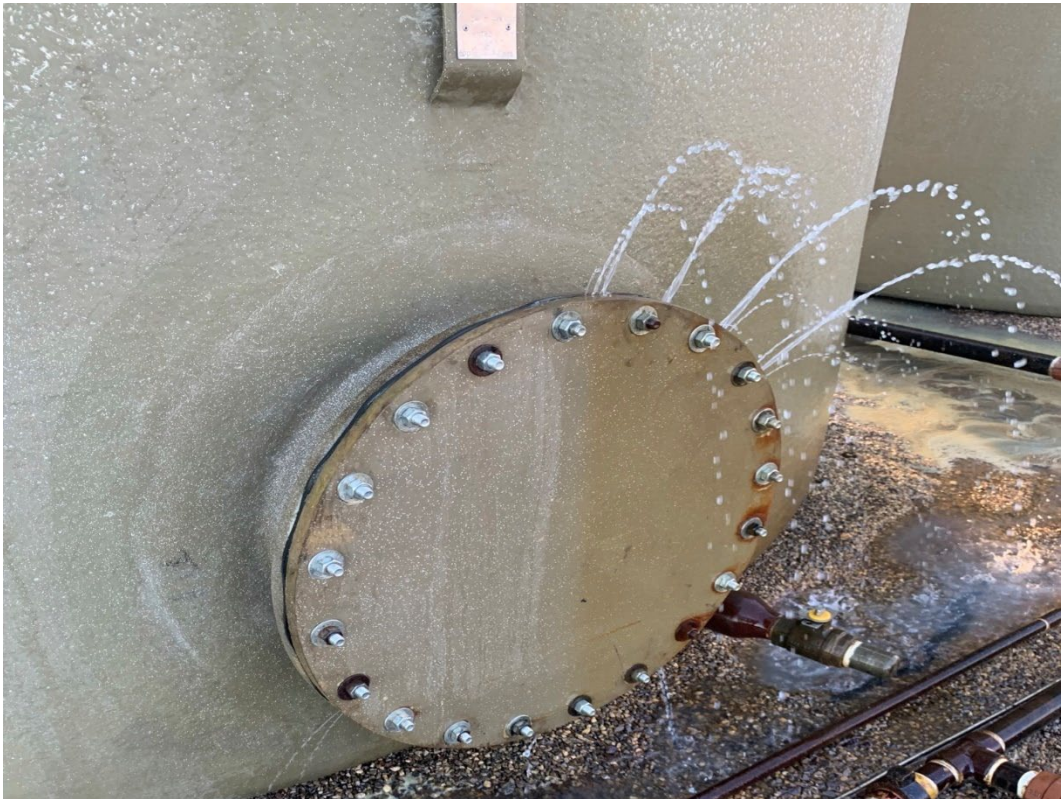
According to information provided in the C-141, the release was caused when a tank gasket failed on January 26, 2023. The C-141 stated that the full release extent was noted as on-pad. The provided L48 spill calculator estimates 41.7 bbls released. 38 bbls were recovered out of the 41.7 bbls of PW. A partial release extent was identified based on information provided by ConocoPhillips representatives and review of photographs. Based on provided information, COP personnel went to check the water transfer meter and saw standing fluid in containment. The tank was observed leaking between lid and gasket. From photos, the release footprint appeared to have been contained within the lined containment area. The GPS in the C-141 is inside the containment, south of the battery.

TETRA TECH, INC. PROJECT NO. 212C-MD-03040	DESCRIPTION	Close up view of tank valve leak.	2
	SITE NAME	Airbonita 12 Federal Com #001H Tank Battery Release	1/26/2023

On March 6, 2023, COP Operations personnel, as a proactive release response, removed impacted gravel within the battery facility, cleaned the exposed liner, and replaced clean base course material. This work was completed prior to the liner inspection could be officially completed by Tetra Tech.

The base course material that was saturated or visibly stained was removed and properly disposed of at an approved facility. Through a scheduling oversight, Tetra Tech personnel were not onsite during this gravel cleanout. However, COP personnel did provide photos of the work, before, during and after completion. Photographic documentation of the February 2023 remedial activities is included in Appendix C.

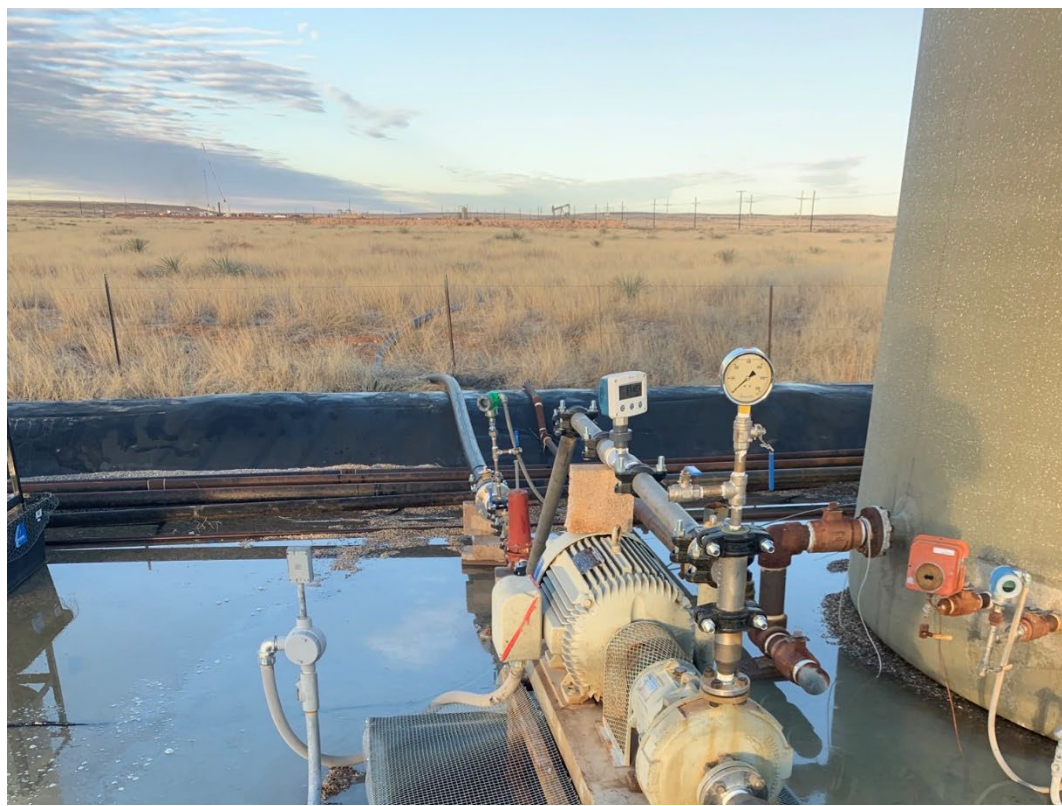
Based on photographs of the release area immediately following the release discovery, the released fluids pooled within the secondary containment allowing substantial recovery of fluids by vacuum truck. The

TETRA TECH, INC. PROJECT NO. 212C-MD-03040	DESCRIPTION	View west of pooling at battery pump.	3
	SITE NAME	Airbonita 12 Federal Com #001H Tank Battery Release	1/26/2023

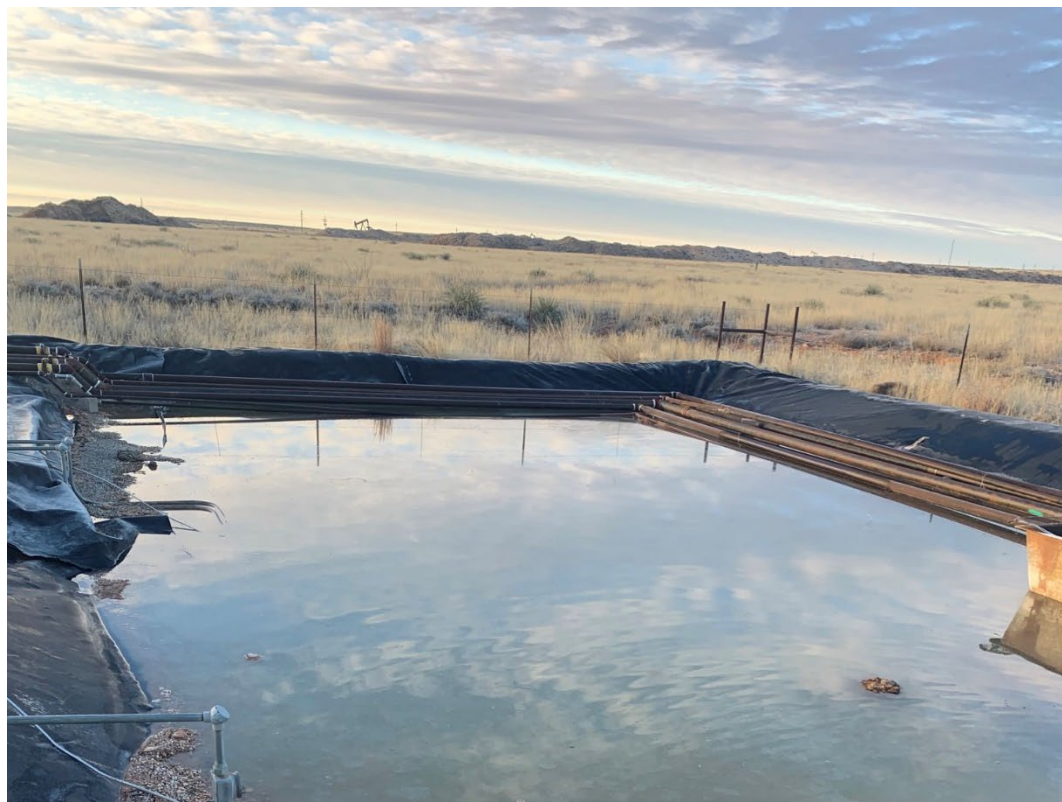
TETRA TECH, INC. PROJECT NO. 212C-MD-03040	DESCRIPTION	View south-southwest of pooling in berm corner.	4
	SITE NAME	Airbonita 12 Federal Com #001H Tank Battery Release	1/26/2023

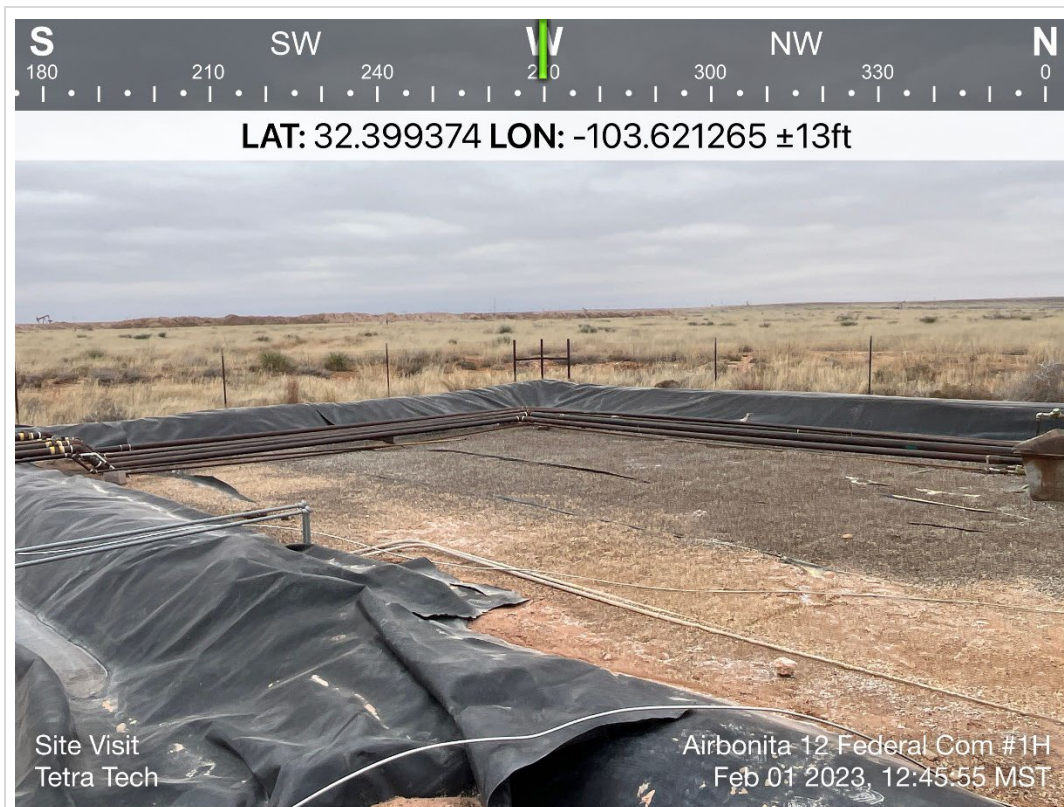
During the site visit, it was apparent that all free liquids appeared to have been recovered, and the remaining released fluids were held in the base course material within the secondary containment. The secondary containment is made up of earthen berms approximately 2 feet tall with an intact polyethylene liner. As mentioned, the release was reported as having been contained within the lined secondary containment and, as documented in the C-141, initial response efforts were successful in recovering 38 bbls of released fluids. Photographic documentation of site conditions at the time of the site visit is included in Appendix C.

TETRA TECH, INC. PROJECT NO. 212C-MD-03040	DESCRIPTION	View of former release extent in lined area.	6
	SITE NAME	Airbonita 12 Federal Com #001H Tank Battery Release	2/1/2023

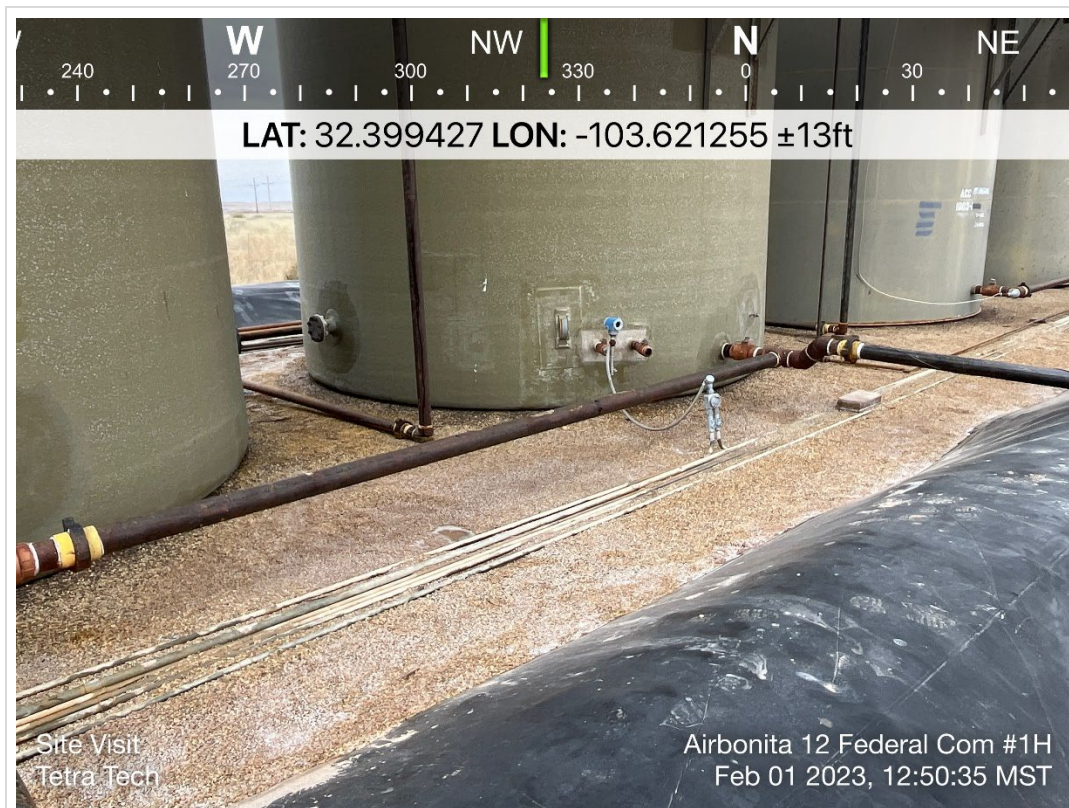
TETRA TECH, INC. PROJECT NO. 212C-MD-03040	DESCRIPTION	View of former release extent in lined area.	7
	SITE NAME	Airbonita 12 Federal Com #001H Tank Battery Release	2/1/2023

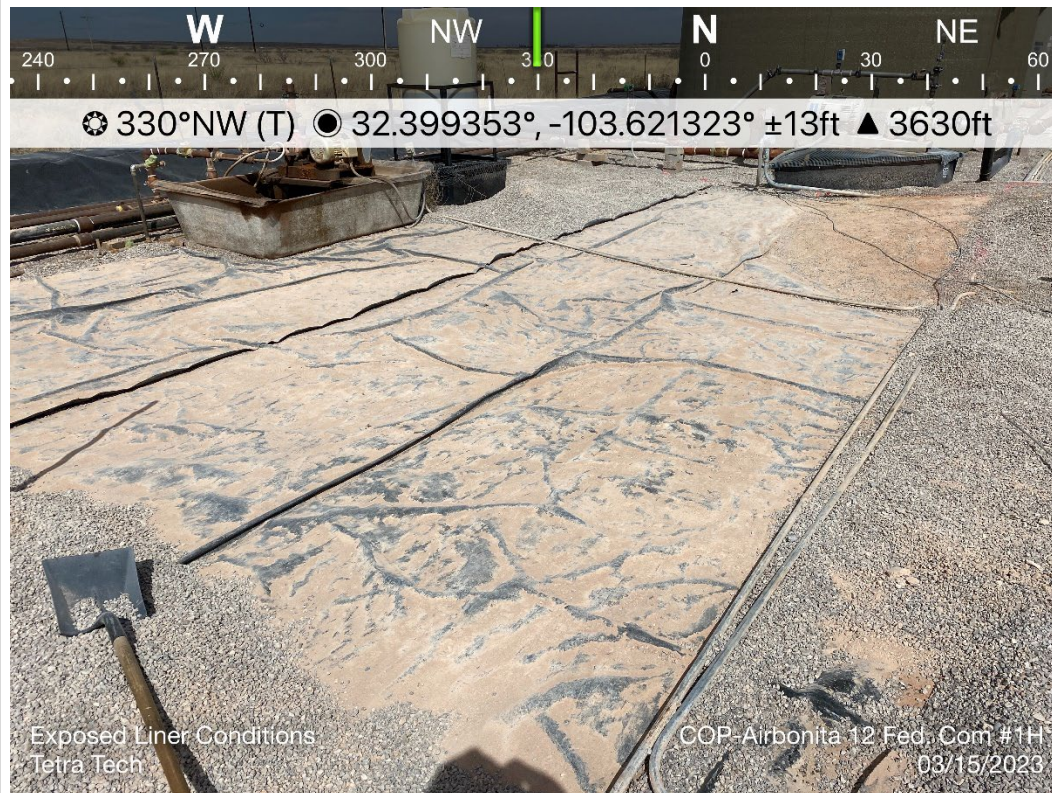
On March 15, 2023, Tetra Tech personnel performed an inspection of the liner within the secondary containment of the Airbonita Federal 12 #1H – Tank Battery. Due to the liner being covered with clean material resulting from the previously mentioned February 6 activities, clean base course material was removed by hand in order to expose the polyethylene liner beneath. This work was completed to verify the previous documentation provided by COP. The clean base course/gravel material was carefully extracted from the area surrounding the tanks and the surrounding vicinity. The liner was observed to underlie the release point and tank lid within the secondary containment area. The liner was intact, with no visible rips or tears and encompassed by a 2-foot-tall earthen berm. The liner extended up and over the earthen berm and was anchored on the exterior side. Photographic documentation of the liner inspection is included in Appendix C.

TETRA TECH, INC. PROJECT NO. 212C-MD-03040	DESCRIPTION	View north-northwest. Exposed liner in the northern portion of the lined secondary containment.	10
	SITE NAME	Airbonita 12 Federal Com #001H Tank Battery Release	3/15/2023

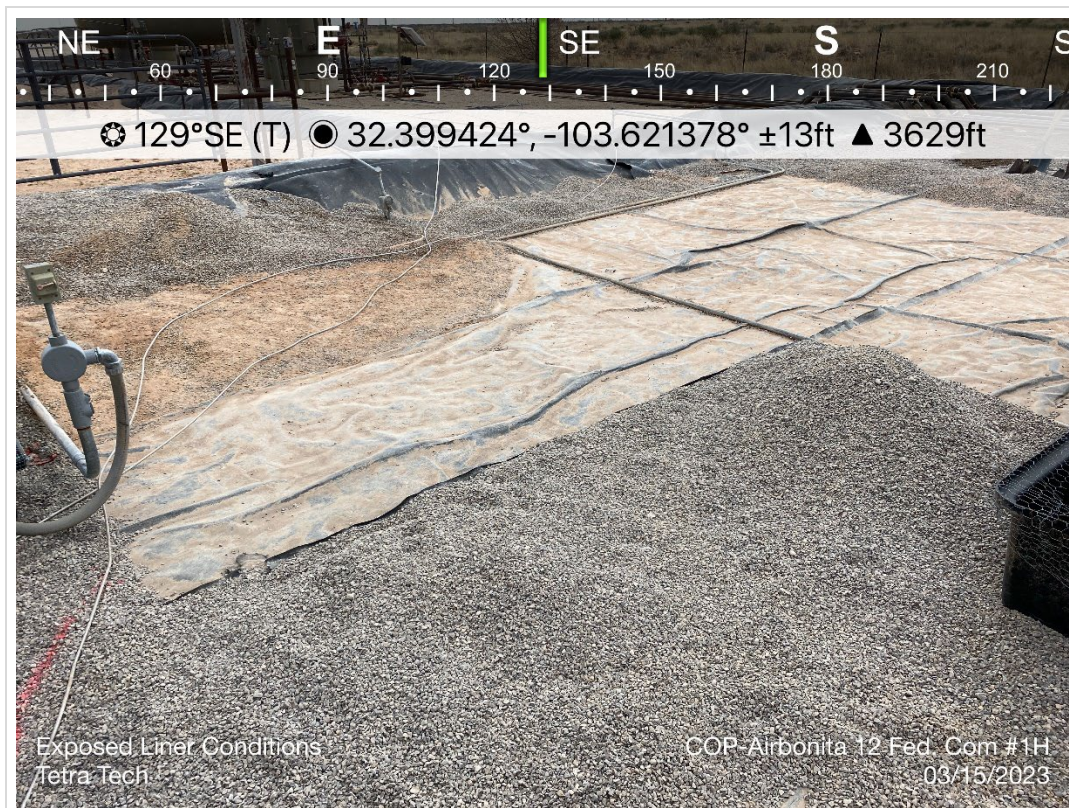
TETRA TECH, INC. PROJECT NO. 212C-MD-03040	DESCRIPTION	View -south-southeast. Exposed liner in the northern portion of the lined secondary containment.	11
	SITE NAME	Airbonita 12 Federal Com #001H Tank Battery Release	3/15/2023

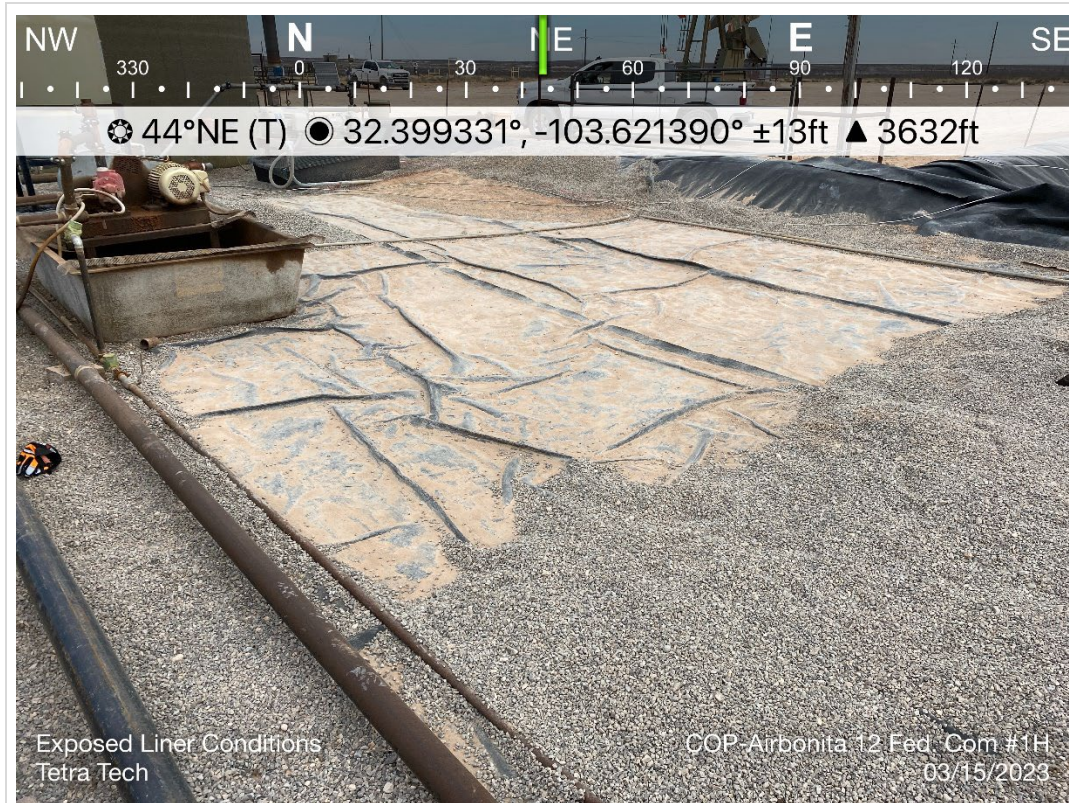
TETRA TECH, INC. PROJECT NO. 212C-MD-03040	DESCRIPTION	View northeast. Exposed liner in the northern portion of the lined secondary containment.	12
	SITE NAME	Airbonita 12 Federal Com #001H Tank Battery Release	3/15/2023

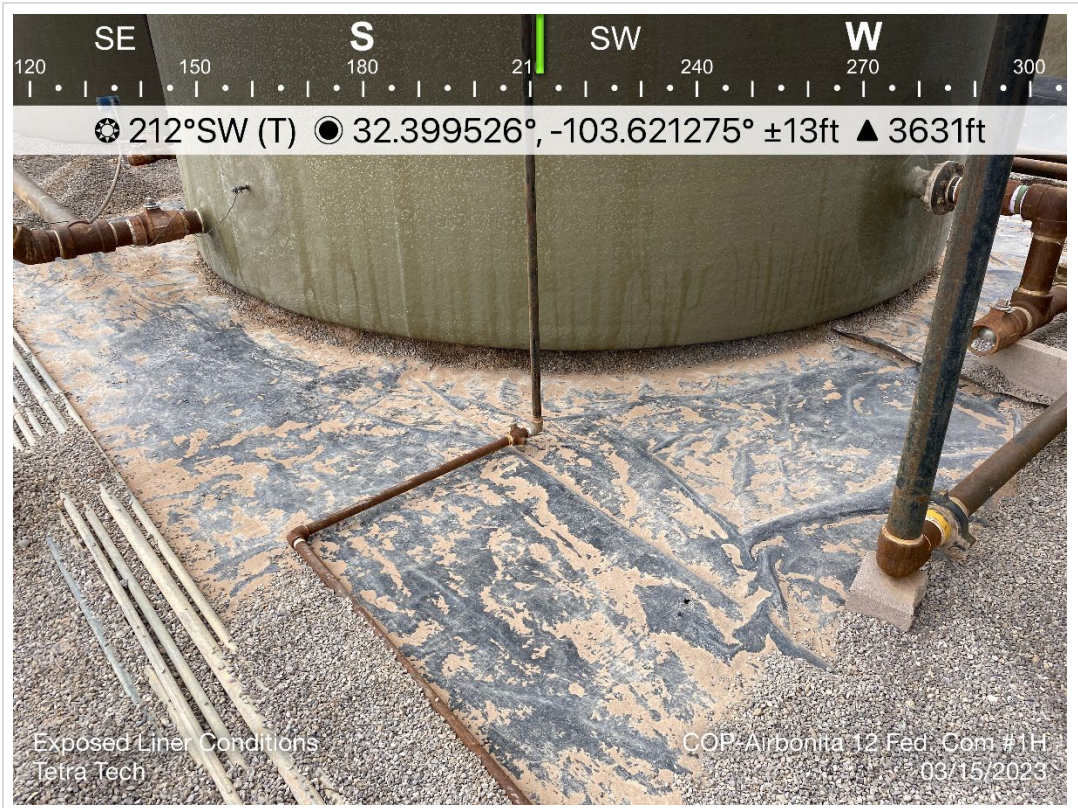
TETRA TECH, INC. PROJECT NO. 212C-MD-03040	DESCRIPTION	View south-southwest. Exposed liner in the northern portion of the lined secondary containment.	13
	SITE NAME	Airbonita 12 Federal Com #001H Tank Battery Release	3/15/2023
