Pima Environmental Services, LLC (Pima) has conducted a site assessment, soil sampling and has prepared this Closure Report on behalf of Devon Energy Production Company (Devon) for the Vega 29 Fed #1H (Vega). This incident was assigned 2RP-3888 by the New Mexico Oil Conservation Division (NMOCD).

Vega 29 Fed #1H  
API 30-015-39863  
Eddy County, NM  
Location Map

Location name: VEGA 29 FEDERAL 1

OCD Spill Number: nAB1625955713

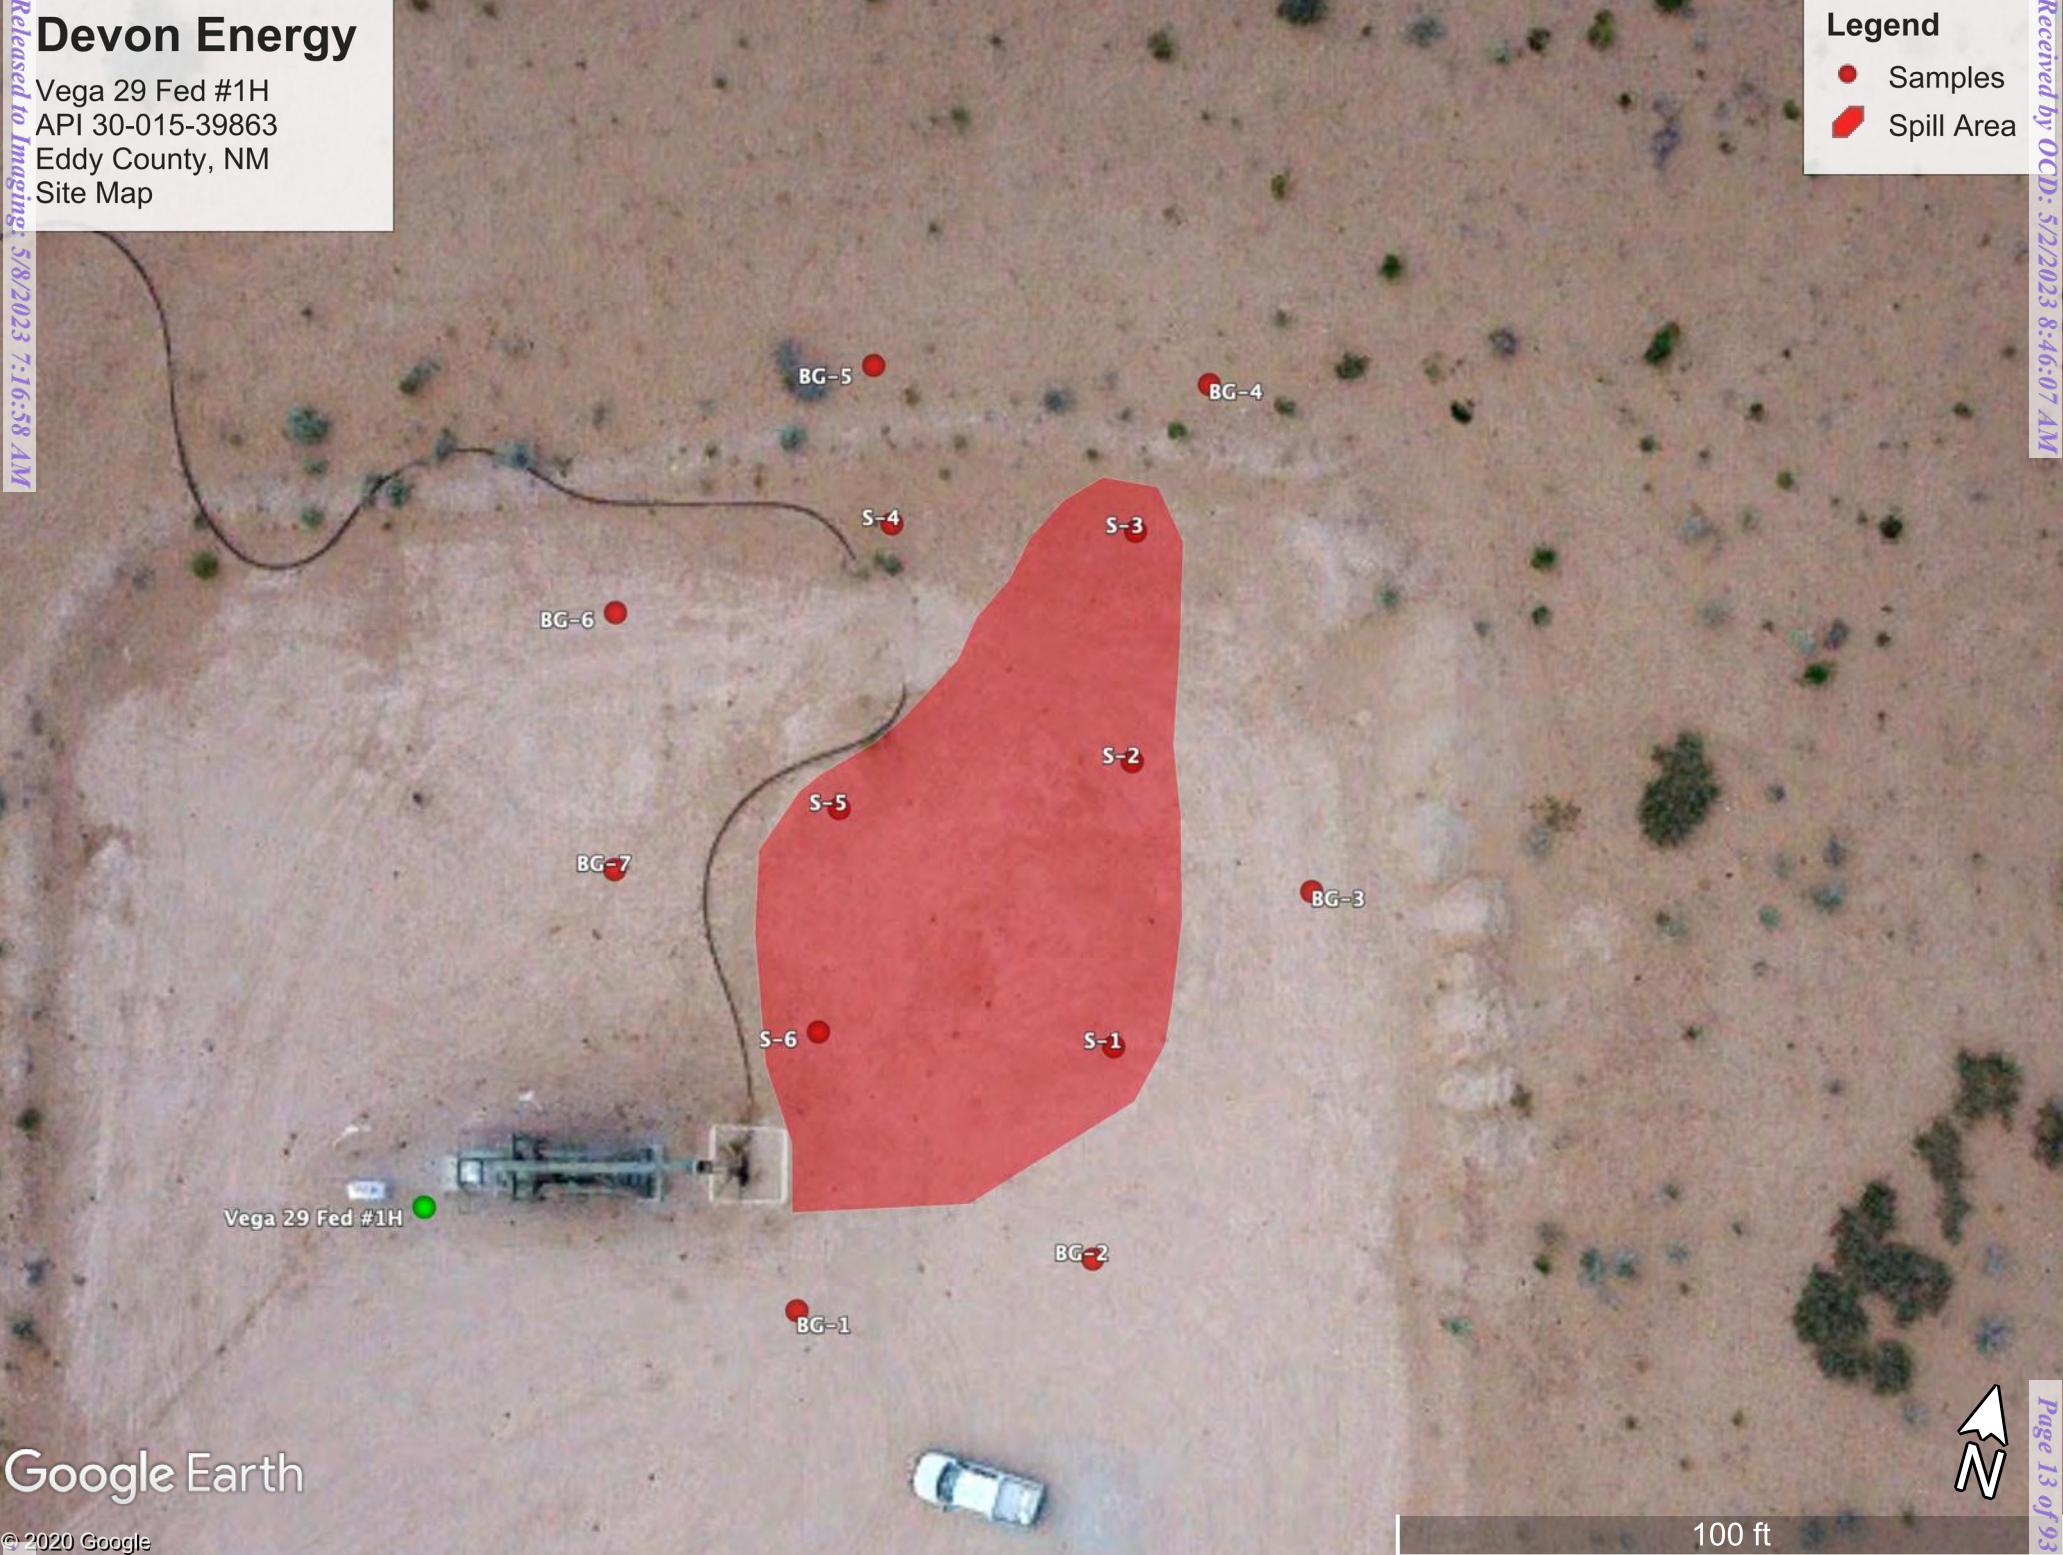
Vega 29 Fed #1H  
API 30-015-39863  
Eddy County, NM  
Site Map

On June 8, 2020, composite samples were collected outside the containment walls to verify that the liner had not been breached, and the integrity was still intact. The laboratory results of this sampling event can be found in the following data table.

**Legend**  
● Samples  
■ Spill Area

The sample results were below NMOCDD Closure Criteria 19.15.29 NMAC. Based on these findings, no remediation activities were needed at this location.

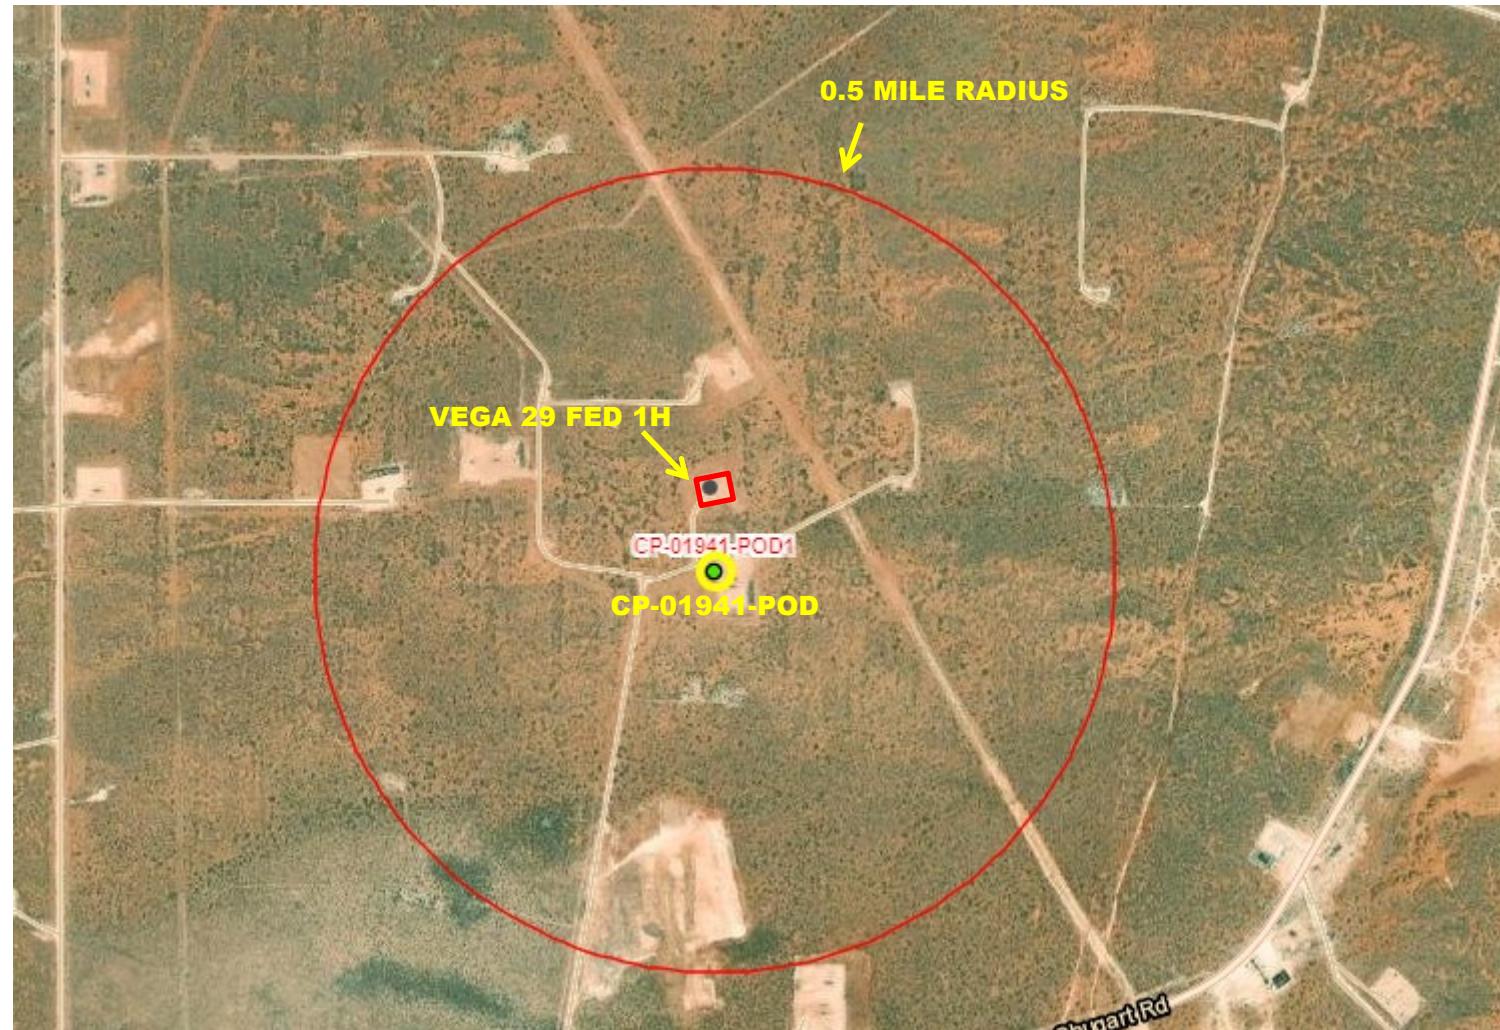
FIGURE 1: NM OSE POD LOCATIONS	
VEGA 29 FED 1H	
32.6377792,-103.885788	
drawn by: RDW	Date: 05/2023

CP-01941 POD 1 (installed in 2023) did not encounter groundwater at 55 feet and is 0.1 miles south of the location

C-01941- POD1 (DTW = 55 feet) = 0.1 miles from location (4/4/2023)

The spill was remediated to criteria for DTW of greater than 51 feet bgs.
