Site Name Gossett EU #1	Site Type Former Battery
Date Release Discovered 11/14/2017	API# 30-015-21627

EOG RESOURCES  
EDDY COUNTY, NEW MEXICO  
GOSSETT EU #1

**GOSSETT EU #1 (2RP-4516)  
UNIT K, SECTION 26, TOWNSHIP 17S, RANGE 25E  
EDDY COUNTY, NEW MEXICO  
32.80361, -104.5809  
RANGER REFERENCE NO. 5375**

**SITE CHARACTERIZATION AND REMEDIATION WORK PLAN  
GOSSETT EU #1 (2RP-4516)  
UNIT K, SECTION 26, TOWNSHIP 17S, RANGE 25E  
EDDY COUNTY, NEW MEXICO  
32.80361, -104.5809  
RANGER REFERENCE NO. 5375**

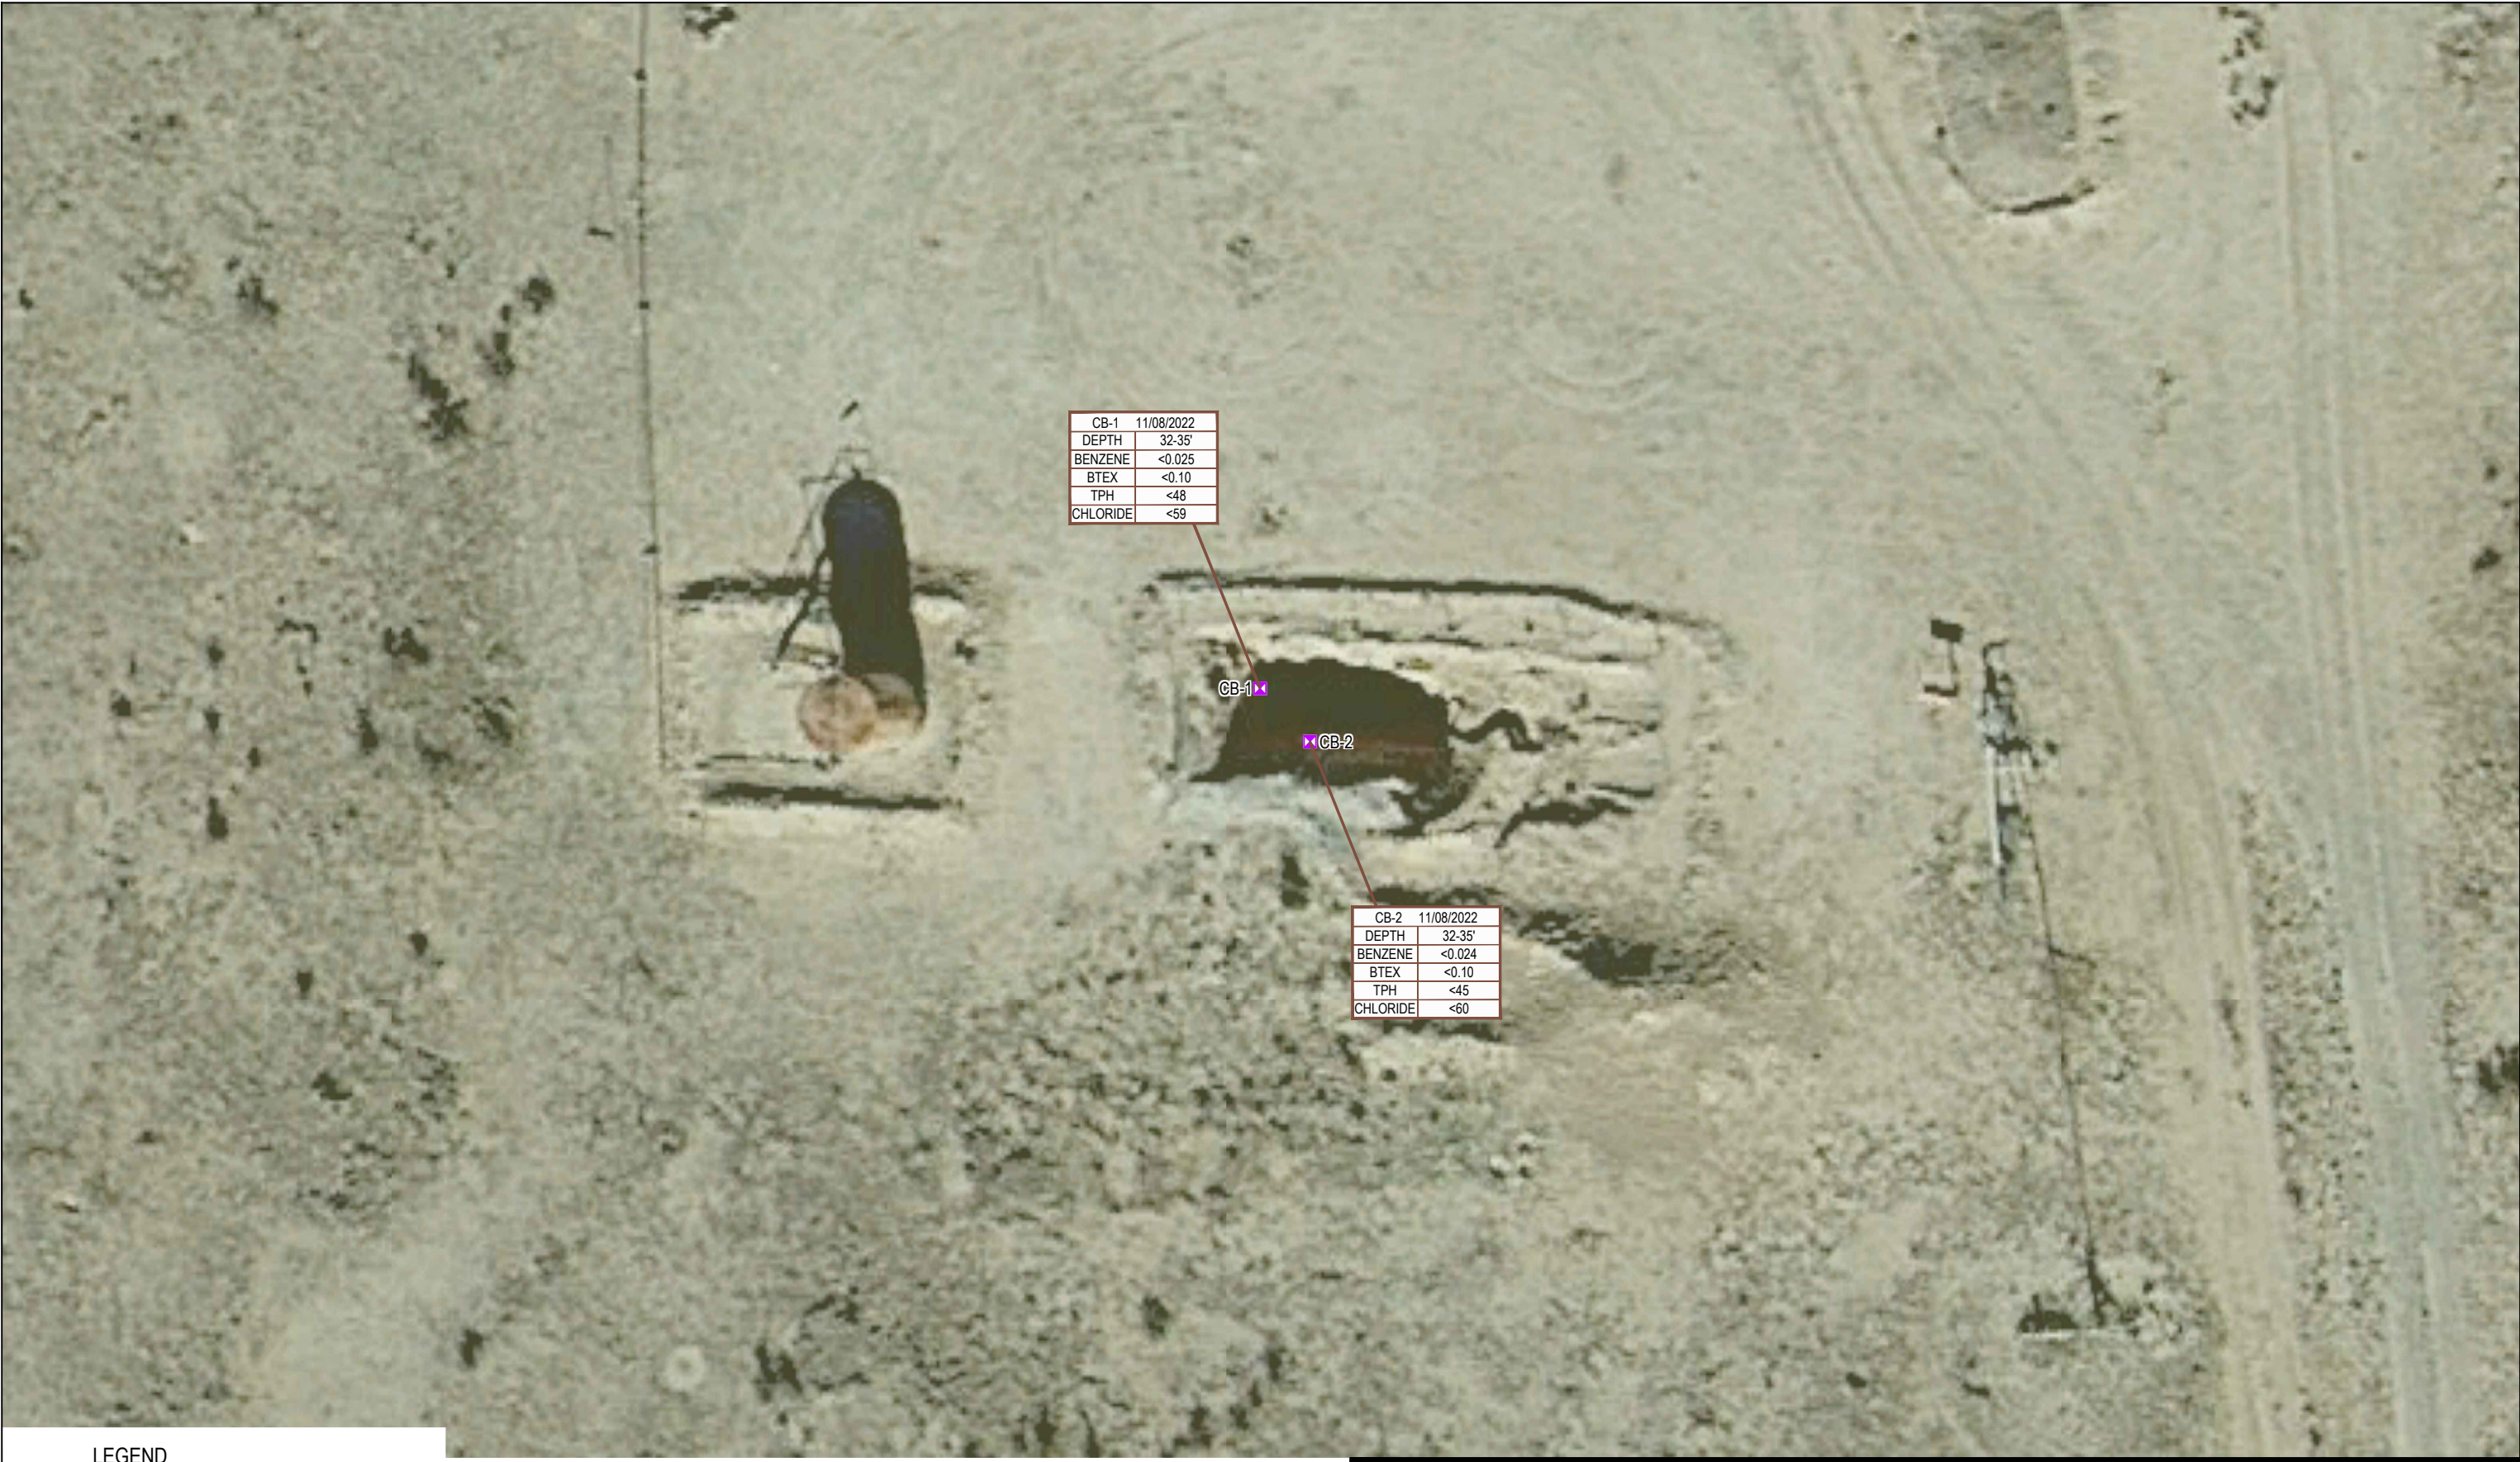
CB-1	11/08/2022
DEPTH	32-35'
BENZENE	<0.025
BTEX	<0.10
TPH	<48
CHLORIDE	<59

CB-2	11/08/2022
DEPTH	32-35'
BENZENE	<0.024
BTEX	<0.10
TPH	<45
CHLORIDE	<60

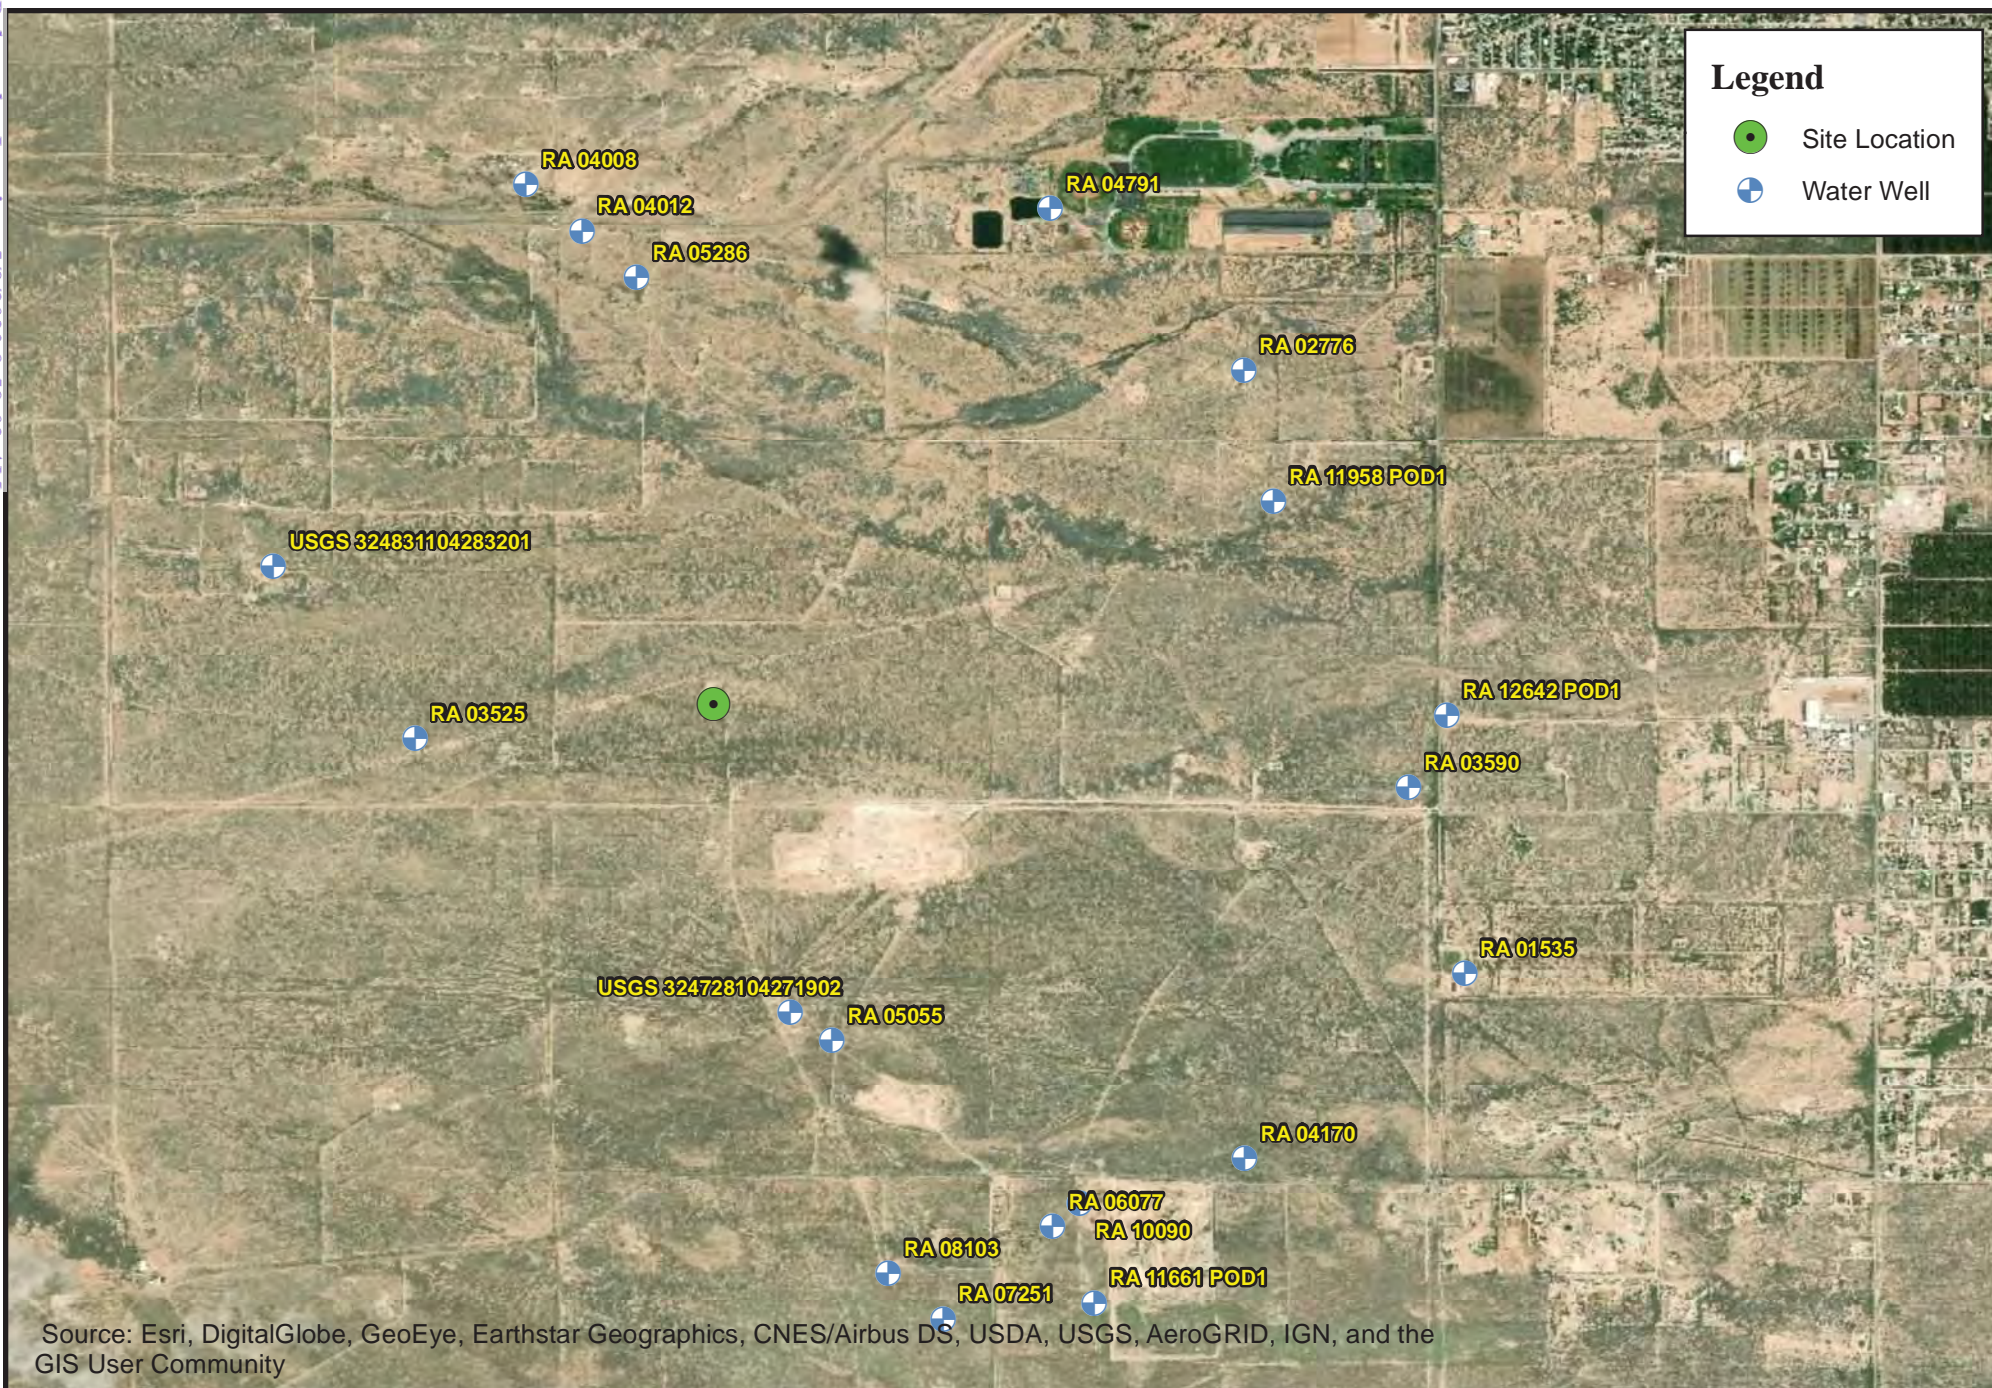
**FIGURE 2 - AREA MAP**  
GOSSETT EU #1  
EOG RESOURCES, INC.

The Gossett EU #1 (Site) is located on private land, approximately 4.4 miles southwest of Artesia within Eddy County, New Mexico. The facility is situated in Unit K, Section 26, T17S-R25E at GPS coordinates 32.80361, -104.5809. Figures 1 and 2 are topographic and area maps which illustrate the site location and surrounding area.

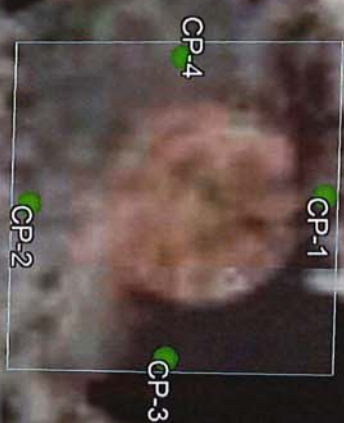
## Figure 4

### Stockpile Sample Point(s)

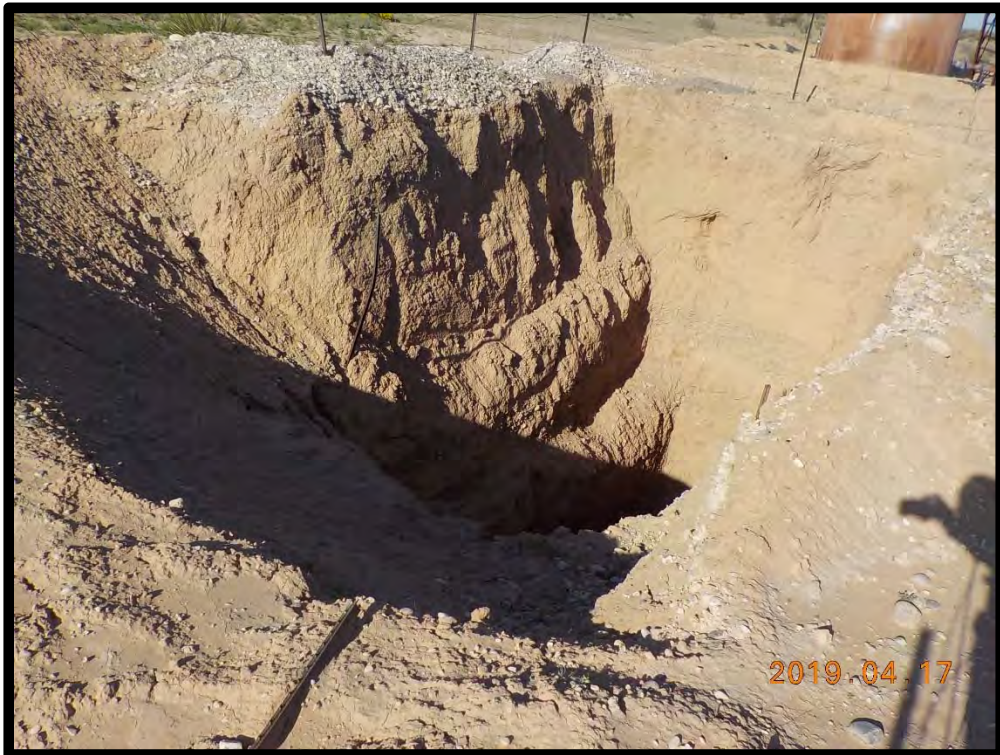
**PHOTOGRAPH NO. 1 – A view of the impacted/excavated area at the Site on April 17, 2019. The view is towards the southwest.**

In total, approximately 575 cubic yards of excavated soil were generated during the performance of the November and December, 2017 site activities. These soils are currently stockpiled on-site surrounded by an earthen berm. Following the completion of the November 2017 soil removal operations, two composite soil samples were collected from the soil stockpiles and analyzed for BTEX, TPH and chloride. No elevated chloride concentrations were found in the stockpiled soils; however, BTEX and TPH concentrations in excess of the proposed Site closure criteria were documented to be present.

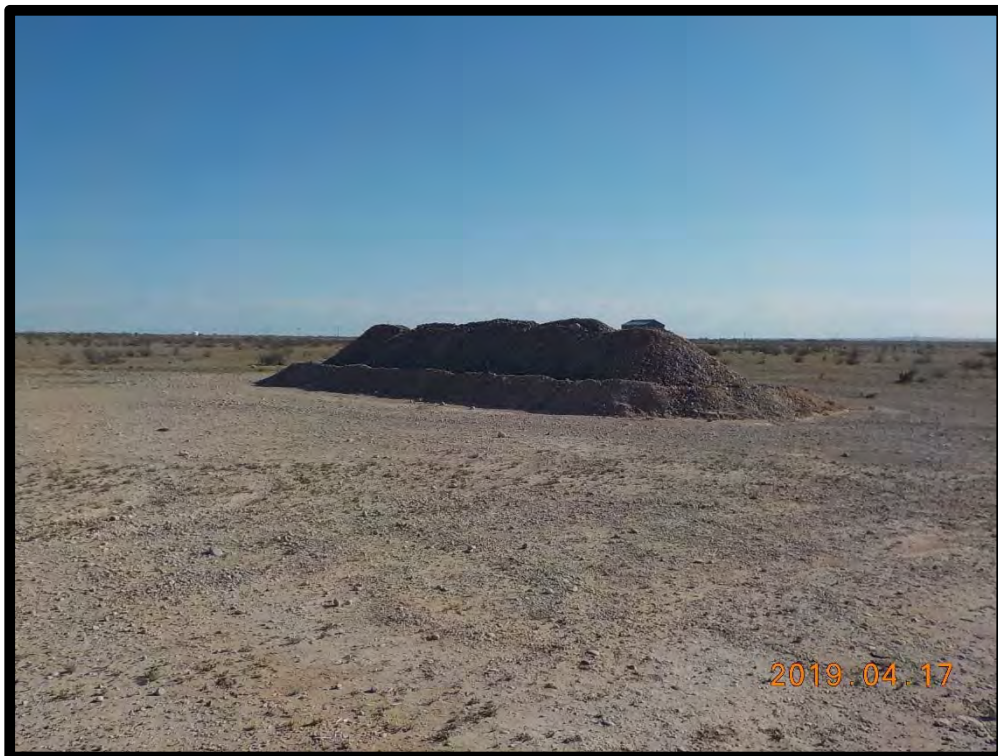
**PHOTOGRAPH NO. 1 – A view of the excavated material currently stockpiled on-site. The view is towards the north.**
