**Re: Closure Request  
Ochoa Tank Battery - Dump Valve Washout  
Incident Number nAPP2230437260  
Eddy County, New Mexico**

BTA Oil Producers, LLC  
Closure Request  
Ochoa Tank Battery - Dump Valve Washout

BTA Oil Producers, LLC  
Ochoa Tank Battery - Dump Valve Washout  
nAPP2230437260  
Unit D, Section 7, Township 23S, Range 29E  
Eddy County, New Mexico

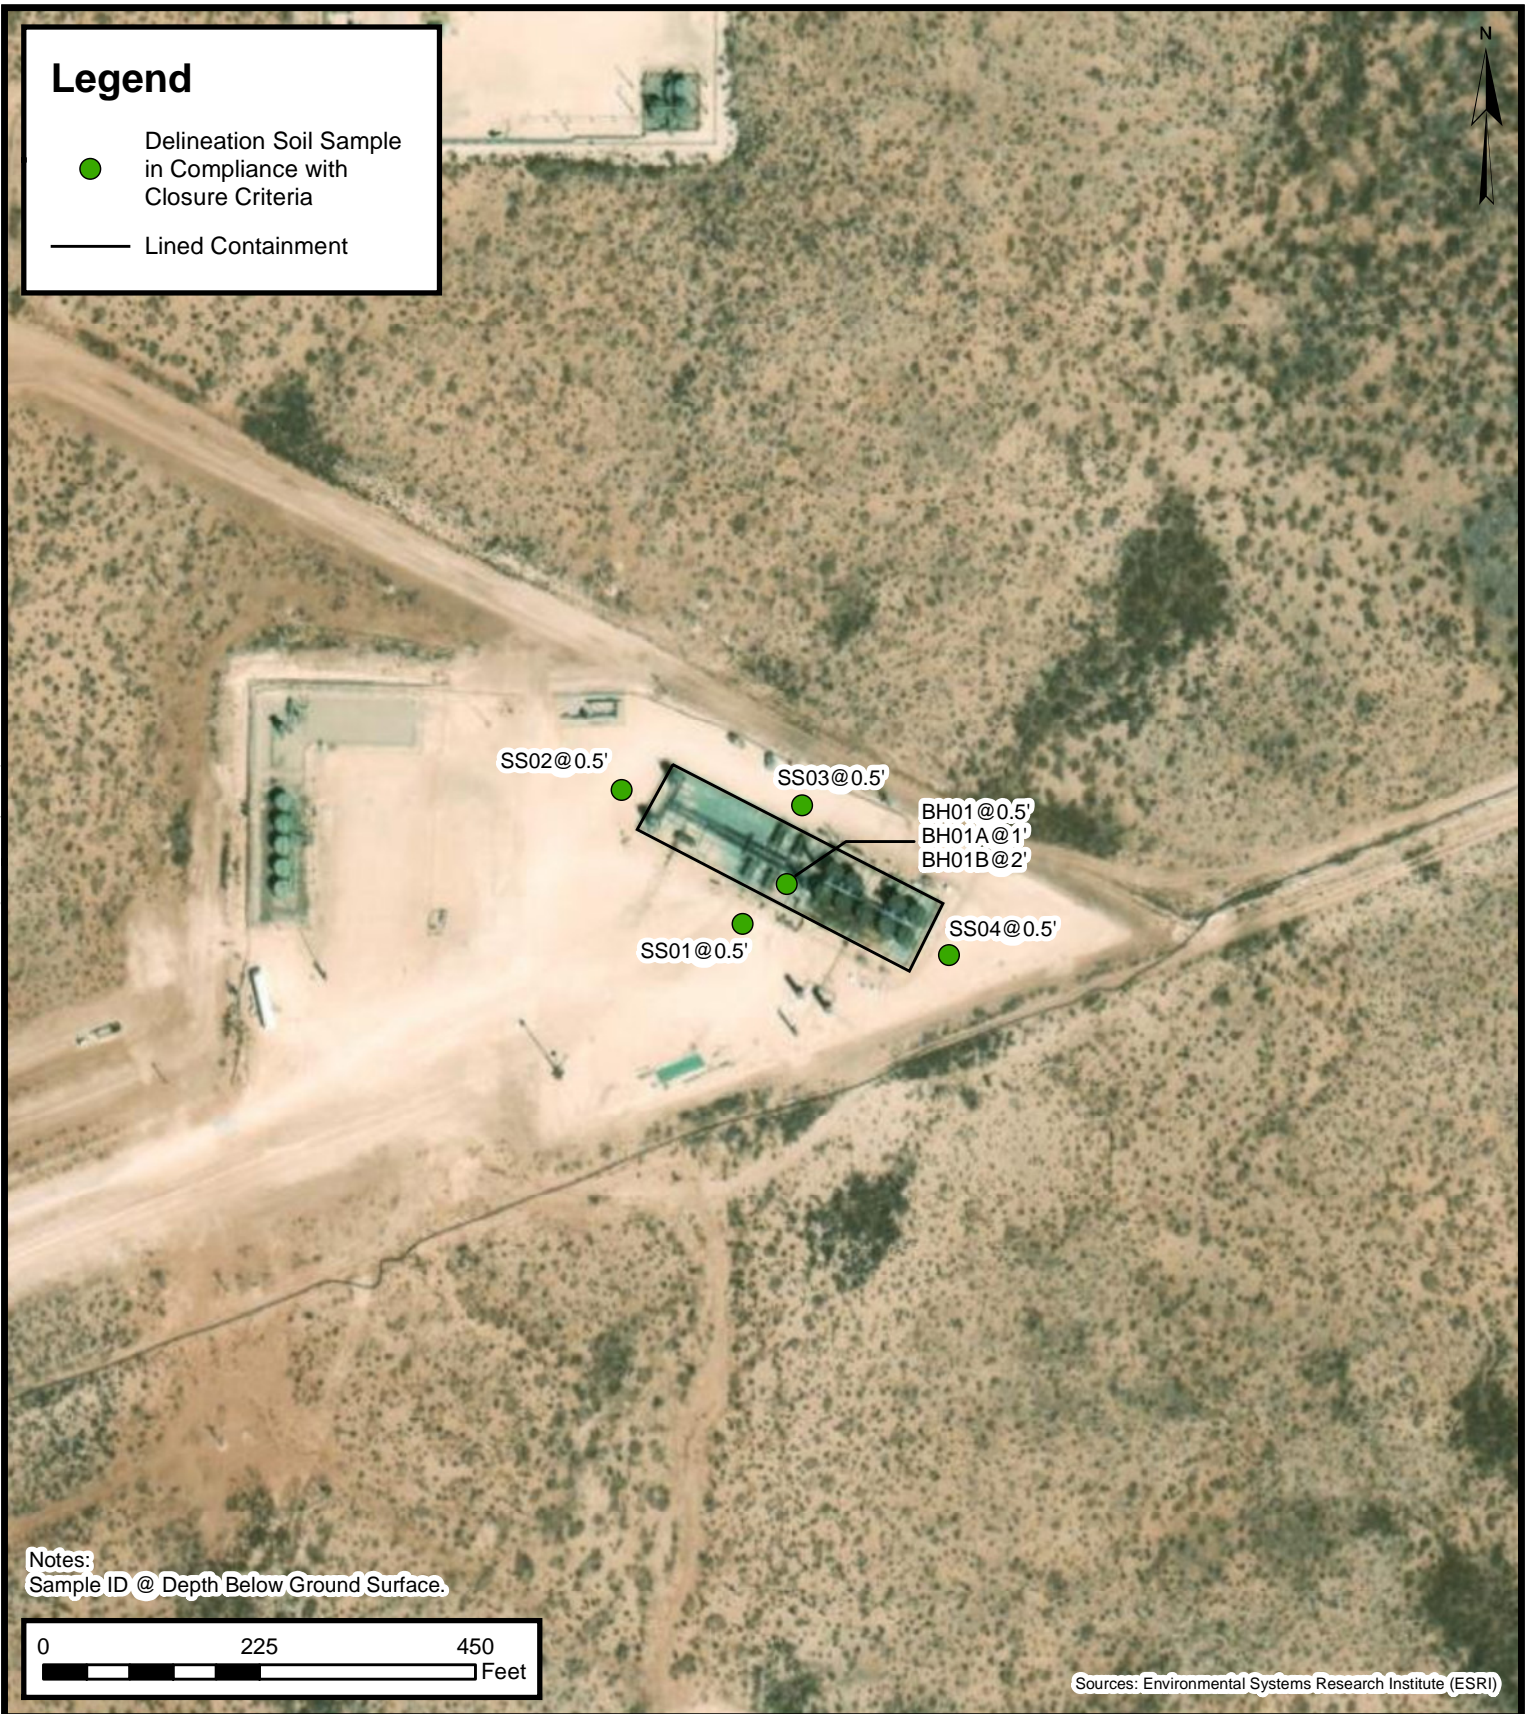
**FIGURE**  
**2**

On November 7, 2022, Ensolum personnel visited the Site to evaluate the release extent and conduct Site assessment activities. Four delineation soil samples, SS01 through SS04, were collected around the lined containment at 0.5 feet bgs to confirm the lateral extent of the release.

A 48-hour advance notice of the liner inspection was provided via email on November 10, 2022, to the NMOCD. A liner integrity inspection was conducted by Ensolum personnel on November 11, 2022. Upon inspection, the liner was determined to be insufficient. One borehole (BH01) was advanced via hand auger near the location of the tear in the liner to assess the vertical extent of potentially impacted soil. Three discrete delineation soil samples were collected from the borehole (BH01/BH01A/BH01B) at depths ranging from 0.5 feet to 2 feet bgs.

## Delineation Soil Sample Locations

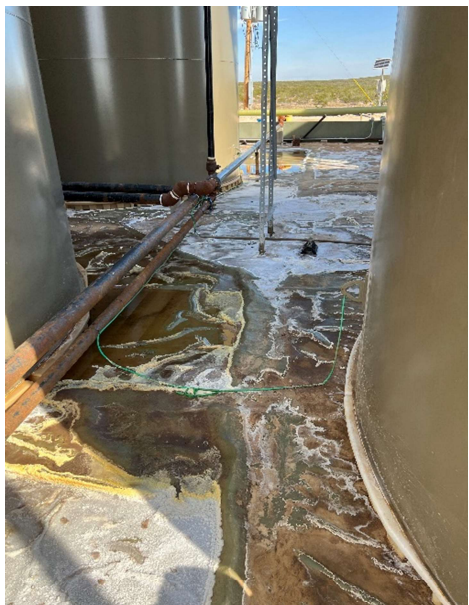
Photograph: 1 Date: 11/7/2022  
Description: Photo of Liner during initial assessment.  
View: Northwest

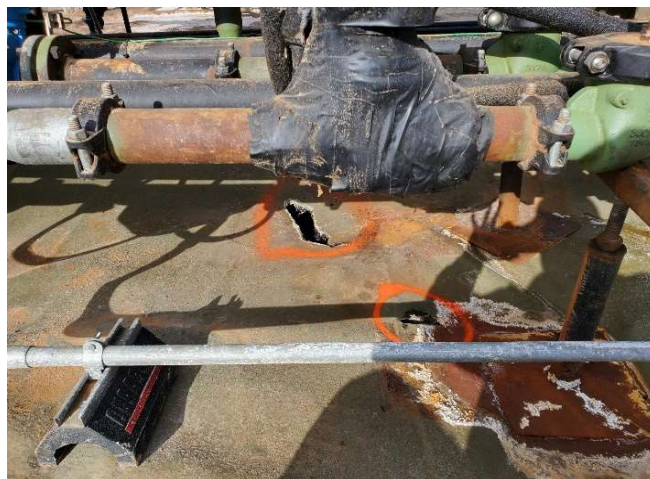
Photograph: 2 Date: 11/11/2022  
Description: Photo of liner delineation.  
View: Southeast

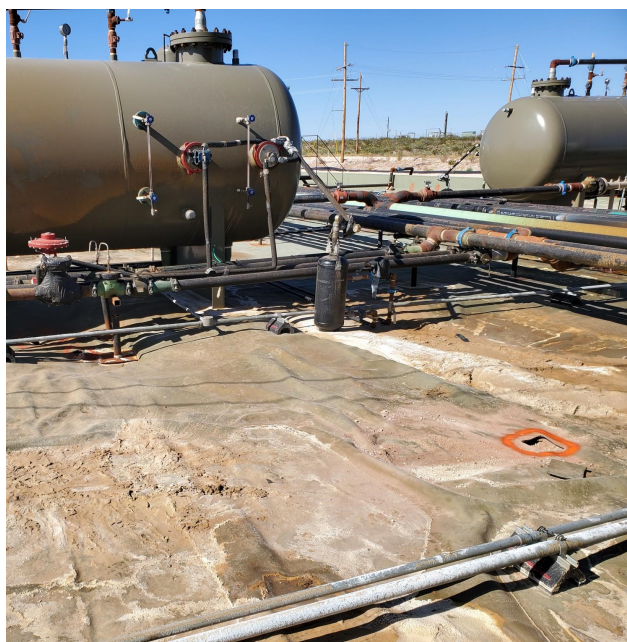
Photograph: 3 Date: 11/11/2022  
Description: Photo of liner delineation.  
View: Southwest

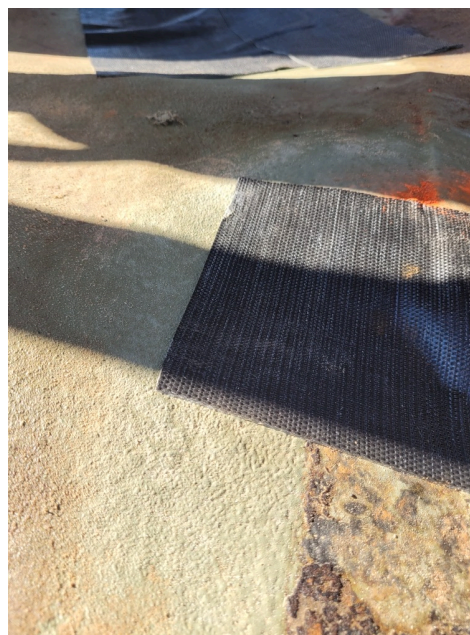
Photograph: 4 Date: 11/12/2022  
Description: Photo of patched liner

Following the failed liner integrity inspection at the Site, Ensolum personnel advanced one borehole (BH01) at the location of the tear in the liner to assess for the presence or absence of impacted soil resulting from the October 28, 2022, produced water release within lined containment. Three delineation soil samples were collected from borehole BH01, at depths ranging from 0.5 feet to 2 feet bgs. Laboratory analytical results for the delineation soil samples indicated all COC concentrations were compliant with Site Closure Criteria. Additionally, laboratory analytical results for soil samples SS01 through SS04, collected around the containment, were compliant with the most stringent Table I Closure Criteria. The release was contained laterally by the lined containment. The tear in the liner was subsequently repaired.
