CLOSURE REPORT

**Lateral 2C-45 – McKenzie #2 (04/14/22)
Unit Letter J, S24 T25N R6W
Rio Arriba County, New Mexico**

NM EMNRD OCD Incident ID No. NAPP2211046720

July 15, 2022
Ensolum Project No. 05A1226188

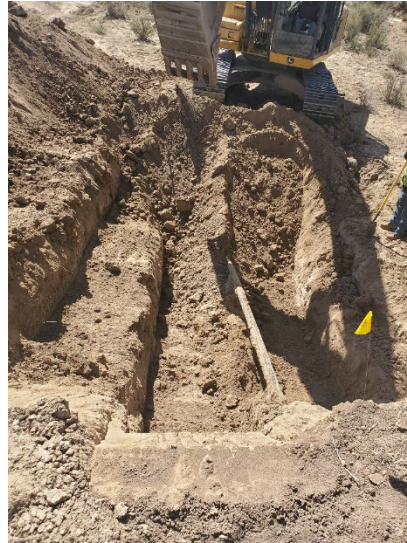
**Photograph 1**

Photograph Description: View of the in-process excavation activities.

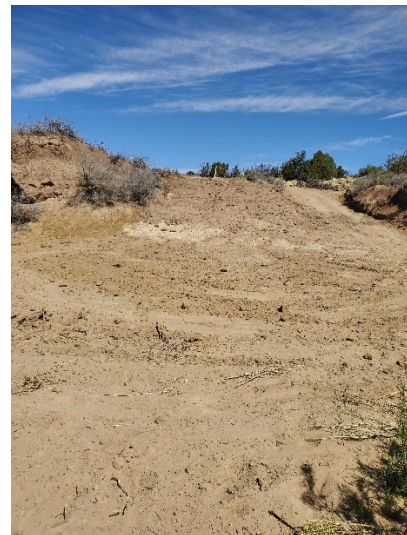
**Photograph 3**

Photograph Description: View of the site after initial restoration.

The excavation was backfilled with clean imported fill and then contoured to the surrounding topography.
