CLOSURE REPORT

Lateral K-17 (02/28/23)
Unit Letter O, S20 T27N R8W
San Juan County, New Mexico

New Mexico EMNRD OCD Incident ID No. NAPP2305944258

June 8, 2023

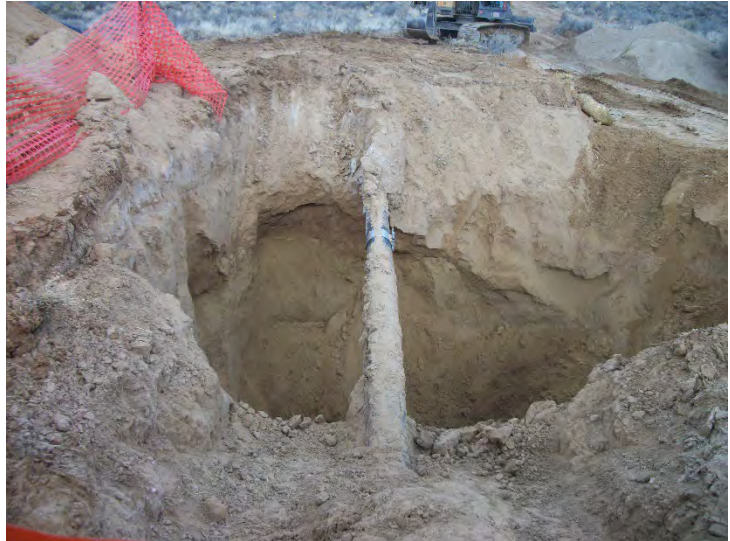
**Photograph 1**

Photograph Description: View of the in-process excavation activities.

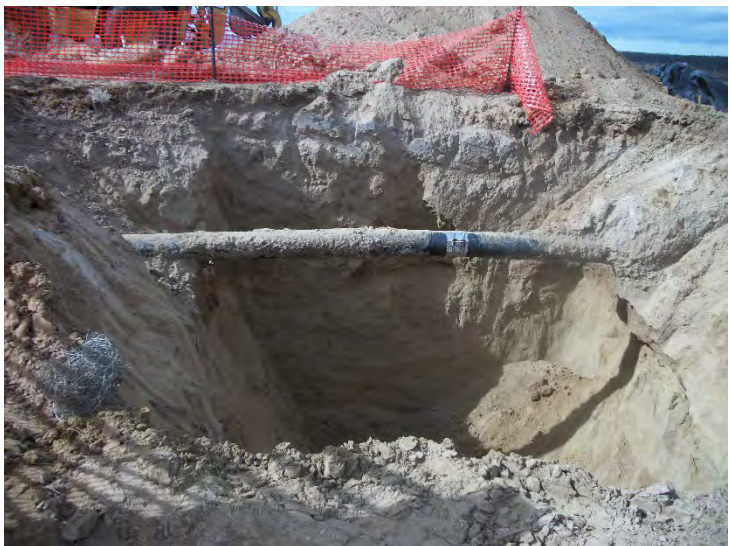
**Photograph 2**

On March 1, 2023, sampling was performed at the Site. The NM EMNRD OCD was notified of the sampling event although no representative was present during sampling activities. Composite soil sample S-1 (13') was collected from the floor of the excavation. Composite soil samples S-2 (0' to 13'), S-3 (0' to 13'), S-4 (0' to 13'), and S-5 (0' to 13') were collected from the walls of the excavation. Subsequent soil analytical results identified total BTEX, and TPH concentrations that exceeded the NM EMNRD OCD closure criteria for composite soil sample S-1.

Photograph Description: View of the excavation (first sampling event).

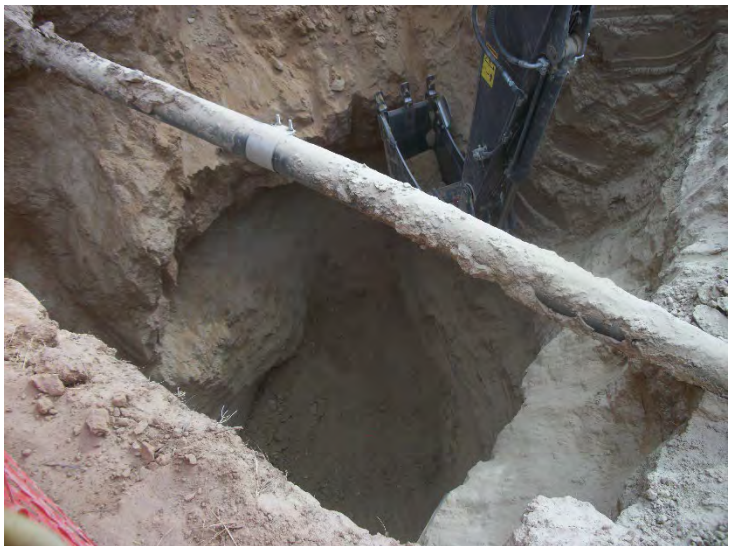
**Photograph 3**

In response to the exceedances of composite sample S-1 during the first sampling event, the excavation was deepened. The impacted soils were removed by excavation and transported to the landfarm for disposal/remediation. On March 7, 2023, a second sampling event was performed at the Site. The NM EMNRD OCD was notified of the sampling event although no representative was present during sampling activities. Composite soil sample S-1a (22') was collected from the floor of the excavation to replace composite soil sample S-1.

Photograph Description: View of the excavation (second sampling event).

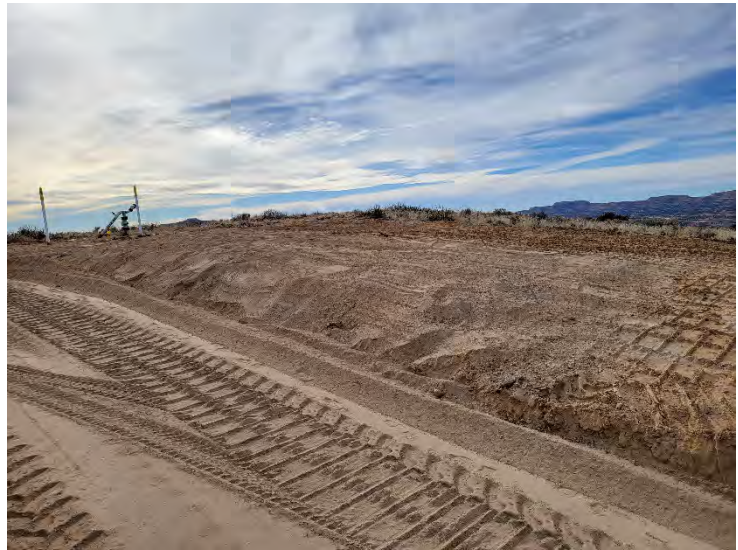
Photograph 4

Photograph Description: View of the site after initial restoration.

The excavation was backfilled with imported fill and then contoured to the surrounding topography.
