Release Notification

CLOSURE REPORT

Lateral 2A-2 (03/20/23)
Unit Letter I, S21 T27N R10W
San Juan County, New Mexico

New Mexico EMNRD OCD Incident ID No. NAPP2307927327

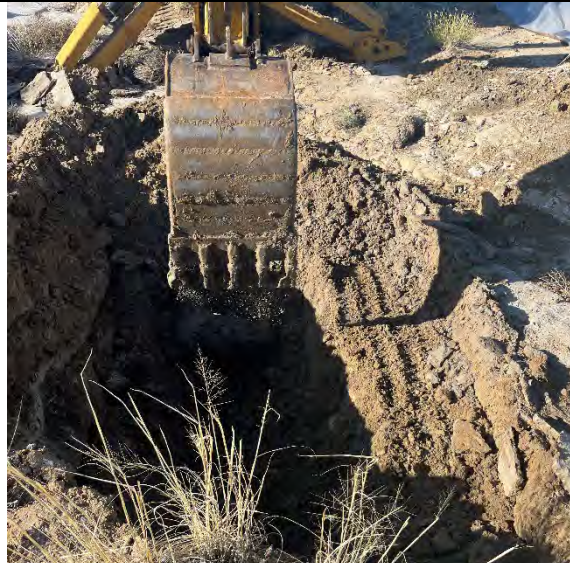
**Photograph 1**

Photograph Description: View of the in-process excavation activities.

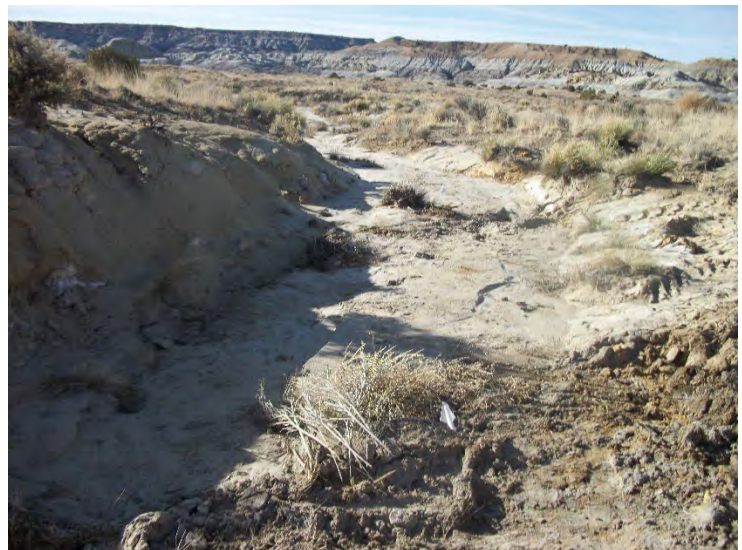
**Photograph 2**

Photograph Description: View of the wash and FP-1 and FP-2 sample locations.

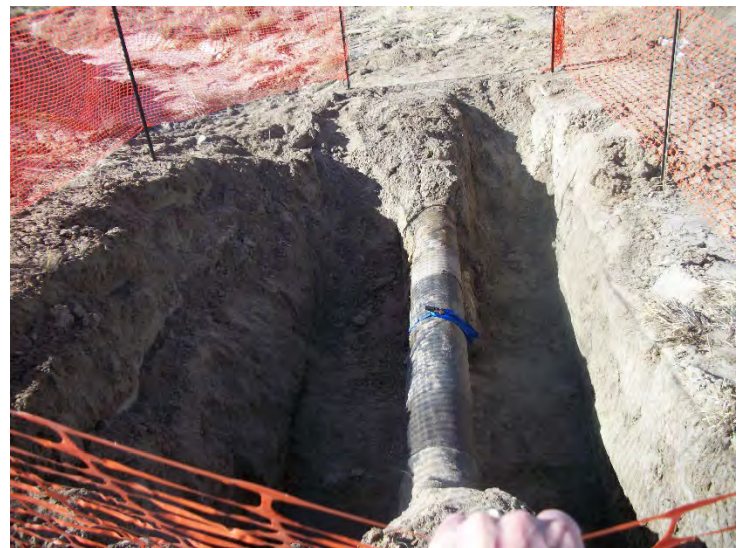
**Photograph 3**

Photograph Description: View of the final excavation.

The final excavation measured approximately 12 feet long and 7 feet wide at the maximum extent. The maximum depth of the excavation measured approximately 4.5 feet bgs. The flow path measured approximately 100 feet long and 1 foot wide. The lithology encountered during the completion of remediation activities consisted primarily of silty sandy clay.

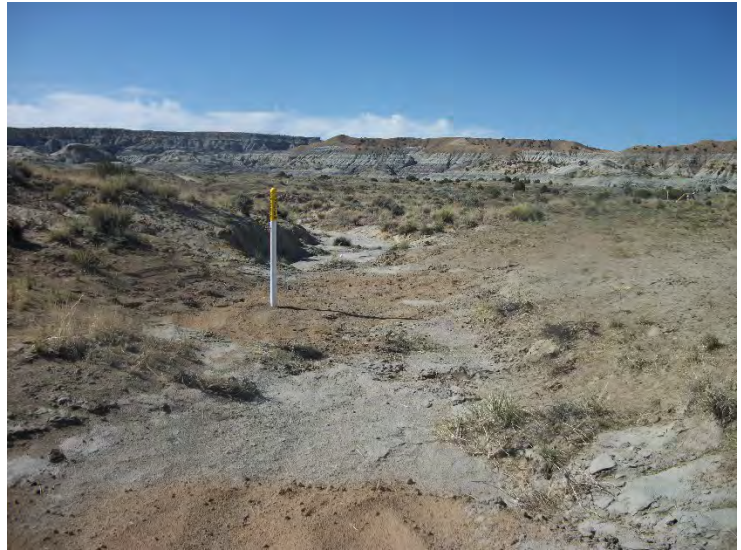
Photograph 4

Photograph Description: View of the site after initial restoration.

The excavation was backfilled with imported fill and then contoured to the surrounding topography.
