Release Notification and Corrective Action

Name of Company: BOPCO, L.P. ALW137	Contact: Bradley Blevins
Address: 522 W. Mermod, Suite 704 Carlsbad, N.M. 88220	Telephone No. 575-887-7329
Facility Name: Poker Lake Unit 78 Tank Battery	Facility Type: Exploration and Production
Surface Owner: Federal	Mineral Owner: Federal
API No. 30-015-27536

Poker Lake Unit 78 Tank Battery

Incident Number nAB1606239294

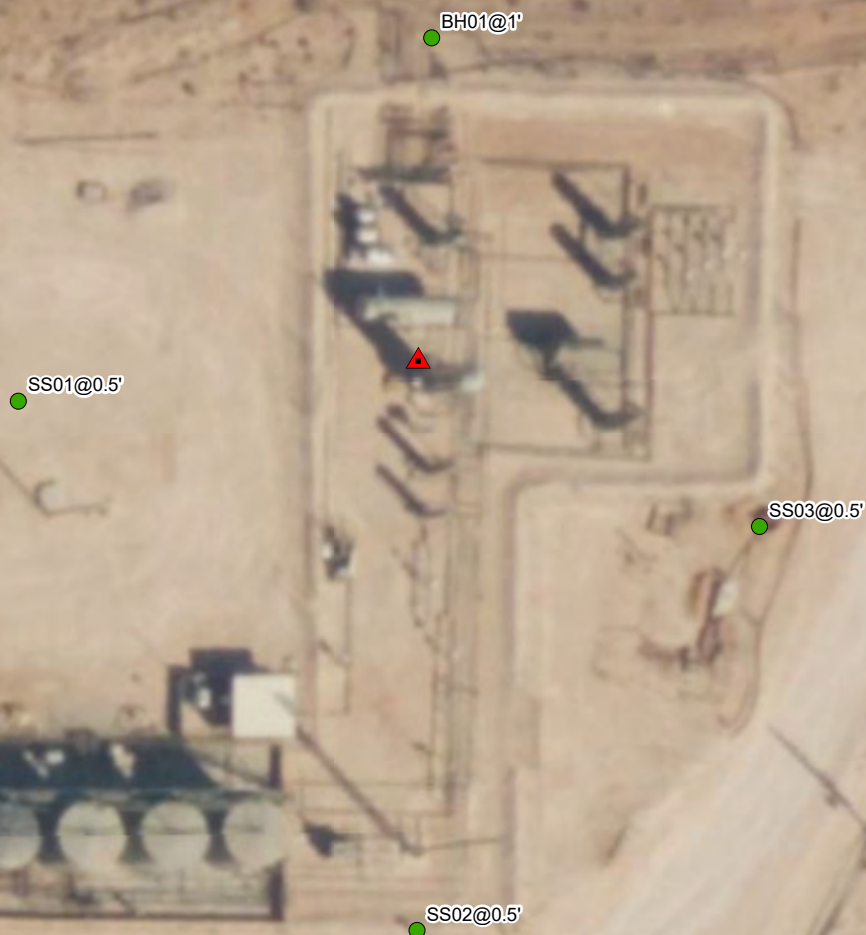
- Soil Sample Location
- ▲ Point of Release (POR)

Notes:
Sample ID @ Depth Below Ground Surface.

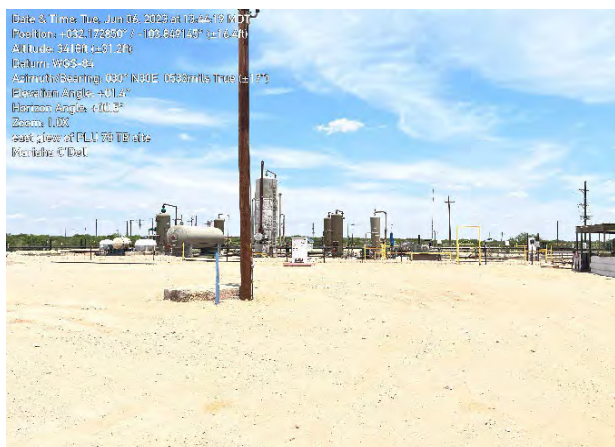
Photograph 1 Date: 6/6/2023
Description View of historical release area
View: East

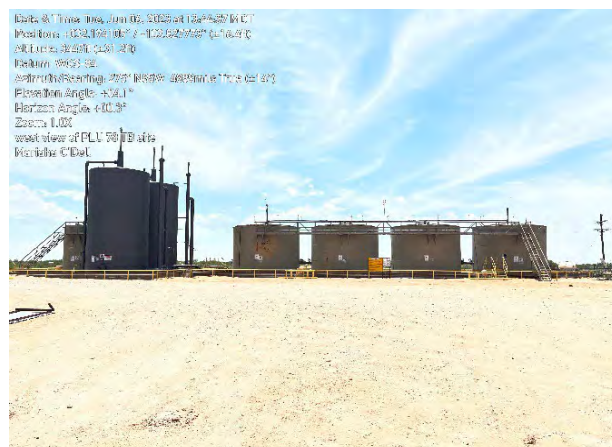
Photograph 2 Date: 6/6/2023
Description View of historical release area
View: West

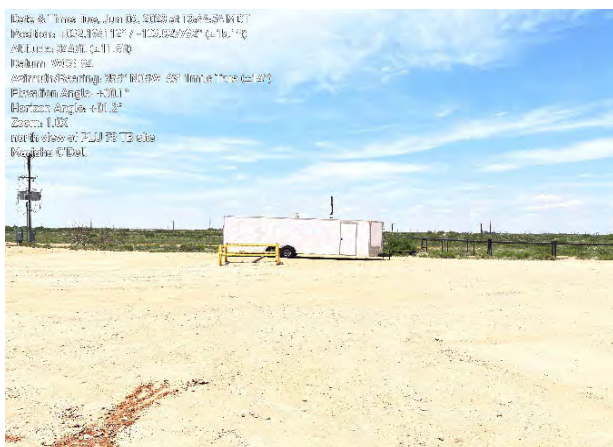
Photograph 3 Date: 6/6/2023
Description View of well pad
View: North

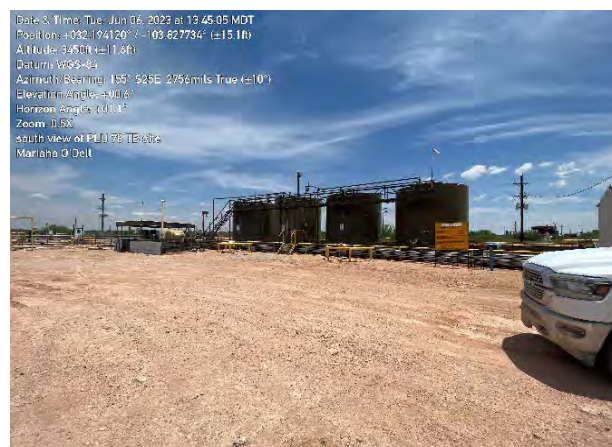
Photograph 4 Date: 6/6/2023
Description View of well pad
View: South
