Liner Inspection and Closure Report

Beetle Juice 19 Fed 1 Central Tank Battery
Eddy County, New Mexico
*2RP-4562, *2RP-5578
Talon Project #700794.321.01

Subject: **Liner Inspection and Closure Report**
Beetle Juice 19 Fed 1 Central Tank Battery
Eddy County, New Mexico
*2RP-4562, *2RP-5578

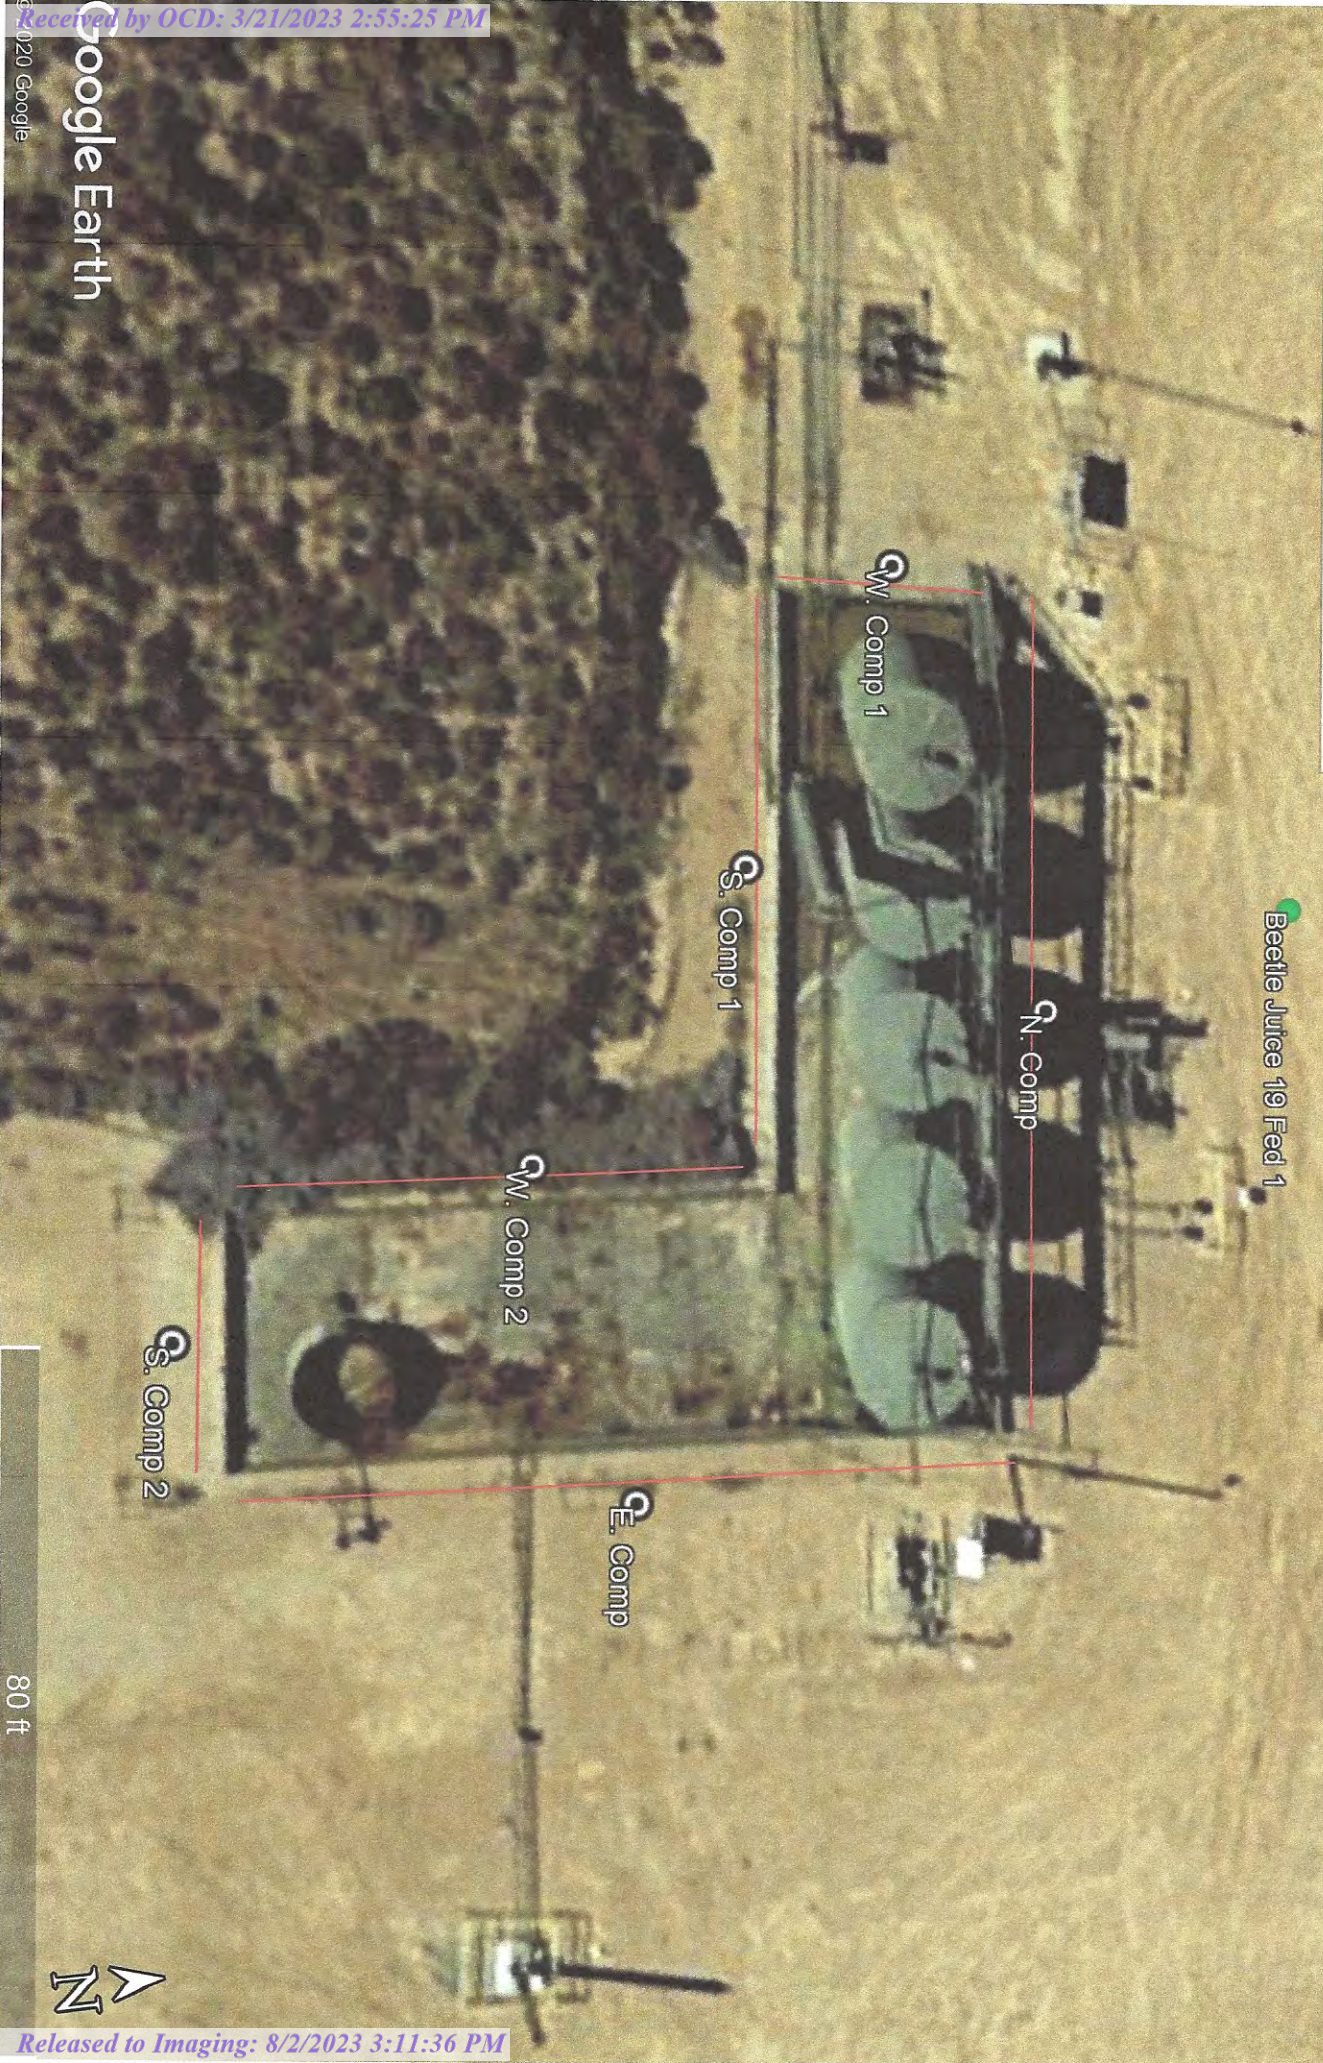
Devon Energy Production Company
API 30-015-38484
Eddy County, NM
Site Map

The Beetle Juice 19 Fed 1 CTB is located approximately twenty-five (25) miles northeast of Carlsbad, New Mexico. The legal location for this release is Unit Letter A, Section 19, Township 19 South and Range 31 East in Eddy County, New Mexico. More specifically, the latitude and longitude for the release are 32.65166 North and -103.90142 West. A Site Map is presented in [Appendix I](#).

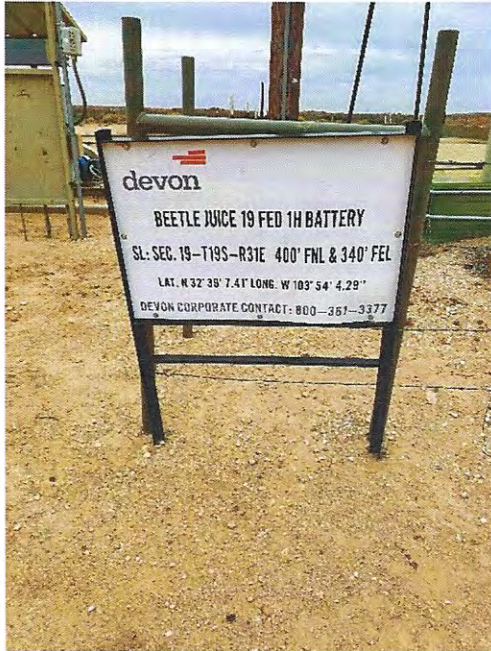
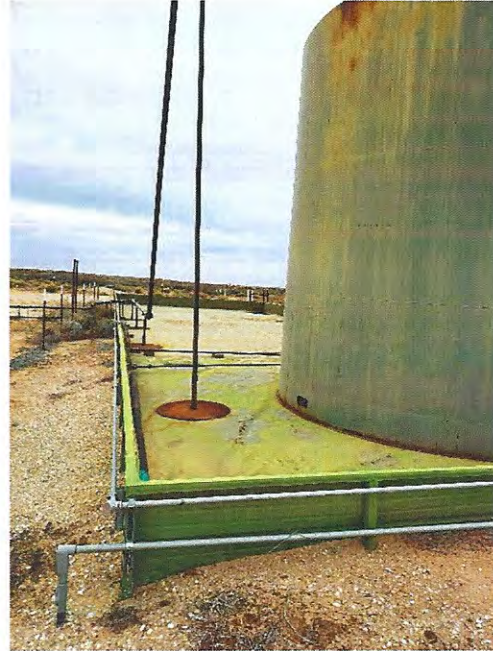
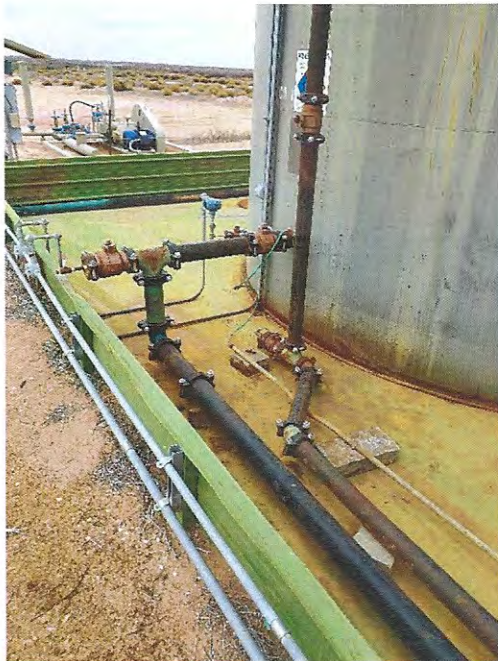
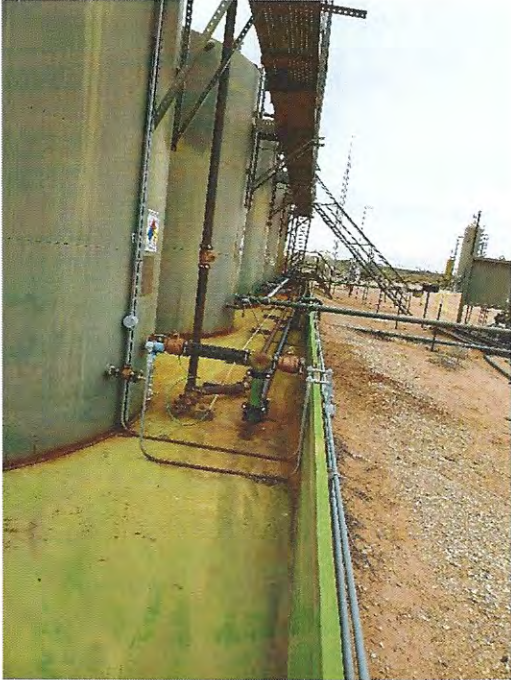
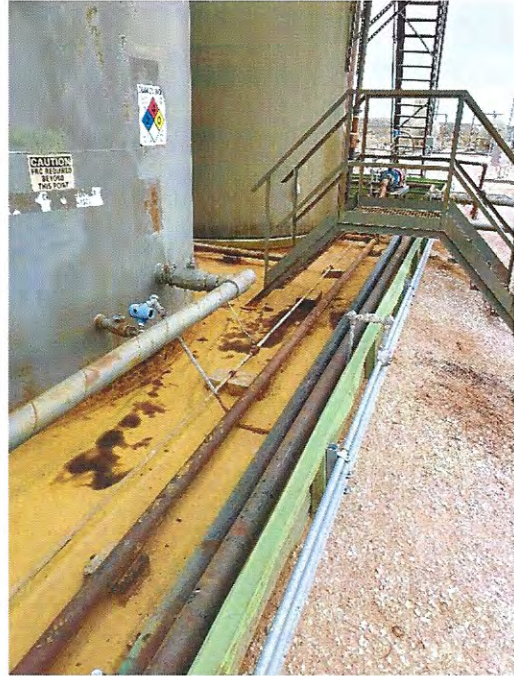
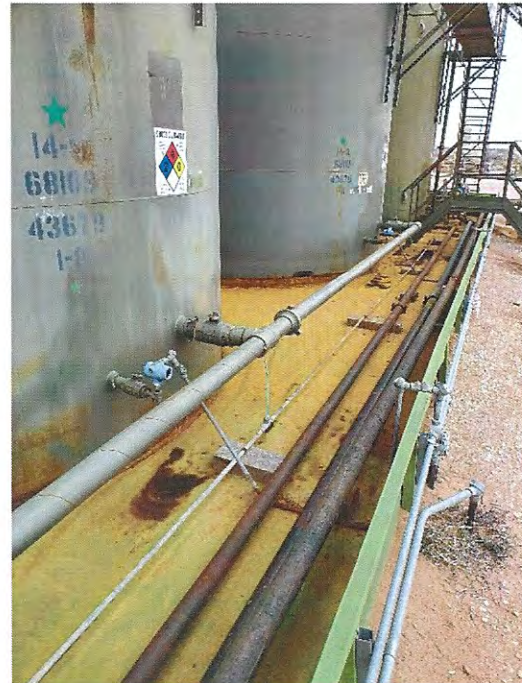
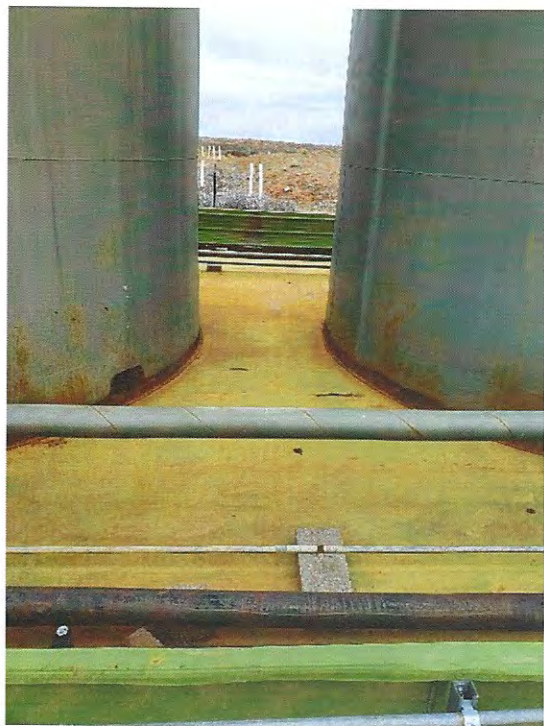
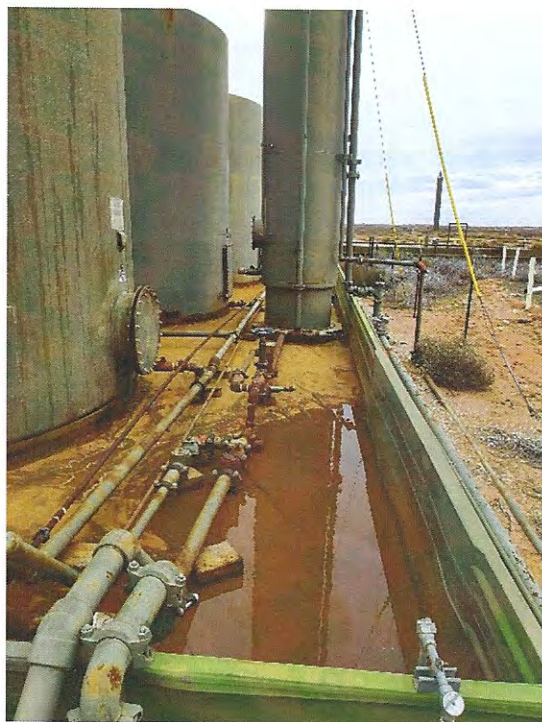
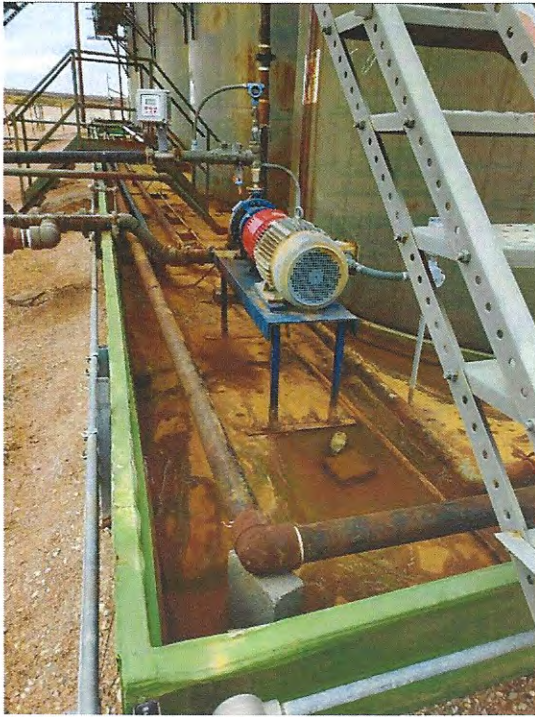
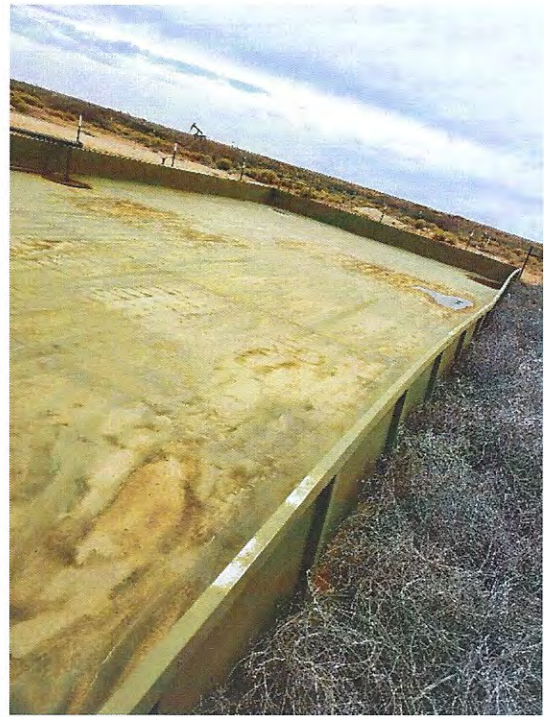
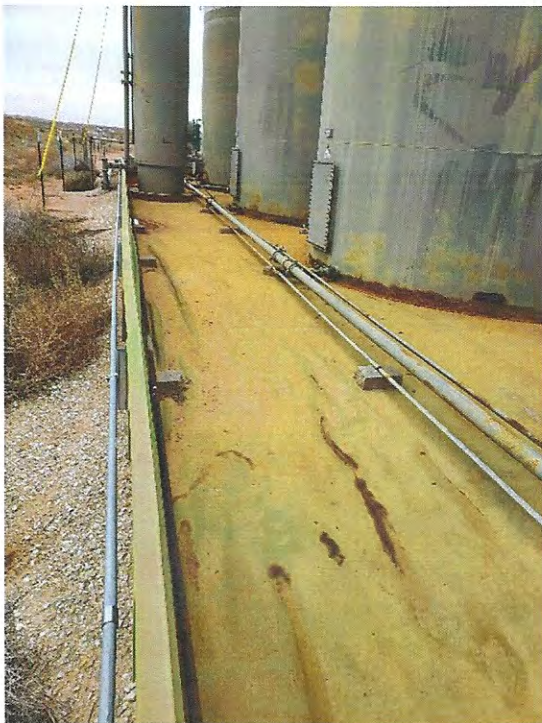
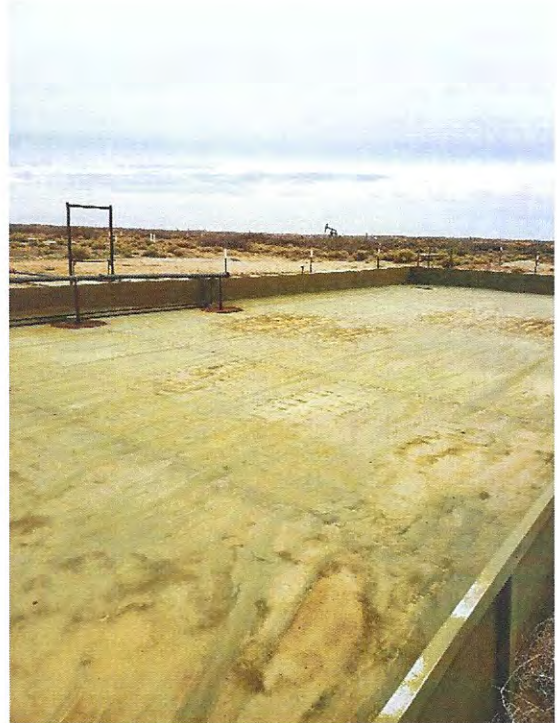
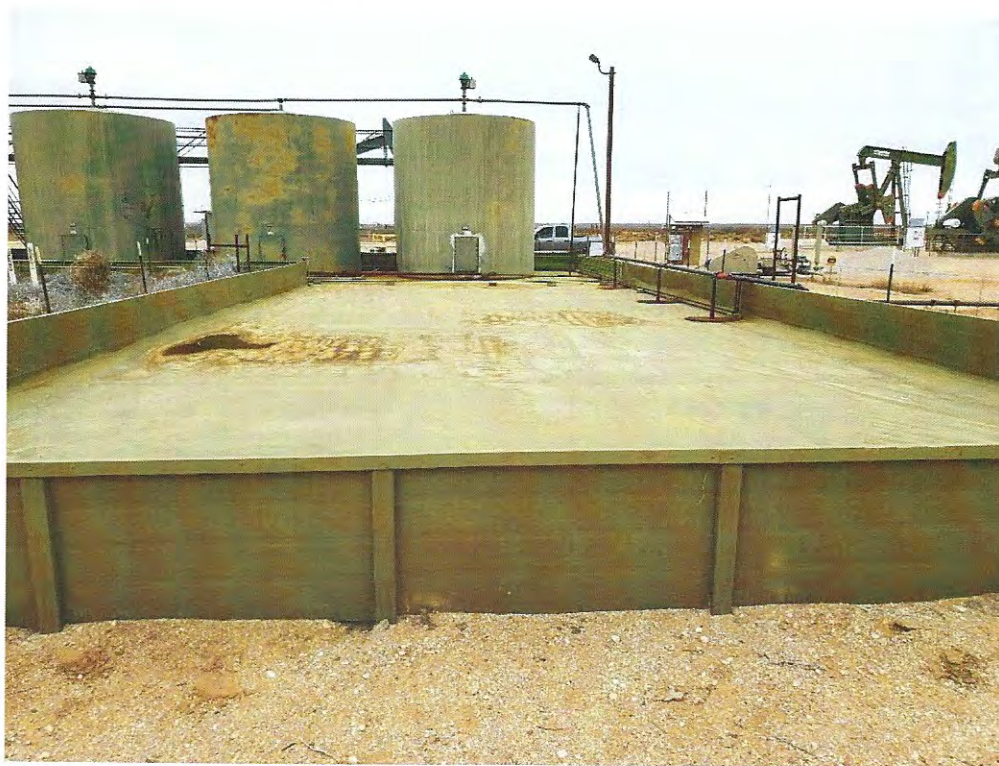
Liner Inspection Photographs

On February 19, 2020, Talon mobilized personnel to the site and conducted the liner inspection, taking photos for the record. Background samples around the battery were collected to ensure the integrity of the liner was not breached. Sample locations are shown on the attached site plan, and the results of our sampling event are presented in the following data table.

Based on this site characterization, liner inspection, and analytical results, we request that no further actions be required, and that closure with regard to the attached incident be granted.
