Vertex Project #: 23E-00466

Spill Closure Report: RDX Federal 17 #016H
Section 17, Township 26 South, Range 30 East
API: 30-015-41089
County: Eddy
Incident Report: nAPP2301628129

2023 Spill Assessment and Closure
March 2023

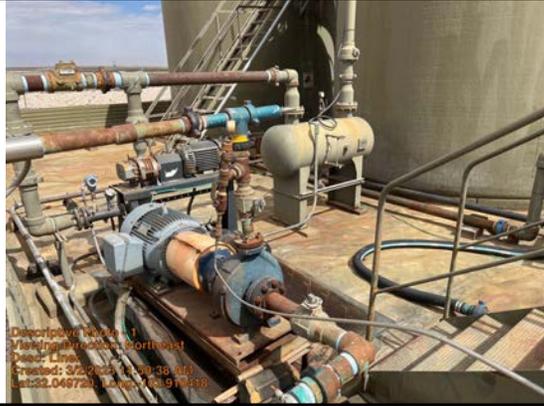
Descriptive Photo - 9
Viewing Direction: Northeast
Desc: Liner
Created: 3/2/2023 11:50:38 AM
Lat:32.048729, Long:-103.910308

Liner in good condition at northwest corner of battery.

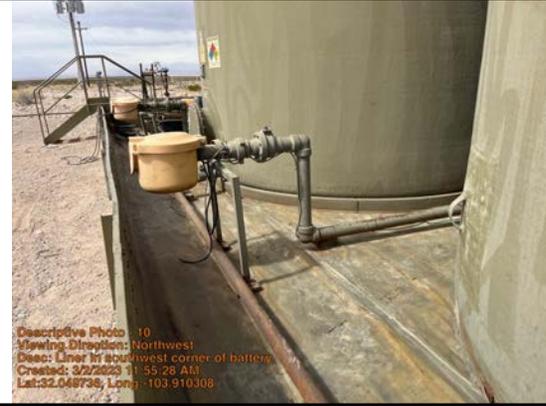
Descriptive Photo - 10
Viewing Direction: Northwest
Desc: Liner in southwest corner of battery
Created: 3/2/2023 11:55:28 AM
Lat:32.048736, Long:-103.910308

Liner in southwest corner of battery.

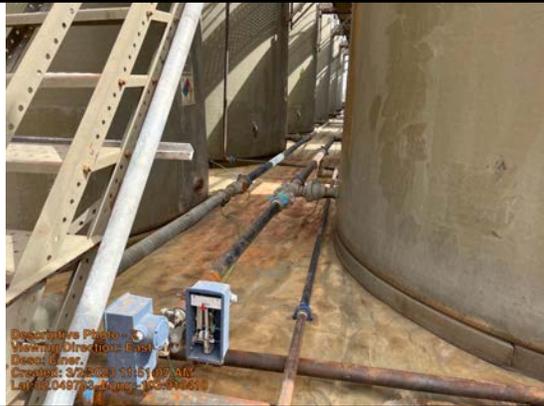
Descriptive Photo - 5
Viewing Direction: East
Desc: Liner
Created: 3/2/2023 11:51:09 AM
Lat:32.048729, Long:-103.910308

Liner in good condition looking into center of battery from the west side.

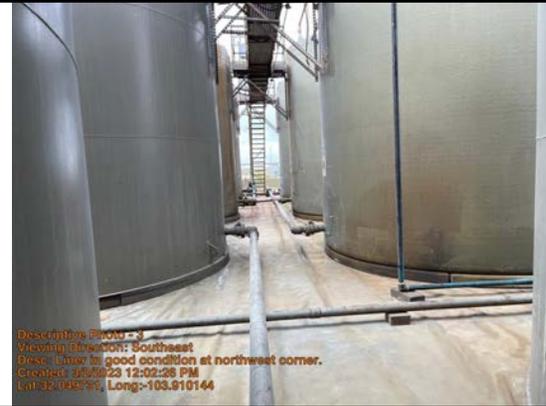
Descriptive Photo - 3
Viewing Direction: Southeast
Desc: Liner in good condition at northwest corner.
Created: 3/2/2023 12:02:28 PM
Lat:32.048729, Long:-103.910144

Liner in good condition in western center of battery.

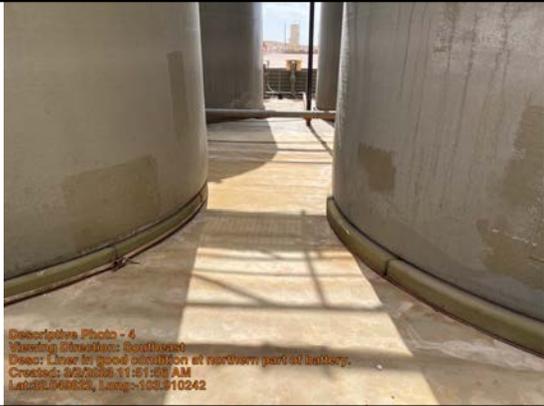
Descriptive Photo - 6
Viewing Direction: South
Desc: Liner in good condition at northern part of battery.
Created: 3/2/2023 11:51:59 AM
Lat:32.046832, Long:-103.910242

Liner in good condition at northern part of battery.

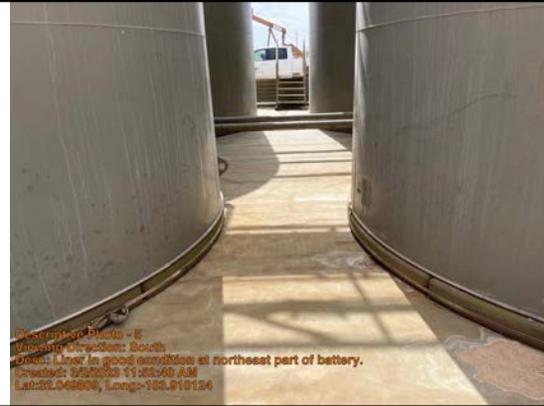
Descriptive Photo - 6
Viewing Direction: South
Desc: Liner in good condition at northeast part of battery.
Created: 3/2/2023 11:52:40 AM
Lat:32.046836, Long:-103.910124

Liner in good condition at northeast part of battery.

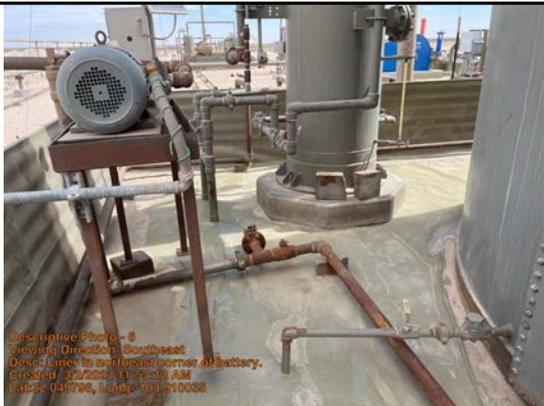
Descriptive Photo - 8
Viewing Direction: Southeast
Desc: Liner in northeast corner of battery.
Created: 3/2/2023 11:54:11 AM
Lat:32.046766, Long:-103.910008

Liner in northeast corner of battery.

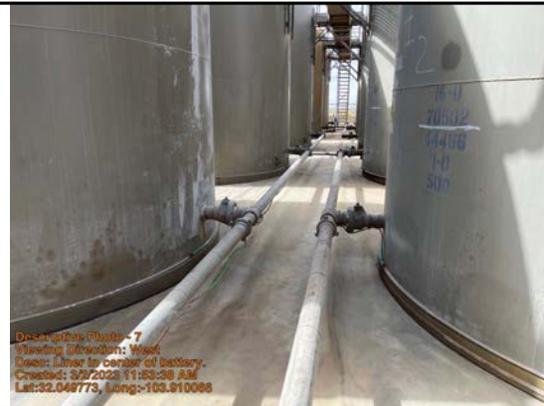
Descriptive Photo - 7
Viewing Direction: West
Desc: Liner in center of battery.
Created: 3/2/2023 11:53:58 AM
Lat:32.046773, Long:-103.910008

Liner in center of battery.
