CLOSURE REPORT

City of Carlsbad

**Eddy County, New Mexico
32.3576775 N, 104.2441101 W
NMOCD Incident ID: nAB1800955279
RP No.: 2RP-4556
API No. 30-015-20325**

May 31, 2023
Ensolum Project No. 03B1417055

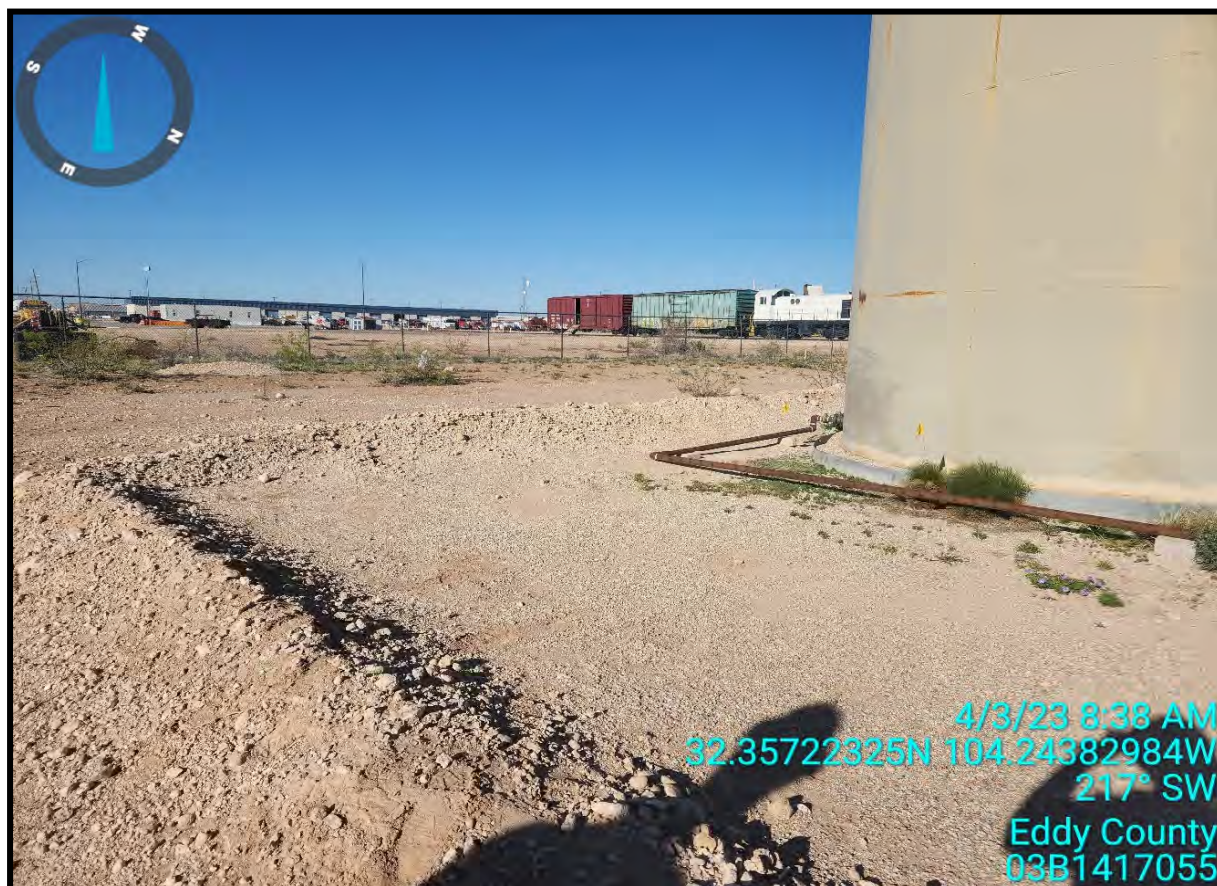
View of impacted area during remediation activities, facing west.

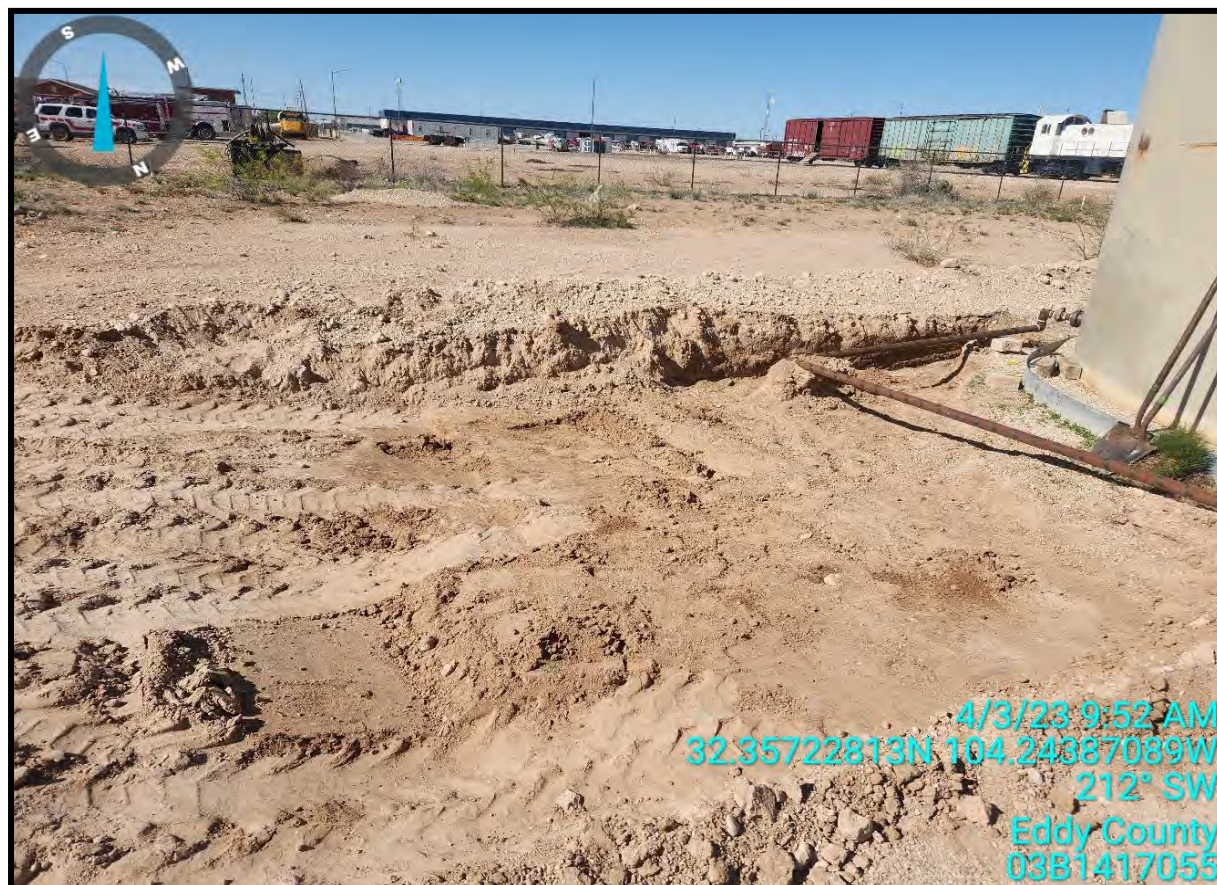
View of impacted area during remediation activities, facing southwest.

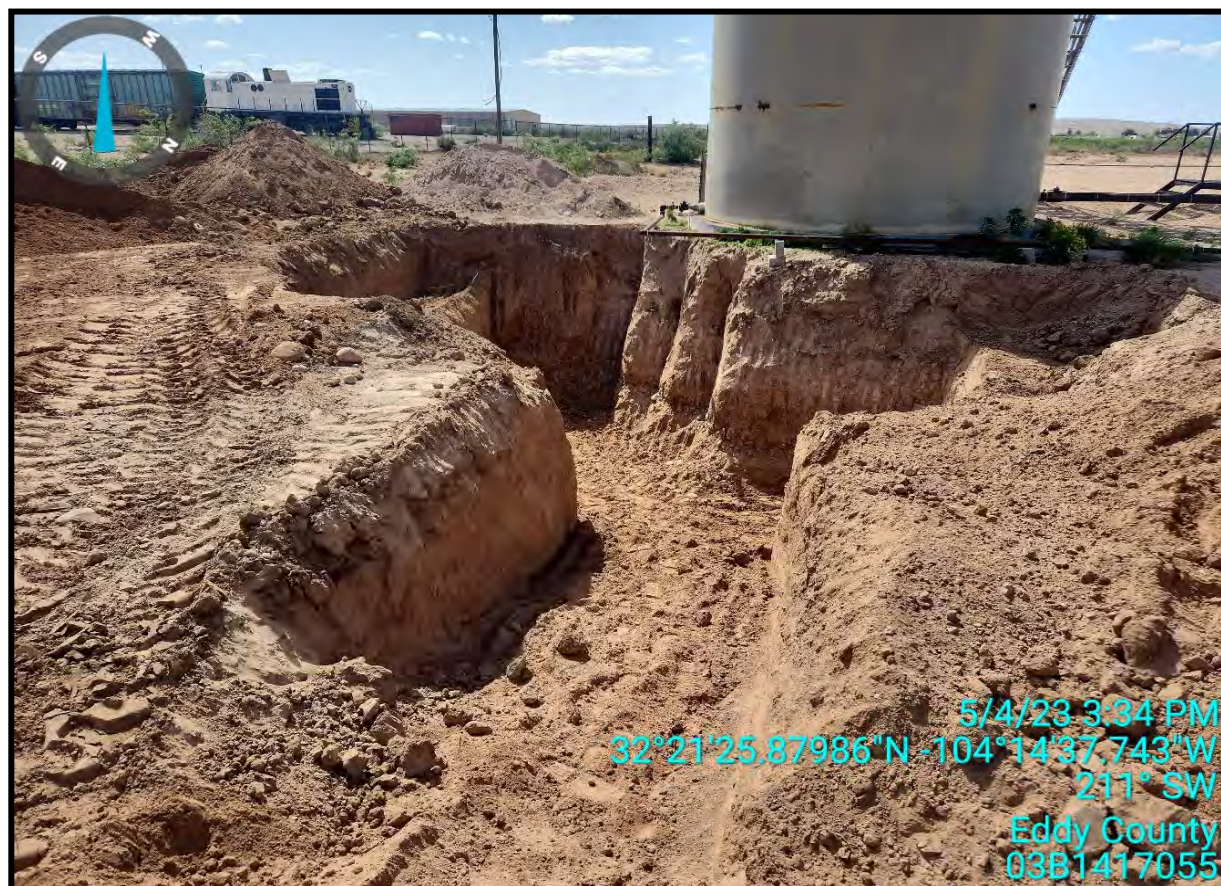
- The final excavation area measured approximately 17.5 feet long by 10 feet wide. The maximum depth of the excavation measured approximately eight feet bgs.

View of final excavation area, facing southwest.

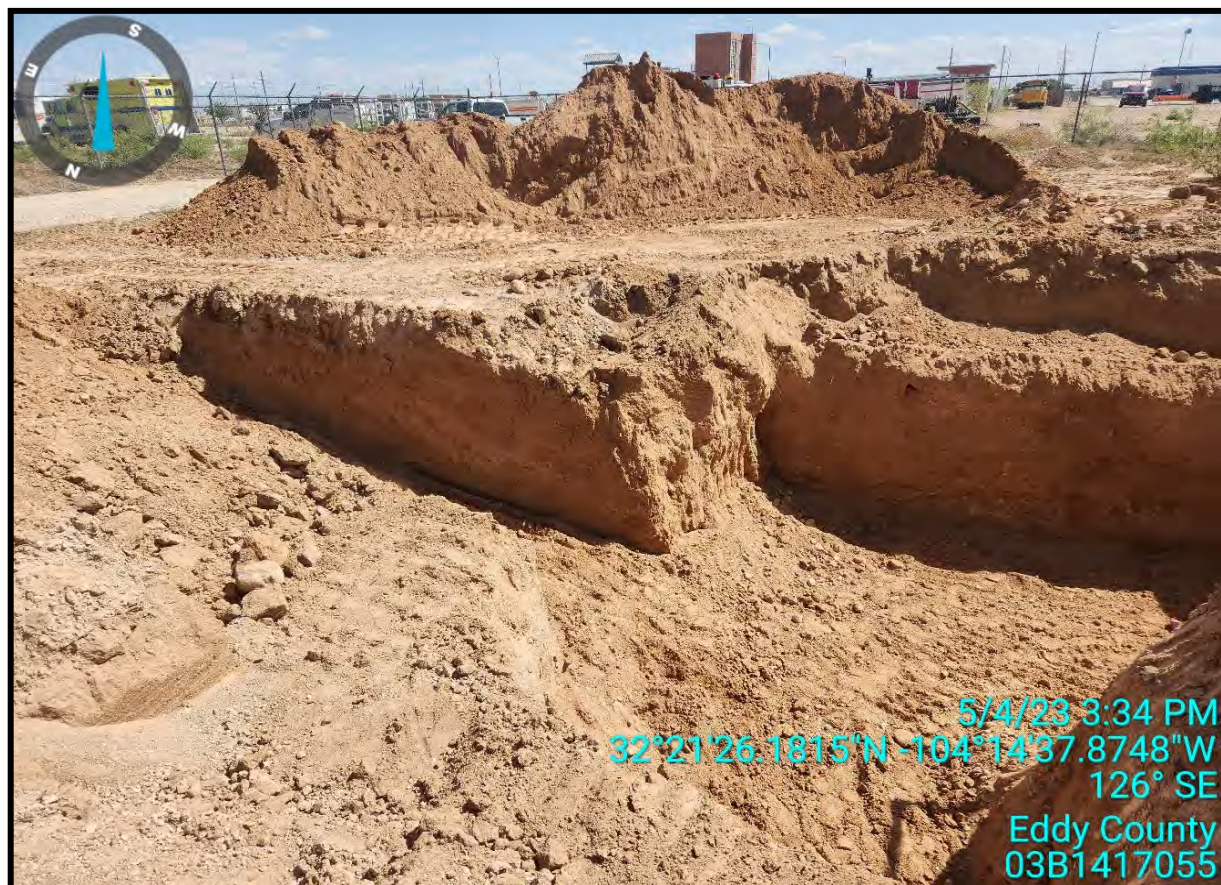
View of final excavation area, facing south.
