**Re: Site Assessment, Remediation, and Closure Report**  
**Antares 23 Fed Wellpad**  
**API No. N/A**  
**GPS: Latitude 32.646662 Longitude -103.848072**  
**UL -- E, 23, T19S, R31E**  
**Eddy County, NM**  
**NMOCD Ref. No. NAPP2304155265**

# Antares 23 Fed Wellpad

**SITE PHOTOGRAPHS  
DEVON ENERGY  
ANTARES 23 FEDERAL #1H**

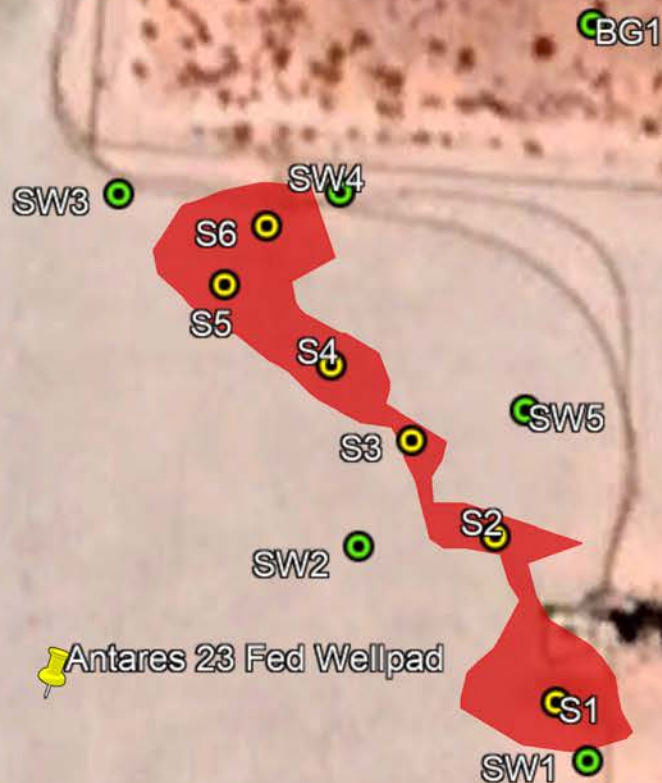
4-Site Map

February 23, 2023, Pima mobilized personnel to the site to begin collecting soil samples from spill area. The laboratory results of this sampling event can be found in the following data table. A Site Map can be found in Figure 4.

Devon Energy  
API: 30-015-41105  
Eddy County, NM  
Site Map

Spill Area 2,516 Sqft

On March 31, 2023, the Devon Construction Department mobilized personnel and equipment to begin remediation activities. They began excavating the area to a depth of 2' BGS. The contaminated soil, approximately 186 cubic yards, was hauled to an approved, lined disposal facility and clean backfill material was brought in.

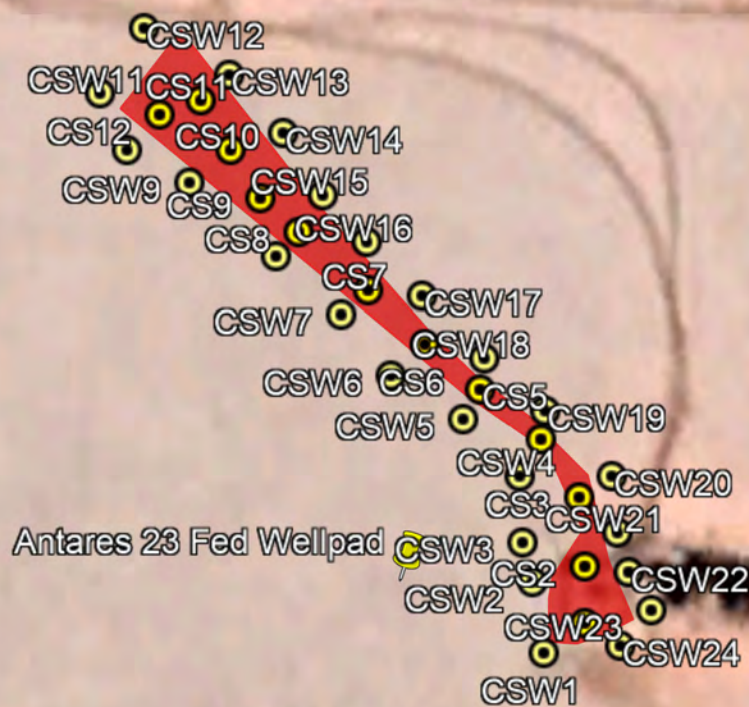
5-Confirmation Sample Map

On April 7, 2023, after sending a 48-hour notification (Appendix C), Pima returned to the site to collect confirmation samples of the excavation. The results of this sampling event can be found in the following table. A Confirmation Sample Map can be found in Figure 5.

Devon Energy  
API: 30-015-41105  
Eddy County, NM  
Confirmation Sample Map

Confirmation Samples

Based on the sample results, the bottoms and sidewalls were below NMOCD Closure Criteria 19.15.29 NMAC. The contaminated material was sufficiently removed then transported to an NMOCD approved disposal site. The excavation was then backfilled with clean like material, machine compacted and returned to its previous state. See Appendix D for Photographic Documentation.

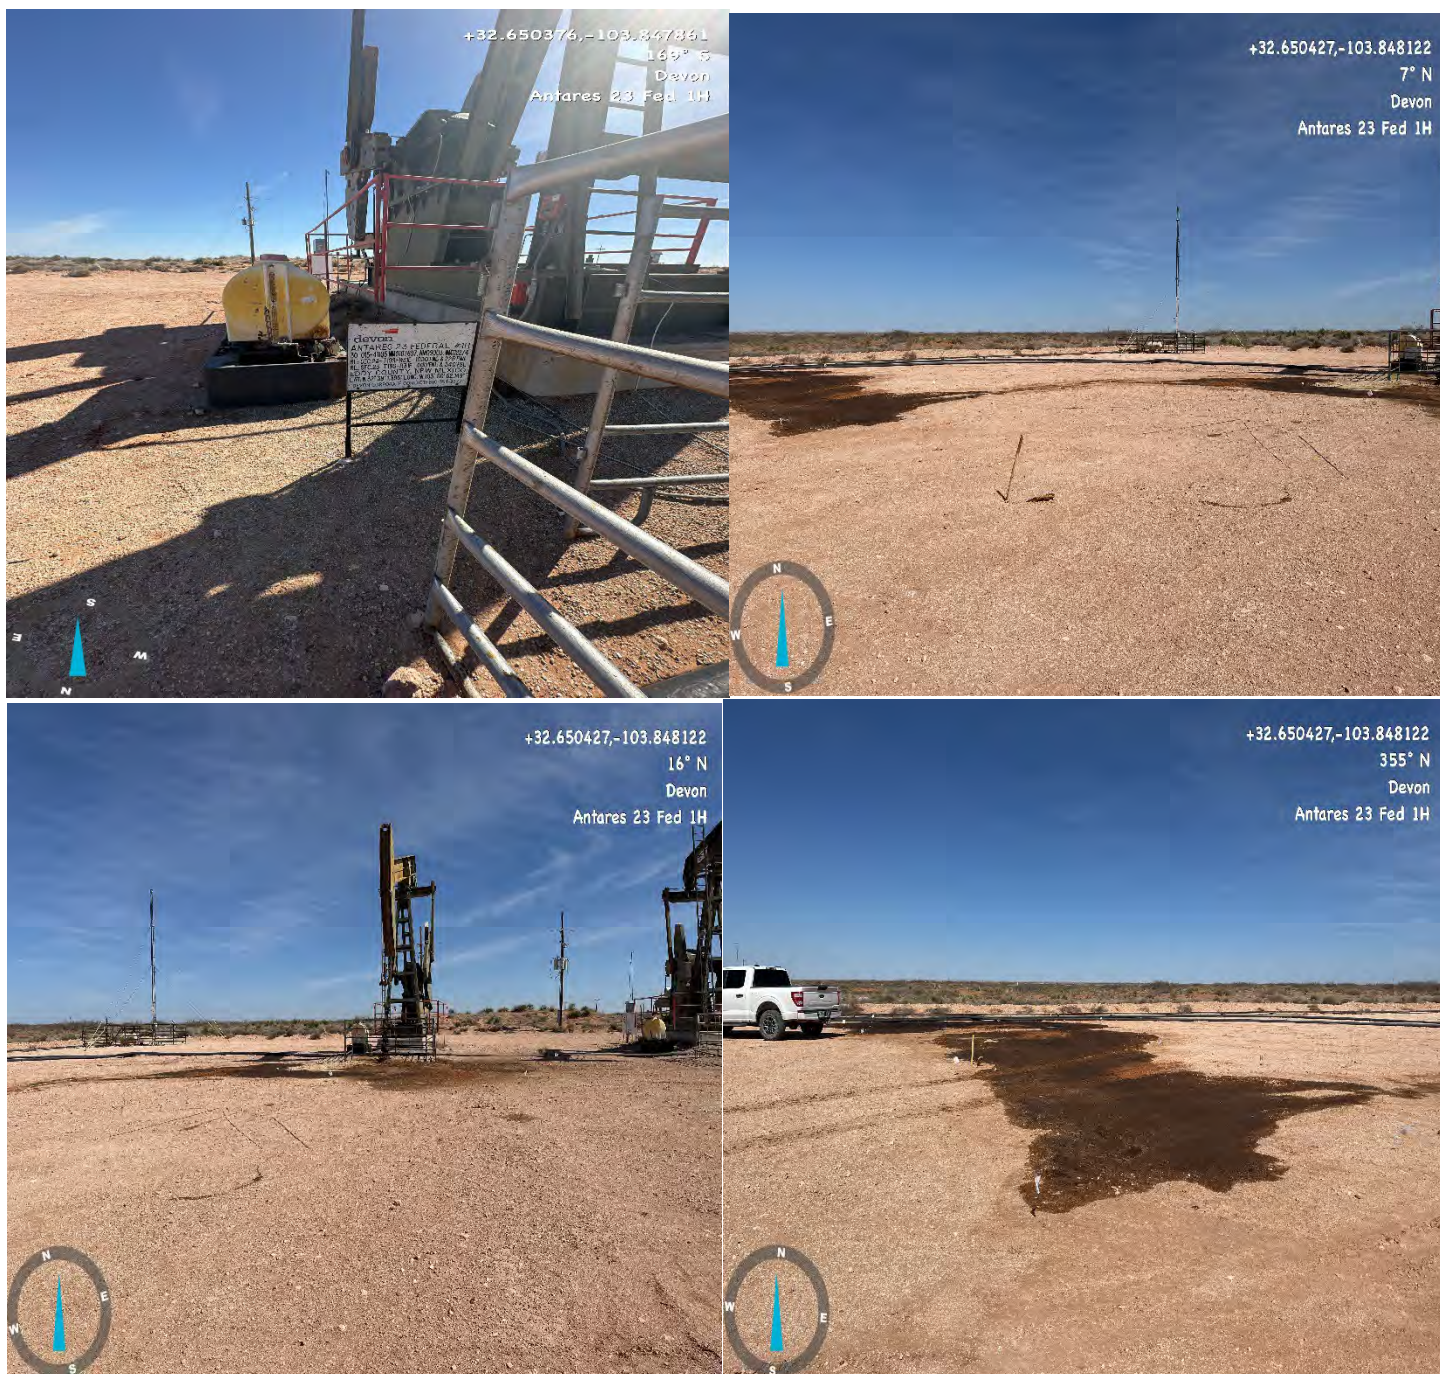
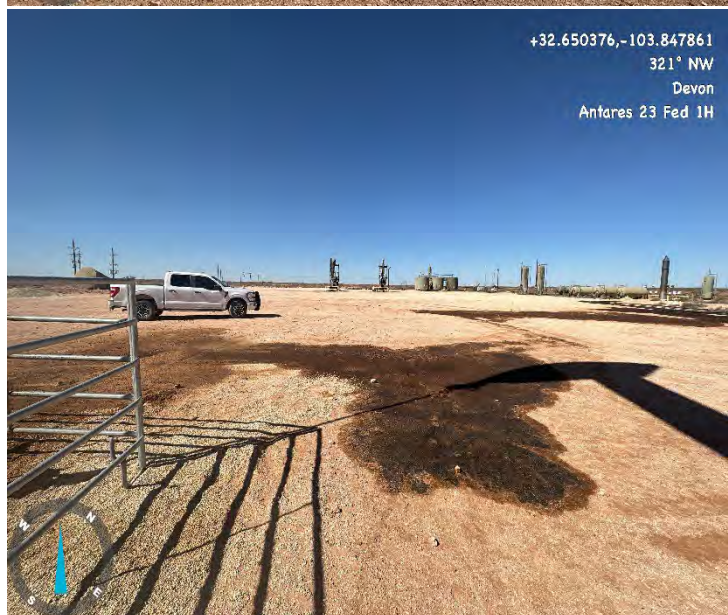
**Site Assessment**

**NAPP2304155265:** On February 10, 2023, a leak developed from the stuffing box flange, causing a fluid to be released on the pad. The released fluids were calculated to be approximately 7.4 barrels (bbls) of crude oil. A vacuum truck was able to recover 4 bbls of standing fluid.
