**Re: Remediation Work Plan**

Aztec #9  
Aztec, New Mexico  
Hilcorp Energy Company  
NMOCD Incident No: nAPP2307357709

Ensolum, LLC (Ensolum), on behalf of Hilcorp Energy Company (Hilcorp), presents this *Remediation Work Plan* (Work Plan) for a release at the Aztec #9 natural gas production well (Site). The Site is located on private land in Aztec, New Mexico (Figure 1). This proposed Work Plan includes additional delineation and remediation of impacted soil and groundwater originating from a release of produced water and condensate due to external corrosion of an aboveground storage tank (AST). The Site is located in Unit M, Section 9, Township 30 North, Range 11 West, in San Juan County, New Mexico.

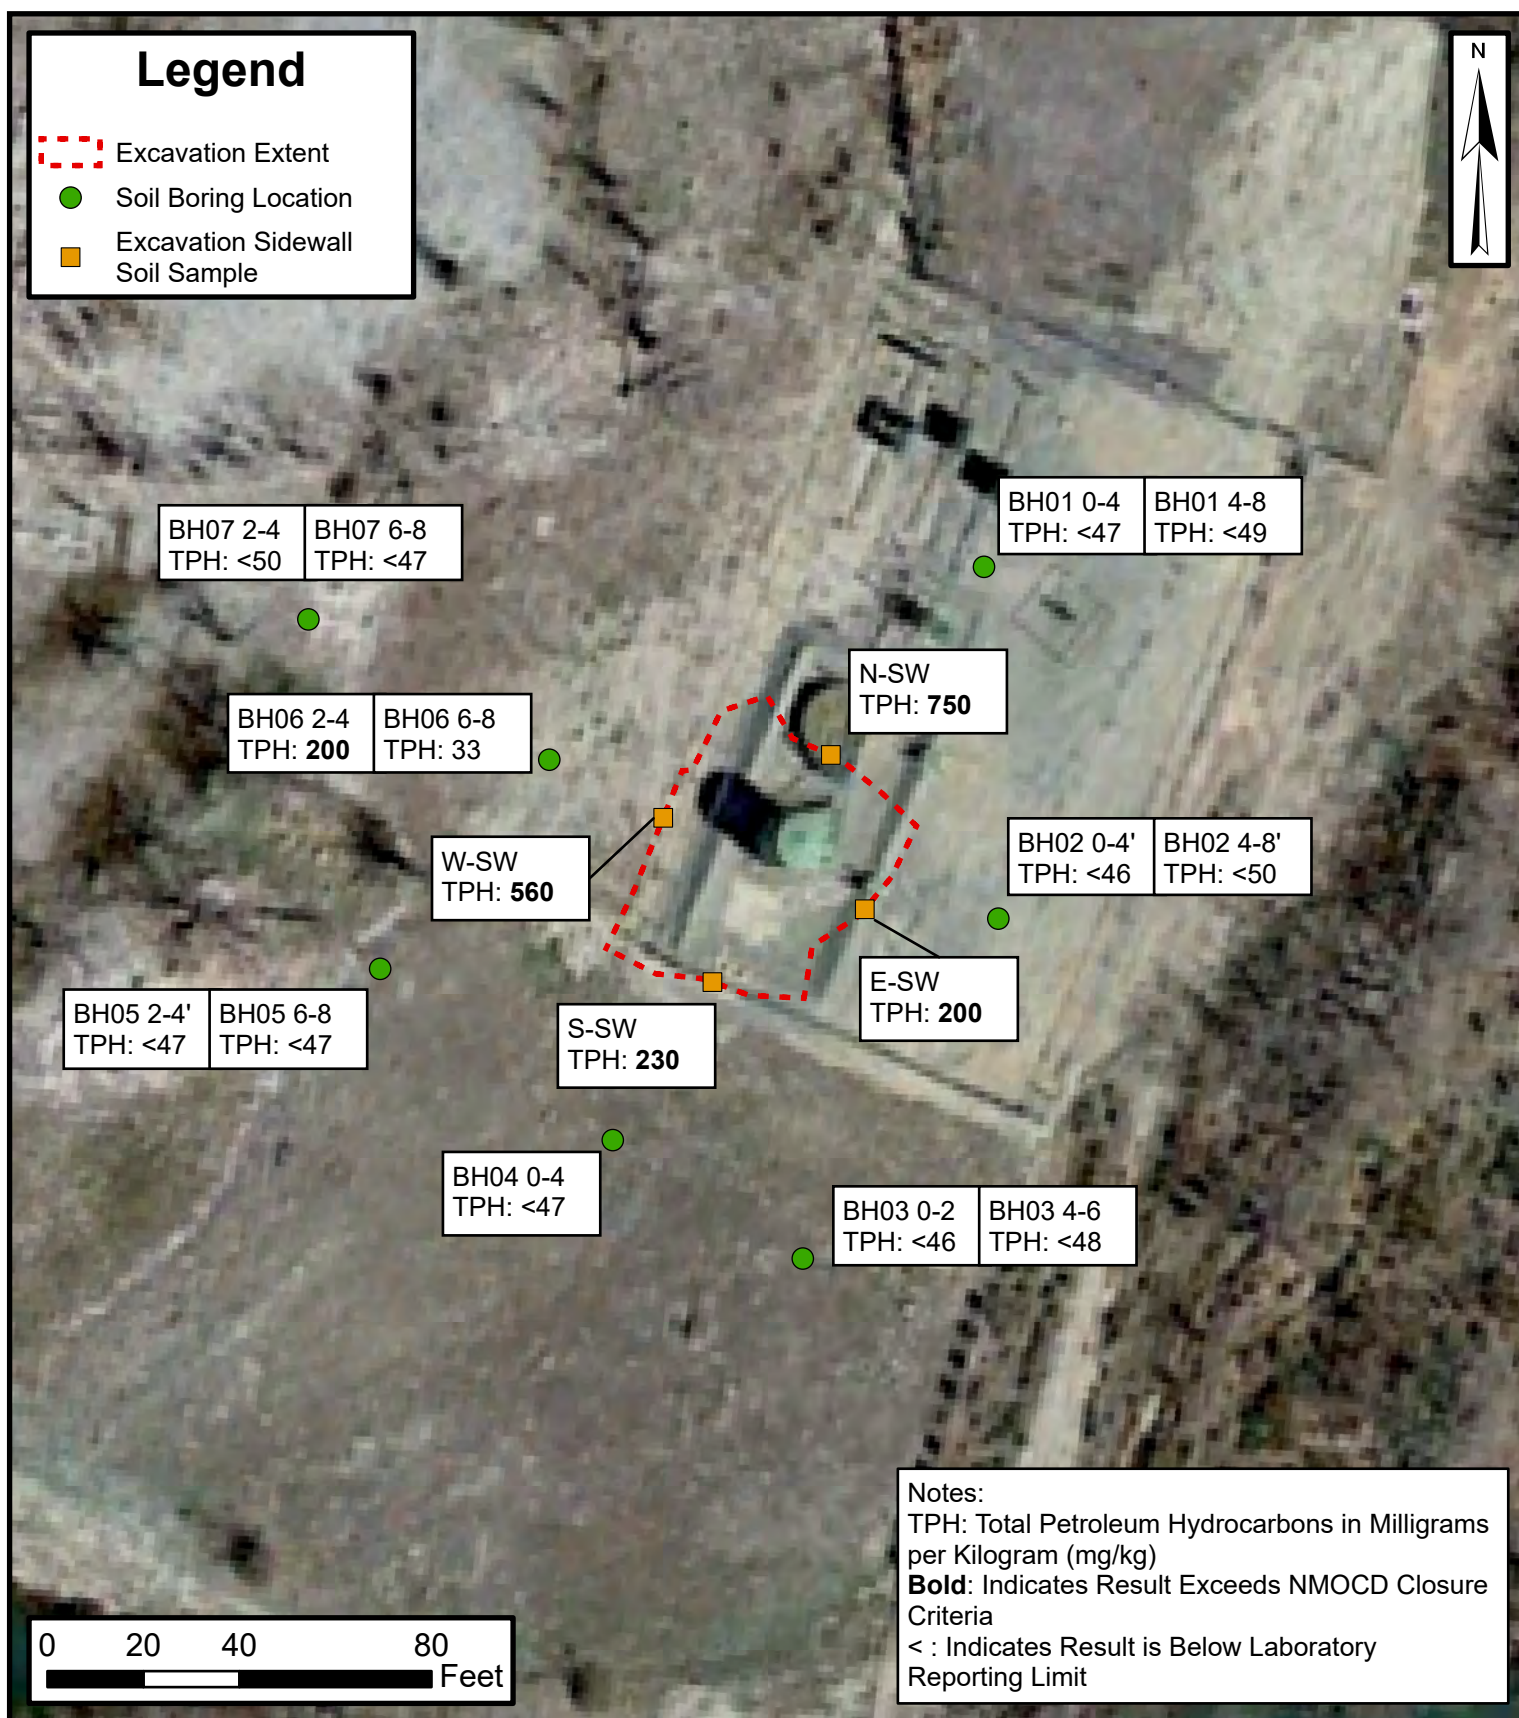
## Soil Analytical Results

Due to the likelihood of shallow groundwater at the Site, Hilcorp conducted excavation activities of impacted soil located on the well pad on March 6 and 7, 2023. Soil was removed from the area indicated on Figure 2 to a depth of approximately 6 feet bgs, at which point groundwater was encountered within the excavation. During excavation, an Ensolum geologist logged soil lithology and inspected the soil for petroleum hydrocarbon staining and odors. Soil descriptions were noted in a field book and generally followed the Unified Soil Classification System (USCS), as specified in American Society for Testing and Materials (ASTM) method D2488. Soil samples were also field screened for the presence of volatile organic compounds (VOCs) using a calibrated photoionization detector (PID), with results noted in the field book.

Five-point composite soil samples were collected from each sidewall (north, south, east, and west) and immediately placed on ice. Samples were submitted to Hall Environmental Analysis Laboratory (Hall) for analysis of BTEX following United States Environmental Protection Agency (EPA) Method 8021B, TPH following EPA Method 8015D, and chloride following EPA Method 300.0. Based on analytical results, summarized in Table 1, TPH remained in all sidewalls at

concentrations exceeding the NMOCD Closure Criteria. However, BTEX and chloride concentrations were not detected above their respective Closure Criteria in any of the analyzed samples.

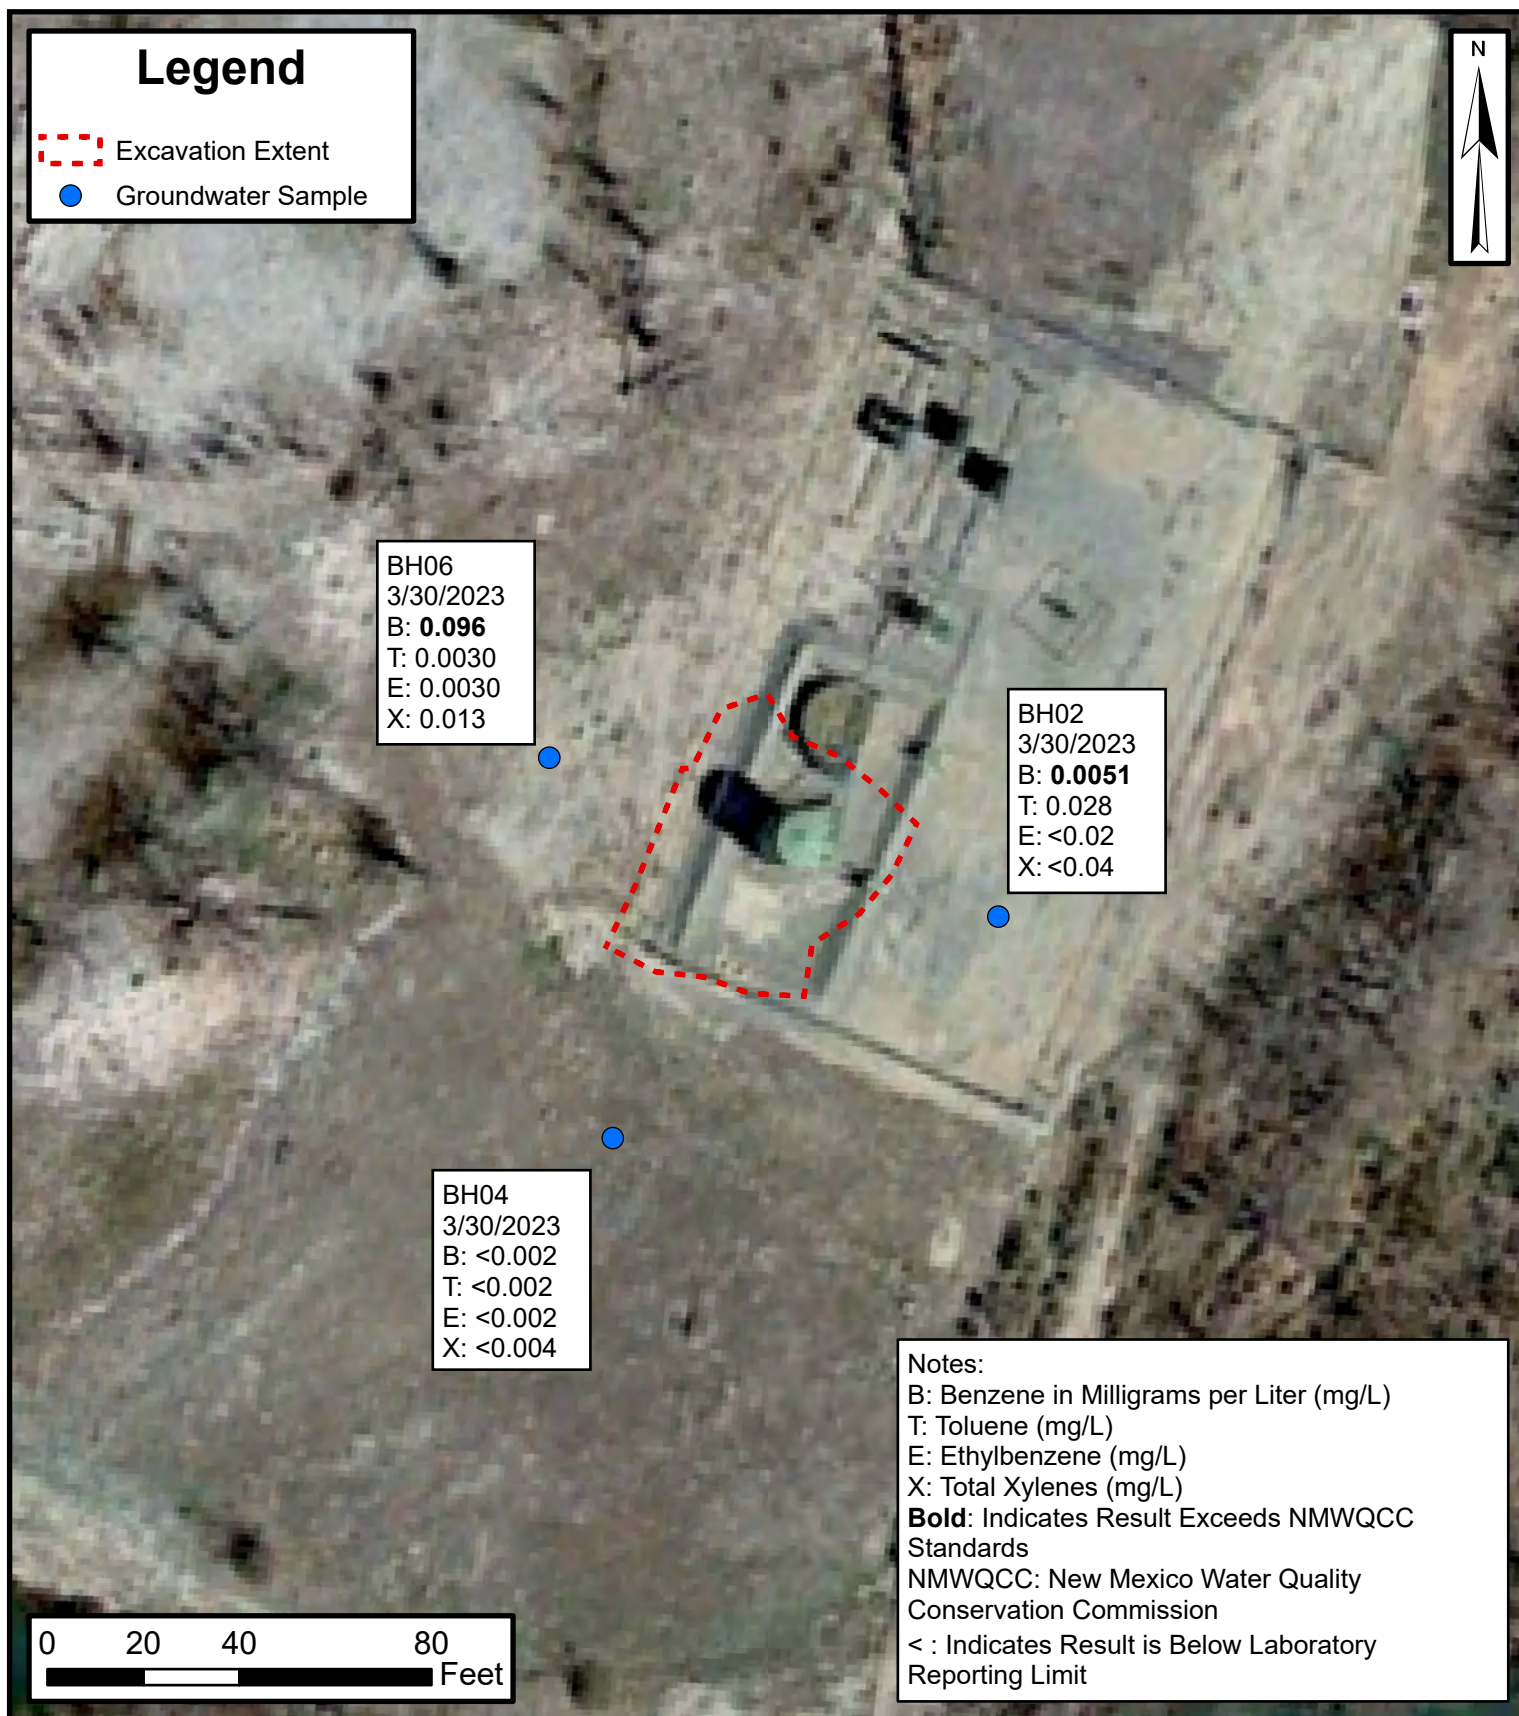
## Groundwater Analytical Results

Grab samples of groundwater were collected by advancing a Geoprobe® Hydropunch into the saturated zone at locations BH02, BH04, and BH06 (Figure 3). After the required depths were reached to encounter groundwater, the sample rod was retracted several feet to expose a stainless-steel well screen housed inside of the sample rod. Once exposed, groundwater was allowed to infiltrate into the well screen. Tubing was placed through the sample rods into the well screen and samples were collected directly into laboratory provided containers using a peristaltic pump. Samples were submitted to Hall for analysis of BTEX by EPA Method 8021B.

Benzene was detected in the groundwater samples at concentrations exceeding the New Mexico Water Quality Control Commission (NMWQCC) standard at locations BH02 and BH06. No other constituents were detected above NMWQCC standards from any of the wells. A summary of analytical results are summarized in attached Table 3 and Figure 3, with complete laboratory reports also attached in Appendix E.

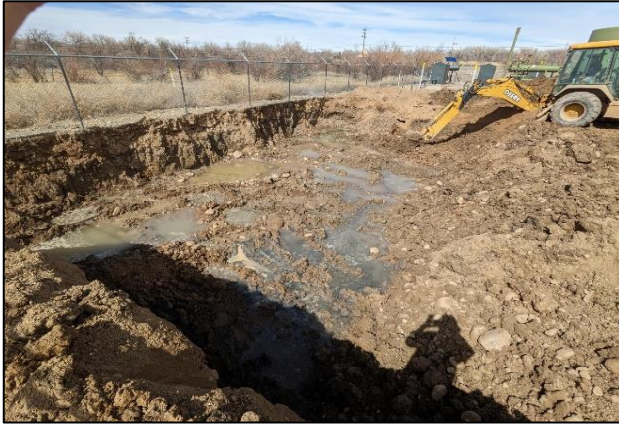
Photograph: 1                      Date: 3/6/2023  
Description: Excavation extent on March 6, 2023  
View: Northwest

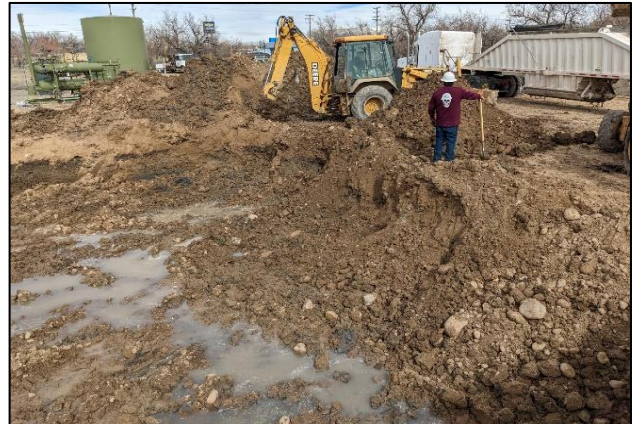
Photograph: 2                      Date: 3/6/2023  
Description: Excavation extent on March 6, 2023  
View: Northeast

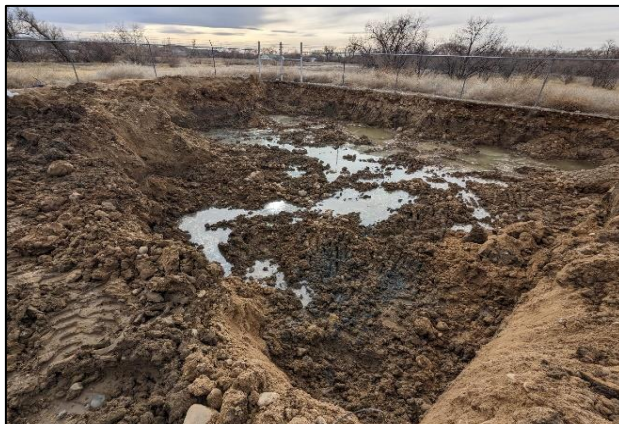
Photograph: 3                      Date: 3/7/2023  
Description: Excavation extent on March 7, 2023  
View: Southwest

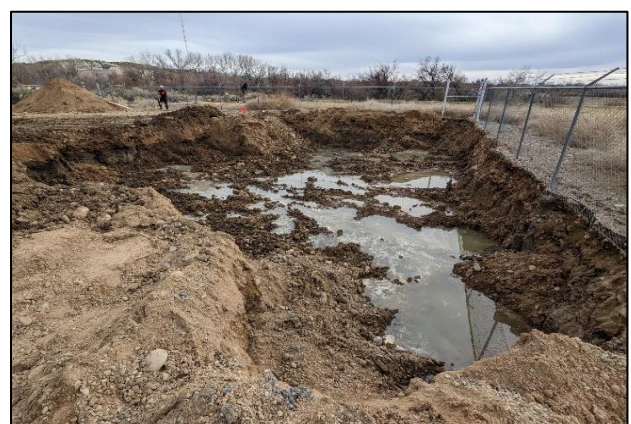
Photograph: 4                      Date: 3/7/2023  
Description: Excavation extent on March 7, 2023  
View: South
