## Release Notification

Site Name: Blue Bell #2	Site Type: Central Tank Battery
Date Release Discovered: 03/04/2023	API# (if applicable)

Cause of Release: Human error during loading operations and overfilled tank trailer. Released crude flowed off the tank battery pad onto the pasture area.

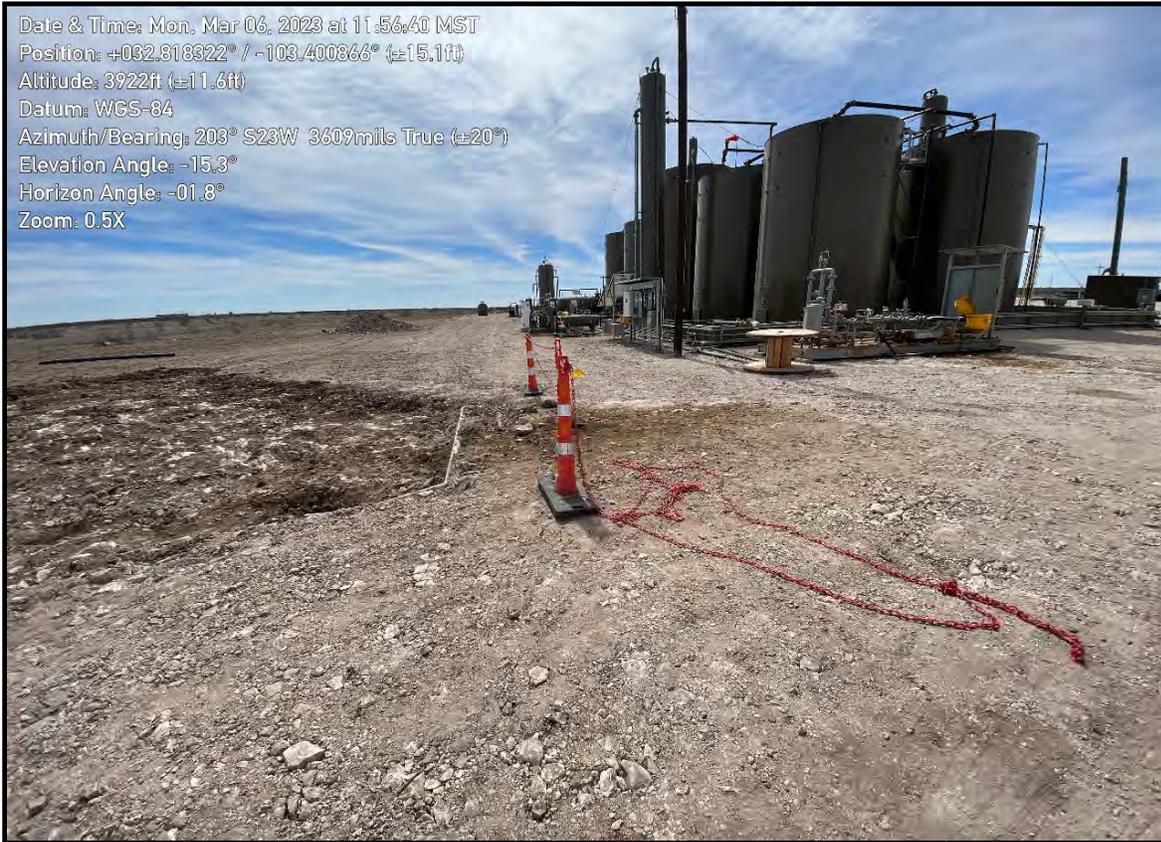
View of the release area during initial response action activities, facing southwest.

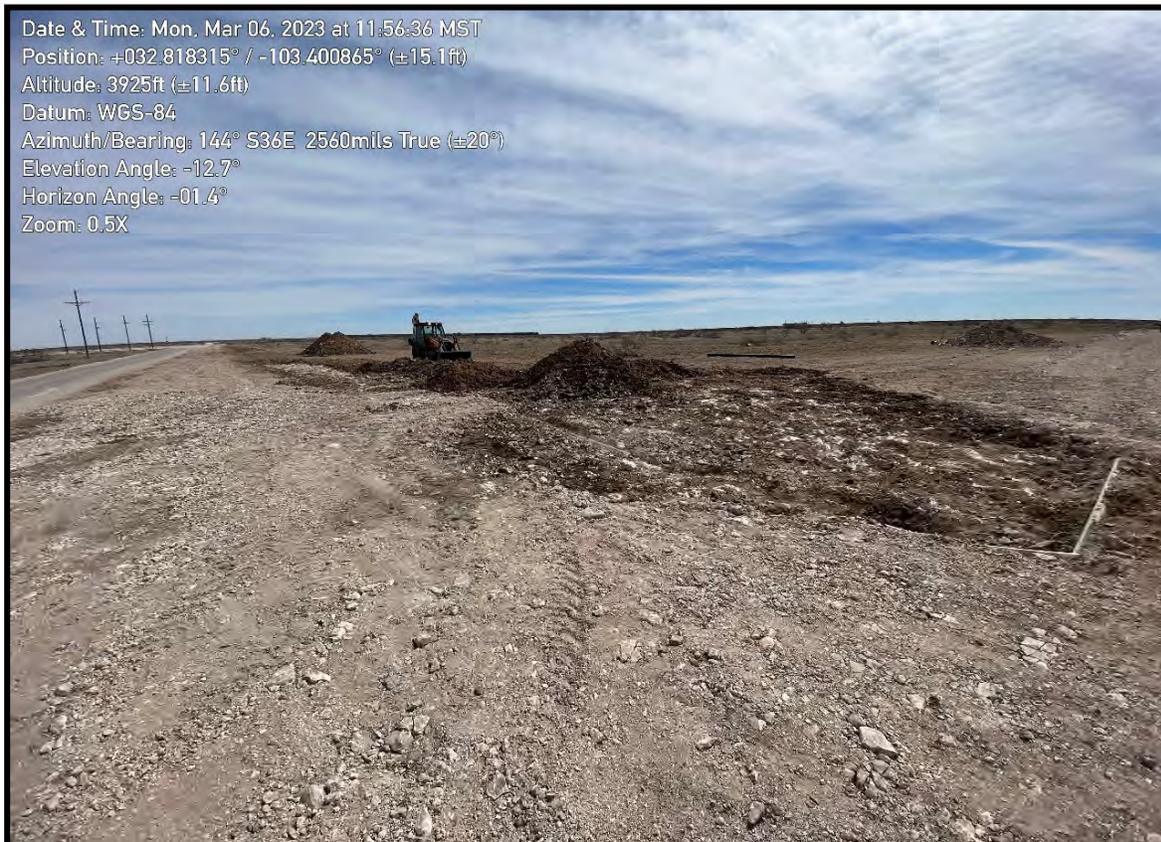
View of the release area during initial response action activities, facing southeast.

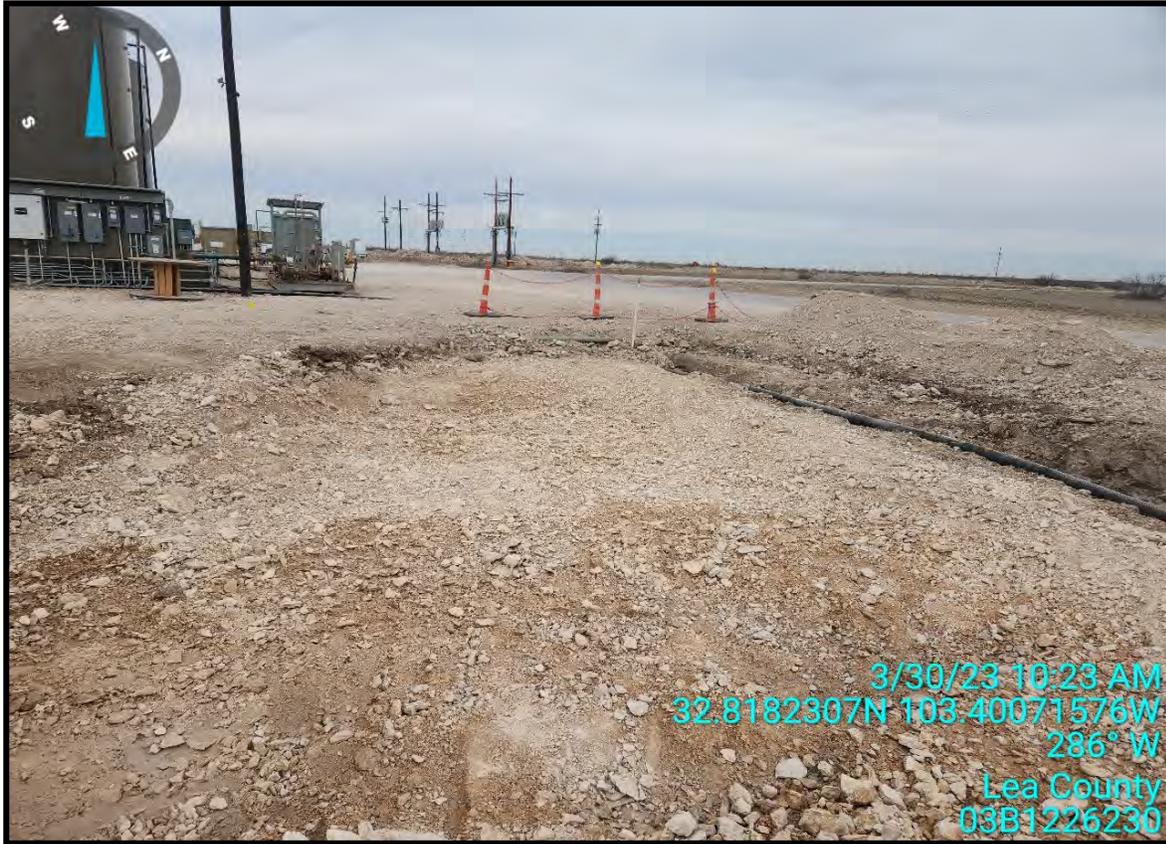
View of the excavation area during response action activities, facing west.

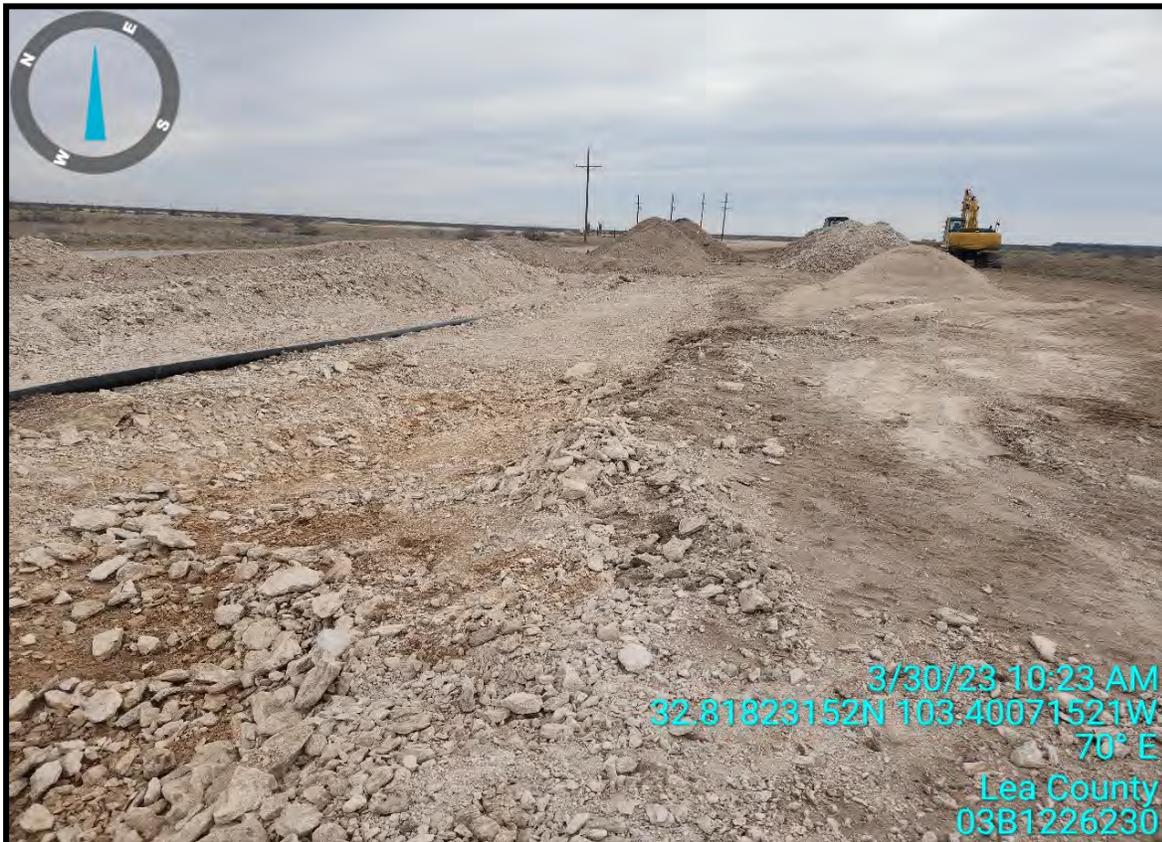
View of the excavation area during response action activities, facing east.
